Tree Inventory Report

**25500 Clawiter Road
Hayward, CA**

October 7, 2020

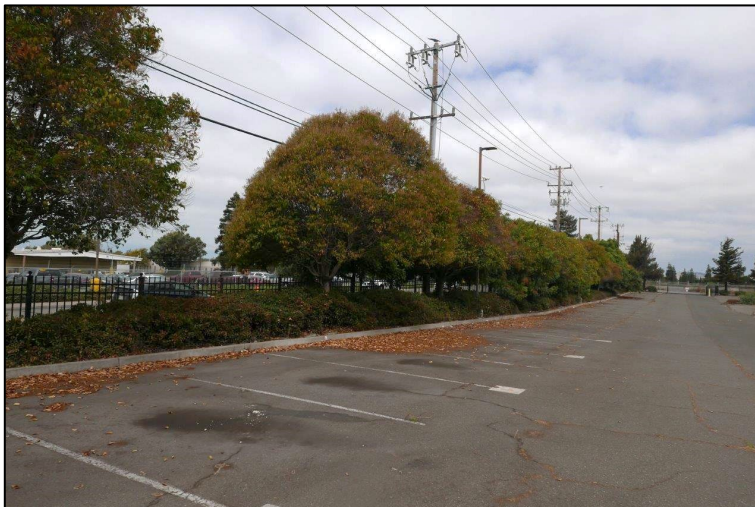
Photo 1. Japanese privets lined the parking lot at the western side of the property along Clawiter Road.

More than half of the privets (15 trees) were in poor condition, while 10 were in fair condition and only one tree (#352) was in good condition (Photo 1). The privets ranged in size from 4 to 12" in diameter. Many of the privets had varying degrees of thinning in their crowns and twig dieback, common indicators of stress and decline.

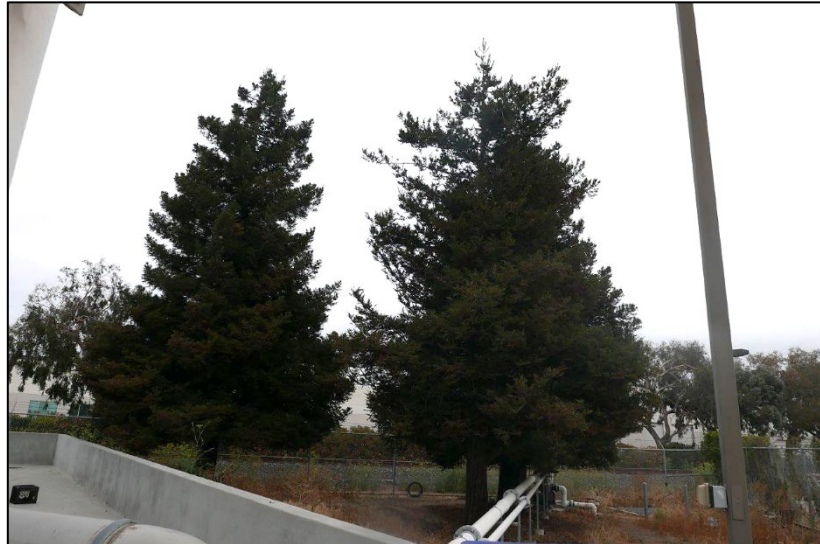
Photo 2 (right). Coast redwoods #362, 359 and 360 (left to right) were growing in the southeast corner of the property, in moderate to good condition.

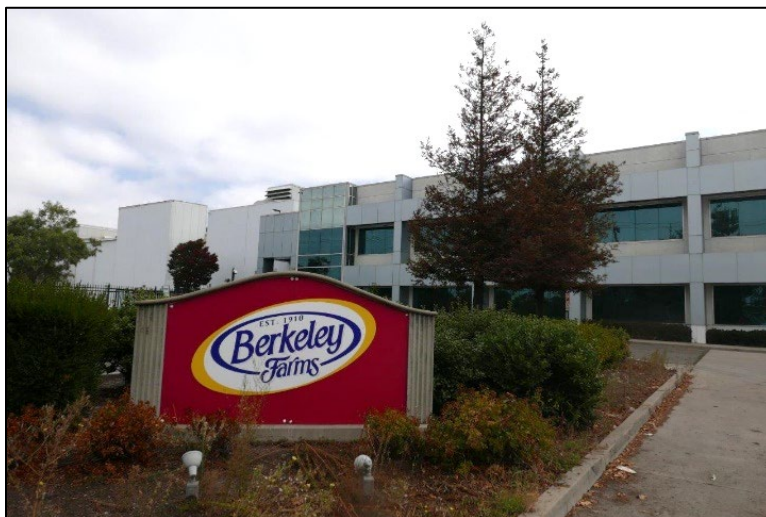
The second most frequently occurring species was the coast redwood, with 20 trees (23% of the population). Seven trees were in good condition, nine were in fair condition, and four were in poor condition. They ranged in size from 8 to 22-inches in trunk diameter. Generally, the coast redwoods growing in groups were in better condition; whereas, single trees growing in small beds near parking areas were severely drought-stressed (Photos 2 and 3).

Photo 3 (below). Coast redwoods #333 and 332 (left to right) were drought-stressed, with browned foliage.

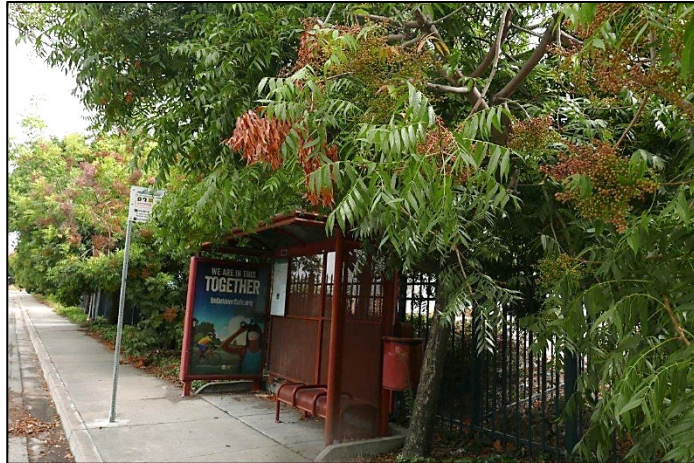
growing in the right-of-way along Clawiter Road. These trees were vigorous with low branches overhanging the sidewalk (Photo 4). These street trees appeared healthy, but exhibited structural issues such as crossing branches and multiple attachments arising from the same point along the trunk.

Photo 4. Chinese pistache #364 (right side of photo) was growing next to the bus stop on Clawiter Road. Other pistache trees are visible along the sidewalk in the background.

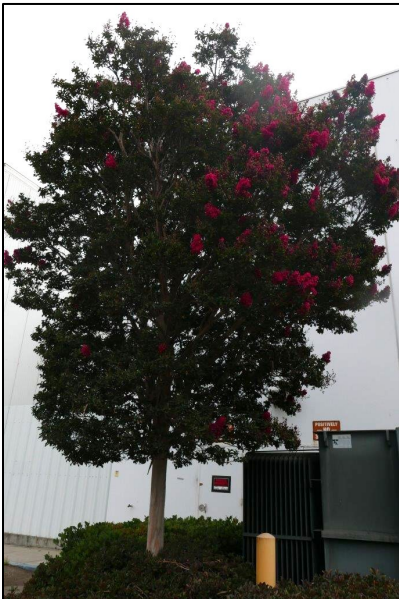
Photo 5. Crape myrtle #301 was a vigorous tree in good condition.
