**North American Society for Trenchless Technology (NASTT)
NASTT's 2016 No-Dig Show**

TA-T2-03

Trenchless Rehabilitation Planning and Design, Using Diagnostic Imaging, Condition Assessment and Multimodal Rehabilitation Techniques: A Case Study

Alex Palmer, Inversa Systems, Fredericton, New Brunswick
Stephen McCormick, Inversa Systems, Fredericton, New Brunswick
Daniel Madore, Via360, Montreal, Quebec

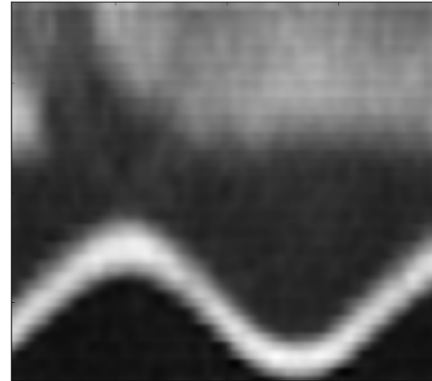
Figure 6. Sample BCT image which shows a soil void along the CMP wall as well as “piping” going towards the top left corner of the image, indicating the direction from which water is washing away the supporting soil.

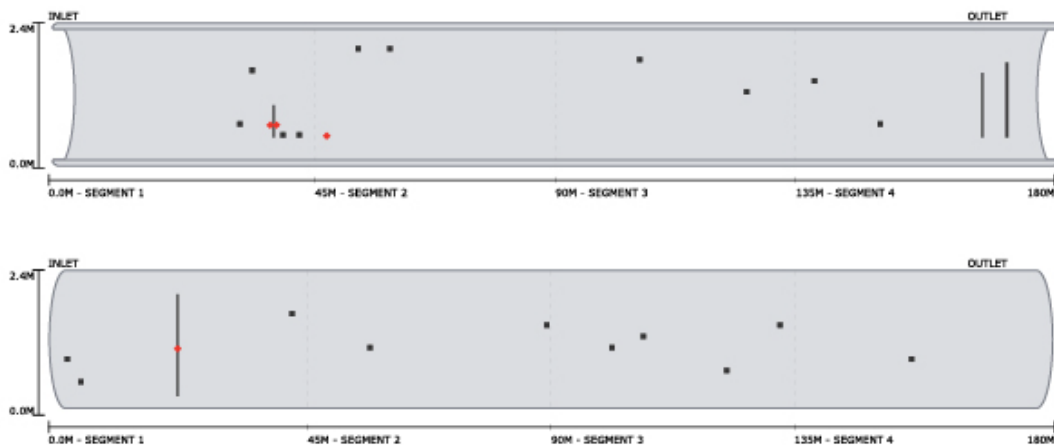
4.1.1 Condition Assessment Results A visual and acoustic assessment was carried out. Four acoustic anomalies were identified during the “knock test” of which two were chosen for follow-up BCT imaging. Only two locations chosen because the outlet section of pipe presented unsafe conditions for hardware deployment. The locations were measured from manhole access (STA0+000) to the outlet (STA0+180).

Figure 8. Overview pipe map displaying visual indicators as black squares, acoustic anomalies as black rectangles and BCT image locations as red diamonds.

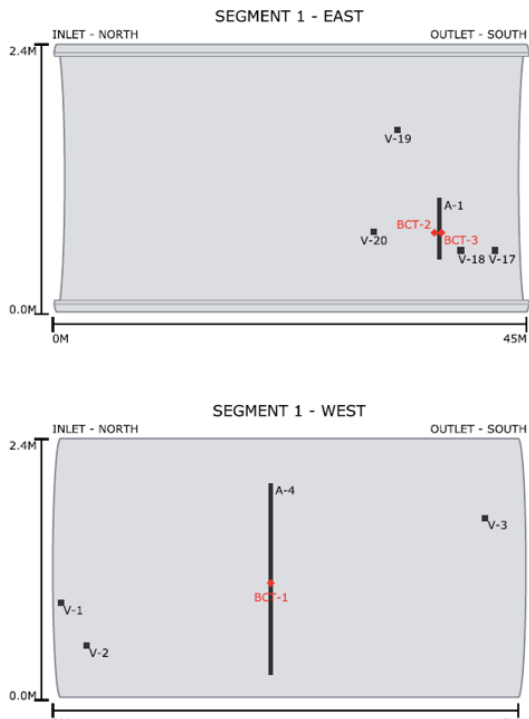
Figure 9. Segmented pipe map of pipe section 0m-45m.

The visual inspection documented several deficiencies associated with the pipe barrel and the embankments. Most notably seams throughout the storm drain are in poor condition, several with visible voids both above and below the pipe, allowing water to run underneath causing flow related soil failure. The ovality of the pipe is greater than 10%, with the majority of issues being underneath Autoroute #73. Several rock impingements were noted, the largest of which was located directly beside the manhole entrance located beneath Autoroute #73, at (STA0+137). The bitumen coating throughout the pipe has become dried out and brittle, chipping during hammer testing. The outlet of the storm drain (STA0+156) to (STA0+180) is in very poor condition, two acoustic anomalies were found. Evidence of buckling and significant scour was noted. The outlet of the pipe is damaged with several large indentations.

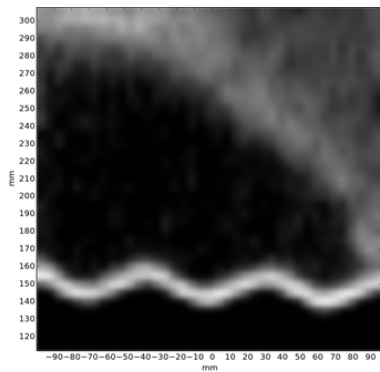
BCT images were taken at two locations to verify soil structure. The largest confirmed void was verified in image A-2141 and quantified to 14cm in depth spanning at least 3 corrugations. The location of this void was concerning due to its location directly under Autoroute #73. Image B-2142 displays discontinuous CMP wall, which was covered by a low density rubber seal, and a small soil void pocket behind a seam separation. Image C-2143 indicates a void in a single corrugation but it does not span corrugations. Image D-2144 confirms adequate backfill supporting this region of pipe

Figure 10. BCT images show various soil voids behind the pipe wall.

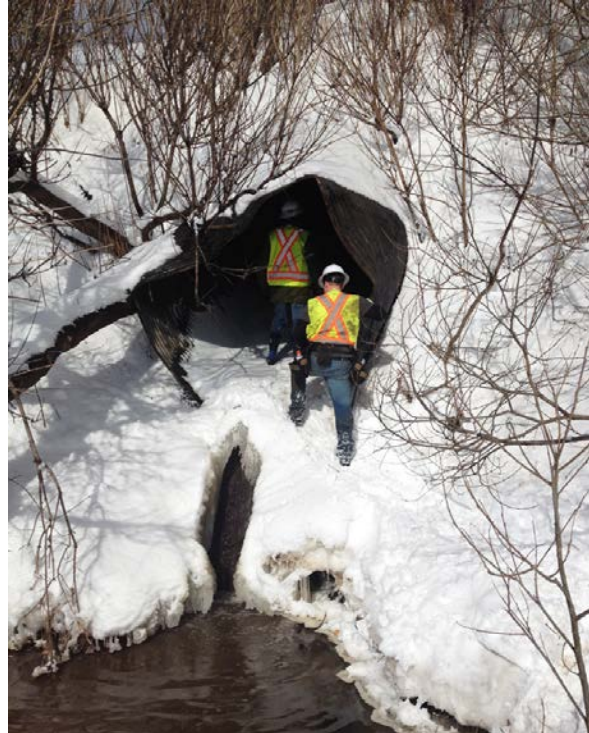
The outfall segment of pipe (STA 0+156 to STA 0+180) was installed at a severe downward slope, this section of pipe is not directly under Autoroute #73, but it does support the embankment and contribute to the Autoroute's stability. There are numerous and significant deficiencies noted in this segment, it is severely undermined and a highly visible wall buckling failure is occurring. It may be possible to temporarily stabilize this segment, but replacement is the only long-term viable solution, due to the advanced state of deterioration.

Figure 11. Outlet of pipe.

This section discusses the recommended action for the down sloping outfall section of the pipe from STA 0+156 to STA 0+180. This segment of the pipeline was in a state of advanced deterioration. There were obvious signs of undermining throughout the entire invert, wall buckling failure in the invert, and severe damage to the pipe end. The long term viability of this segment was questionable, therefore replacement of this section was recommended.

Possible risk mitigation strategies can be undertaken to prolong the effective service of this segment of the pipeline. The invert of the outfall must be stabilized and soil stabilization will be of key importance to this effort. If the asset owner deems (maximum service life extension is a priority for this segment) a spray applied protective coating is highly recommended.

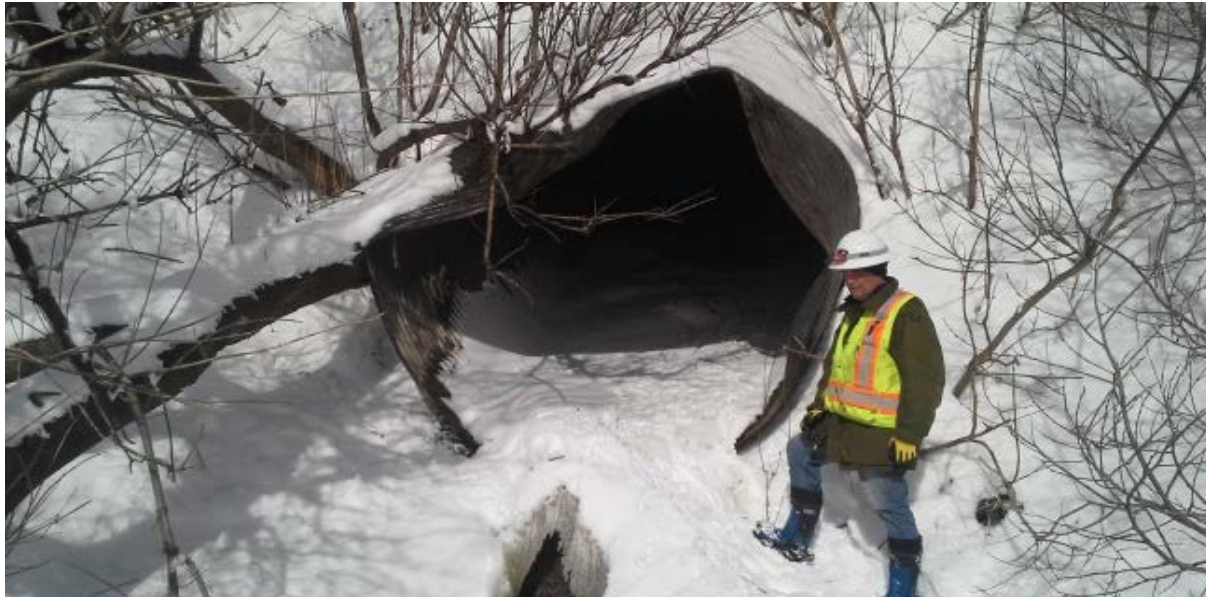
Figure 13. The outlet of the CMP asset.
