Troubleshooting Guide

imageRUNNER ADVANCE

8500/6500 Series

April, 2017

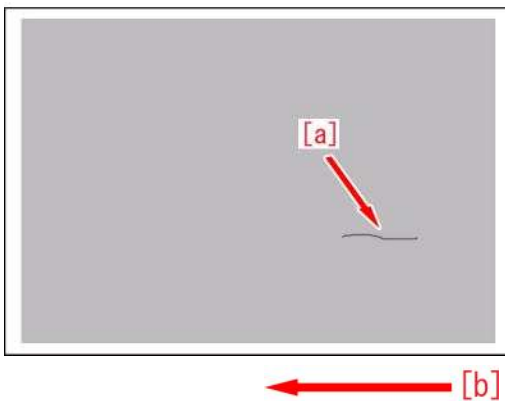
Black line in sub scanning direction [a] may occur.
The arrow [b] indicates the direction of feeding.

If fluffy foreign matter is adhered to the leaser exposure path which is located between the Laser Scanner Unit and the Developing Unit, the laser light is blocked and a latent image cannot be formed. As a result, the symptom occurs.

- 1) Remove the process unit by following the steps in Service Manual "Parts Replacement and Cleaning > Image Formation System > Cleaning the Process Unit".
- 2) Remove the developing unit by following the steps in Service Manual "Parts Replacement and Cleaning > Image Formation System > Removing the Developing Assembly".
- 3) Check to see if any fluffy foreign matter is attached to the developing sleeve [a] in the developing assembly and remove if found.

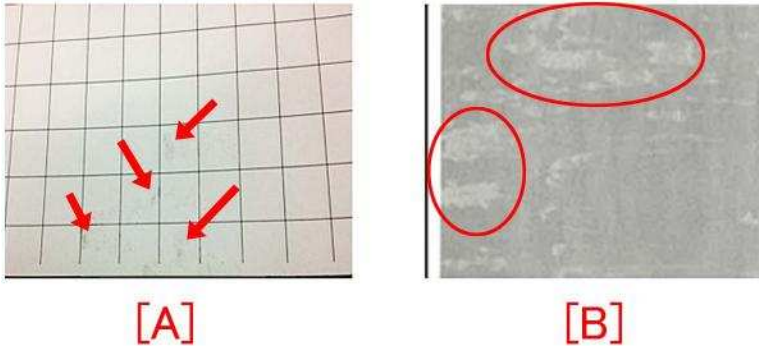
On the machines with the serial number earlier than the following countermeasure cut-in serial number in factory, soiled image [A] or blank image [B] may occur directly after machine installation or developing assembly replacement.

Prepare the new-type developing assembly (FM4-5429-010) with the surface finishing process of its lower sleeve changed, and replace it by referring to service manual.

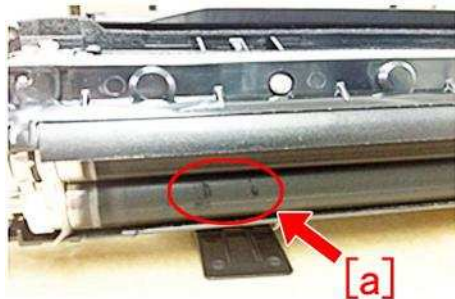
If there is a fault in the surface finishing of the developing assembly lower sleeve, the toner is charged more than necessary. Therefore, toner clump [a] may occur especially in the environment of low temperature and low humidity, resulting in the above-mentioned symptom.

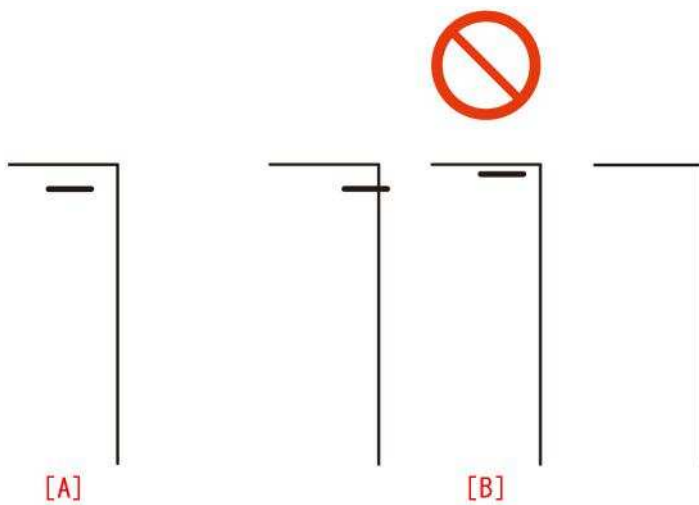
When using the manual stapler, staple position may be shifted and sheets may not be stapled due to a spring coming off. Fig.[A] shows correct stapling. Fig.[B] shows incorrect staple positions and missing staples.

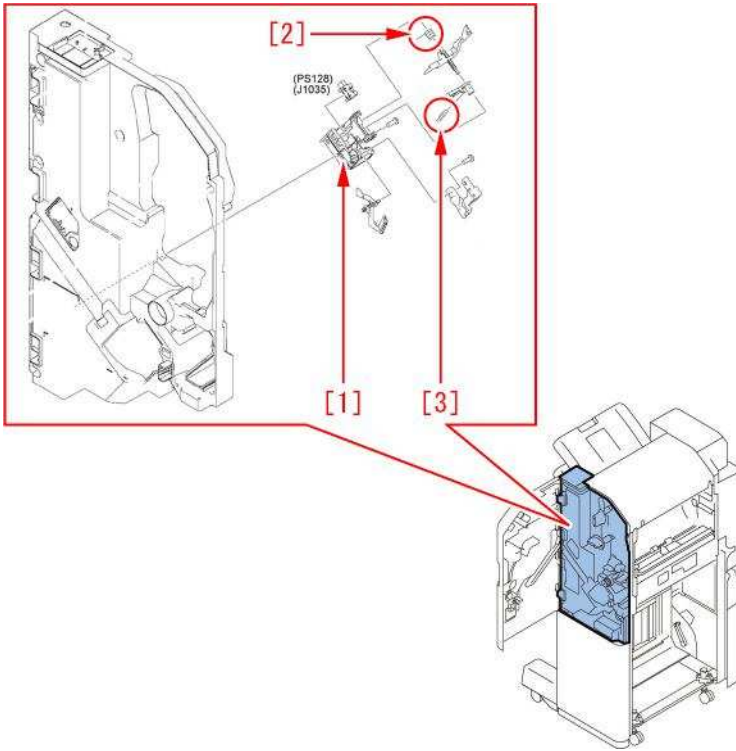
The torsion spring [2] or the tension spring [3] of the sensor holder [1] in the inner cover assembly comes off. It results in misdetection by sensor flags causing the above symptom.

- 7) Check whether the torsion spring [1] and tension spring [2] in the sensor holder come off. If the springs are not in normal place, place them back in the correct positions.

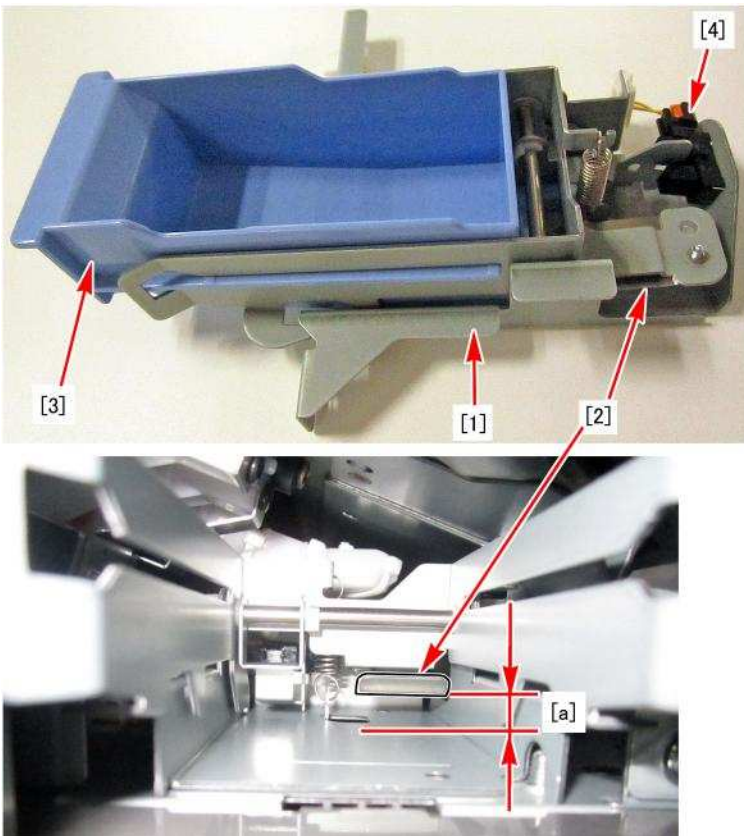
Due to the high position [a] of the leaf spring [2] of the staple collect unit [1], the waste staple case [3] is loosely fixed, the waste staple case is displaced, and the needle chip full sensor [4] detects falsely, which causes the above-mentioned symptom.

If the above-mentioned symptom occurs, add the shim (XD1-1104-635) by following the procedures below. Adding the shim and lowering the position of the leaf spring [1] will fix the waste staple case [2] more firmly and it will become less prone to be displaced.

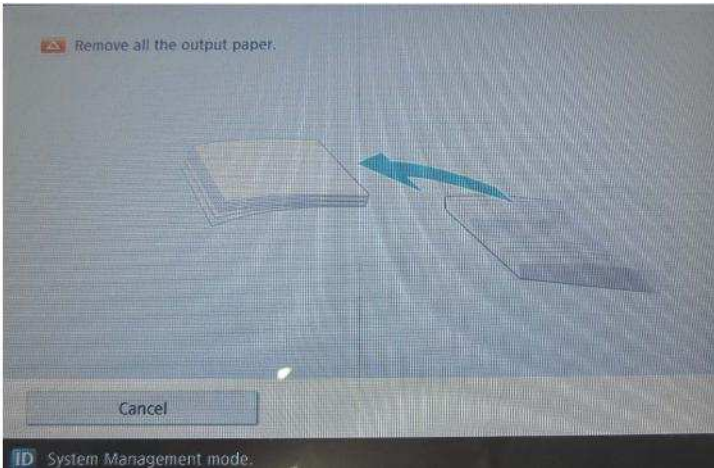
When delivering to the escape tray in printing or copying, "Remove all the output paper (Remove the paper in the delivery tray)" message may be displayed.

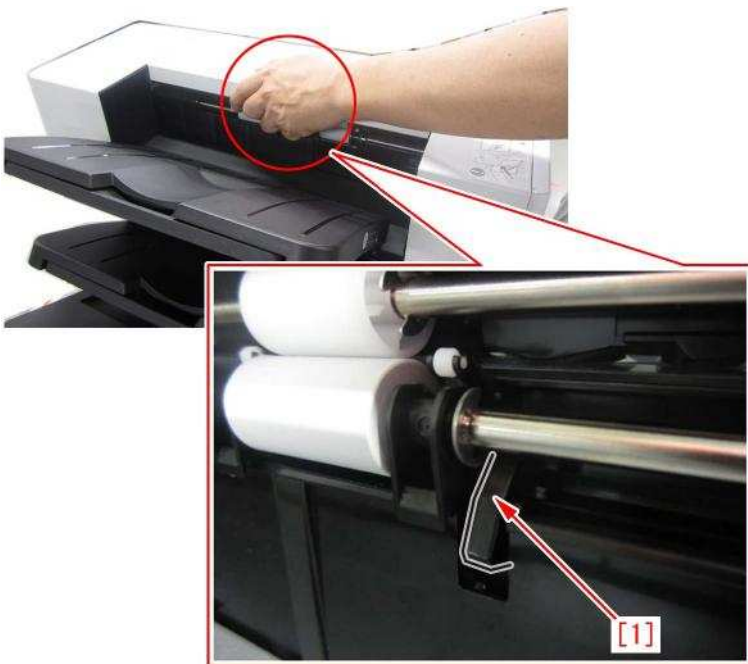
To install or move the finisher, if the worker holds the position shown in the below photo, the full detection sensor flag [1] is pressed towards the back side with fingers, then it becomes unable to come back to the normal position and ends in the above mentioned symptom.

- 1) Turn the main power of the main body off.
- 2) Push the delivery roller [2] of the upper escape tray towards the rear side
- 3) Check if the sensor flag [1] comes back to a normal position by its own weight as shown in the figure [A].

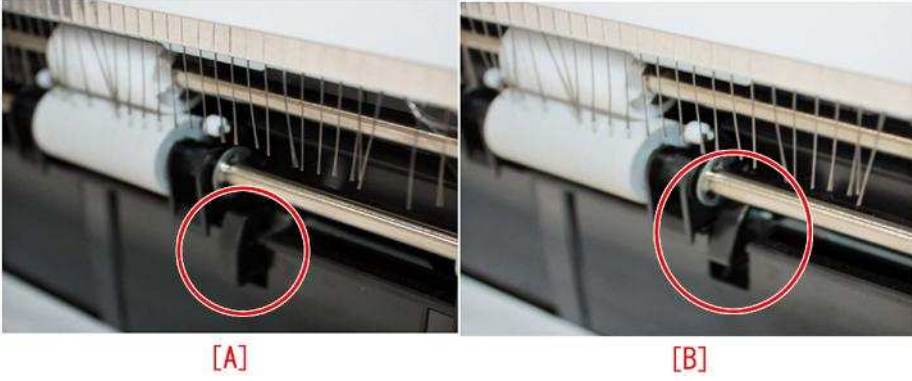
The figure [A] shows a condition where the sensor flag is at a normal position and the figure [B], the sensor flag is pushed towards the back side.

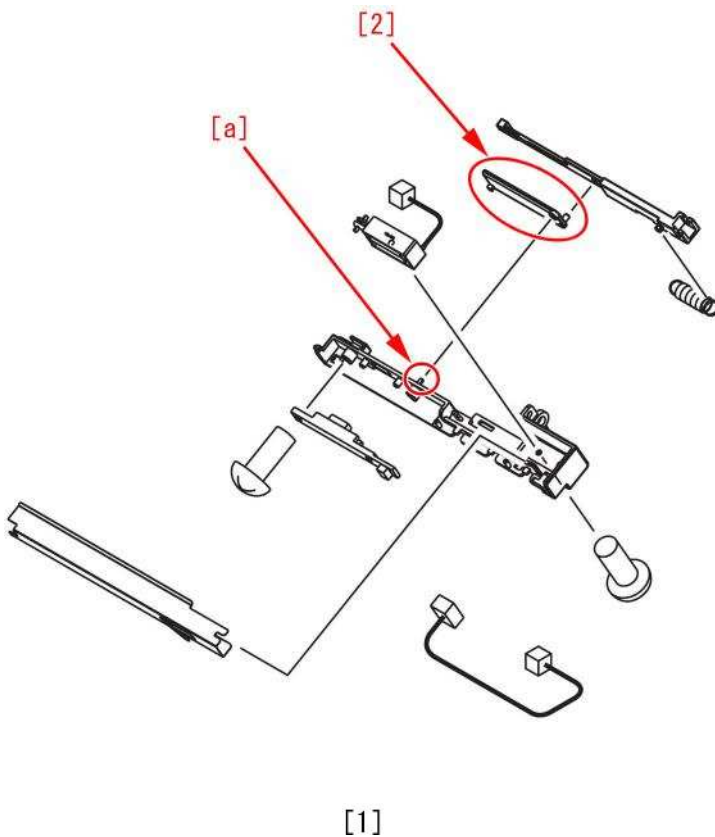
In the machines prior to the Countermeasure cut-in serial number in factory described below when opening the shutter [2] in the patch sensor assembly [1], the boss [a] which acts as a supporting point may break.

Stress caused by opening and closing the shutter applies to the root of the boss intensively for a long time, resulting in the above symptom.

When the above symptom occurs, refer to Service Manual and replace with the new type patch sensor assembly (FM3-7298-010) and the shutter (FC8-9669-010).

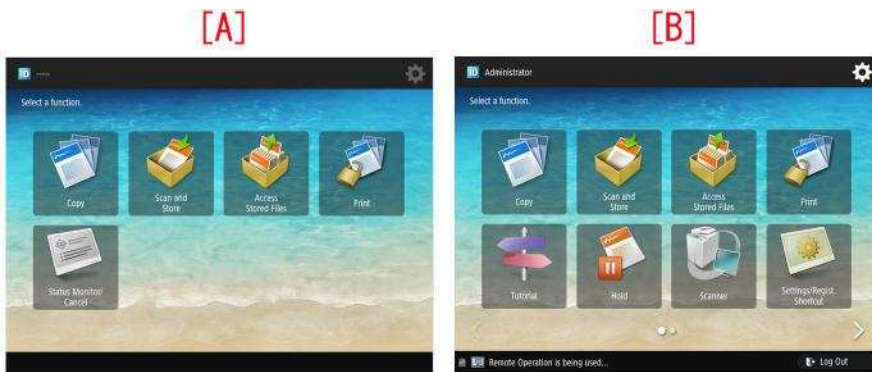
[A] shows the UI screen at the time of the symptom occurs. and [B], the normal UI screen.

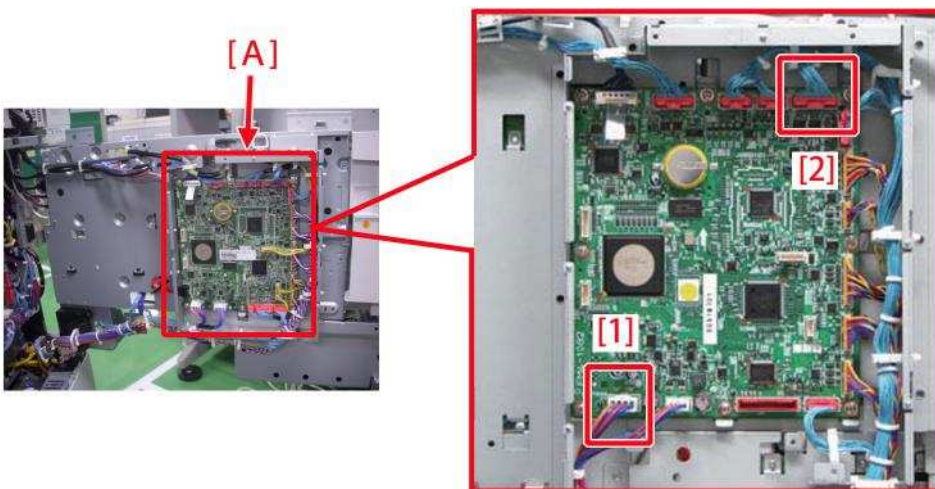
- The connectors J401 [1] and J442 [2] of the DC controller PCB [A].

1-1) See if the connectors J401 and J442 of the DC controller PCB are not disconnected.

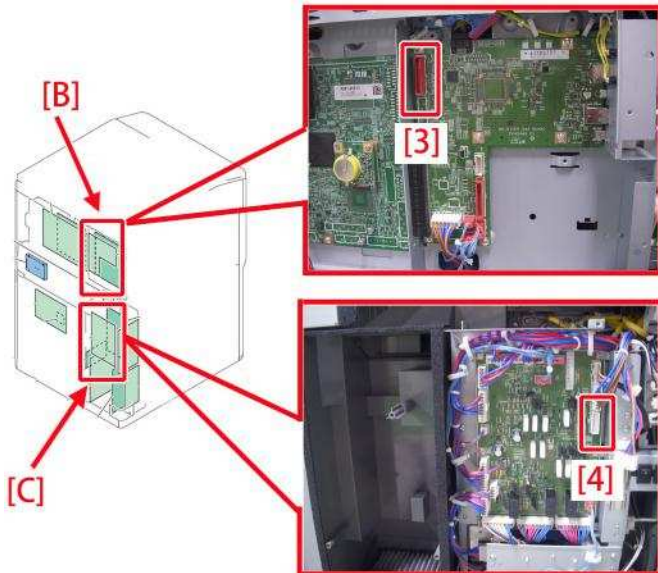
- The connector J5202 [3] of the main controller PCB2 [B] and the connector J518 [4] of the relay PCB [C]

1-2) See if the connector J5202 of the main controller PCB 2 is not disconnected.

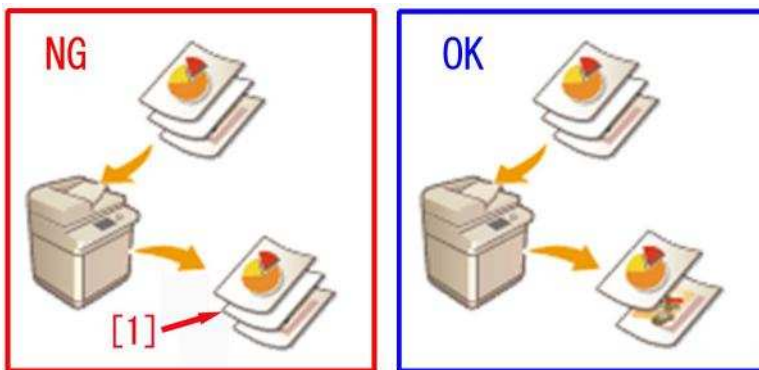
Blank pages may be mixed [1] (Skip Blank Originals fails) even if "Skip Blank Originals" is selected in Scan and Send/Scan and Store (Advanced Box).

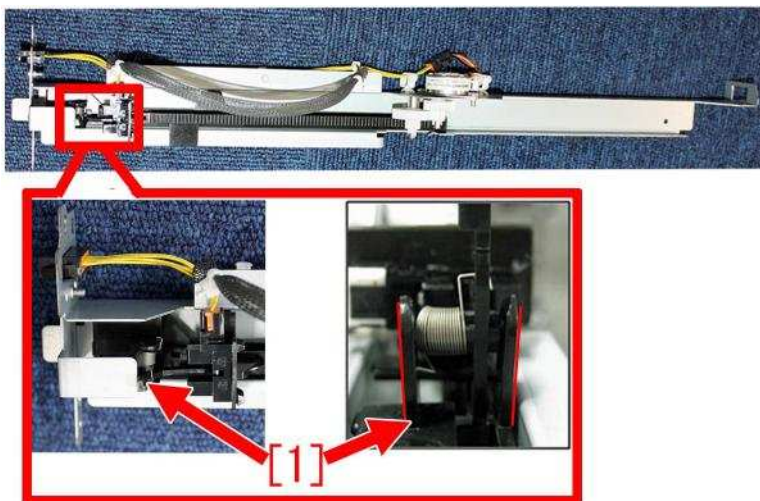
Although, in rare cases the detection flag holder [1] of the photo sensor assembly is loose. For this reason the detection flag comes off, then the detection does not work properly and results in the above mentioned symptom.

When the aforementioned symptom has occurred, prepare a new photo sensor assembly (FM4-0897-010) and replace with it following the procedure below.

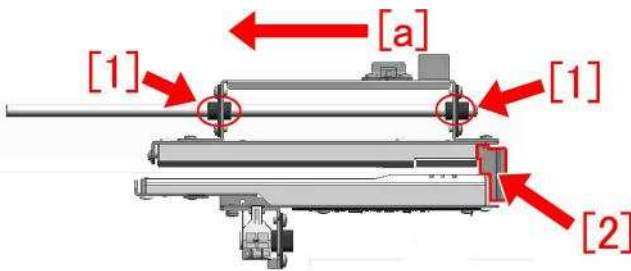
When the sliding load from the sliding part [1] inside the side registration sensor assembly is great, the side registration sensor assembly drive motor steps out and the position of the support [2] is displaced towards the front side of the product [a]. In the said condition, the paper contacts the support [2], would be skewed in delivery and may result in the aforementioned symptom.

When the above mentioned symptom frequents, prepare and replace with the new type side registration sensor assembly for each product referring to the service manual.

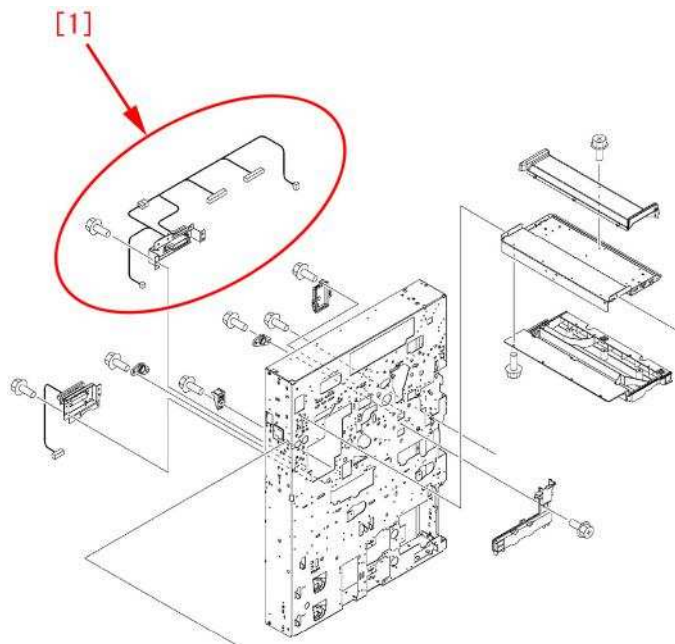
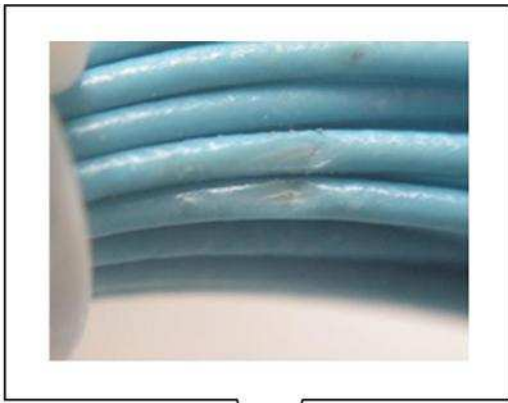
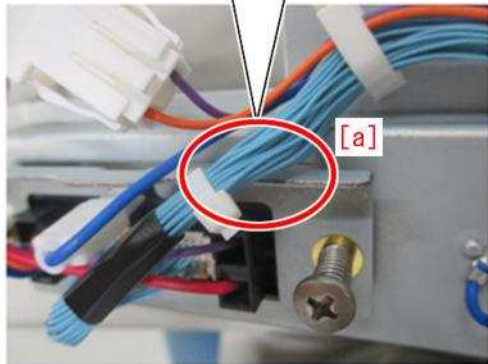
The fixing drawer cable [1] comes in contact with the sheet metal [a], and the cable coating is broken and short-circuited to cause the above-mentioned symptom.

Note: There were cases that short-circuit caused the defective main drive driver PCB assembly and the relay PCB assembly.

If the above-mentioned symptom occurs, replace the fixing drawer cable with the new type of the fixing drawer cable (FM3-7351-020) having the additional protective tape to prevent the coating breakage.

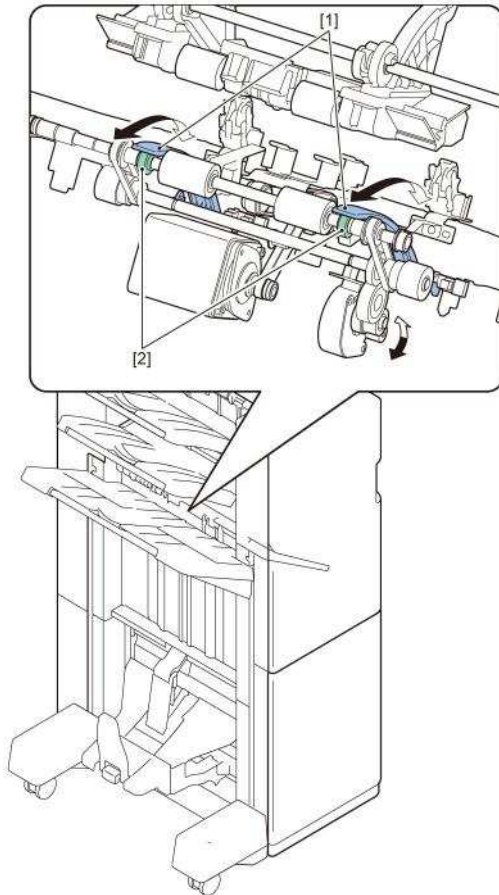
- When the rack of the front/rear tray auxiliary guide [1] does not engage properly with the pinion gear [2], this condition has brought malfunction.

9) Rotate the gear [1] in the direction of the arrow with fingers and let the front/rear tray auxiliary guide [2] protrude by approximate 10mm longer.

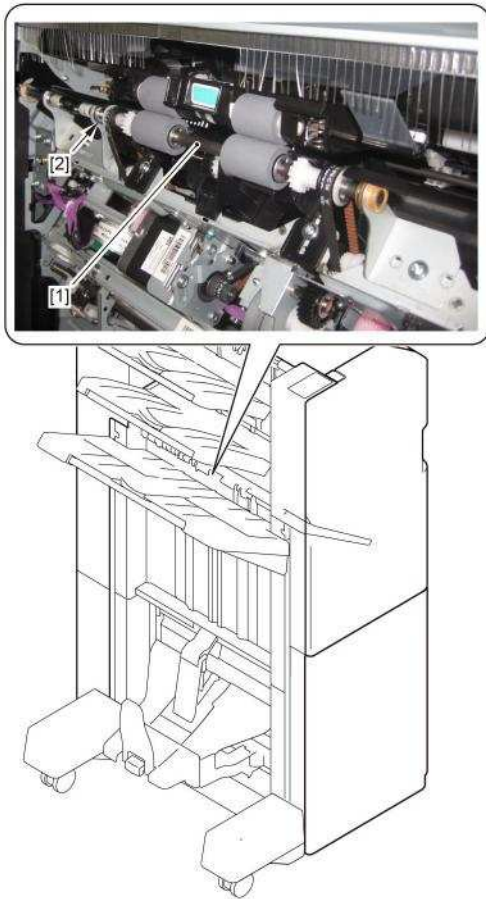
- When the clearance of the mounting of the lower stack delivery roller [1] is so wide that the bearing [2] has come off.

6) Attach the washer (XD1-1106-235) [3] between the E-ring [1] and the bushing [2].

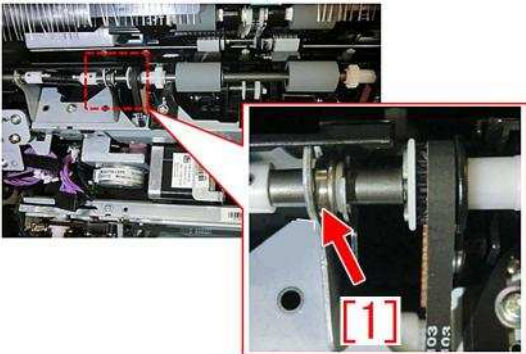
The figure below shows a condition where the bearing [1] has come off.

3) If the bearing [2] of the lower stack delivery roller [1] has come off, reattach the bearing [2] in a proper state and go to the step 4). If the bearing [2] has not come off, then go to the step 8).

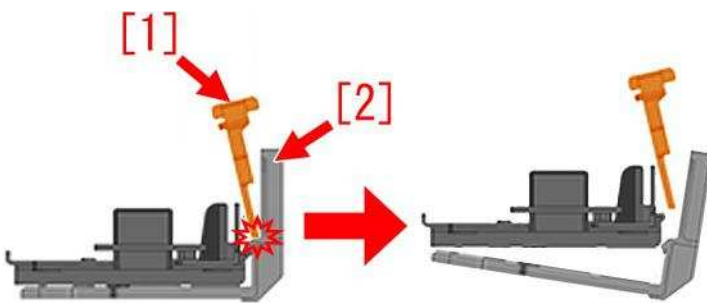
If the scanner fixation tool [1] is inserted obliquely when moving the main body, the tool becomes in a state where it is pressing the flat cable unit [2]. If the main body is moved in this state, the flat cable unit [2] may be detached, which may cause the above-mentioned symptom.

[Attention] If attaching the scanner fixation tool when moving the main body, insert it in a correct and straight way.

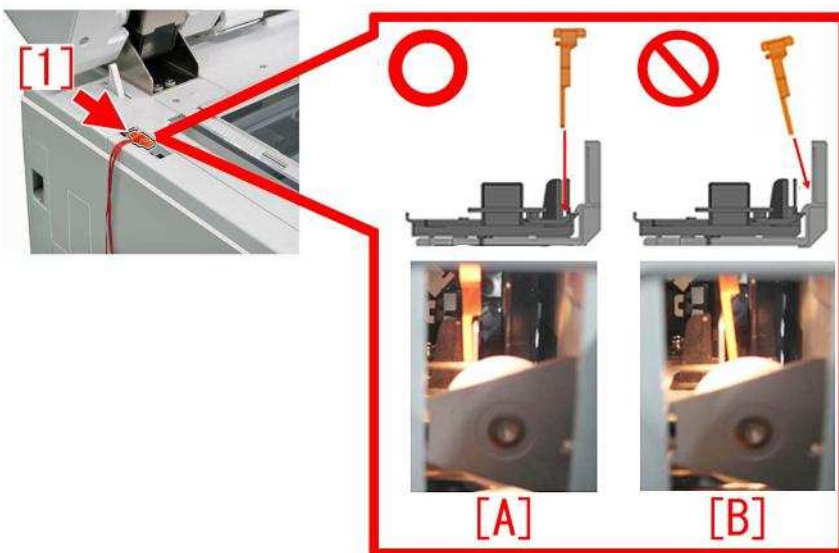
Fig.[A] shows the state where the scanner fixation tool [1] is inserted in a correct and straight way.

Fig.[B] shows the state where the scanner fixation tool [1] is inserted in a wrong and oblique way.

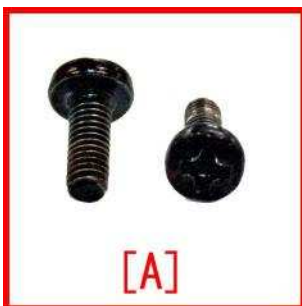
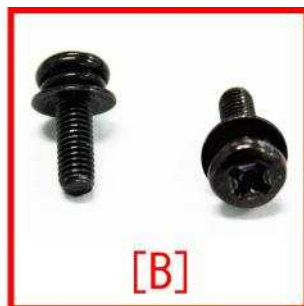
The screws securing the fixing shutter motor are loosened and come off after some endurance time has elapsed and from vibration, then the fixing shutter motor becomes unable to be driven the fixing shutter and ends in the above mentioned symptom.

The Fig.[A] shows the previous screw and Fig.[B], the screw with washer to be replaced with.

When the above mentioned symptom has occurred, replace the screws that are securing the fixing shutter motor with the screw with washer (XB2-8301-009) referring to the service manual.

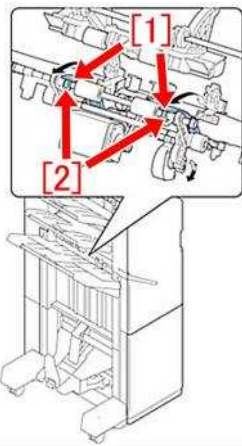
1) Operation failure of the front/rear tray auxiliary guide due to shift in engagement of the rack and the pinion [2] of the front/rear tray auxiliary guide [1]

7) Loosen the 2 screws [1], rotate the gear [2] in an arrow direction with a hand, pull out the front/rear tray auxiliary guide [3] for approx. 10 mm, and then tighten the 2 screws [1].

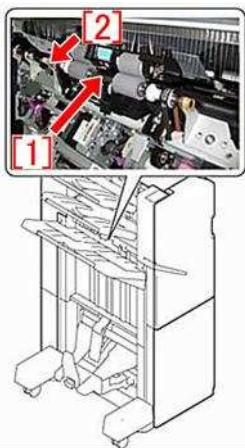
2) Operation failure of the front/rear tray auxiliary guide due to large clearance of the mount of the lower delivery roller [1] dislocating the bushing [2] on the rear side.

5) Attach the washer (XD1-1106-235) [3] between the E-ring [1] and the bushing [2] of the lower delivery roller. However, if the lower delivery roller is a new type, attaching the washer (XD1-1106-235) [3] is not required.

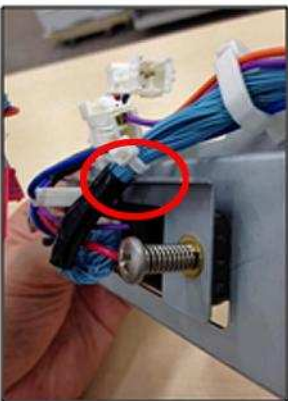
If a vibration is loaded to the fixing drawer cable (FM3-7351) on the back side of the main body or if the fixing/feeding assembly is removed and installed while the fixing drawer cable (FM3-7351) is pinched by the duct, the coating of the cable may be damaged, and this will lead to the above mentioned symptoms.

When the aforementioned symptoms have occurred and if the device will not be restored even after performing the usual error release operation, check for the wire pinching on the fixing drawer cable. If the cable is damaged, prepare and replace with the new type fixing drawer cable (FM3-7351-040) [1].

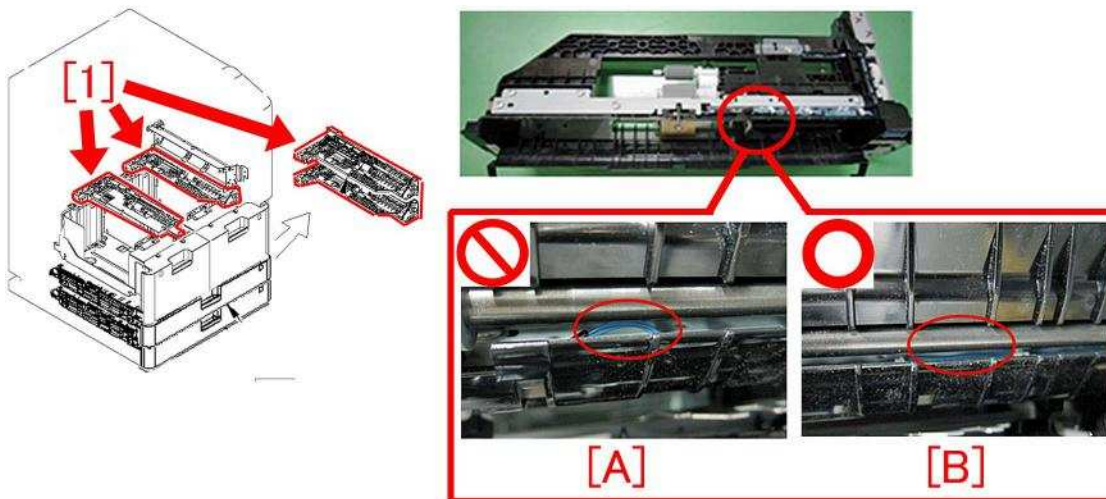
If the cable is in contact with the roller spindle for the pick-up assembly [1] and its coating is worn, a short circuit occurs and it results in the above-mentioned symptom.

If the coating of cable has worn, the replacement of paper pick-up assembly or cable is required. If the coating of cable has not worn, check for the other causes.
