Turkish Airlines 1951
25 February 2009, Schipol Airport
(EHAM)

SYST 560

Accident Turkish Airlines 1951

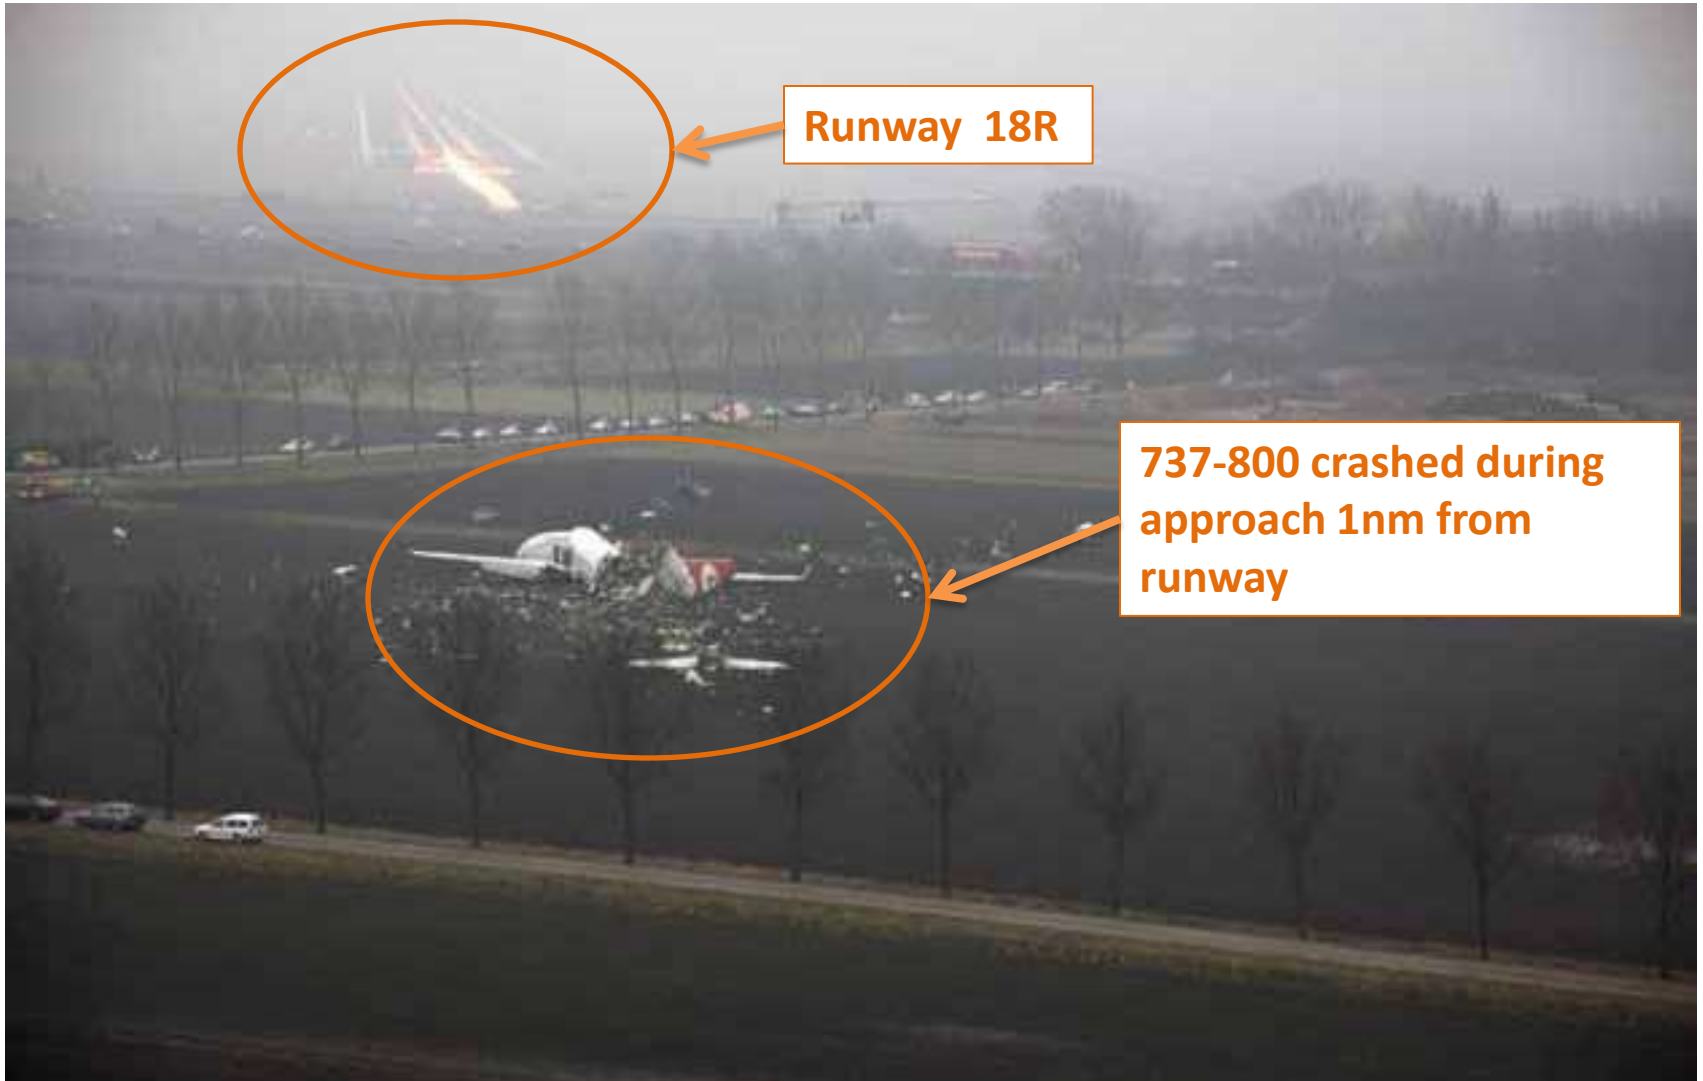
Runway 18R

737-800 crashed during approach 1nm from runway

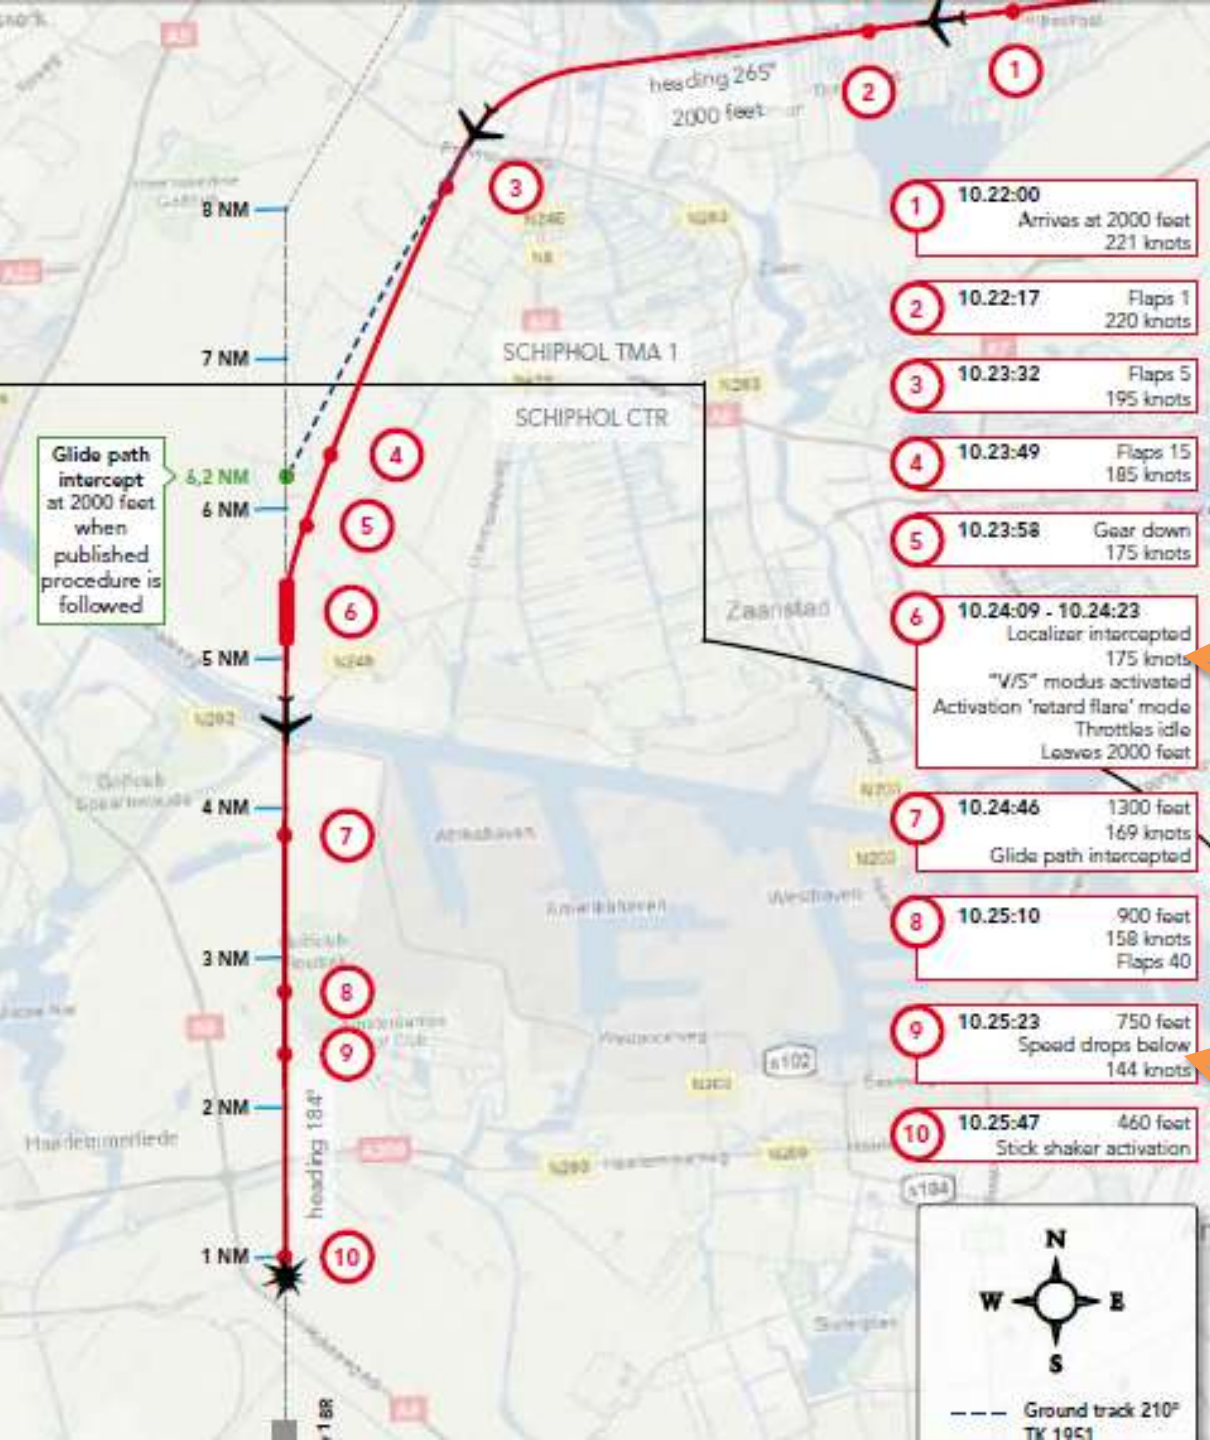
High and fast
V/S mode selected
Throttle lever retards to
idle (as it should)

Continued deceleration
through 144 knots (as it
should), but throttles
remain at Idle (instead of
adding thrust)

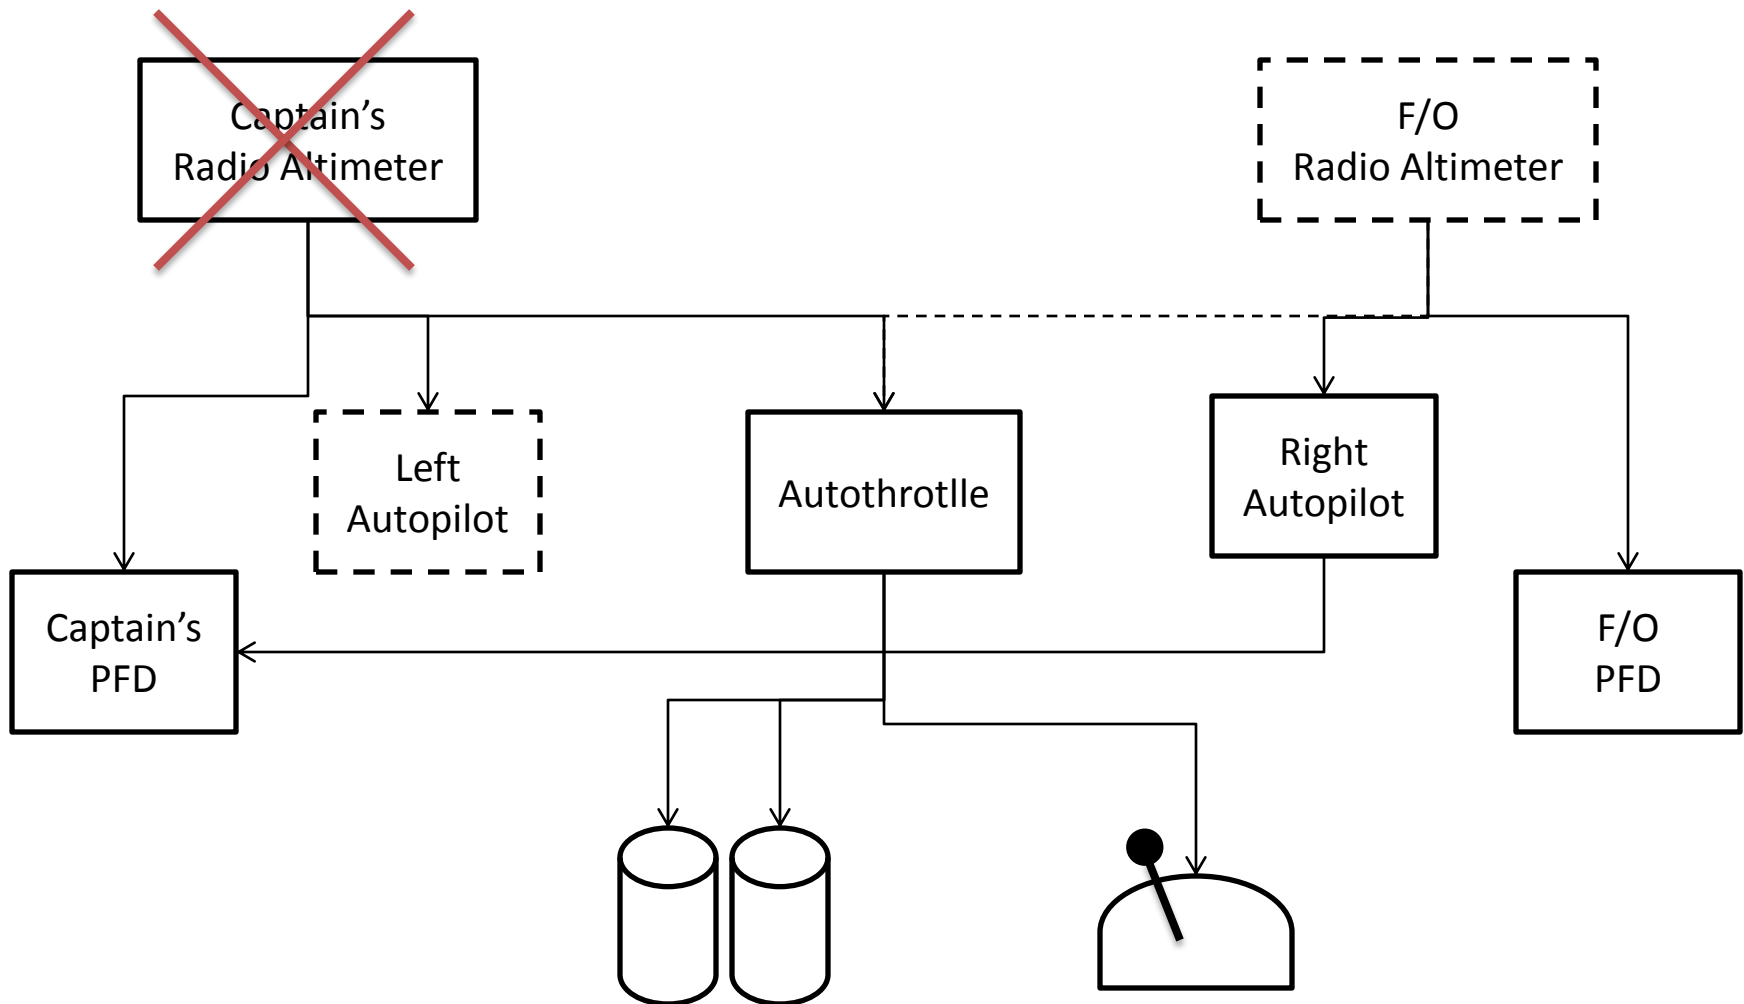
Non-intuitive Automation Configuration

- Primary cause:
 - faulty radio altimeter (had failed 2x in previous 25 hours) triggered incorrect automation reaction
- Contributing factor:
 - Crew noticed too late to take appropriate action to increase the throttle and recover aircraft (before stalled and crash)
- Solution:
 - Boeing issued a bulletin to remind pilots of all 737 series aircraft
 - “... importance of monitoring airspeed and attitude,”
 - “.. advising against the use of autopilot or autothrottle while landing in cases of radio altimeter discrepancies”

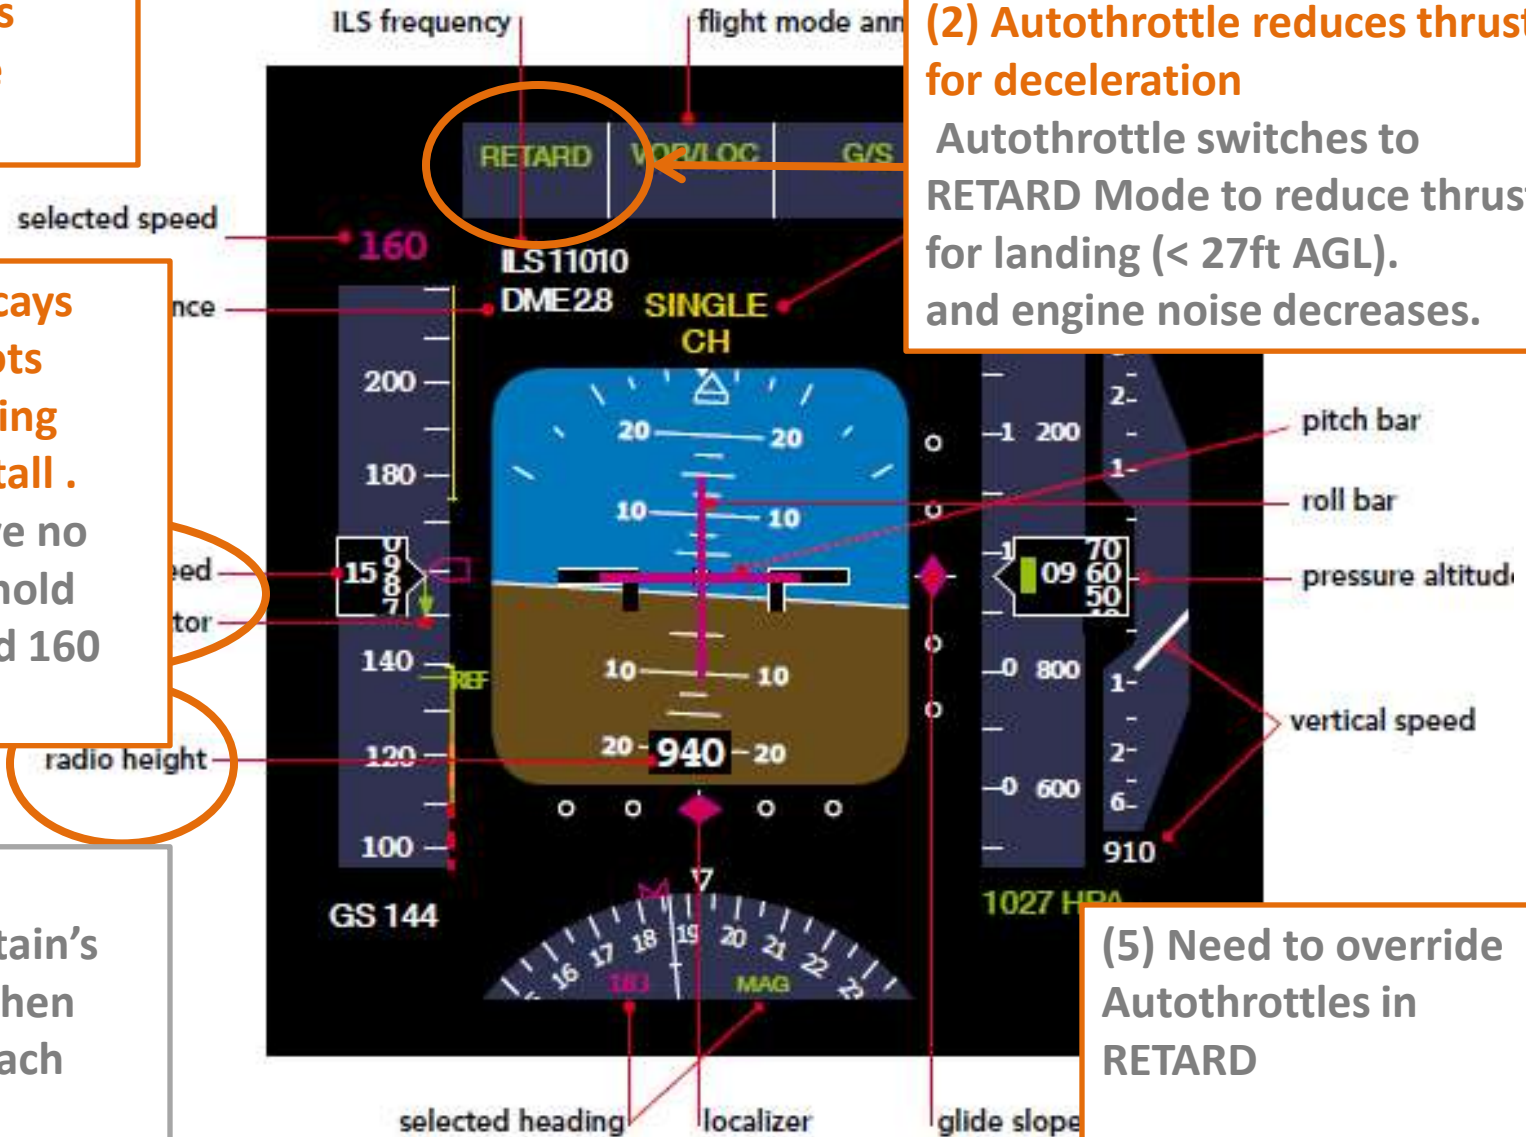
What did the PF (F/O) Know?

(3) Throttle levers move and engine noise decreases.

(4) Speed decays from 210 knots through landing speed until stall. Throttles have no intention to hold desired speed 160 knots

(1) Faulty radio altimeter on Captain's side reads "-8" when aircraft on approach starting at 2000'

(2) Autothrottle reduces thrust for deceleration

Autothrottle switches to RETARD Mode to reduce thrust for landing (< 27ft AGL) and engine noise decreases.

(5) Need to override Autothrottles in RETARD

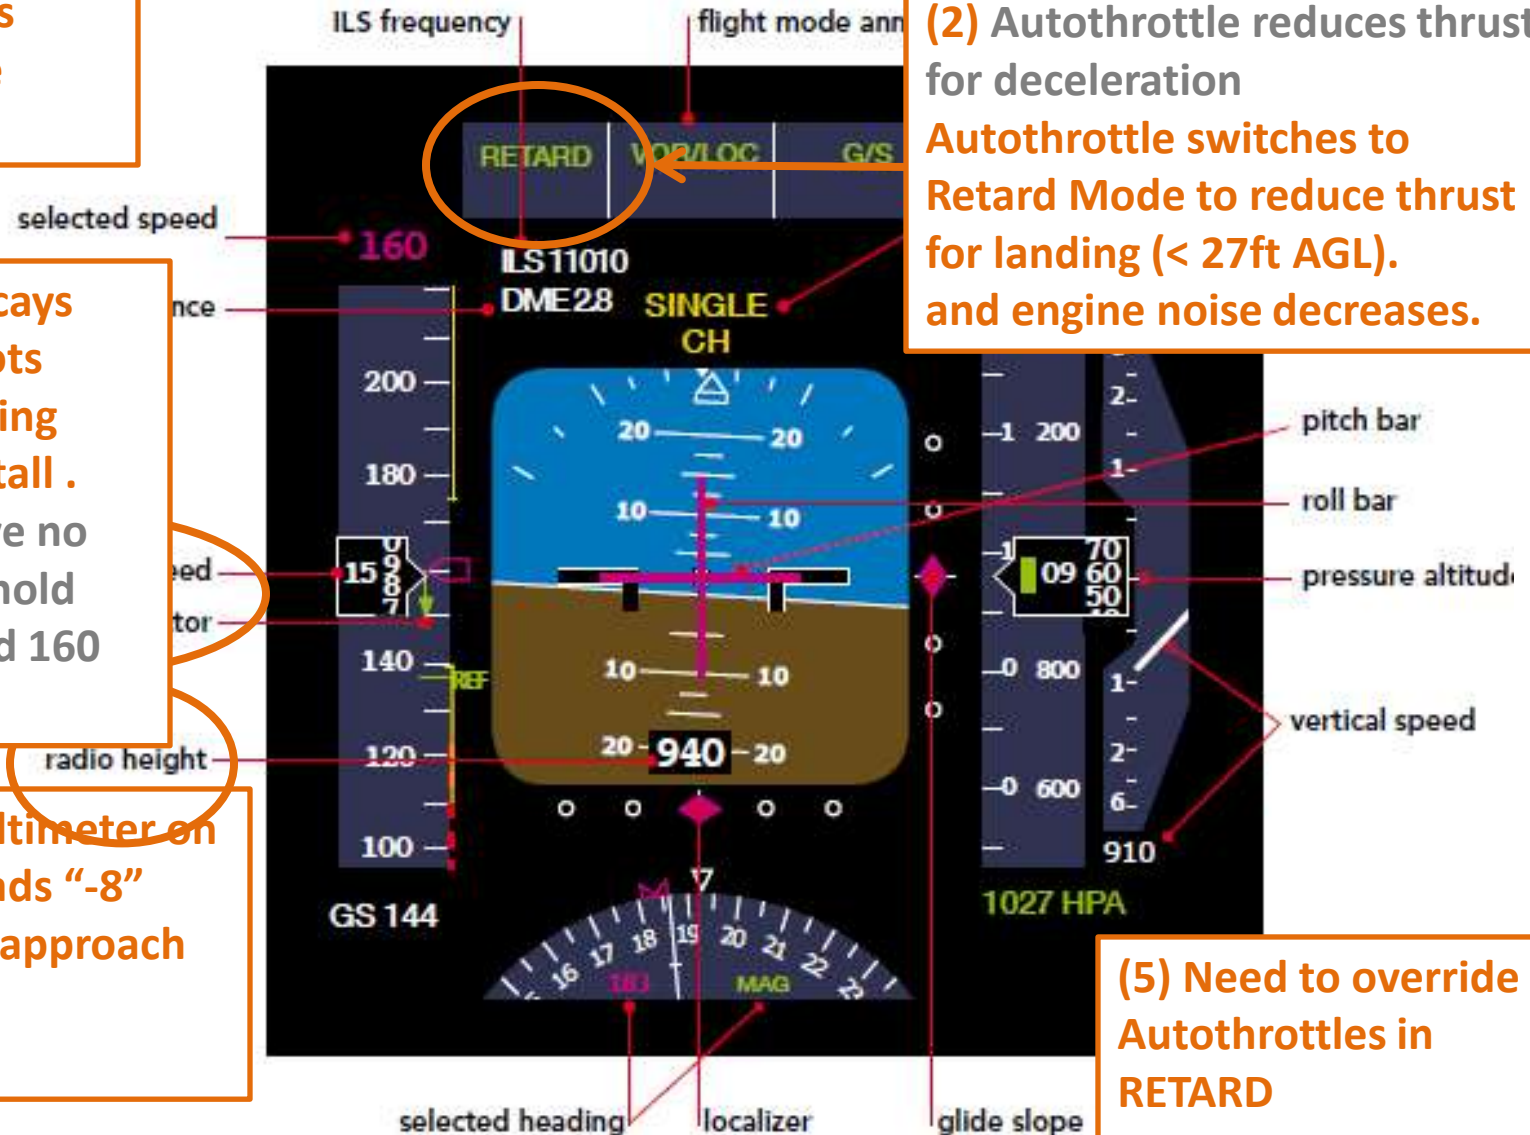
What did the PM (Captain) Know?

(3) Throttle levers move and engine noise decreases.

(4) Speed decays from 210 knots through landing speed until stall. Throttles have no intention to hold desired speed 160 knots

(1) Faulty radio altimeter on Captain's side reads "-8" when aircraft on approach starting at 2000'

(2) Autothrottle reduces thrust for deceleration
Autothrottle switches to Retard Mode to reduce thrust for landing (< 27ft AGL) and engine noise decreases.

(5) Need to override Autothrottles in RETARD
