**U.S. ARMY CORPS OF ENGINEERS
INSTITUTE FOR WATER RESOURCES
RISK MANAGEMENT CENTER
PRELIMINARY LESSONS LEARNED FROM OROVILLE INCIDENT**

DATE: 7 April 2017

PURPOSE OF PAPER: Review of Oroville Dam Spillway Incidents, USACE Current Methodology for Evaluating Similar Spillway Potential Failure Modes, and Identification of any Systematic Shortcomings in USACE Practice.

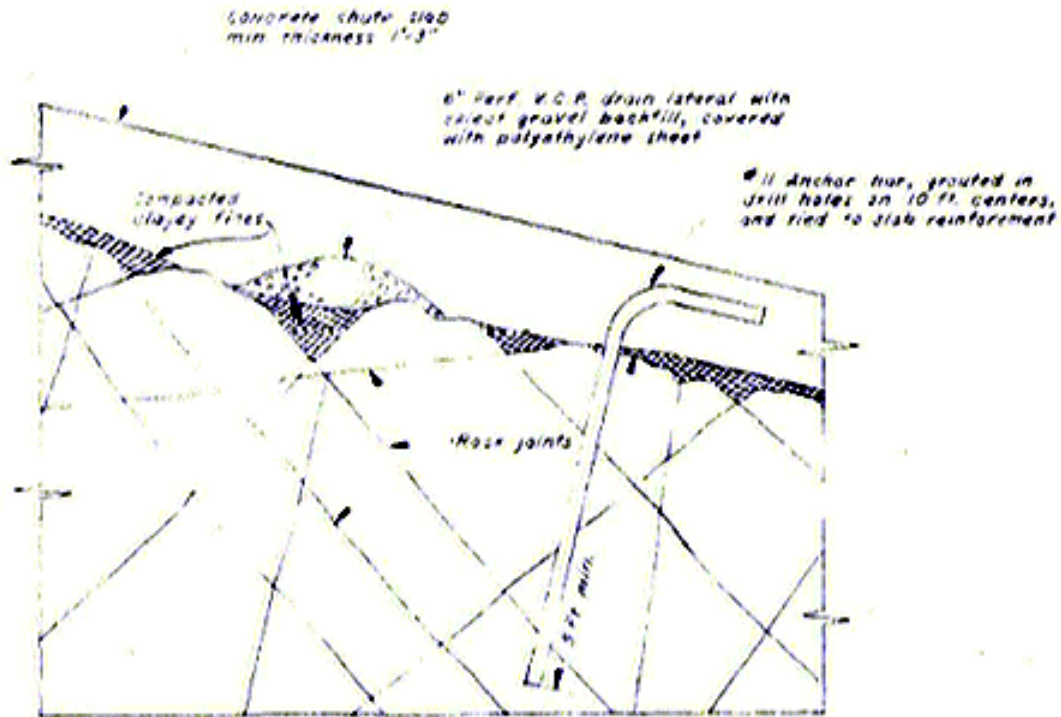
Figure 1. Spillway Chute Slab Foundation and Drainage Details

Details of the spillway chute design are shown in Figure 1, taken from Drawing IF 262. Note that the concrete slab is only 15 inches (minimum) thick. Although no waterstops were placed in the spillway chute panel joints, steel dowels were placed across the joints and keys were constructed to prevent upward movement of the downstream slab into the flow, as shown in Figure 2 (taken from Drawing A-3B9-1). The irregular rock foundation was brought to a more uniform grade using compacted clayey fines. Passive anchor bars to tie the slab down were anchored five feet into rock and "hooked" into the concrete. The slab reinforcement was only placed near the upper surface of the slab. No reinforcing steel was placed in the bottom of the slab. A drainage system was installed at the base of the slab consisting of perforated vitrified clay pipe in a "herringbone" arrangement, with outfalls exiting the spillway walls back into the chute. Significant flows have been observed exiting the underdrain system since original construction. In addition, the herring bone drain pipes extended up into the concrete slab with not much clearance to the top of the slab (minimum 7-inches). This has apparently produced cracking in the concrete. Crack repairs have been ongoing prior to the incidents.

1. The service spillway chute slab is relatively thin for this type of structure
2. Typically two mats of reinforcing steel would be installed on the upper and lower sides of the concrete chute slab

4. Drainage pipe would typically not be allowed to project up into the concrete chute slab, especially a slab this thin, which in this case caused large open cracks in the chute

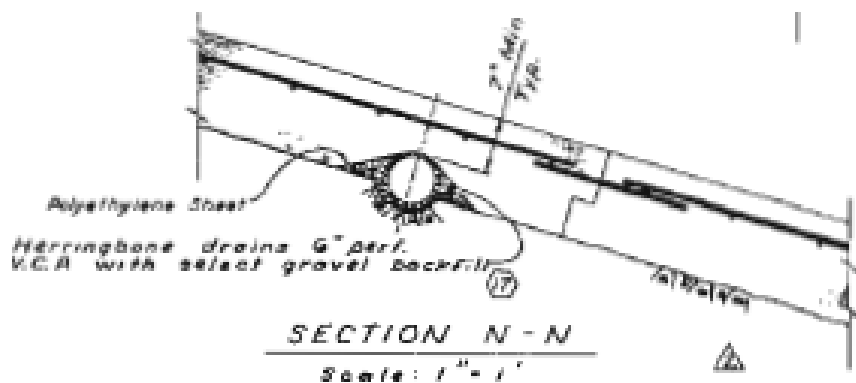
Figure 2. Spillway Chute Joint and Drainage Details

3. PVC waterstops would typically be installed at all slab and wall joints in a concrete spillway chute. Waterstopped or water tight joints/cracks in a spillway chute are key during operation. When the joints/cracks at Oroville were sealed, the underdrain output reduced by about 75%. The "secondary" factors of uplift or erosion beneath the slabs were both highly influenced by flow through unsealed joints/cracks.

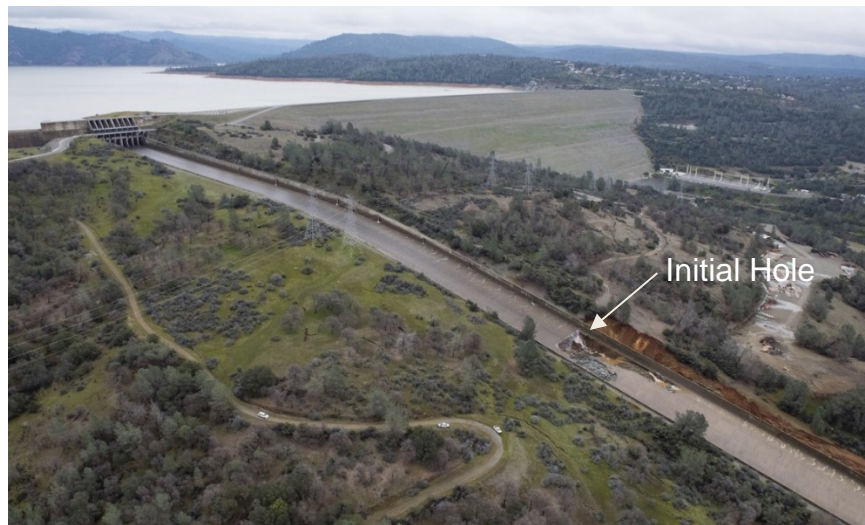
Figure 3. Initial Hole in Spillway Slab

OROVILLE INCIDENT: In early February 2017, following several years of drought, high inflows to Lake Oroville caused dam operators to open the service spillway gates to control the lake level. Releases were less than the previous maximum releases. On February 8, 2017, a portion of the service spillway chute failed. A 150 foot wide hole formed in the chute around stations 33+00 to 34+00, about half way down the chute, as shown in Figure 3, and a significant amount of the underlying foundation was eroded. Spillway releases were shut off for inspection at a time when the level was rising at unprecedented rates. The upstream remaining spillway slab was cantilevered

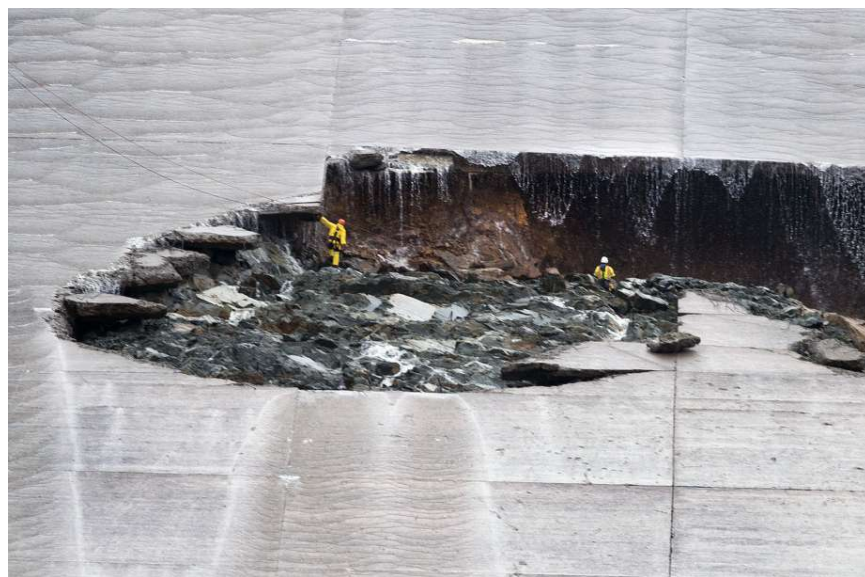
Figure 4. Close-up of Initial Hole in Spillway Chute

about 45 feet over a 45-foot-deep hole, as shown in Figure 4. It was decided to release two test flows on February 8–9, following which the upstream cantilevered section of the chute failed and was washed away, and the length of the hole increased from 250 feet to 300 feet. This left two choices for subsequent operations: (1) continue to use the service spillway, knowing it would likely be further damaged, or (2) allow the reservoir to rise until it overtopped the emergency spillway.

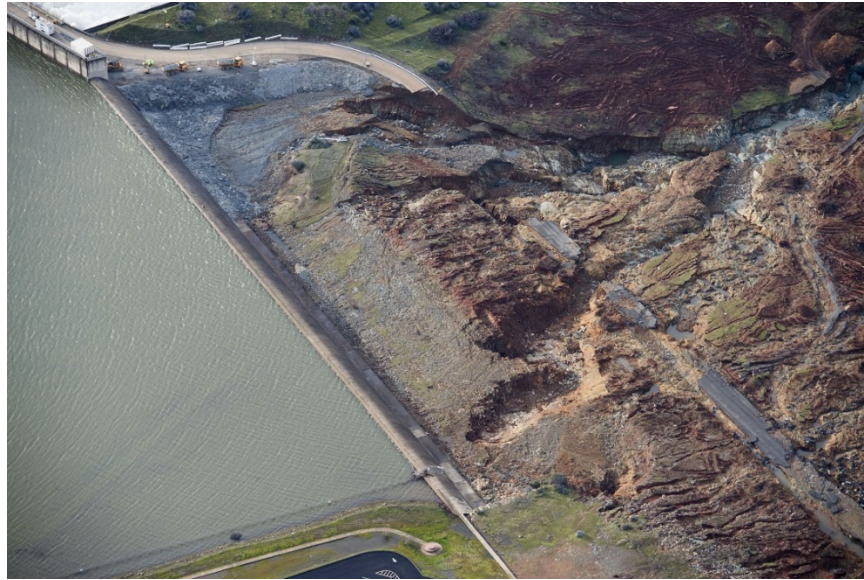
As the lake level rose, measures were taken to prepare the emergency spillway for use including placing of limited grouted rip-rap in areas thought to be susceptible to erosion, near the toe of the deep section of the Ogee weir, where a concrete apron was not present. On February 10, 2017, power transmission lines were moved, and workers began clear-cutting trees on the hillside below the emergency spillway. Shortly after 8:00 am on February 11, 2017, the emergency spillway began discharging water for the first time since the dam's construction in 1968. Flows peaked at 12,600 cfs causing erosion of soil and rock materials on the hillside below (as shown in Figure 5). If the erosion was significant enough to undermine the right section of the emergency spillway (where the erosion was most severe) and cause it to collapse, a 30-foot-high wall of water could plunge into the Feather River below and potentially flood communities downstream. Fearing such a collapse, officials issued an evacuation order.

Figure 5. Damage from Releases over Emergency Spillway (the large hole near the right side of the ogee section is downstream of Monoliths 4, 5, and 6)

10. The erosion downstream of the emergency spillway also tended to follow highly weathered shear zones, and it is not clear how these shears affect the foundation of the ogee weir or crest wall (to the right of the ogee weir), i.e. were they founded on competent rock or was the foundation adequately treated?

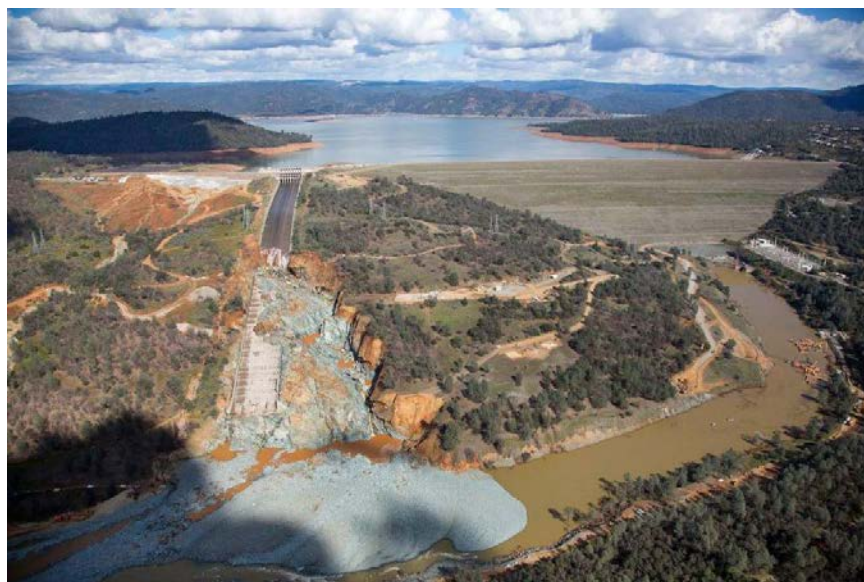
Figure 6. Damage to Service Spillway and Debris Washed into River

Following the evacuation, the decision was made to lower the pool level, using the service spillway, and make repairs. Although additional erosion and loss of the spillway chute and walls occurred (see Figure 6), a somewhat stable condition was eventually reached for releases between 50,000 and 100,000 cfs. Interim repairs to both spillways are in progress. Future major repairs are planned.

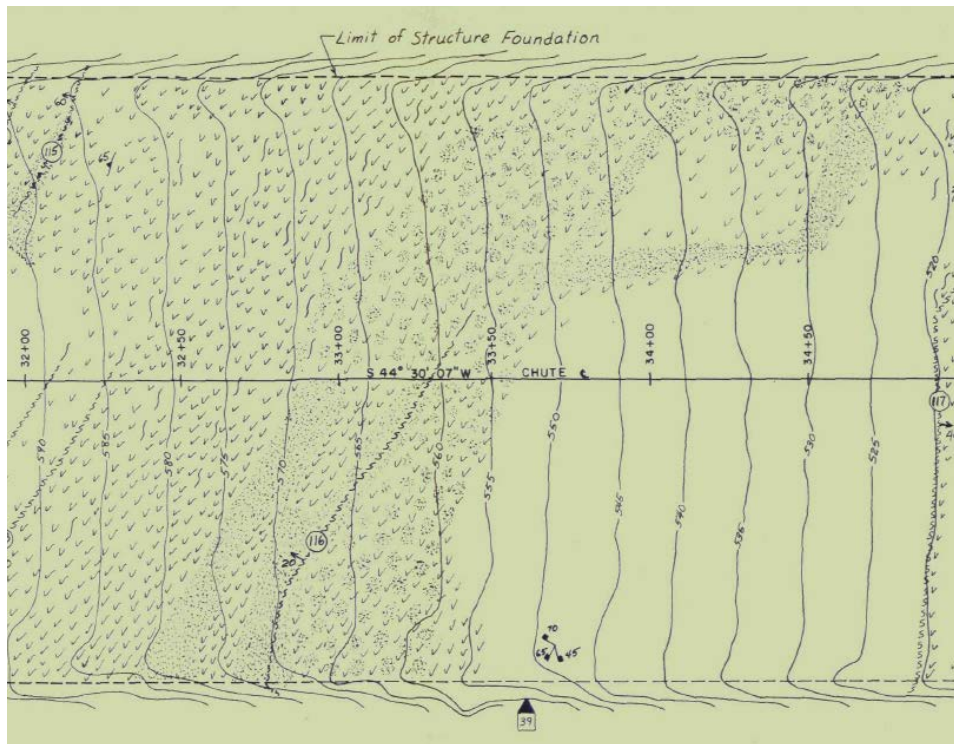
7. Highly weathered decomposed rock associated with a shear zone passes under the chute in the area of the initial service spillway hole, as shown in Figure 7, and continues off to the left where the bulk of the erosion occurred, as shown in Figure 6

Figure 7. Geologic Conditions at Location of Initial Hole (dashed line and fine stippling represent the shear and associated highly decomposed rock)

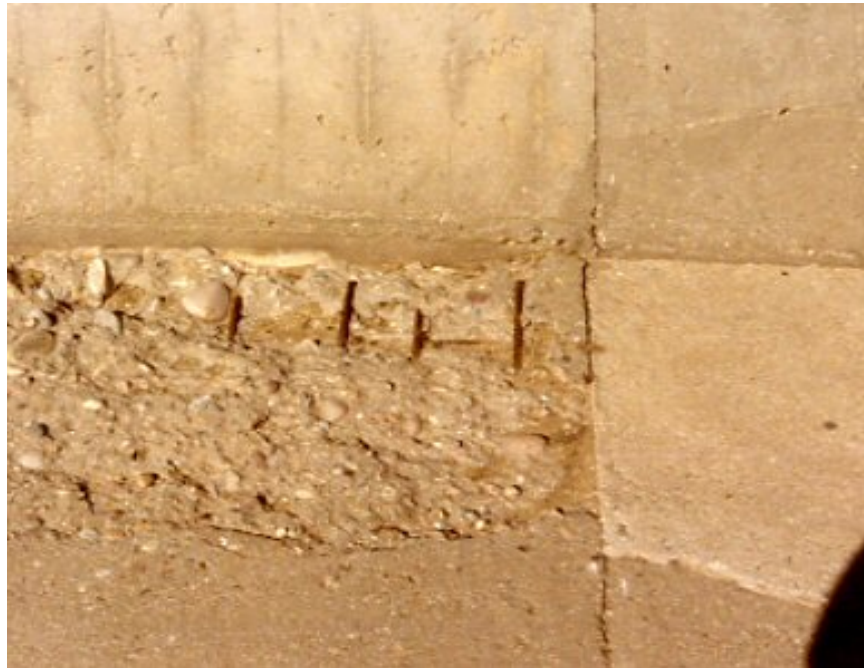
Potential loss of the reservoir related to stagnation pressure jacking of spillway chute slabs was highlighted with the chute failure of Big Sandy Dam (Wyoming) in 1983. Spalling at a slab joint created a small downstream projection into the flow, as shown in Figure 8.

Figure 8. Spalling at Spillway Joint (downstream is toward top of figure)

1. If concrete spillway chutes show offsets that would project into the flow at joints or cracks, the offsets should be ground down prior to flood season to help reduce the chance of stagnation pressure failure. More guidance is needed on this. Preferred detail(s) of the post grinding shape of joints and/or cracks should be developed and provided to the Districts. Guidance is

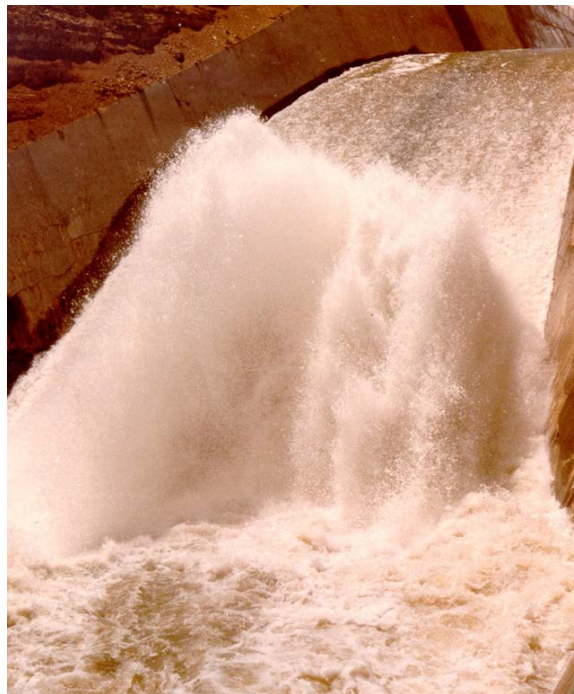
During releases of 400 cfs in 1983, a large “rooster tail” developed (Figure 9). Following releases, it was discovered that a large section of the chute slab had been jacked out of place (Figure 10).

Figure 9. Rooster tail during spillway releases

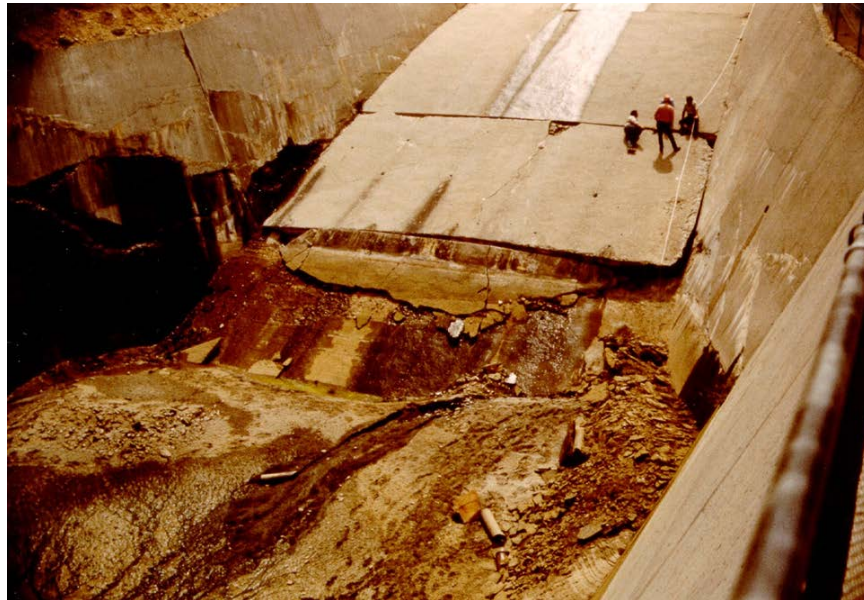
Figure 10. Lost spillway slabs

The slab was only 15 inches thick, and the anchor bars were thought to be poorly grouted. Fortunately, the releases were small and the underlying rock was able to withstand the flow. This incident prompted research into the phenomenon of stagnation pressure jacking of spillway chutes by the Bureau of Reclamation. Hydraulic models were developed to help estimate pressures that could develop beneath a slab for various joint openings and offsets into the flow. These relationships have been incorporated into “Best Practices” for use in estimating the risks posed by this type of potential failure mode. Recommended details for joint treatment were also developed, as shown in Figure 11. The more of these features that are included, the better the chances that stagnation pressure failure will not initiate.

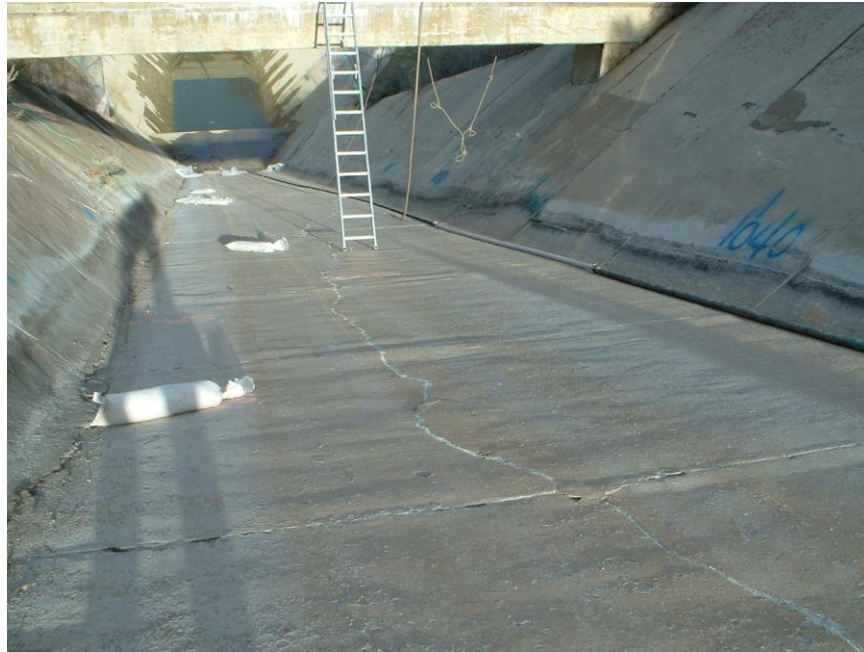
It should be noted that the research into stagnation pressure slab jacking was strictly based on hydraulics. There was no consideration for the geological or geotechnical foundation conditions. In several cases, cracks have been found in spillway chutes that related to voids underneath the chute, as shown in Figures 12 and 13 at Hyrum Dam. These voids are related to erosion of the underlying materials either through stagnation pressures pushing material through the drains, drain flows carrying material, or under-seepage erosion. These voids could lead to collapse of the chute during operations, or settlement of upstream sections creating projection of the slab into the flow potentially leading to stagnation pressure failure of the slab. Although the Best Practices chapter on Rock and Soil Erosion contains ways to evaluate this type of erosion, in practice it is difficult to understand the foundation and flow conditions well enough to make reasonable likelihood estimates without some good performance information. The best way to evaluate this type of potential failure mode is to monitor for signs of material movement through the underdrain system outfalls or seepage exit points, cracking in the slab that indicates moment capacity is exceeded due to bridging over a void, or sounding the slab using a hammer listening for “hollow” sounds or using ground penetrating radar in areas suspected of having a void. If this information is collected routinely and rigorously, a reasonable evaluation of the potential for foundation erosion to lead to voids under a chute can be made.

Figure 12. Cracking along the Center and Sides of the Chute Suggest Loss of Underlying Foundation Support

4. Concrete chute slabs should be routinely sounded using a hammer to locate hollow sounding areas that might represent a void that needs to be investigated. In cases of severe cracking, Ground Penetrating Radar should be considered as a means to locate such voids. In critical cases, surveys (even LIDAR) can be used to compare existing elevations to theoretical or as built elevations if you have them. At Bull Lake, simple surveys showed the slab had heaved up the exact amount of the depth of the underlying void across the entire chute. Yet the void was blamed on internal erosion.

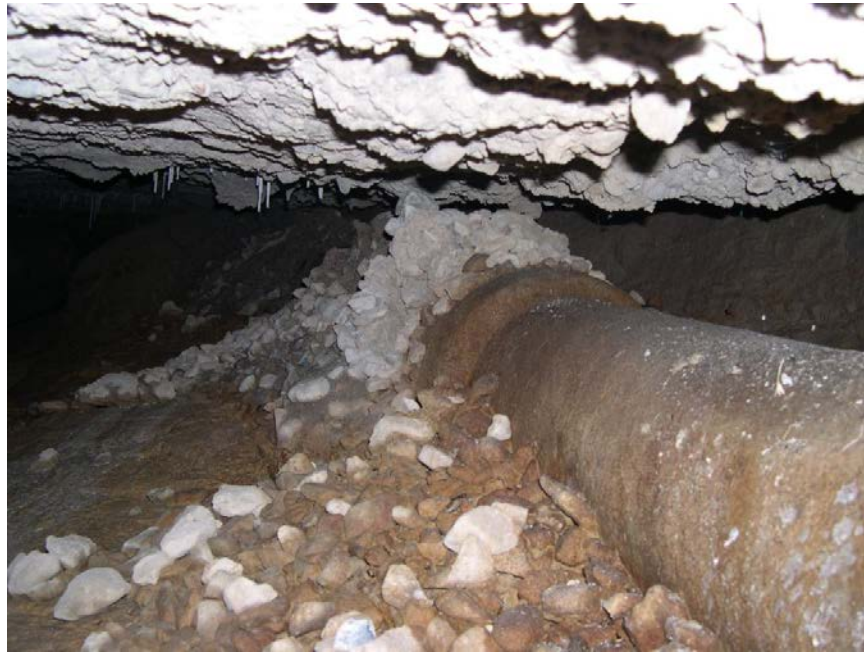
Figure 13. Erosion of Foundation Material Creating Void under Chute
