USE OF PROFILE RADIOGRAPHY TECHNIQUE FOR IN-SERVICE INSPECTION IN
PETROLEUM REFINERY- CASE STUDIES

V. S. Desai, Mahendra Pal, Mayank Banjare, Chandana Nancharaiah, Sushil Guria and Harsh Vardhan

Indian Oil Corporation Limited, Guwahati Refinery, Guwahati, Assam, India- 781020

CASE-I: USE OF PROFILE RADIOGRAPHY FOR
HYDROGEN REFORMER OUTLET PIGTAIL
WELDOLET INSPECTION

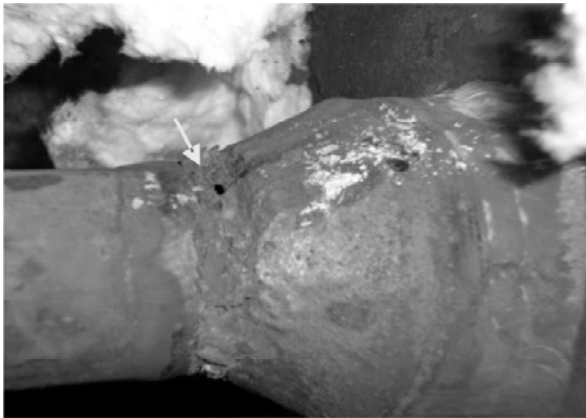
Photograph No. 01: Leaky weldolet showing 5mm dia. hole at neck portion. Severe external scaling marks can also be seen.

A leak was noticed in one of the outlet pigtail weldolet from 12 o'clock position. A hole of approximately 5 mm diameter was noticed at the leaky spot (Photograph no. 1). Grayish color loose scales were noticed on weldolet external surface. Uniform roughening and pitting was also noticed on entire surface of the weldolet. Approx. 1-1.5 mm thick external surface of the weldolet was found corroded/ scaled-up leading to shining appearance (photograph no. 2).

Failed weldolet was repaired by replacing approx. 4" length of the pigtail starting from the weldolet. The new insert piece was provided by cutting a length of approx. 100mm from the available spare new outlet pigtail (Alloy 800HT, 42.16mmX6.35mm). The external surface was ground to match the profile of the weldolet (to avoid stress concentration at this location).

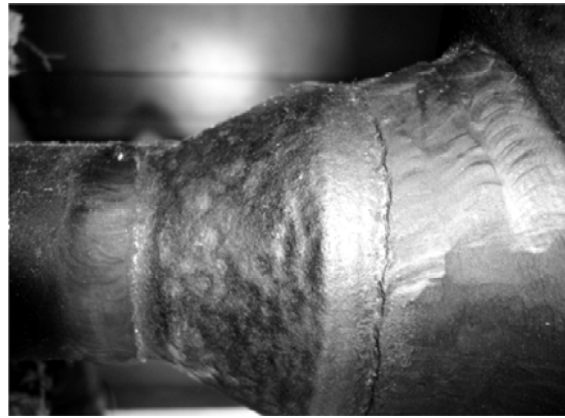
Photograph No. 02: Pitting marks and general surface grooving (1.5 mm deep) noticed on external surface of weldolet.

In remaining 35 nos. of pig tail tubes, the externally corroded grooved portion of weldolet was weld built up to make up for the thickness loss detected by profile radiography using Inconel 625 (ER NiCrMo3) filler wire. Hard scale deposits near the corroded/ grooved neck of weldolet was removed by pencil grinder prior to weld built-up. After weld build up, these joints were DP tested and radiographed. Finally all the weld joints were tested by pressurizing with nitrogen for 3 hrs to observe any pressure drop.

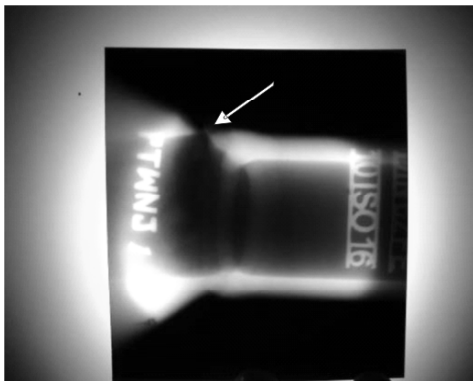
Photograph No. 03: RT Film

As discussed previously, Profile radiographic examination was selected for identifying the remaining wall thickness and corrosion behavior on the inner surface of all 36 nos of outlet weldolets, including the leaking weldolet assembly, for accurate decision making. Ir-192 source of 5 Curie activity was used for carrying the radiography. It can be seen from the radiograph that there is no thickness loss in the pigtail pipe (photographs 03,04). The weldolet neck portion has corroded from external side at 12 o'clock position. The corrosion in the neck portion is preferentially in the 3 o'clock thru 12 o'clock to 9 o'clock position. There is no visible or appreciable corrosion from inner side.

Radiography of remaining 35 numbers of outlet weldolet assembly were matching with the visual observations. The deterioration was primarily on the external surface in the neck portion of the weldolet.

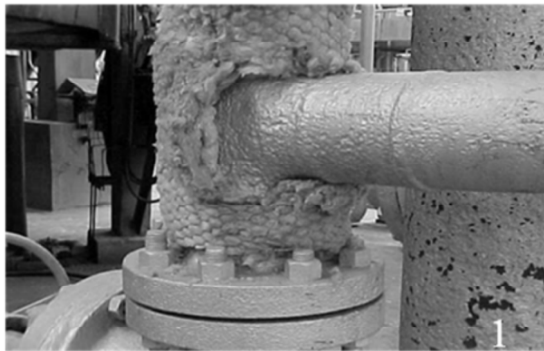
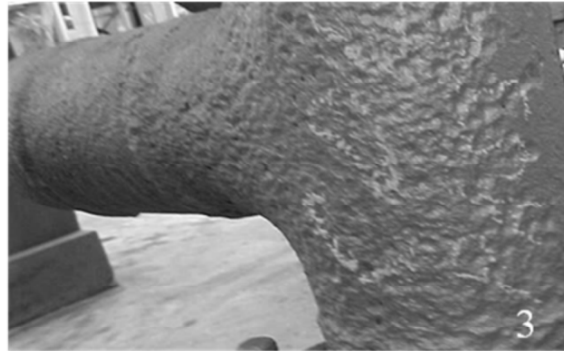
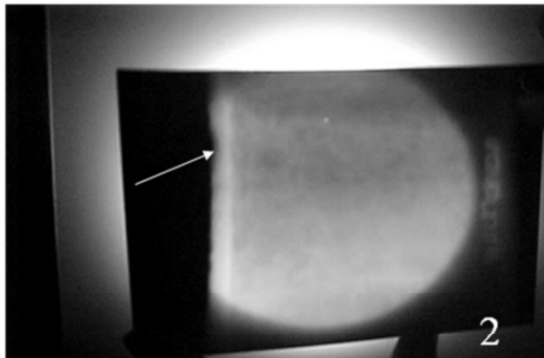
Photograph No. 05: Profile Radiography Technique for CUI for pipeline

PITTED BLOW DOWN LINE (DIA 4")

- 1) INSULATED PIPE
- 2) RADIOGRAPH TAKEN ON THE INSULATED PIPE SHOWING PITTING ON THE WALL SECTION.
- 3) PIPE AFTER REMOVAL OF INSULATION

and the radiography observations and actual visual observation after insulation removal were matching (photograph no. 5)

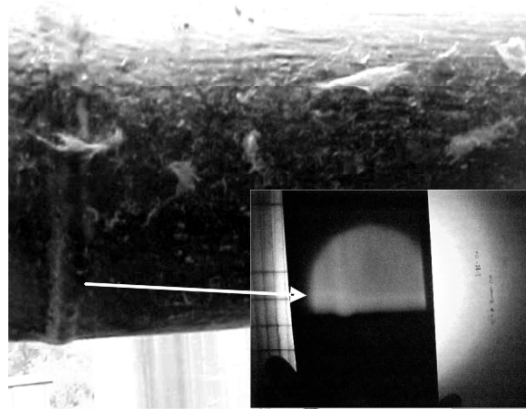
Photograph No 06: Priority II location in ISOSIV Technique for CUI unit

beneath the insulation. This was verified after physical opening of the insulation (photograph no 6 ,7).

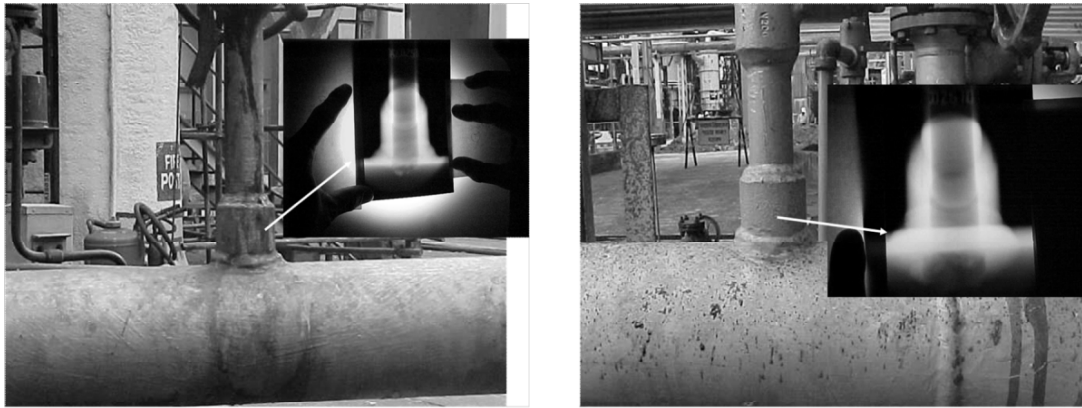
Photograph No 07 : Photographic and Radiographic Images of $\frac{3}{4}$ "small bore piping on 3" & 4" main pipelines respectively.

No corrosion sign or indications were noticed in the radiograph. These observations were corroborated with the actual conditions after removal of the insulations.

Damaged end caps of small bore piping were repaired with new caps and sealed using mastic material. The moist chiller circuit insulation was completely renewed.
