## **Water Loss Test Results for Lateral A Before and After Lining Hidalgo County Irrigation District No. 2**

**February 6, 2006**

**IRRIGATION TECHNOLOGY CENTER  
Texas Cooperative Extension – Texas Agricultural Experiment Station  
Texas A&M University System**

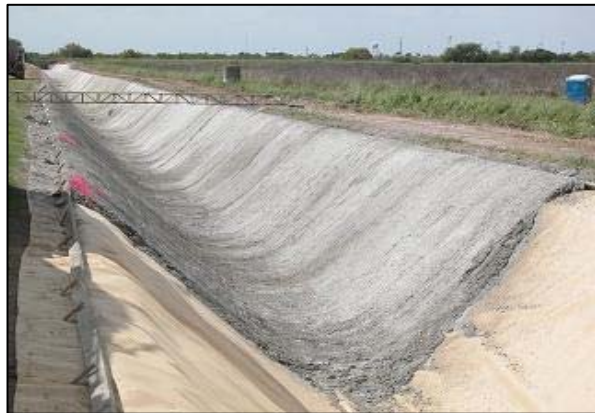
Four sets of water loss tests have been completed on segments of Lateral A canal in Hidalgo County Irrigation District No.2 (HCID2). The first tests were conducted in September 2002 and January 2003. In October 2004, Lateral A was lined with a geomembrane (geo-textile) liner overlaid with 3-inches of shotcrete (Figure 1). Two follow-up sets of water loss tests were completed in November 2004 and July 2005.

Figure 1. Layering of the new lining on Lateral A.

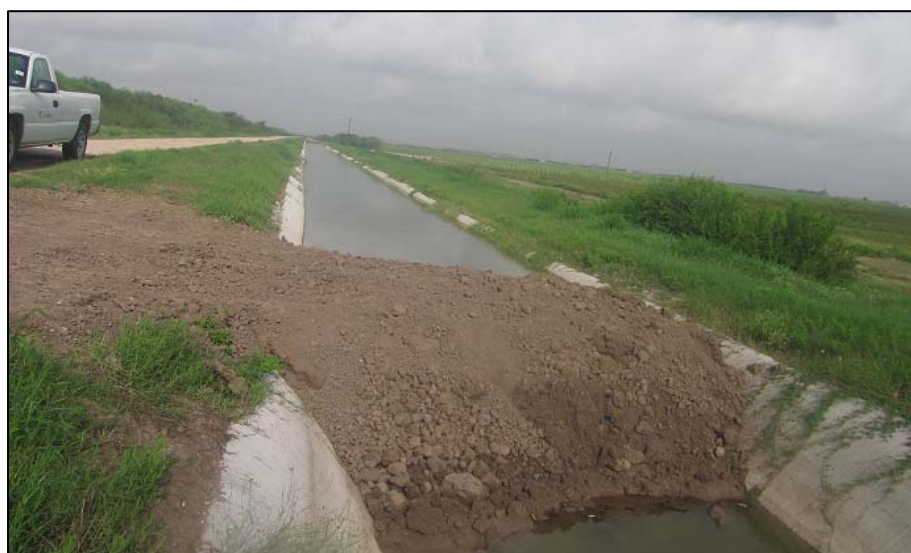
**Figure 6. Earthen dam on Lat. A-7. (Test SJ15)**

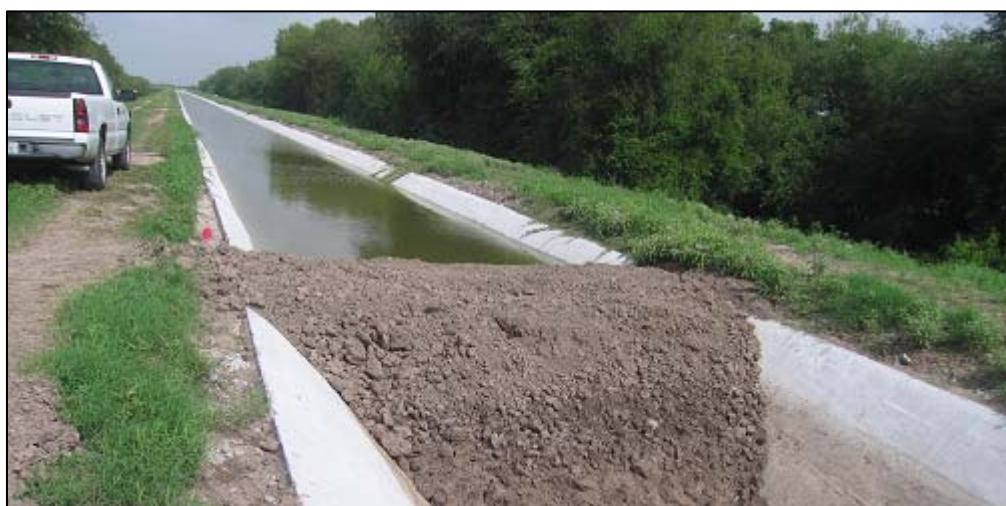
**Figure 10. Earthen dam on Lat.A-8. (Test SJ12)**

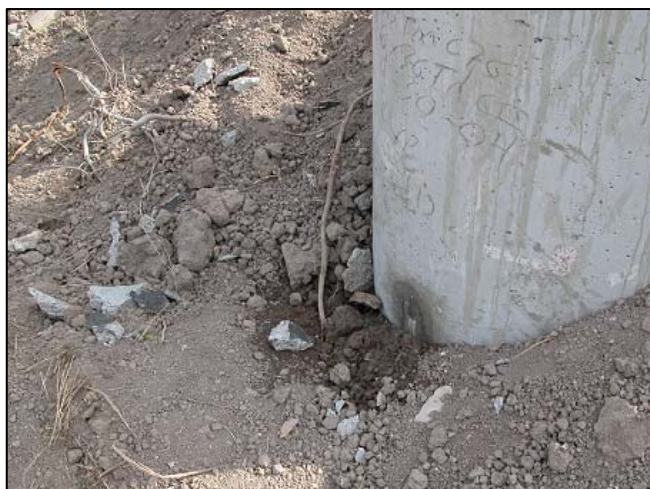
Leaks were discovered at several gates and valves with in the test segment. However, these losses could not be accounted for due to the difficulties in obtaining measurements.

**Figure 11.** This photograph shows a standpipe connecting off of Lateral A-8 leaking during test. Leaks like this are very difficult to measure and are usually hard to notice.
