May 2017

**2010-2013 Mazda3 - Gap between Instrument Panel and Information Display  
Warranty Extension Program – Special Service Program (SSP) A9**

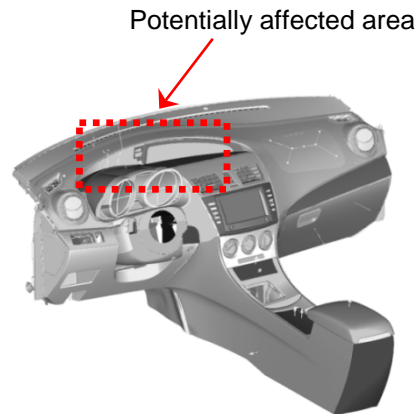
On certain 2010-2013 Mazda3 vehicles, the instrument panel just above the information display may be warping, generating a gap between the instrument panel and information display, if exposed to heat under high ambient temperature.

If the instrument panel of your Mazda3 vehicle has the warping on its surface or a gap exists between the instrument panel and information display, please make an appointment with your Mazda dealer to have your vehicle repaired. Your dealer will replace the instrument panel of your vehicle with a modified one, free of charge.

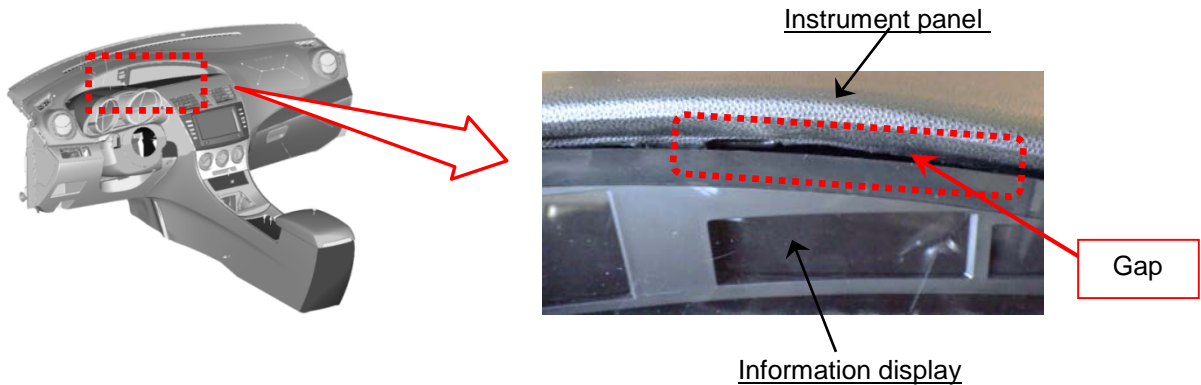
On certain 2010-2013 Mazda3 vehicles, the material of instrument panel surface may shrink and warp if exposed to heat under high ambient temperature. Also, the joint area between the instrument panel and information display may not have enough rigidity due to structural concern. With such conditions, the instrument panel just above the information display may warp, generating a gap between the instrument panel and information display, causing poor appearance.

Please replace the instrument panel according to the Workshop Manual.
