Wire Bonding Issues

Alan Honma, CERN PH-DT

- ◆ The CERN bond lab
- ◆ 5 Selected problems
- ◆ The ATLAS IBL repair (problem #6)
- ◆ Conclusion

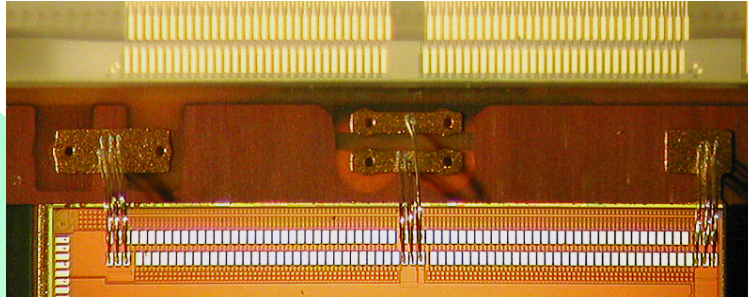
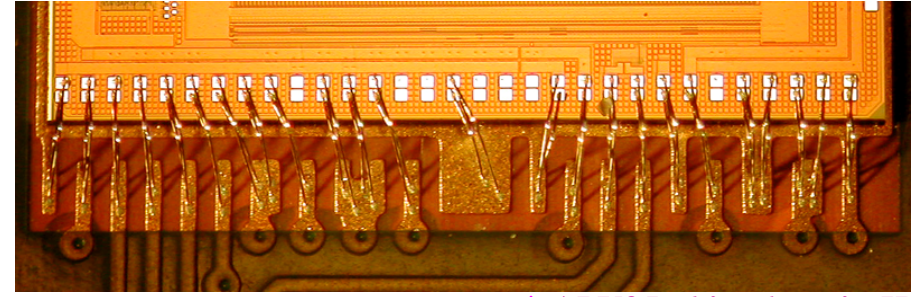
✦ How not to design bond pads on read-out chips*

* APV25 chip, done in IBM 0.25 μ m technology

- Power bonds on signal input side, in between groups of read-in bonds: this requires highly accurate placement of pitch adapter to avoid shorts to read-in bonds.
- Common power bond pads unnecessarily separated by passivation: no freedom for bond foot placement
- Redundant control bond pad rows too close to each other: bond rows interfere, could have made a single very large pad
- Square, small control bond pads (95 μ m): probably for ball bonding, need rectangular with min. length of 150 μ m
- Very thick polyimide passivation (7 μ m): bond tool touches passivation

Only way to avoid these is to inform chip designers before they finalise the layout.

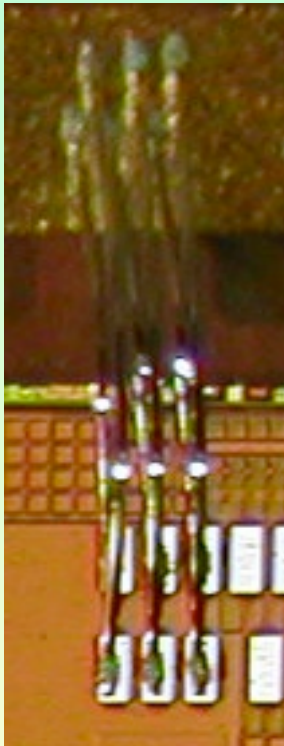
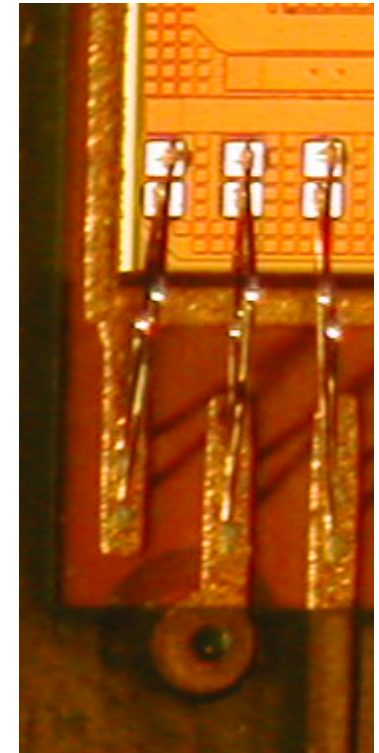
- ✦ Trivial type: someone put their hand/sleeve/screwdriver/etc in the bonds. Unfortunately, the most common reason for repair work at CERN.
- ✦ Bond damage: broken tool caused badly cracked heel, easily broken
- ✦ Insufficient rigidity: substrates can deflect by large amount during bonding (from 25g tool touchdown force). Over-deformation and heel stress on existing bonds as the wires change angle during flexing of substrate.
- ✦ Transport damage: wire breakage found between sensors or between sensor and PA on modules shipped/carried from USA (CMS). Suspected cause: substrate vibration during air or ground transport, insufficient support of sensors along especially long spans (up to 125mm) of bond rows.

*The only real **bonding** problem is the 2nd, the rest are problems of protection and module design. Some wire breakage potential can be reduced by bond loop (height and form) choice, but large relative motions of substrates under each bond foot will cause mechanical stresses. Need to have a bonding expert at the design stage. A good solution to all these wire breakage problems is encapsulation. However, there are some geometries where encapsulation causes bond failure and encapsulation is usually not reversible.*

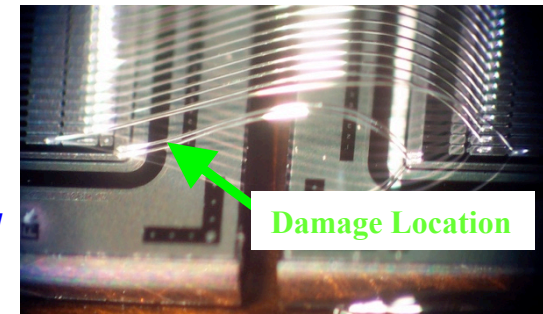
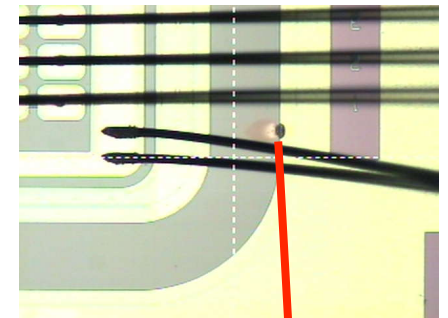
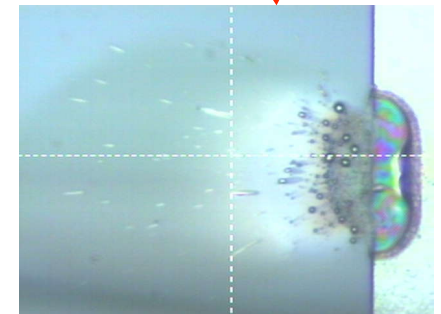
- Read about cases and saw two cases first hand (damaged chip/module brought to our lab), one of which involved bond wires.
- ◆ Examples of this type of damage involving bond wires

- Bond wire carrying HV is too close to conductive object at different potential (usually ground). Corona discharge or spark can melt wire or damage the other object (if sensitive like a sensor or chip). Especially dangerous is bond wire going over edge of sensor which is often at HV.

- ◆ Solution:
 - Increase clearance between HV wire and objects near ground potential. A good rule of thumb is to have $50\mu\text{m}$ clearance for every 100v difference. As SLHC sensors may need to operate as high as 1000v, this means $500\mu\text{m}$ clearance. May require an exotic bond loop or careful module design.

- Much better solution is encapsulation. Only need around $50\mu\text{m}$ of encapsulant protecting wire to hold off 1000v.

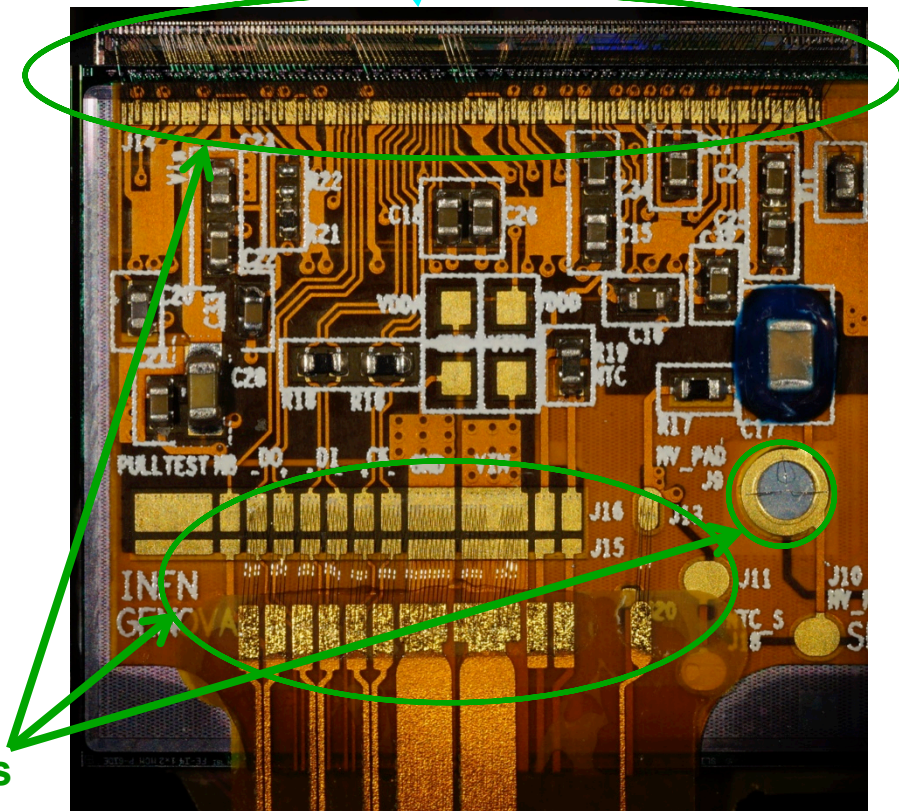
- In Sep. 2013, two staves in an overnight cold test got covered with ice when the cold box was not sealed properly. After thawing and drying, most modules did not work. Visual inspection showed many broken or missing bond wires and large quantities of residues in bonding areas especially around the bond feet.
- The project manager asked me if I had an idea of what had happened. After a quick look at the photos taken of the damage, I recognised the problem was corrosive attack of the aluminium bond wires from halogen ions, most likely chlorine. This was because I had already seen this phenomenon in the OPAL μ vertex and CMS tracker.

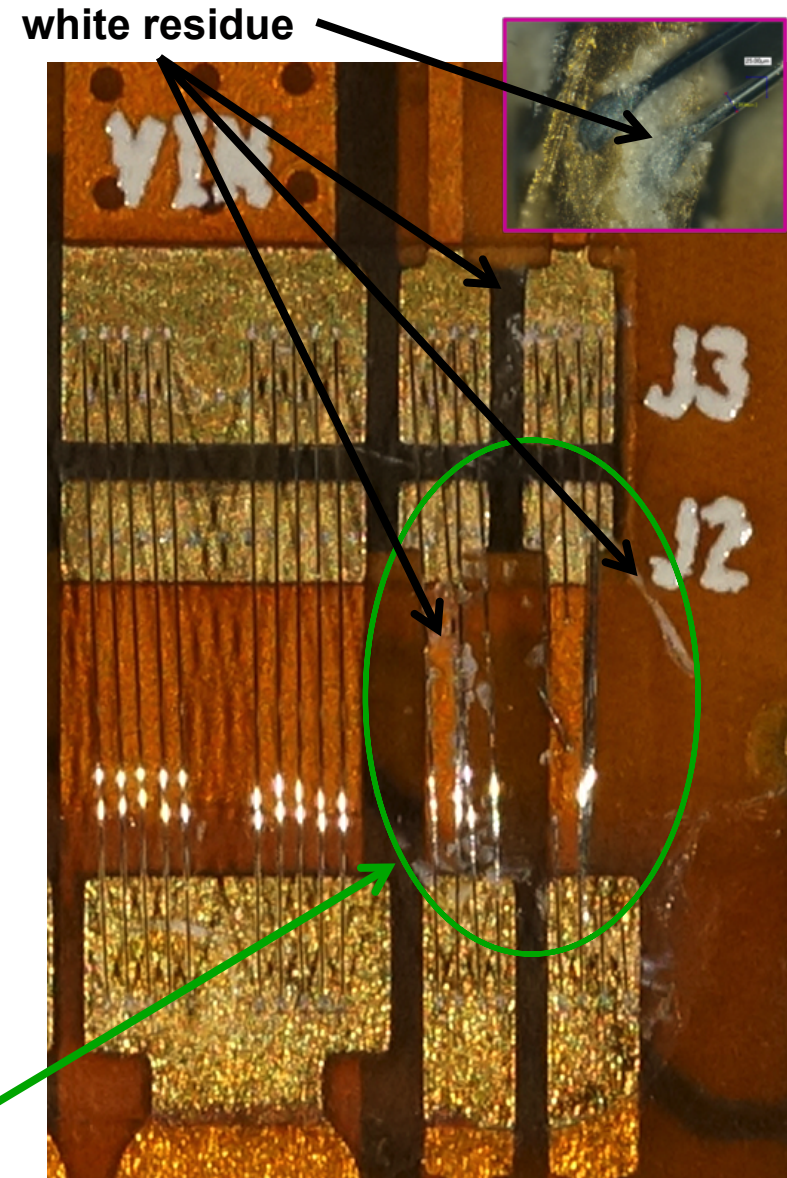
- A spectroscopic analysis showed the residues were $\text{Al}(\text{OH})_3$ with traces of chlorine. Chlorine is the catalyst of a reaction between Al and H_2O giving $\text{Al}(\text{OH})_3$. The worst part is that the Cl is freed at the end of the reaction so that it will never stop until either the Al or H_2O supply is exhausted.
- All 9 other finished staves were inspected for this problem and all showed some or many signs of corrosion damage to bond wires. Most of these had not gotten wet during the cold test (many had not yet been cold tested). It was concluded that these staves had gotten wet during thermal cycling in the large climatic chamber which did not have sufficient humidity control.
- An emergency task force was created to understand the problem and come up with a fast solution, since installation was in 5 months and could not be delayed.

5 out of 8 wires central span eaten away

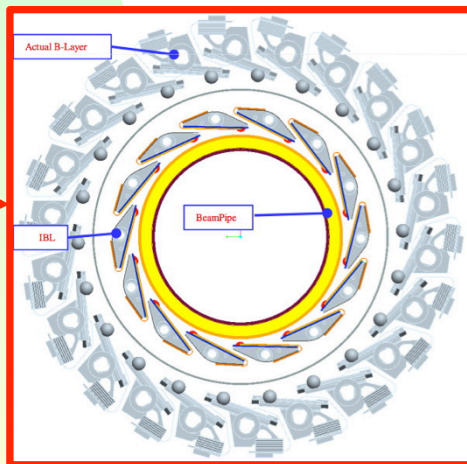
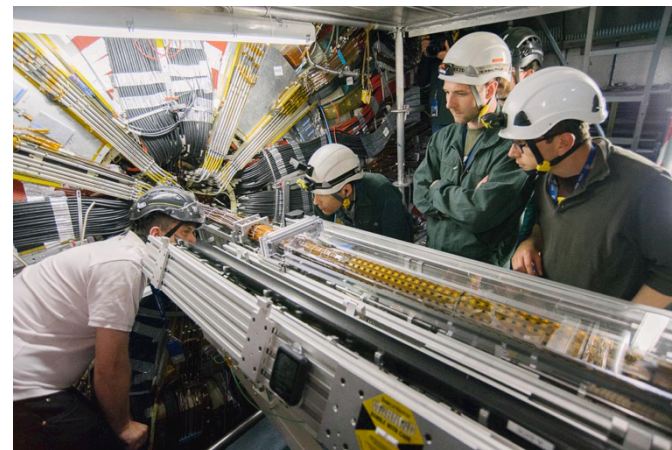
**KEEP
THIS
ZONE
DRY!**

- It was clear that if the repaired staves (and probably the new ones as well) ever got wet, the corrosion damage would again occur. Thus it was absolutely essential that all possible means should be taken to avoid condensation or icing in the IBL.
