Woltz Residence Defect List

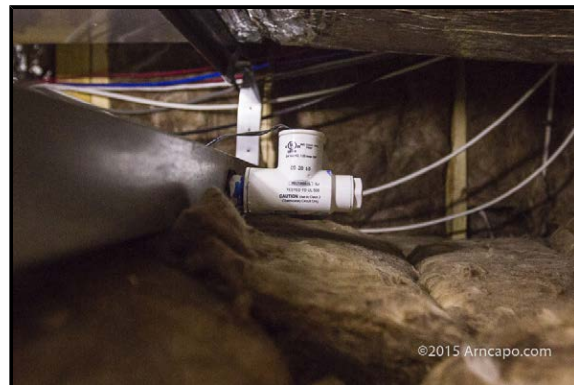
- Failure to follow this caution may result in property damage. A field fabricated auxiliary drain pan, with a separate drain is **REQUIRED** for all installations over a finished living space or in any area that may be damaged by overflow from a restricted main drain pan. (ICP FEM4X60000b2 Fan Coil installation instructions, Page 4)

The installation manual doesn't list any exceptions for the separate drain for the auxiliary drain pan. The secondary overflow safety switch is connected via small gauge copper wire. I guess copper wire never gets damaged or brittle and breaks causing the secondary overflow safety switch to fail. Building to code is building to the lowest quality level allowed.

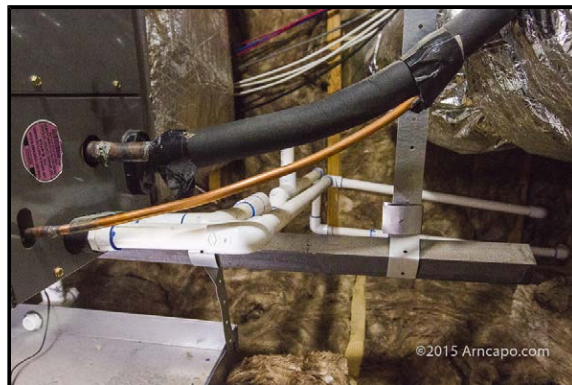
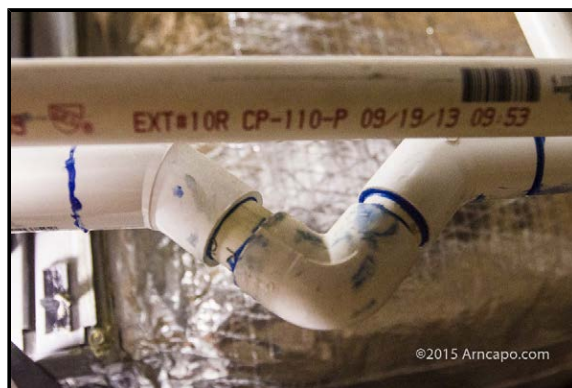
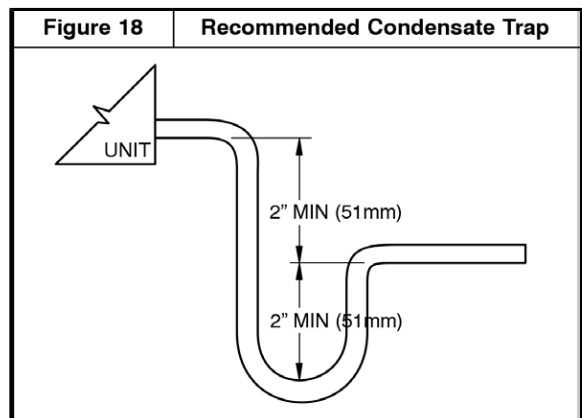
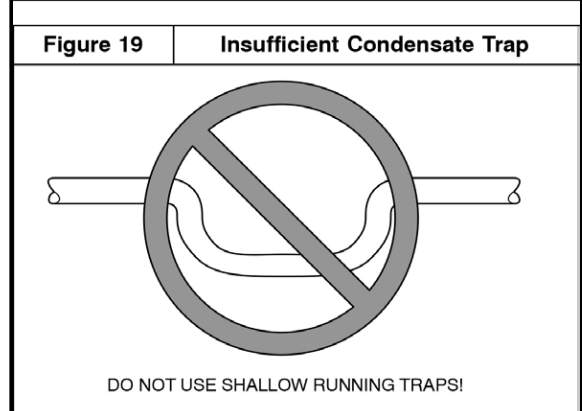
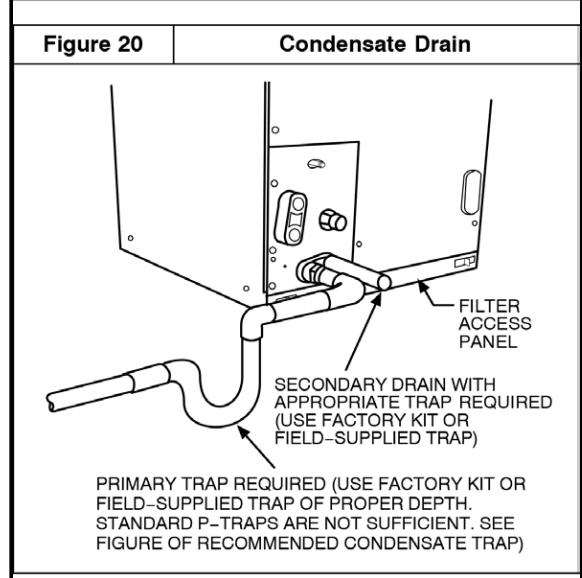
- To prevent property damage and achieve optimum drainage performance, **BOTH** primary and secondary drain lines should be installed and include properly sized condensate traps (refer to Figure 18)

- Failure to follow this caution may result in product or property damage. **Use only full size P-traps in the condensate line (refer to Figure 18). Shallow, running traps are inadequate and DO NOT allow proper condensate drainage** (refer to Figure 19). (ICP FEM4X60000b2 Fan Coil installation instructions, Page 14)

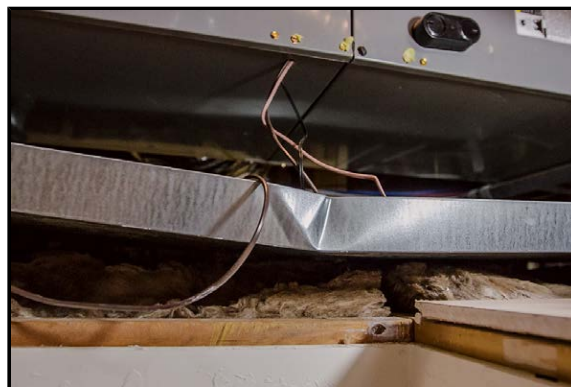
Air-handler overflow pan side was buckled. Good possibility overflow would not have triggered shutoff switch.

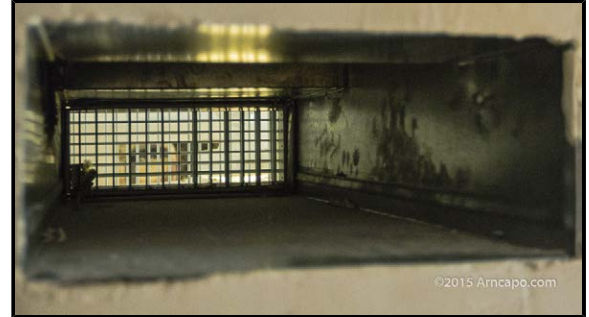
The east bedrooms supply registers are 'back to back' supply registers, meaning 2 room supply registers are aligned on the same duct. In this case the result is a 14" x 6" hole in the wall between the rooms. The obvious result is any noise in one room can be heard in the other. This is the result of a poorly designed system and is not acceptable.

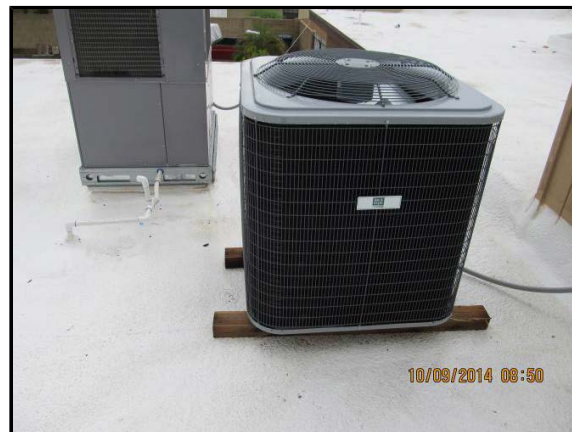
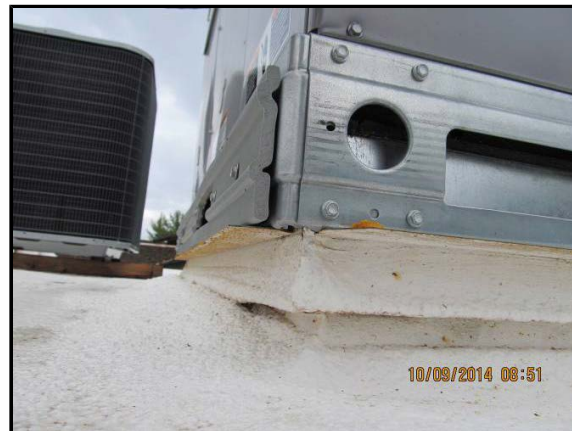
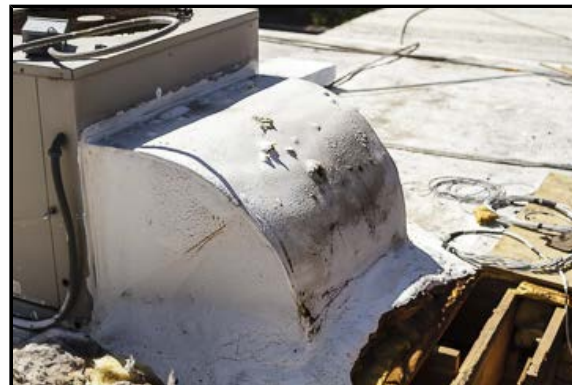
- The 2 ton packaged system unit is not secured correctly.
- The 5 ton split system compressor unit does not have protection for the underlying foam from vibration or other mechanical stresses.
- The 2 ton packaged system mounting curb is too short which does not meet industry or manufacturers' standards.
- The 2 ton package system is mounted with airflow directly into the house from the bottom of the unit. Not installing an elbow duct or a properly sized mounting curb causes excessive noise and vibrations to enter the bedrooms below.
- **Does not meet pre-loss** condition as well. Previous units were mounted with elbow ducts and mounting curbs of the correct height.

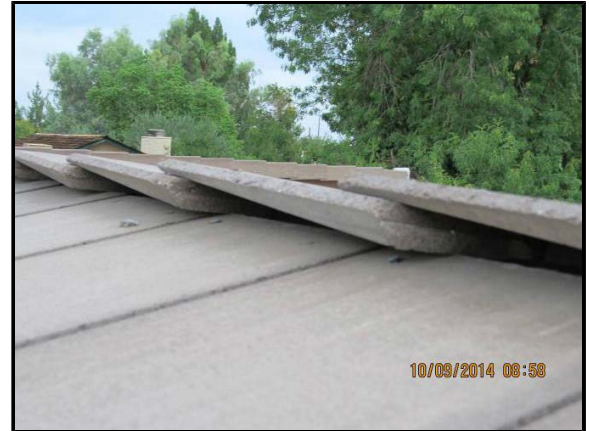
Contractor offered to reinstall ridge tiles, but the new tile color would be different from existing tile and for some unexplained reason contractor would not fix all ridge tiles. Solution was rejected.

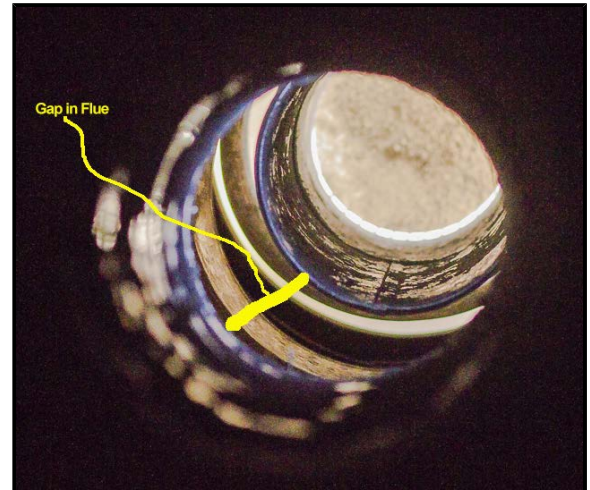
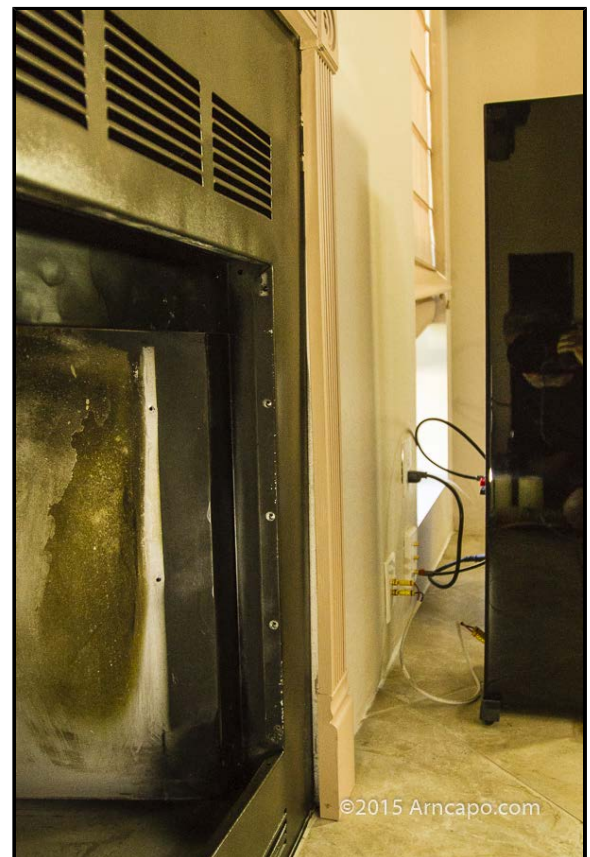
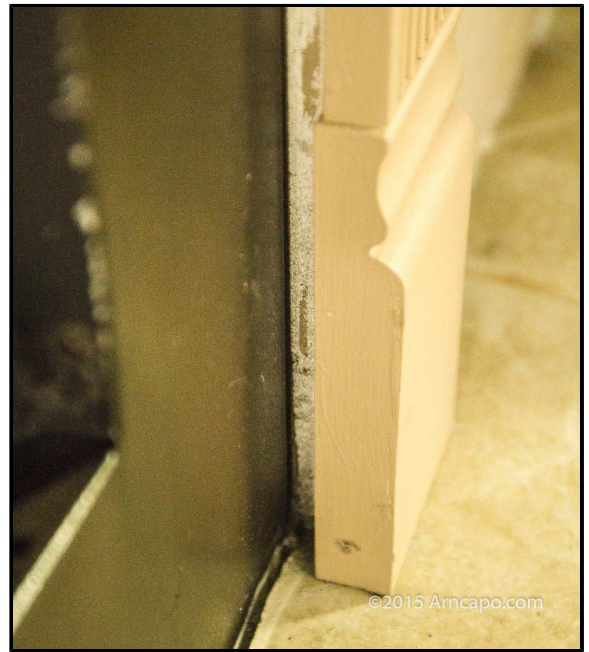
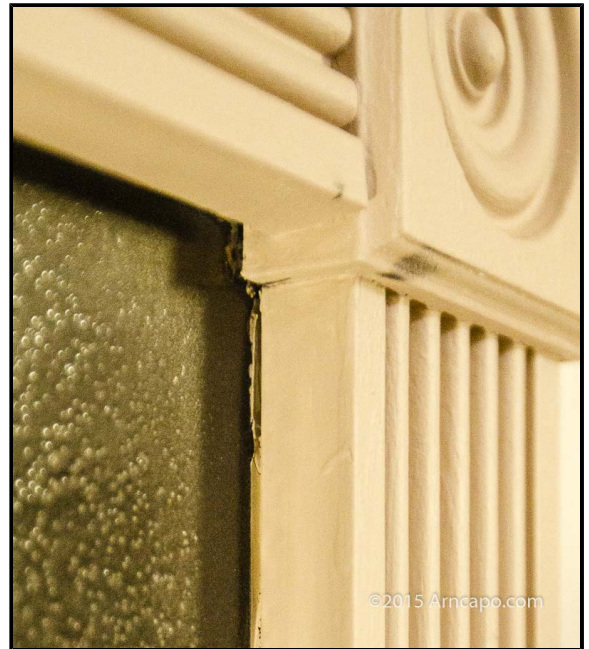
The contractor was paid to lower the family room fireplace firebox to floor level, about 14in. This resulted in a 14in gap in the flue duct and a gap in the flue heat-shield duct. The flue and heat-shield gaps were not repaired by the contractor. Because the structure around the flue is wood 2x4s, wood roof joists, sawdust, construction debris, and insulation, use of the fireplace would almost certainly start the home on fire. Tempe building department has indicated that once it is installed correctly, an inspection is required.

The front of the fireplace was not installed plumb, a vertical deviation of 0.5" over the 36" height of the fireplace firebox front. This makes adding trim very difficult and unsightly.

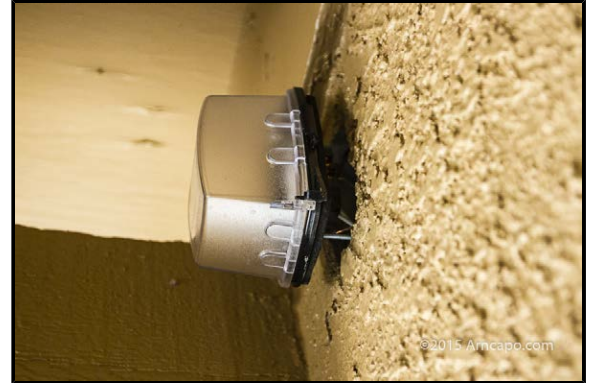
Exterior electrical boxes have been falling out of the wall when unplugging a cord. The failure occurs on the first use indicating an inadequate installation.

The north east exterior flood light is not working.

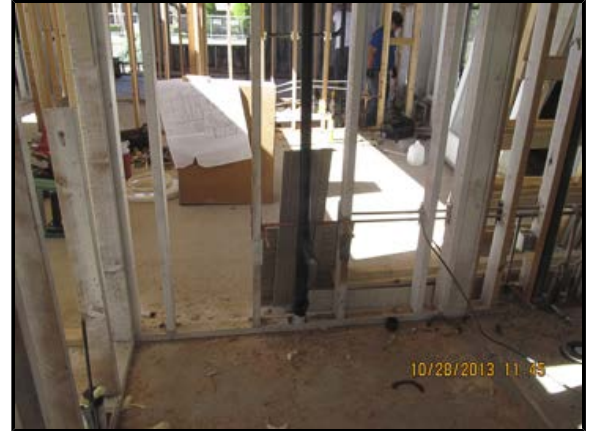
The hall bathroom vanity hot and cold water valves are reversed from what is standard (hot on the left and cold on the right). The site photos show the original plumbing hot and cold valves were correct. The photo to the right shows all new copper pipe to the stub out for the toilet running to the stub out for what should be the hot water stub out. This can be repaired from the family room side eliminating the need to remove the vanity. To date the contractor has refused to repair this workmanship defect.
