# Zink Bridge Rehabilitation Concept Report

City of Tulsa, Oklahoma

July, 2015

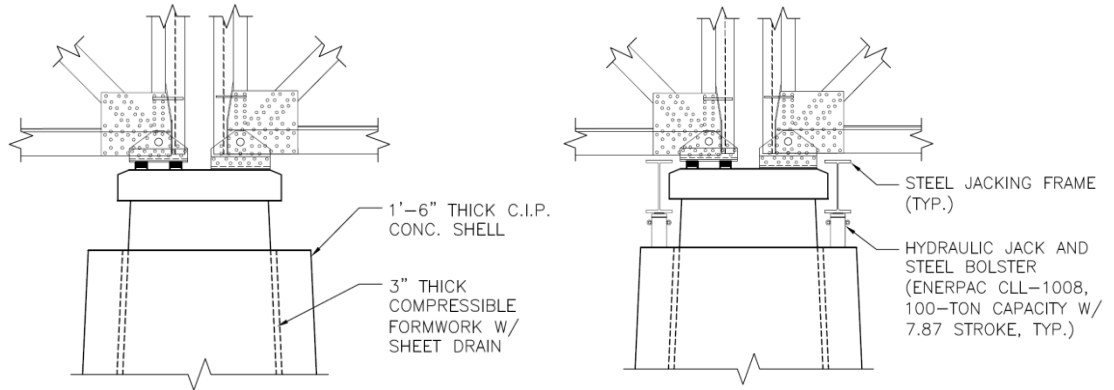
Figure 5-3: Stage 1 Pier Retrofit

The piers are composed of unreinforced, plain concrete. They have cracked and spalled extensively in their 110 year life. The absence of reinforcing steel means conventional repair methods, such as epoxy injection and sparging, are purely cosmetic, and would not restore the structural capacity of the piers. Other repair methods can be implemented in unreinforced, plain concrete to confine the concrete and delay the growth of existing cracks. These repair methods include externally prestressing the pier caps, and wrapping the piers in composite fiber material (FRP or CFRP). External posttensioning was installed on the caps some time before the 1986 flood, and this measure has successfully extended the life of the piers up until now. Unfortunately, the structural (shear) cracks at the caps have continued to grow, and in some circumstances the cracks appear to have propagated across the full depth of the cap. At one location, the continued crack growth has precipitated the spall of a large block of concrete, exposing an underlying through-section shear crack that, if left to grow, could fail the pier and drop the spans. The effect of the external prestressing appears to have been to slow the deterioration of the piers, but it appears that the deterioration has reached the point that additional measures are required to permit the continued safe use of the piers.

a) Shell is built around existing pier, and truss gusset is reinforced to allow for jacking joints. b) The truss is jacked from the new shell, and raised off of the existing pier cap.

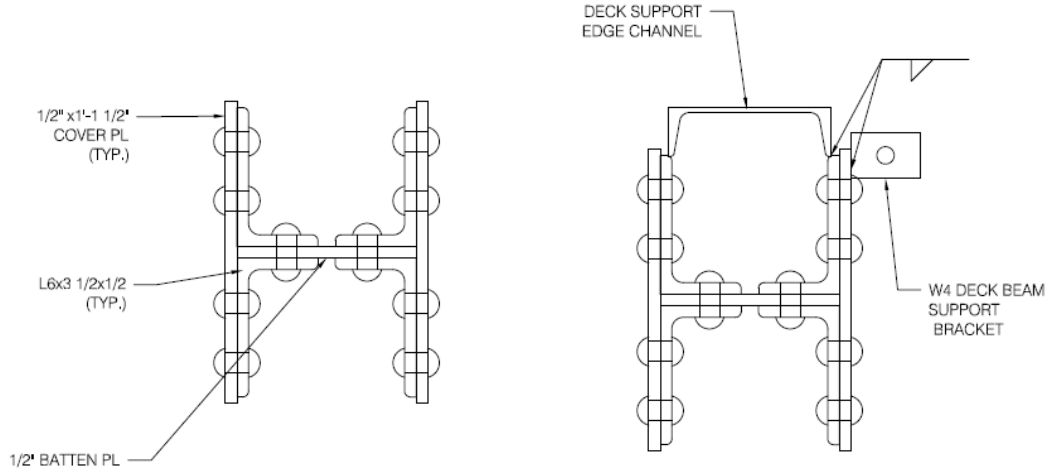
Figure 5-7: Chord Section

The original bottom chord section is comprised of 4 back to back angle sections riveted to batten plates. This type of construction offers some internal redundancy since crack propagation is limited to a single section constituent; however, multiple components of the bottom chord have been welded too. To account for this, the amount of prestressing was determined to be roughly equal to the equivalent force of two angle sections fracturing, with an impact factor of two. Refer to the figures below.

a) Original As-Built Bottom Chord Section. b) 1980's Retrofitted Bottom Chord Section

The original bottom chord section is composed of 4 back to back L6x3-1/2x1/2 angles riveted to batten plates.

The 1980's retrofitted bottom chord section added the deck edge channel and W4 deck support bracket (connection tab) and introduced fatigue / fracture sensitive welds to two angle components.

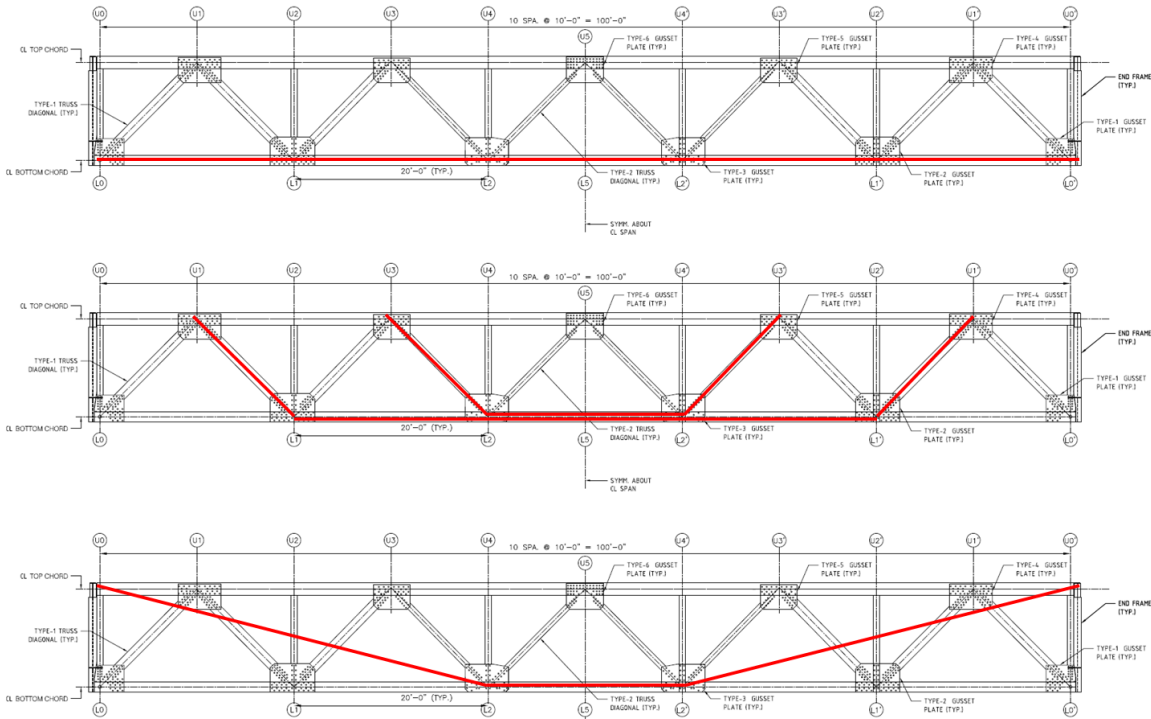
Figure 6-1: Post-tensioning Configurations

The objective of the post tensioning patterns was to reduce tensile forces in the fatigue sensitive members, such as the lower chords, which may have been compromised from previously implemented retrofits. Ultimately, post tensioning along the bottom chord of the truss was determined to be the most effective pattern.

Several post-tensioning configurations were studied as a means to reduce fracture sensitivity.

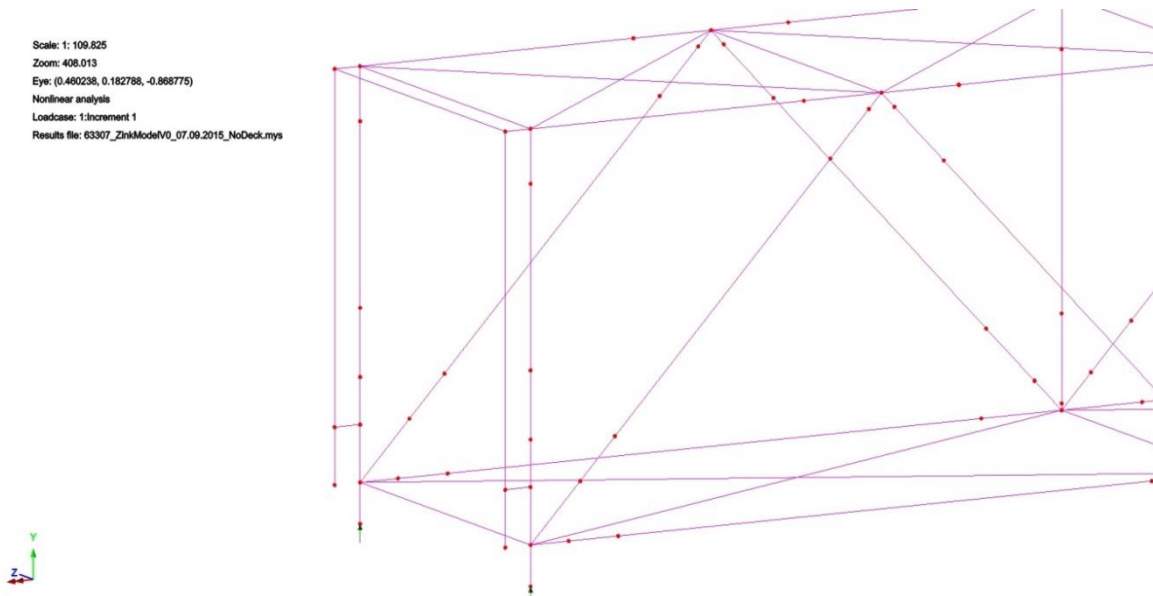
Figure 6-4: Detail View of End Portal Frame

The end portal frames were installed as part of an earlier retrofit strategy. End portal frames, referred to as end frames hereafter, consisted of a W18x50 strut (horizontal member) and two W10x49 columns. The strut was rigidly connected, through several welds, to the top chord members at the ends of the truss; whereas, the end frame columns were connected to the end truss verticals by stitch welds and a shear bar. To adequately model the existing conditions of the end frame, four stub connection elements were used. The top two stub connection elements retained the section properties of the top chord, to reflect the rigid connection between the end frame strut and top chord. The bottom two stub connection elements were given section properties equivalent to the shear plate element connecting the end frame columns to the end vertical. The stitch welds were ignored due to concerns of the existing truss metal weldability.
