#05068C: Product Safety - Front Wheel Speed Sensor Corrosion - (Mar 6, 2008)

Subject:	05068C FRONT WHEEL SPEED SENSOR CORROSION
Models:	1999-2002 CHEVROLET SILVERADO
	2000-2002 CHEVROLET TAHOE, SUBURBAN
	2002 CHEVROLET AVALANCHE
	1999-2002 GMC SIERRA
	2000-2002 GMC YUKON, YUKON XL
	LOCATED IN THE SEVERE CORROSION AREAS LISTED
	BELOW

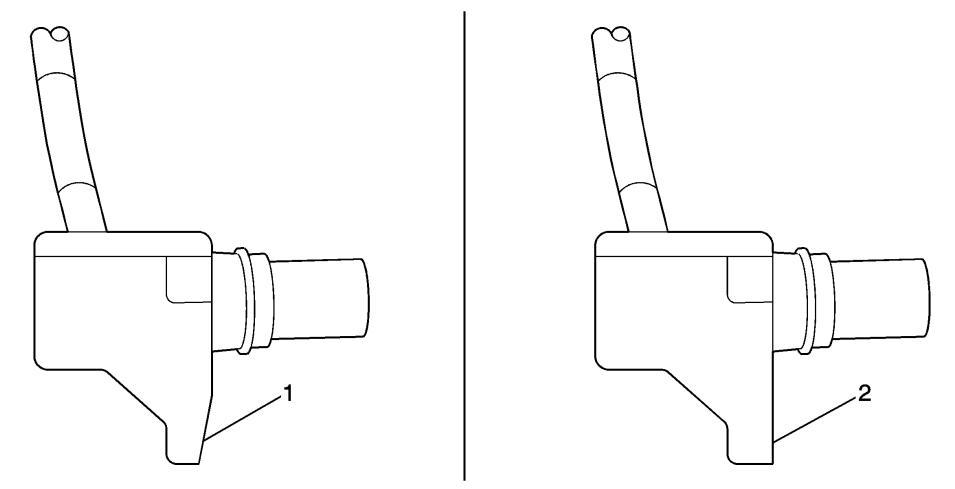
Important: The mounting surface on the sensor must be flat in the next step in order to be mounted correctly on the bearing hub assembly. If the mounting surface on the sensor is warped or bent, the sensor must be replaced.

- 11.Inspect to see if the mounting surface on the sensor is flat. Check the mounting surface on the sensor head for flatness by placing it on the edge of a metal machinist's scale or other suitable straight edge to measure the flatness. Check the sensor for flatness in multiple positions/directions (minimum 3).
 - If the sensor mounting surface is NOT flat (1), the sensor must be replaced. Proceed to the next step and replace the sensor.
 - If the sensor mounting surface IS flat (2), the sensor IS to be reused. Proceed to Step

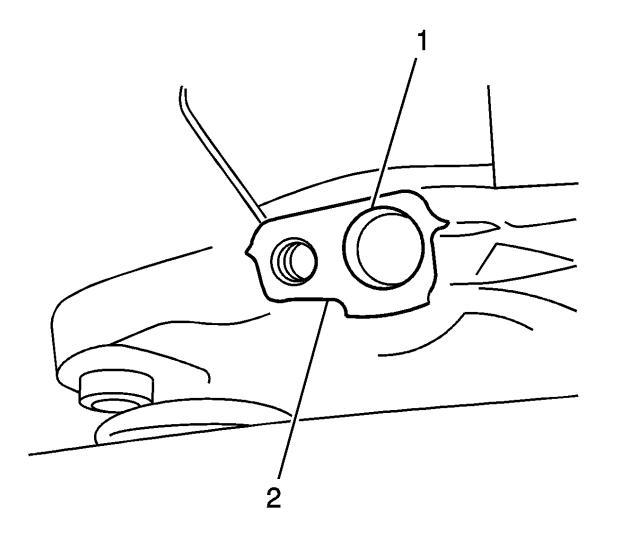
Important: All rust and corrosion must be removed from the wheel speed sensor mounting surfaces on the bearing hub in the next step.

16.Temporarily plug the wheel speed sensor hole (1) in the bearing hub to prevent debris from entering it when you clean it.

17.Using a wire brush, sandpaper, emery cloth, scotch brite, or equivalent, thoroughly clean the wheel speed sensor mounting surface (2) on the bearing hub to remove any rust or corrosion.
