# **Inspection Report**

# Sample Bank and Trust

Property Address: 104 Sample Industrial Drive Somewhere NC

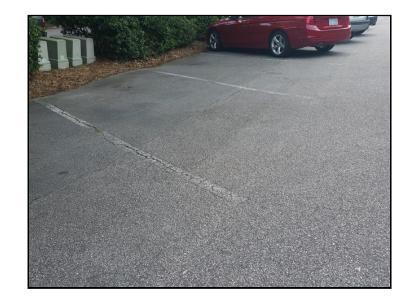
(2) **Recommended Maintenance:** *[location: front side of building at parking lot]* Parking dividers are faded and need to be repainted. Improvements are recommended.

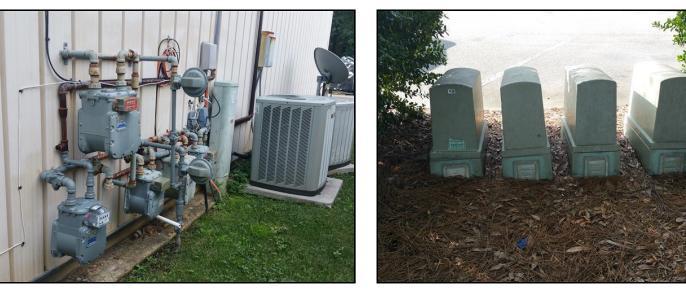
View of gas meters

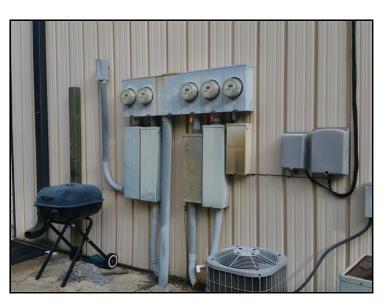
View of power meters

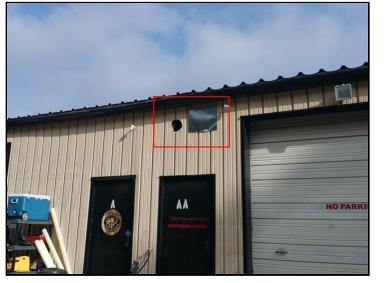
(2) **Repair:** *[location: rear side of building]* The exterior metal wall cladding is bent or severely damaged in several locations. Gutters were also damaged. A qualified contractor should repair.

damaged cladding at rear of building

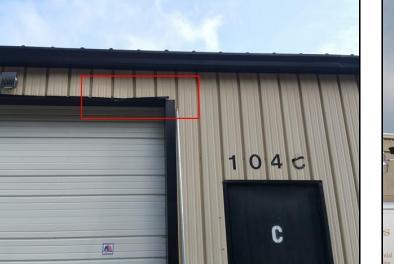
Damaged cladding at unit 104C

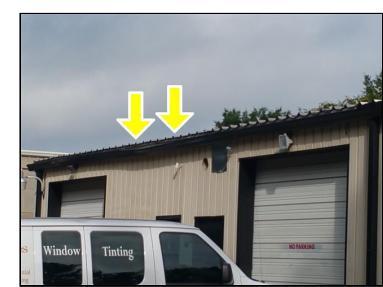
Damaged guttering

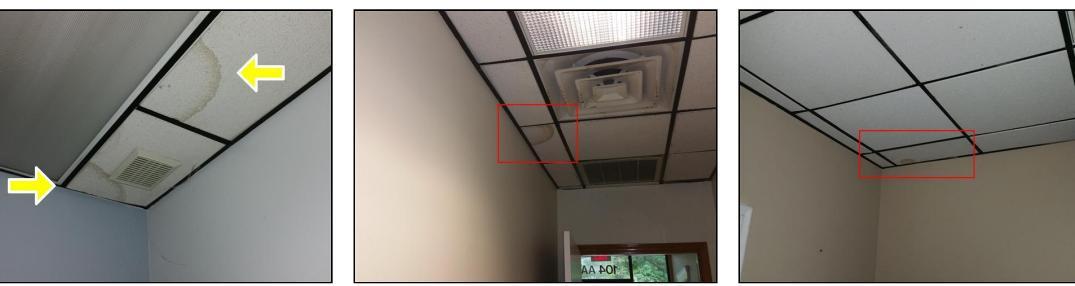
(2) **Repair:** *[location: various locations throughout the building]* The interior drop ceiling tiles show stains which generally indicate multiple roof leaks have occurred. The inspector believes this could be an active problem in some locations. An onsite staff member familiar with the building indicated this is an active ongoing problem during heavy rains (in unit E). Numerous previous repairs were observed along the roof covering. Photographic exhibits are provided at the end of this section. A roofing contractor should walk the entire roof and perform necessary maintenance.

104AA boot water intrusion

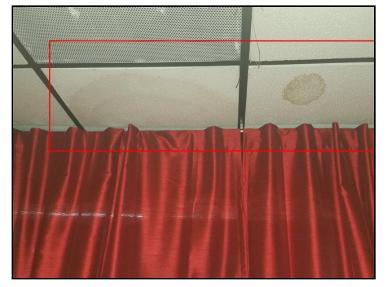
unit 104A (numerous stains)

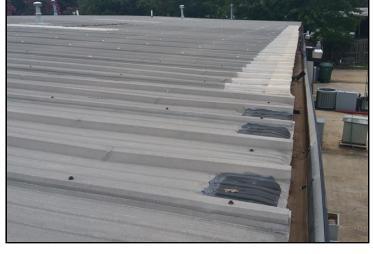
view of previous repairs

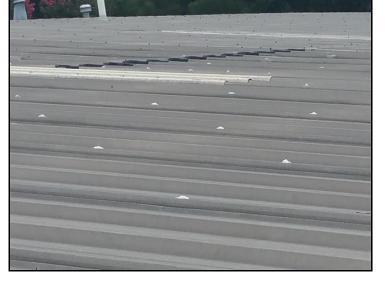
previous fastener sealant

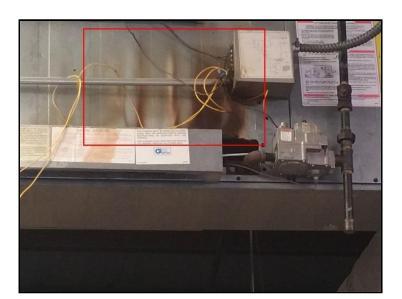
(5) **Investigate-** *[location: unit 104B system]* The gas forced air furnace exhibited conditions that suggest the heat exchanger is cracked. The inspector did not disassemble the furnace and did not physically see a crack in the heat exchanger. A heavy soot stain was observed on the outside of the burner chamber. This could indicate a crack in the heat exchanger. A crack in the heat exchanger can cause carbon monoxide to leak into the living space. A licensed mechanical contractor should provide opinion. Photographic exhibit is provided at the end of this section.

heavy soot on outside of furnace at unit 104B

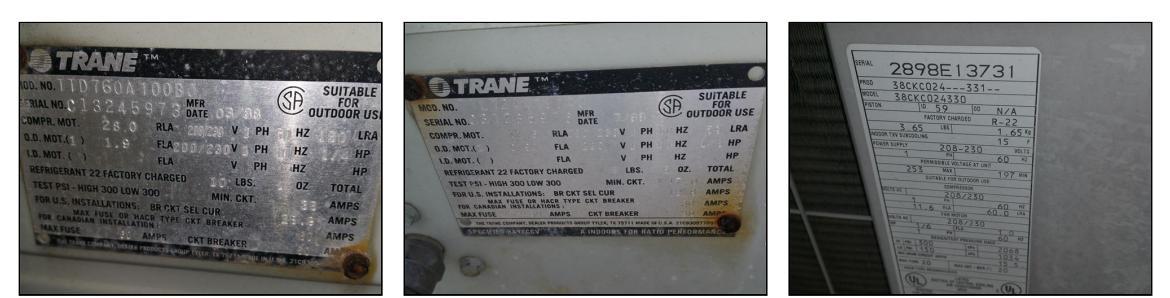
(2) Investigate: [location: 4 exterior units serving the 104B, 104B, 104D, and 104E] The exterior pad mounted condensing unit equipment is over 16 years old. It should be noted that this equipment has outlasted an average life cycle. The average life cycle for this type of equipment is 14-16 years. The inspector is unable to determine how long the outdoor component of the air conditioning system will last before repair or replacement will be necessary. The client should consider gathering replacement cost estimates from a licensed HVAC contractor. The client should budget for repairs.

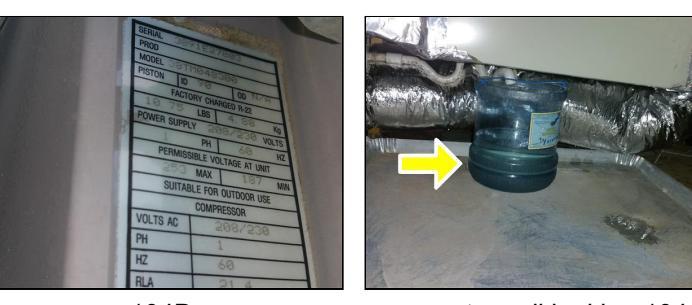
(5) Repair: An evaporator coil was leaking into a bucket at unit 104AA. A HVAC contractor should evaluate to determine necessary repairs.

evaporator coil leaking 104AA

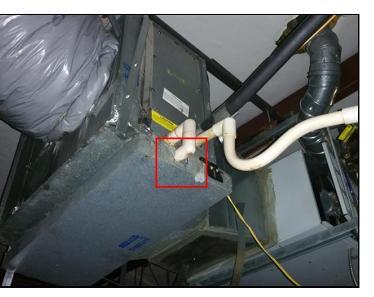
104B

(4) **Repair:** A damaged/modified overflow pan was observed below an evaporator coil. This could cause water to leak from the pan and cause water damage below. Repairs are recommended.

damaged overflow

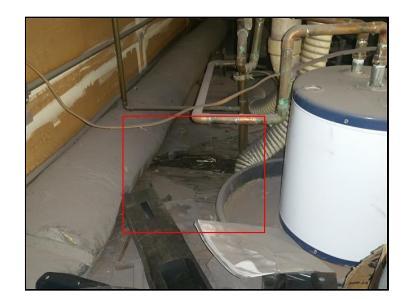
(2) Repair: Hot water at unit 104E was inoperable. An active leak was also observed near the water heating device.

leak above bathroom at unitE

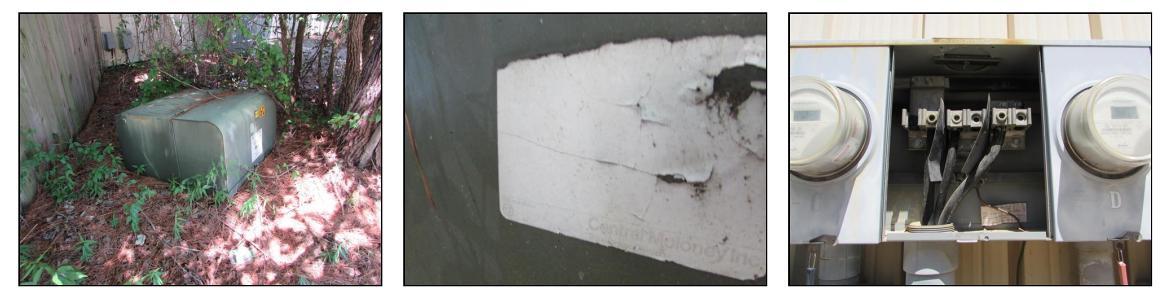
(1) Description: Each individual suite has a separately metered electrical system that is each rated to carry 200 amps. The service rating label at the transformer along the left side of the property has faded and is not legible.
(2) Repair: Significant settling was observed to the pad mounted electrical transformer box at the left side of the property. The equipment is way out of level. Erosion is suspected cause. Gathering repair cost from licensed electrical contractor. Impact on the buildings electrical service is unknown. Reporting this condition to the electrical power provider is recommended. A photographic exhibit is provided at the end of this section.

unlevel transformer

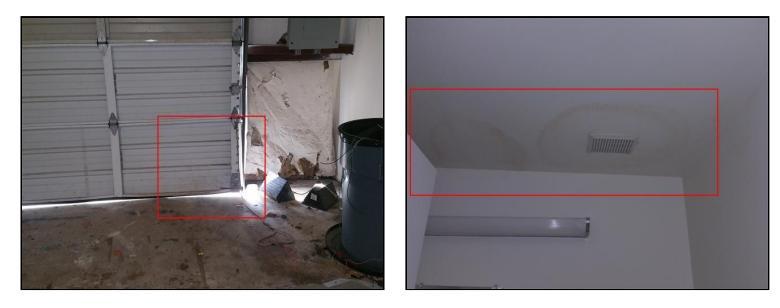
(2) **Investigate:** *[location: unit 104D (above womens bathroom)]* The interior ceiling shows stains which could indicate an active roof leak or a leaking plumbing pipe. A photographic exhibit is provided at the end of this section.

(2) **Repair:** *[location: rear at unit D]* A roll up overhead door is damaged. Repairs are necessary. A qualified contractor should repair. A photographic exhibit is provided at the end of this section.
