5R55S/W HD2 Reprogramming Kit ®

Fits: 5R55S/W 2002-10 Does NOT fit 5R55N

This kit is about: Upgraded Performance,
Reduces/Prevents: Won't Move - Pump Noise,
No Lockup Hot, Lockup Slip/Shudder
Prevents Band failure common after adding Horsepower.

Trouble Codes: P1740, P0732, 733, 735

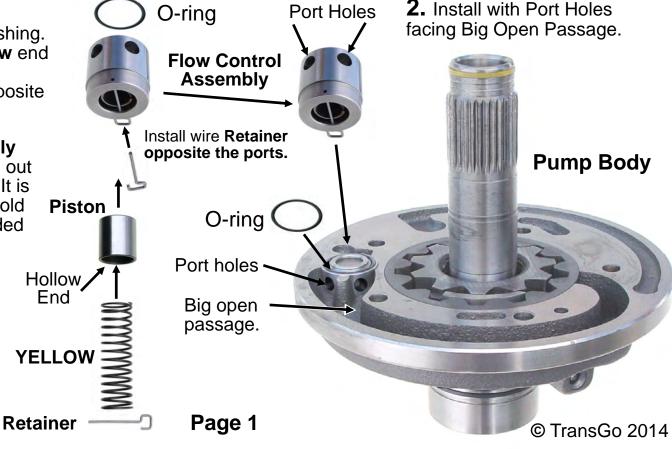
Original Flow Control Assembly

Sticks, causing won't move, wears out causing burned friction and noise. It is included in a new pump, and not sold separately. We believe the upgraded design will outlast the original part.

1. Flow Control Assembly

Install **solid** end of piston into bushing. Insert **YELLOW** spring into **hollow** end of the **Piston**.

Install **Retainer** into **Bushing** opposite port holes and under the spring.

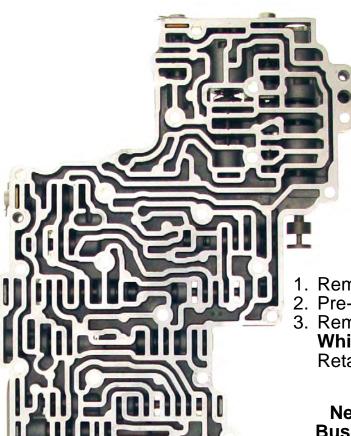
Lockup Valve Upgrade

IMPORTANT: The "W" retainer makes small burr on the inside edge of bushing groove. Using sharp end of a drill bit or sharpened screwdriver, carefully scrape off burr. Then remove bushing by **GENTLY** prying thru opening in bottom of VB.

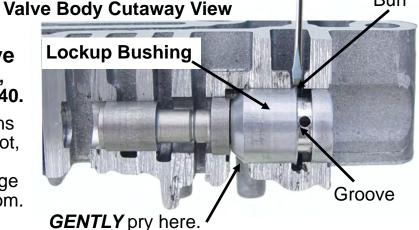
Burr

New Lockup Valve No lockup, Shudder, Slip, and/or Code 1740.

LISTEN UP: If the trans has no lockup when hot, but the fluid and filter look OK: Then this page will fix it from the bottom.

1. Remove and discard original spring, lockup valve, bushing & inner valve.

2. Pre-fit new Lockup Valve. Make sure valve freely strokes to bottom of bore.

3. Remove new Lockup Valve and reassemble in the following order: Install **New White spring** and **Lockup Valve**. Install New Bushing and Inner Valve. Install Retainer. Lock-up will have **smoother engagement** & **more** capacity.
