ATRA WEBINARS

6T40-6T45 Updates and Product Concerns

Presented by:
Steve Garrett
ATRA

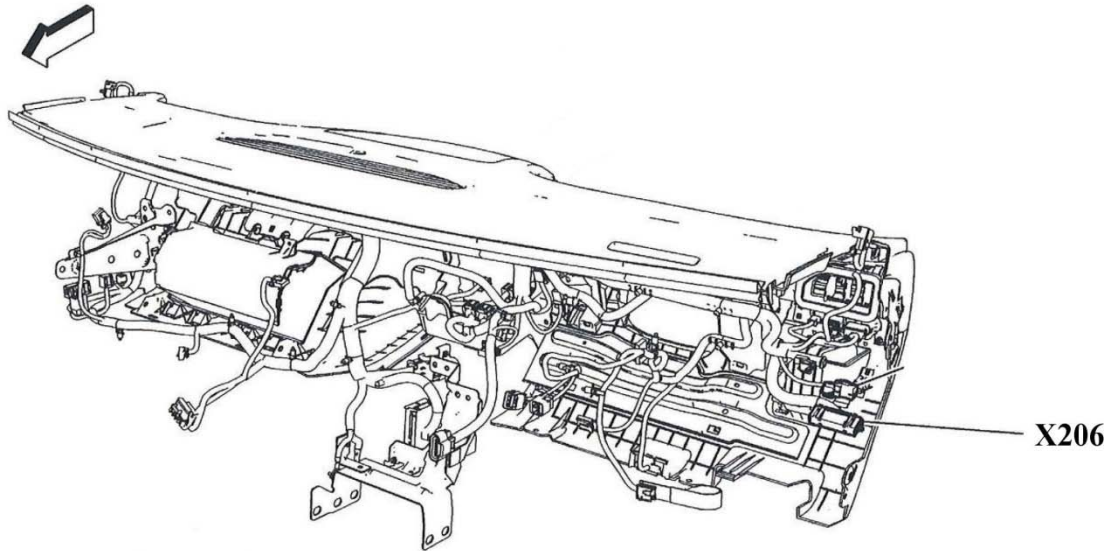
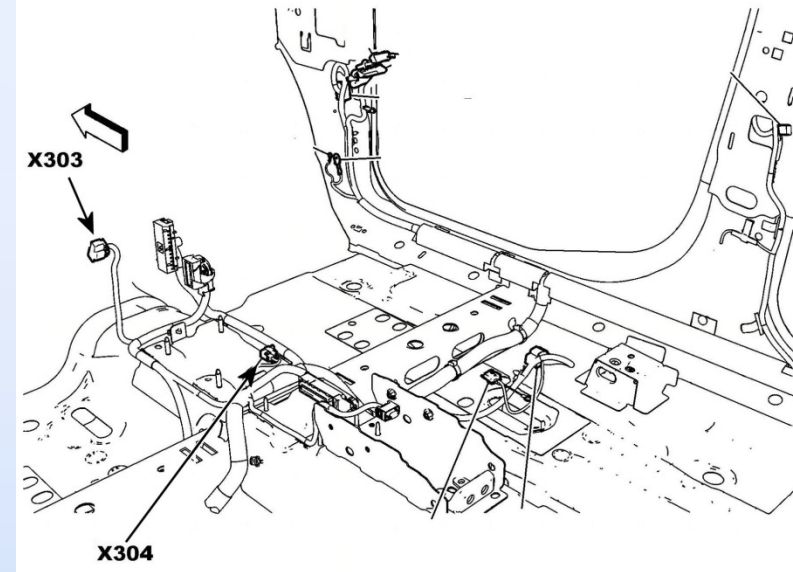
PRNDL Doesn't Illuminate

GM Z body (Malibu, Aura 6T40/45 (RPO MH7/MHC) 6T70/75 (RPO MH2/MH4/MY9/MH6) applications may exhibit a condition where the PRNDL display does not indicate the gear position the customer has selected.

This condition in many instances is intermittent and difficult to duplicate.

Inspect circuits 5981, 5982, 5983 and 5984 for poor or damaged connections between the Instrument Panel Cluster, Body Control Module and the Shift Lever assembly. Inspect connectors X206, X303 and X304 for damaged or loose terminals.

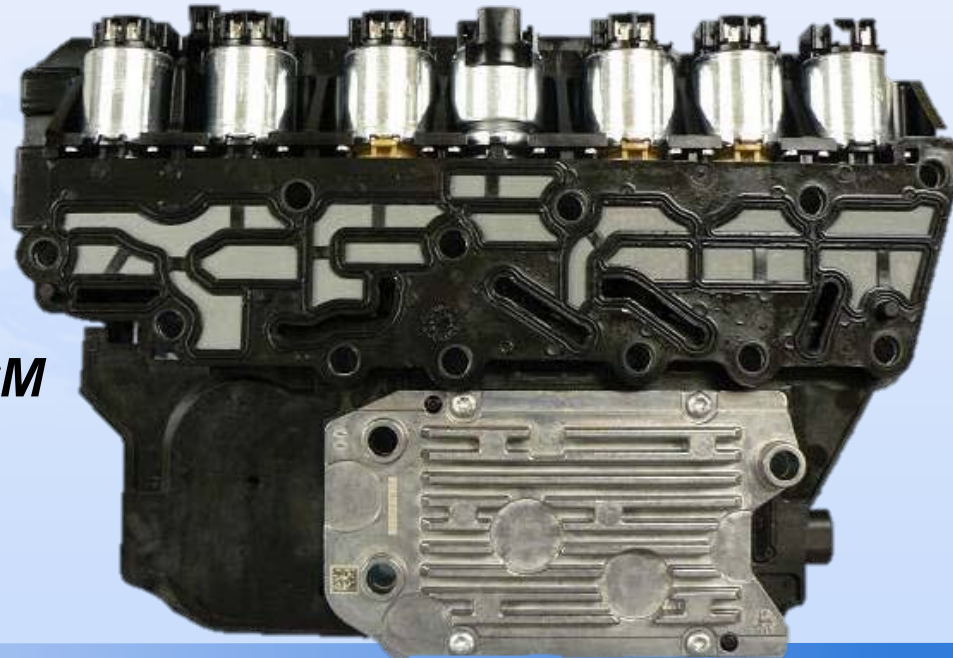
Early GEN I TEHCM

A 2011 Chevrolet Cruze with a harsh, flare or bump shift complaint that is typically more pronounced when the transmission is cold may be caused by a calibration error. In addition the concern may lead some customers to complain and others not to complain depending on the adapt tables they typically operate the vehicle in. This concern is related to applications with GEN I control systems.

This complaint can be corrected with an updated TCM calibration.

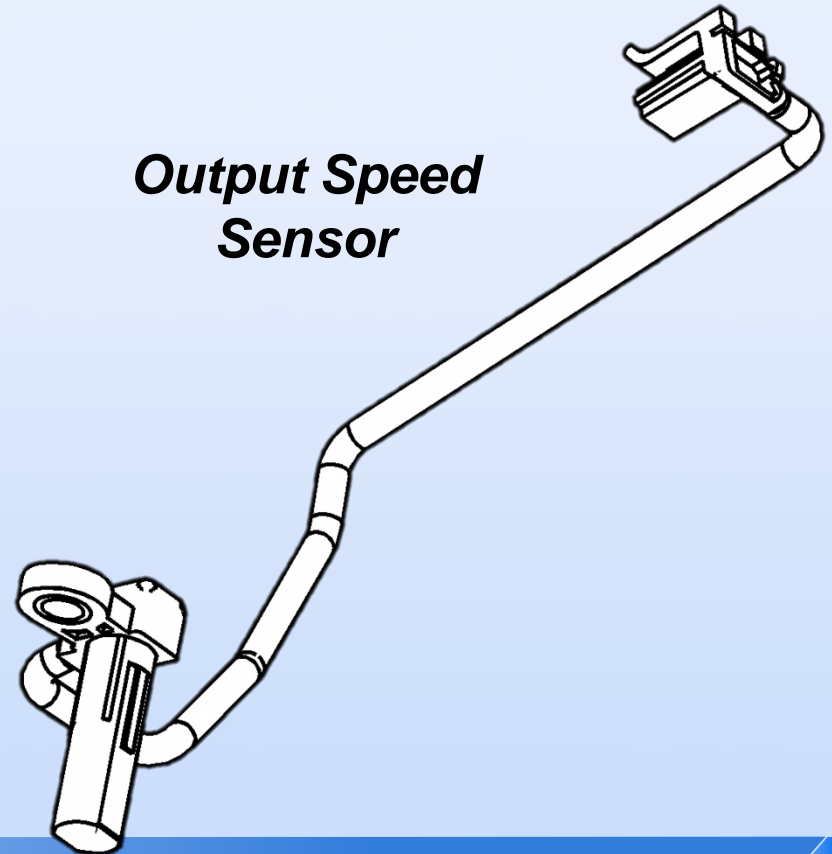
P0723 Sets

A 2009 (Z BODY) Malibu, Aura, G6 with the 2.4L engine may set a Output Speed Sensor code P0723 caused by a calibration error.

If there are no problems found with the output speed sensor. The TCM calculation strategy has been updated to correct this problem. Reflash the TCM with the new strategy.

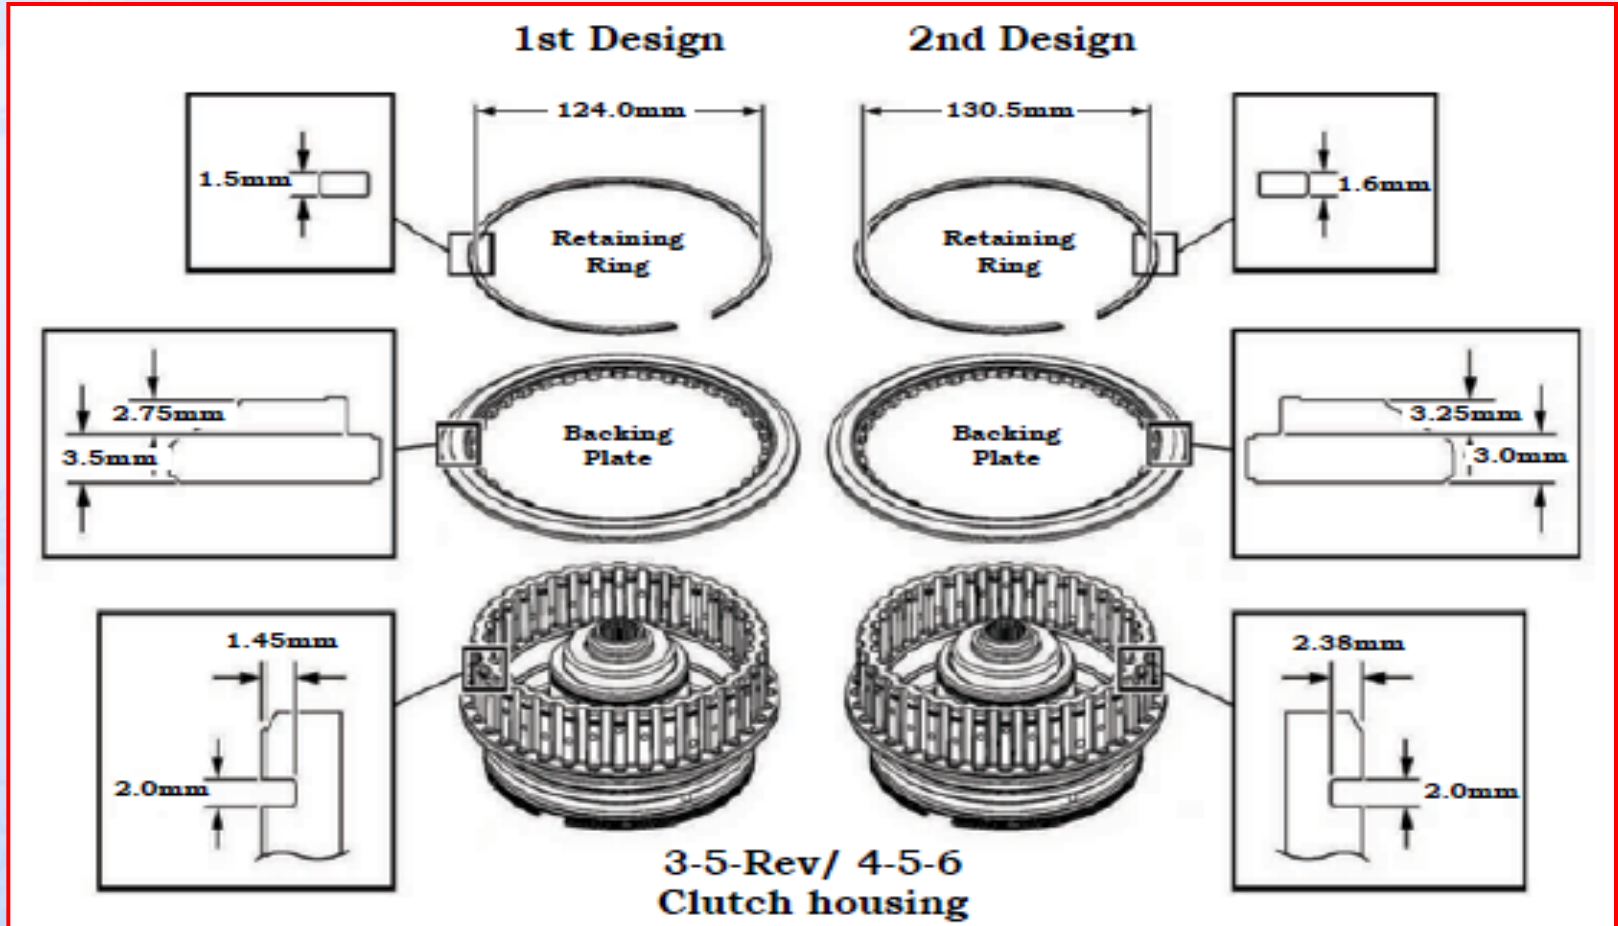
No 3rd, 5th or Reverse Gears

Some applications may develop a no 3rd/5th/Reverse condition.

This may be caused by the 3rd/5th/Reverse clutch snap ring popping out preventing the apply of the clutch.

This condition may occur on 2010 and earlier applications.

DO NOT intermix 1st design and 2nd design parts for the 3-5 reverse clutch housings, snap ring or backing plates. If parts are intermixed shift conditions or clutch failure may result.

As a running change during the 2010 model year the 3-5-Reverse/4-5-6 clutch drum and snap rings were updated to address a problem with snap ring retention. The 2nd design parts will back service if they are used as a complete set.

- 3-5-Reverse/4-5-6 clutch drum (groove dimensional depth changed to 2.38mm)**
- 3-5-Reverse backing plate (step changed to 3.0mm and 3.25mm respectively)**
- 3-5-Reverse backing plate snap ring (thickness changed to 1.6mm)**

The updated parts package is available as kit, part number **#24255922**

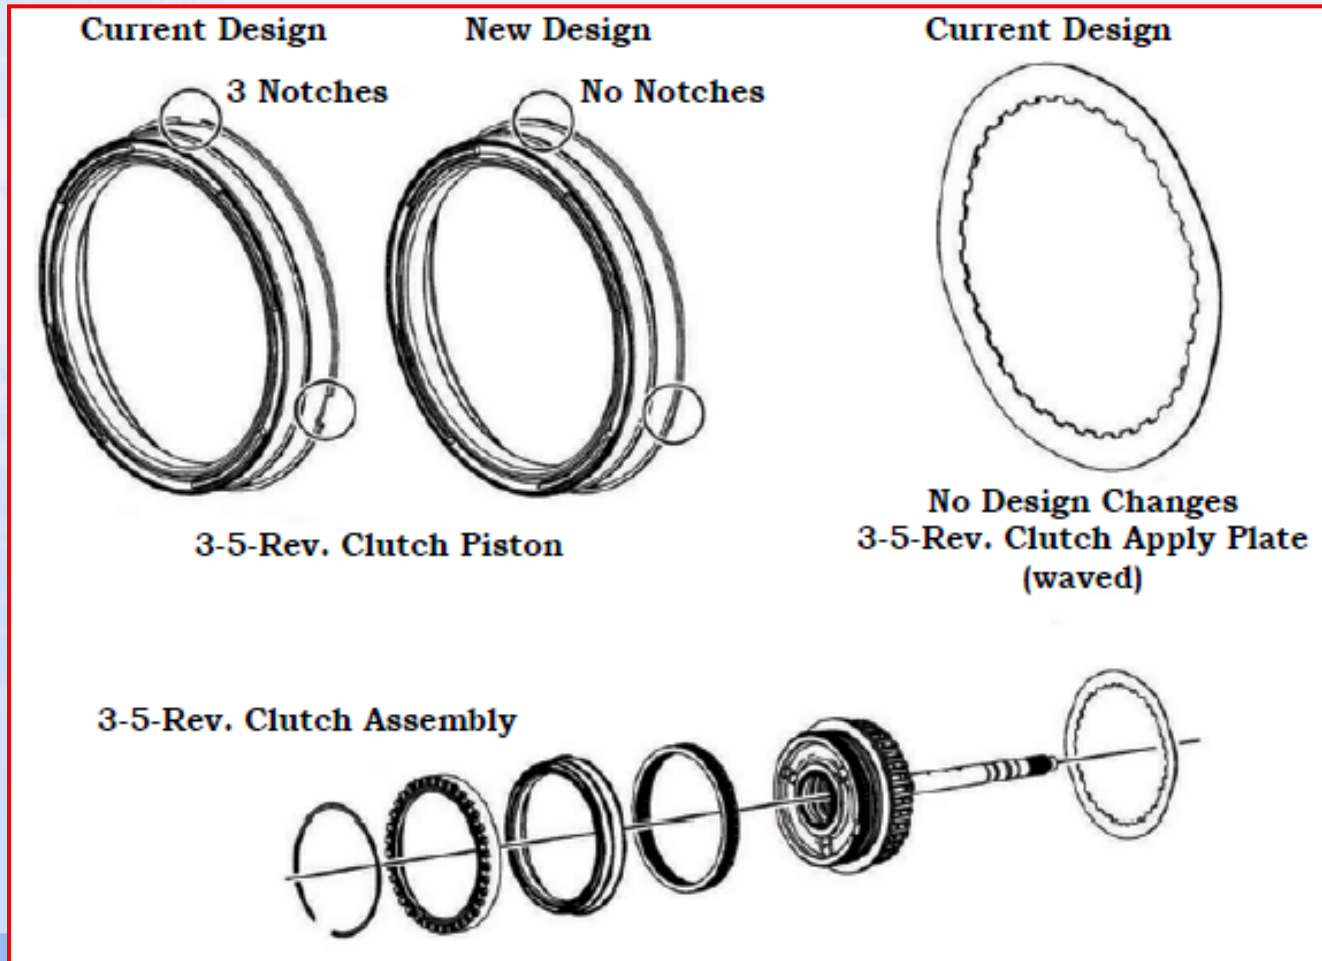
Hard Shifts, Broken 3-5-Reverse Wave Plate, Possible DTC P0776 Set

2011 and earlier and some 2012/2013 6T40/45/50 applications with the generation 1 control system may exhibit a hard shift concern.

This may be caused by the 3-5-Reverse wave plate being broken. The wave plate may have broken due to the design of the 3-5-Reverse piston.

The previous piston design can lead to a fatigue failure of the wave plate. In addition the technician may find DTC P0776 set.

Inspect the 3-5-Reverse piston. The previous design piston can be identified by looking for “Notches” in the OD of the piston. If notches are present, the piston “MUST” be updated to the new design prior to installing the wave plate and clutches or wave plate failure may occur again.

The updated piston is available as part number 24259061.

The wave plate is available as part number 24230757.
