Advanced Materials For Mercury 50 Gas Turbine Combustion System

Final Report

Report SR01-R-6187-25

Solar Turbines Incorporated

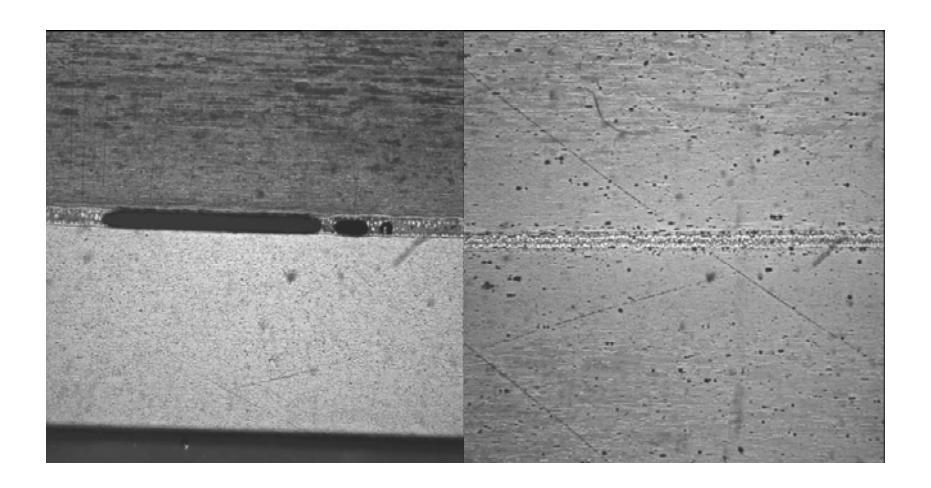
Figure 4.3 Cross Sections of a Braze Joint Showing Lack of Fill (Left) and a Good Braze (Right)

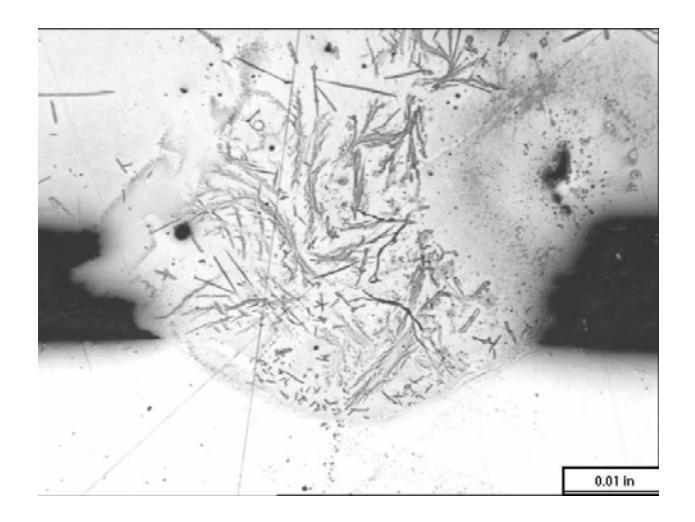
A couple of sheet specimens of MA754 and MA956 were used to evaluate the potential of laser welding as a joining method. Various laser power and speed settings were used. These joints were cross-sectioned for microscopic observation of the joint integrity. The initial laser weld trials showed inconsistent welding of the joints as shown in Figure 4.4. More trials were needed to optimize laser power and speed to obtain suitable joints. However, due to the success with the braze joints, the laser welding was no longer pursued.

Figure 4.4 Micrograph of Initial Laser Weld Trials Showed Inconsistent Welding of the Joint

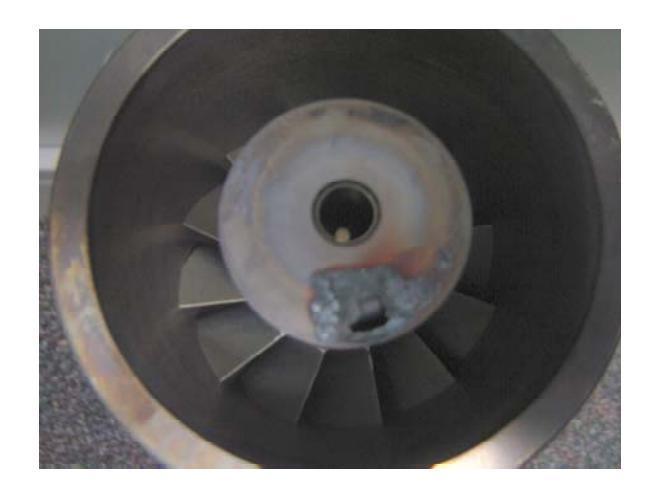
The second configuration tested was a PM 2000 tip fabricated with no cooling holes as shown in Figure 4.22. The no-cooling configuration was to be compared to both the production baseline M50 and PM2000 M50 fuel injectors to try and identify any emissions performance enhancements. The single injector, high pressure facility was again used to evaluate the performance of the uncooled ODS tip injector. The no-cooling hole configuration did not perform well (Figure 4.23), due to the excessive temperature experienced on the tip. The cooling air actually pushes the flame away from the surface of the injector tip, resulting in significantly lower tip temperature. With no cooling, the flame rested on the surface of the tip resulting in burn-through of the material.

Figure 4.23 PM 2000 ODS Injector Tip with No Cooling Following Test

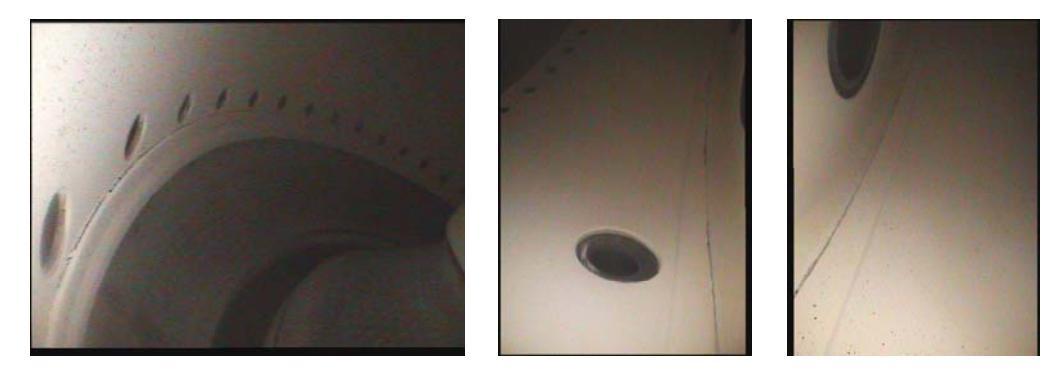
The combustor was inspected by borescope on January 6, 2007, after accruing 4360 hours of commercial operation with 85 starts. Figure 4.25 shows images from the borescope inspection. The advanced 40-mil TBC appeared in excellent condition with no cracking or spalling of the TBC. The program goal of 4000+ hours had been achieved, however Solar's goal is 30,000 hours, which is Solar's typical time before overhaul. Therefore the combustor was allowed to remain at Qualcomm for continued commercial operation. Solar continued to monitor the status

Figure 4.25 Borescope Images of the Advanced 40-mil TBC after 4,360 Hours of Commercial Operation at Qualcomm Inc. with 85 Starts.

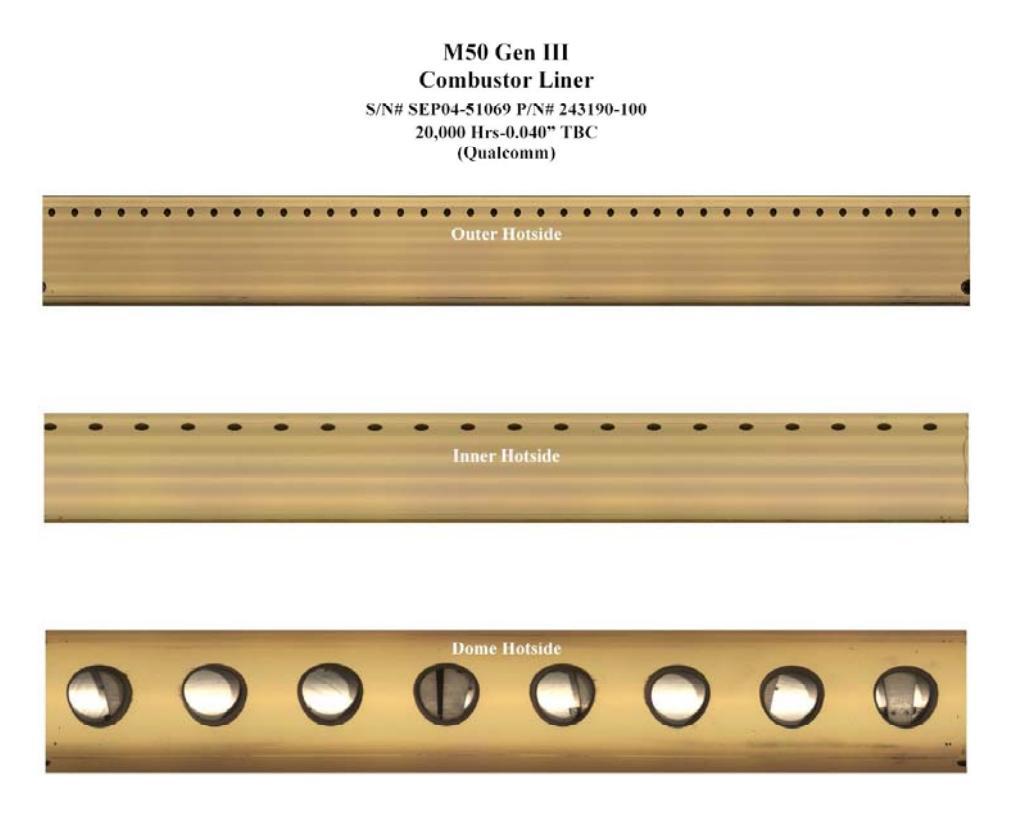
of the TBC through periodic borescope inspections. In December 2008, the engine was returned to Solar for overall engine inspection after 20,000 hours of commercial operation. The combustor was removed and photographically documented, as shown in Figure 4.26. The advanced 40 mil TBC still remained in excellent condition, with no signs of cracking or spalling. The combustor was reassembled into the engine and returned to Qualcomm Inc. for continued operation. The advanced 40 mil TBC system will be destructively inspected after the engine surpasses the 30,000 hour time before overhaul requirement. This advanced coating system is now bill-of-material at various thicknesses up to 40 mils for all of Solar's advanced, backside cooled combustor liners (Centaur 50, Taurus 60, Mars 100, Taurus 70, Taurus 65, Titan 130, Titan 250 and Mercury 50).

Figure 4.26 "Rolled Out" Digital Images of Advanced 40-mil TBC after 20,000 Hours of Commercial Operation in the Mercury 50 Engine at Qualcomm Inc.

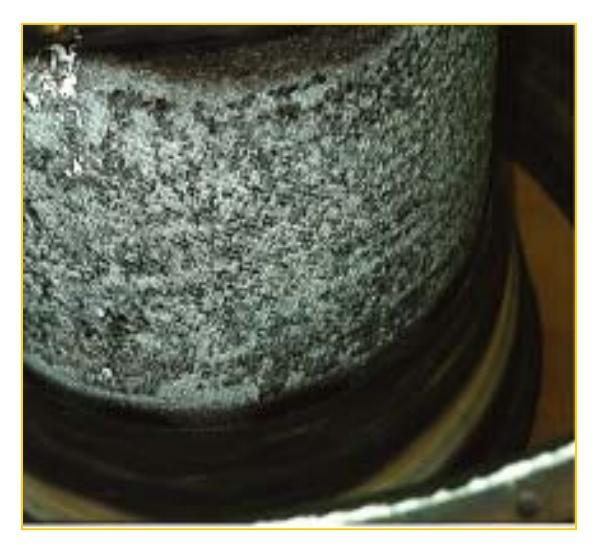
Figure 5.7 CG Ni/PyC/E-SiC (CVI) Inner Liner after 948-Hour Test (CT-1)

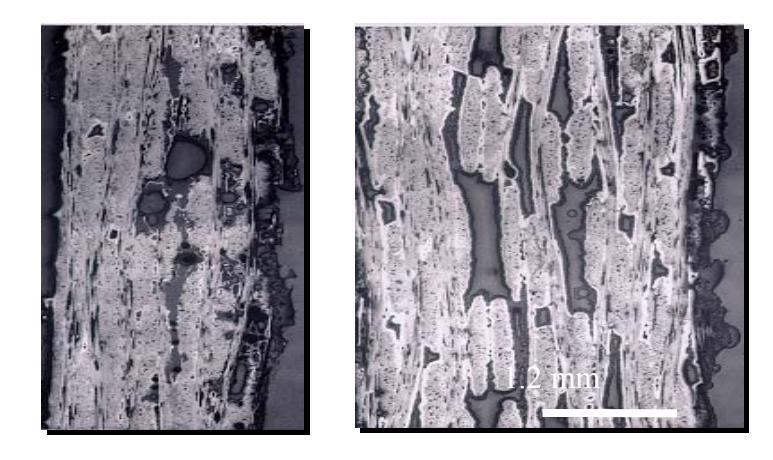
Figure 5.8 Inner (left) and Outer Liner (Right) Sections after 948-Hour Test (CT-1)

The inner liner underwent post-test NDE (thermal diffusivity and air-coupled ultrasound) at Argonne National Laboratory (ANL) prior to destructive evaluation at ORNL (Oak Ridge National Laboratory). Interestingly, the degradation/recession duplicated that encountered in simulated gas turbine environmental exposure testing at ORNL [10]. Therefore, the lower cost ORNL Keiser test rig testing can be used to effectively screen various CMC liner systems. The environmental degradation is attributed to accelerated oxidation of SiC due to the presence of H_2O in the combustion environment [11].

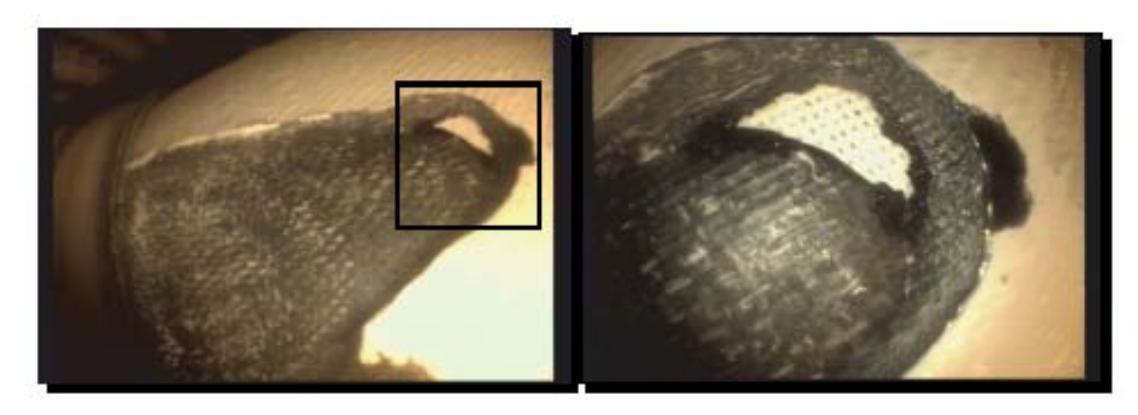
Figure 5.12 Breach in HiNi SiC/BN/SiC-Si (MI) Inner Liner after 13,937-hour Test

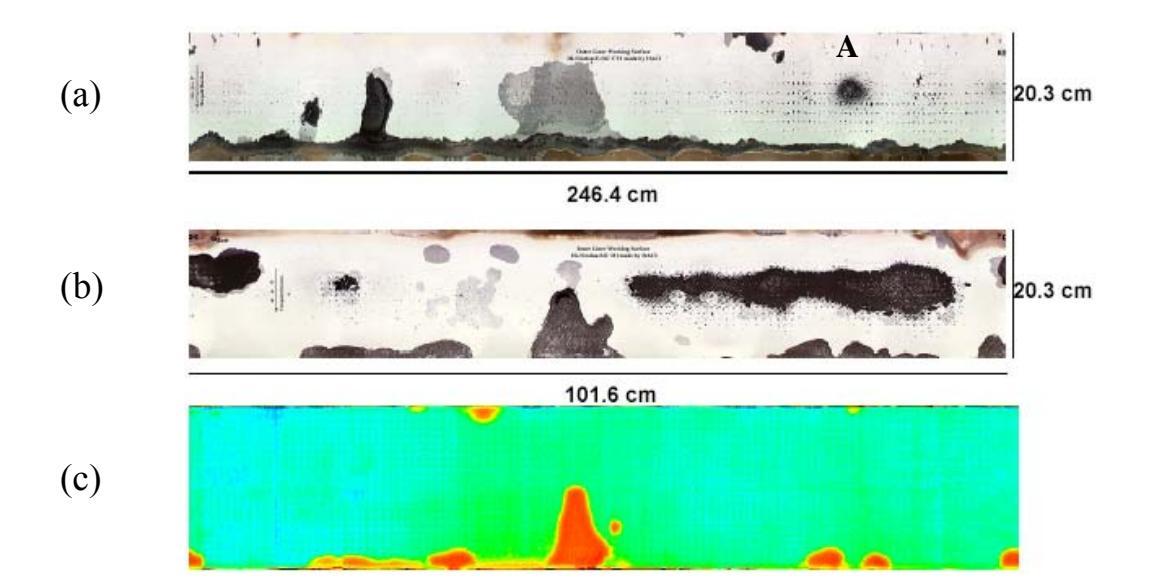
Figure 5.13 Liners after 13,937-hour Test, (a) HiNi SiC/PyC/E-SiC (CVI) Outer Liner, (b) HiNi SiC/BN/SiC-Si (MI) Inner Liner, (c) Thermal Diffusivity Scan of Inner Liner before Test

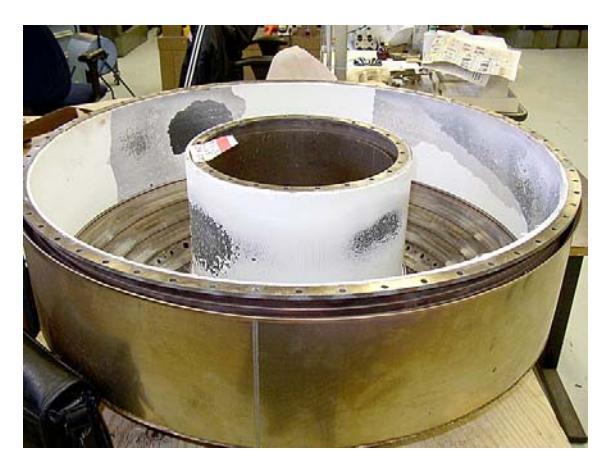
Figure 5.16 Liners of MM-1 Field Test after Additional 5,135-Hours Field Test (CT-6)– Total Test Time: 12,373 Hours (CT-6)

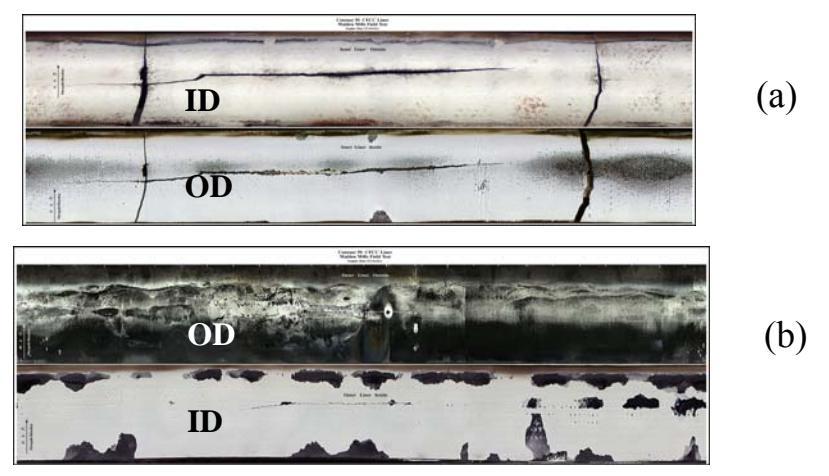
Figure 5.17 Digital Photographs of (a) TyZM/BN/SiC-Si (MI) Inner Liner and (b) HiNi/PyC/E-SiC (CVI) Outer Liner after 15,144-hour Field Test (MM-2); ID/OD: Inner/Outer Diameter

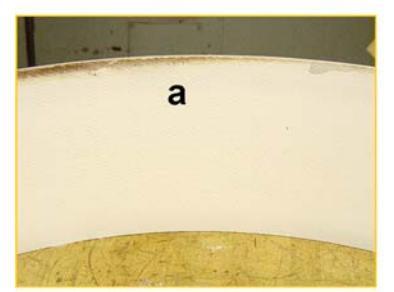
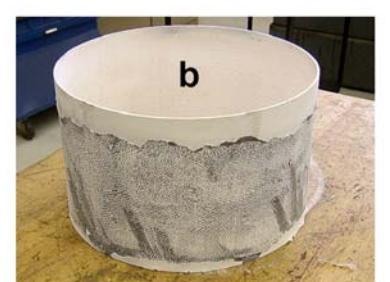
Figure 5.19 TyZMI/BN/SiC-Si (MI) Outer Liner (a) and Inner Liner (b) after 8,368-hour Field Test (MM-3)

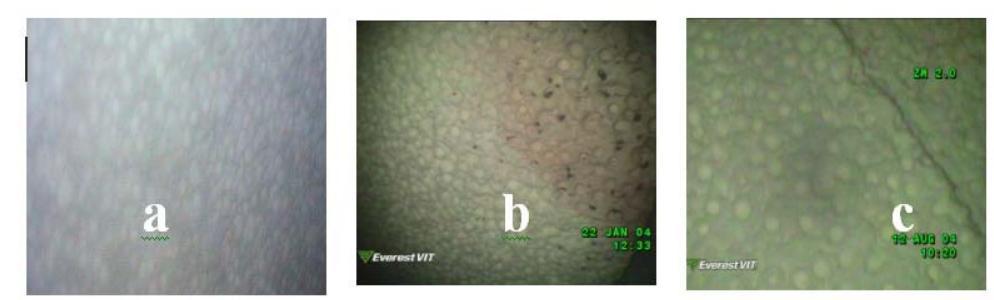
Figure 5.21 Borescope Views of Hybrid Oxide CFCC Outer Liner at (a) 1026 Hours/ 19 Starts, (b) 5,885 Hours/40 Starts, (c) 10,667 Hours/ 61 Starts

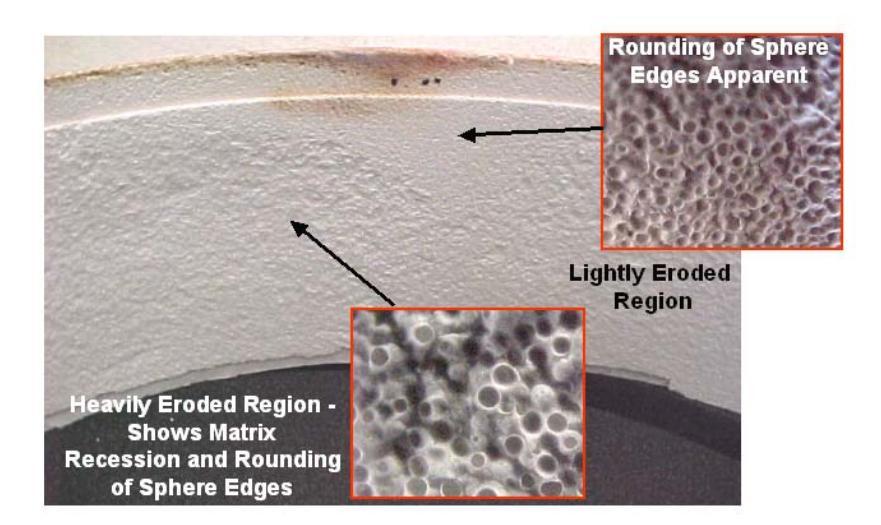
Figure 5.22 Section of the Hybrid Oxide CFCC Liner after 12,582 Hours/63 Starts Showing Surface Erosion

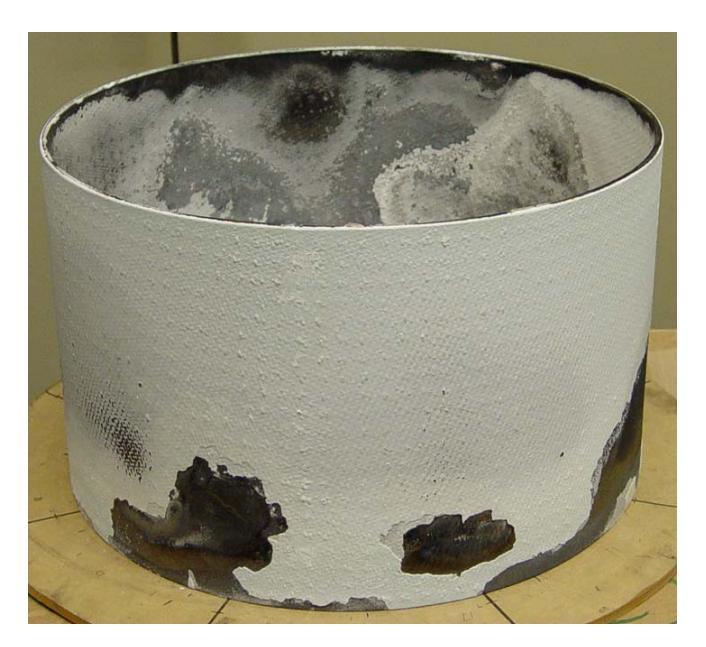
Figure 5.23 SiC/SiC CFCC Inner Liner with EBC after 12,582 Hours of Engine Field Testing

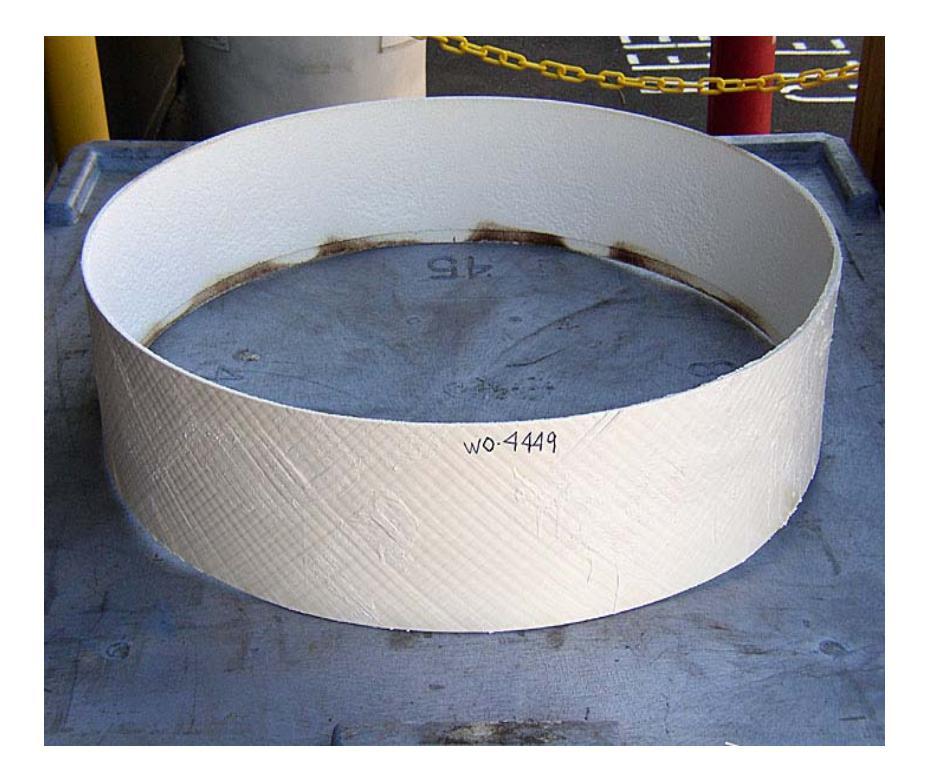
Figure 5.24 Repaired Hybrid Oxide CFCC Liner with FGI Prior to Continuation of the Field Test

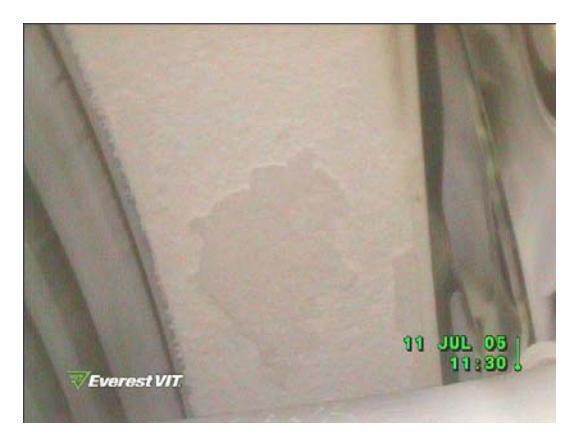
Figure 5.26 Patched Area in Borescope after 16,566 Hours and 81 Starts

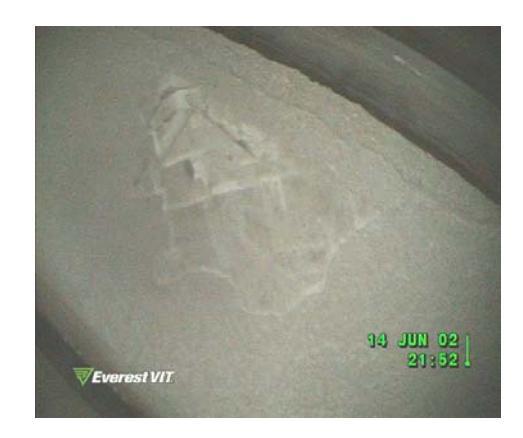
Figure 5.27 Degraded Area in Borescope Taken at 22,132 Hours and 97 Starts

in high thermal gradients. The brown discolorations seen on the end of the liner shown in Figure 27 are a result of contact and contamination with the interfacing metal components.

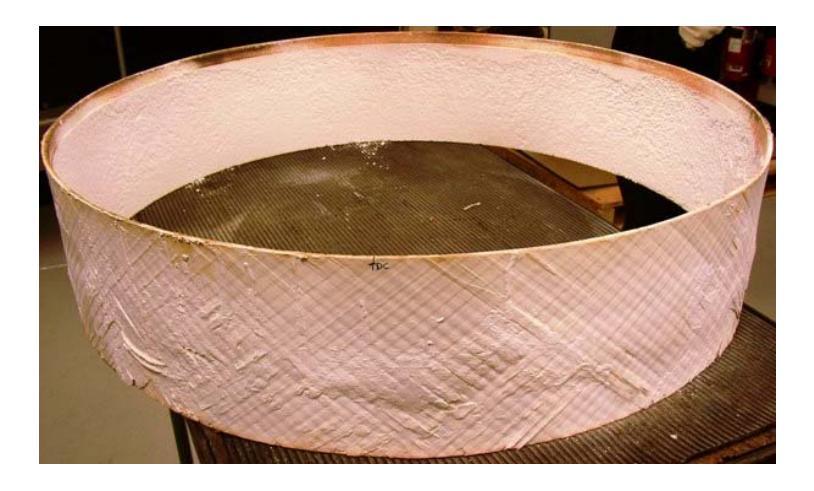
Figure 5.28 Hybrid Oxide CFCC Outer Liner after 25,404 Hours of Engine Testing

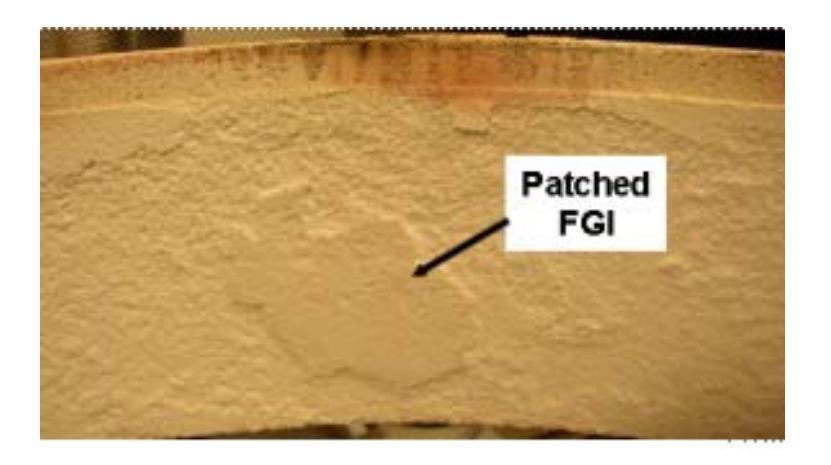
Figure 5.29 Repaired Section of FGI

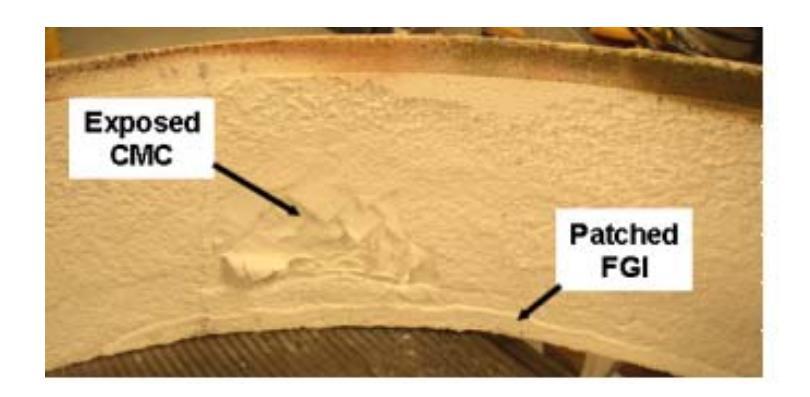
Figure 5.30 Repaired Section of FGI and Exposed CFCC

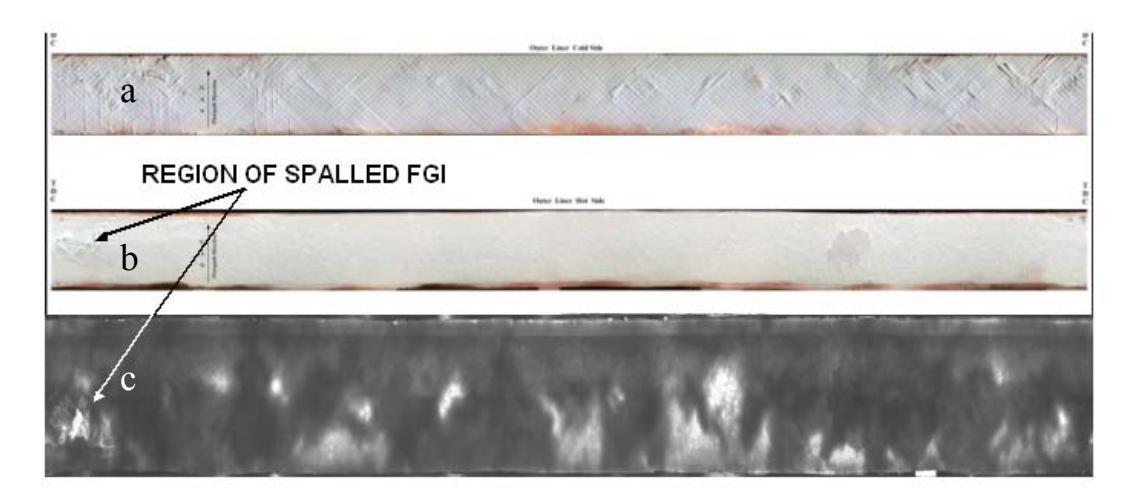
Figure 5.31 Digital Photographs after 25,404 Hours of Engine Field Testing (a) CFCC Surface, (b) FGI Surface, (c) Thermal Diffusivity Scan

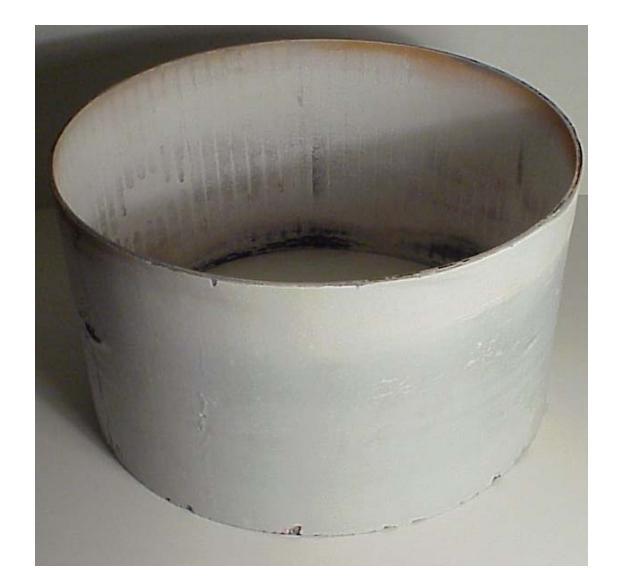
Figure 5.32 SiC/SiC CFCC Inner Liner after 12,822 Hours/46 Starts – Photo courtesy GE GRC

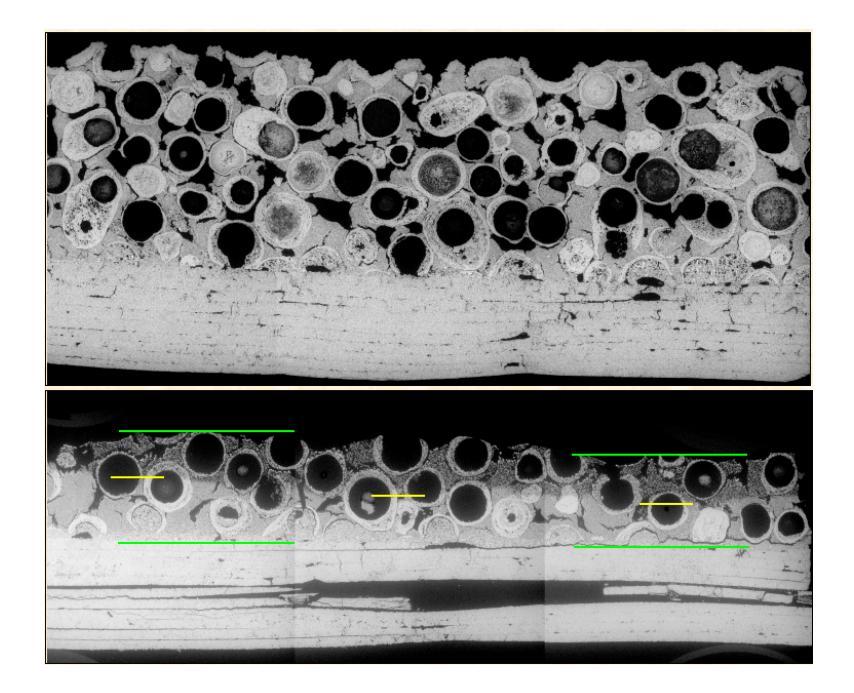
Figure 5.34 As-processed Hybrid Oxide CFCC Liner (Top) and Engine Field Tested Liner Showing Surface Recession (Bottom) – Micrograph Courtesy of ORNL

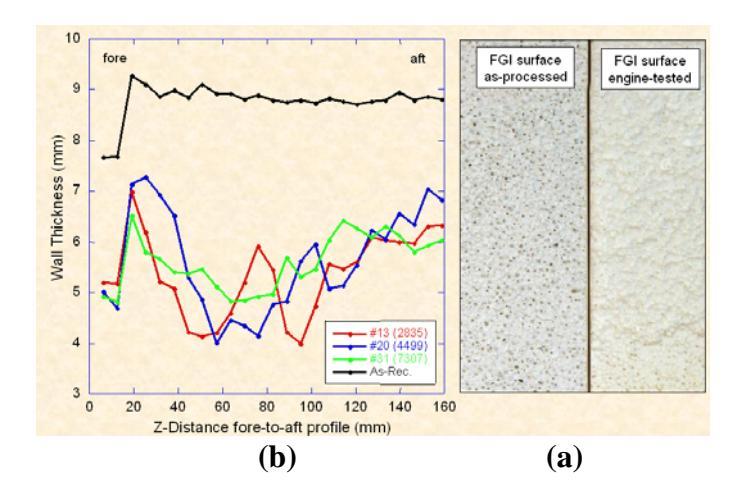
Figure 5.35 (a) Surface Textures of As-processed and Eroded Engine-tested Hybrid Oxide CFCC Outer Liner Areas (b) Thickness Profile across Three Eroded Areas Compared to As-processed Liner – Photo courtesy of ORNL

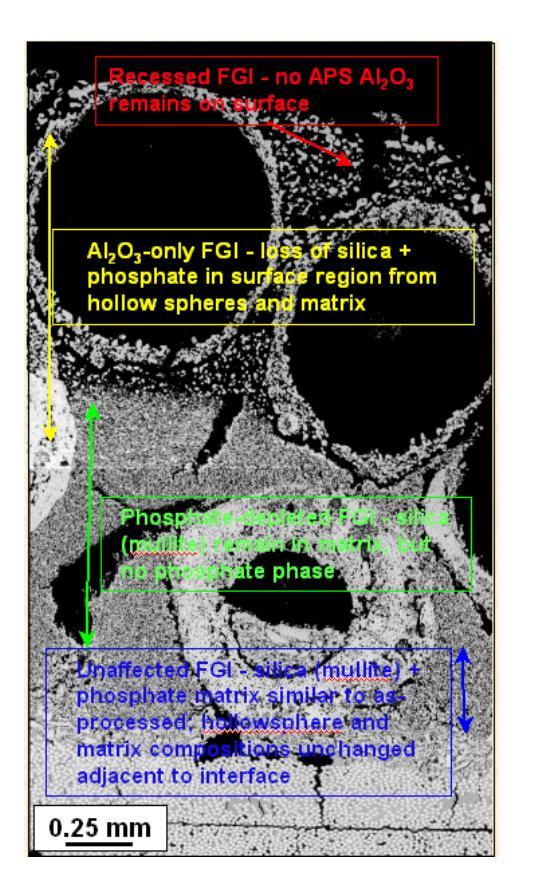
There is a clear delineation between the Al_2O_3 and surface silica-containing subsurface region. Greater Al₂O₃ grain growth occurs closer to the gas-path surface. The loss of connectivity, observed at the surface between Al₂O₃ "particles" due to silica volatilization, was the likely cause of surface erosion (i.e. loss of loose particles). The recession of the FGI appears to occur between depth dependent silica volatilization, which in turn results in loss of connectivity between Al₂O₃ "particles", leading to overall erosion of the Al₂O₃ particulate surface. This scenario can be directly attributed to the greater volatility of silica compared to alumina. The volatilization is most severe in the hottest areas of the liner, i.e. at the central locations in closest proximity to the flame zone, projected from the fuel injectors. It was noted that the liners showed twelve distinguishable areas of enhanced erosion, corresponding with the twelve fuel injectors in the combustor assembly of the Centaur[®] 50S gas turbine.

Figure 5.36 Microstructure of Degraded FGI (Courtesy of ORNL)

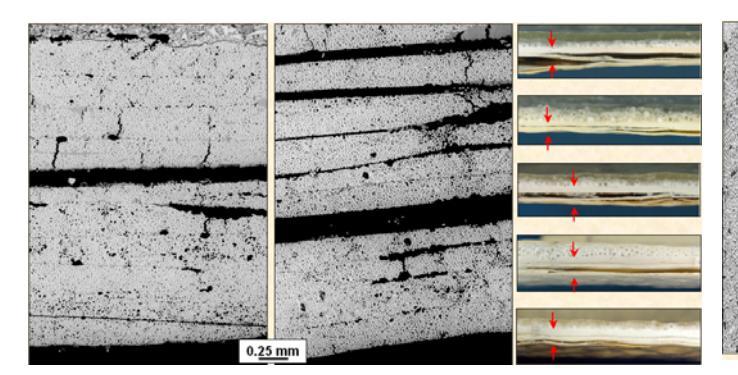
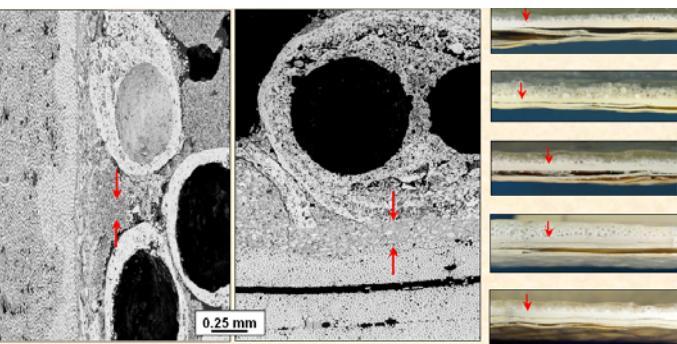
Figure 5.37 Areas of Delamination in the CFCC. Notice cracking in the CFCC . (Courtesy of ORNL)

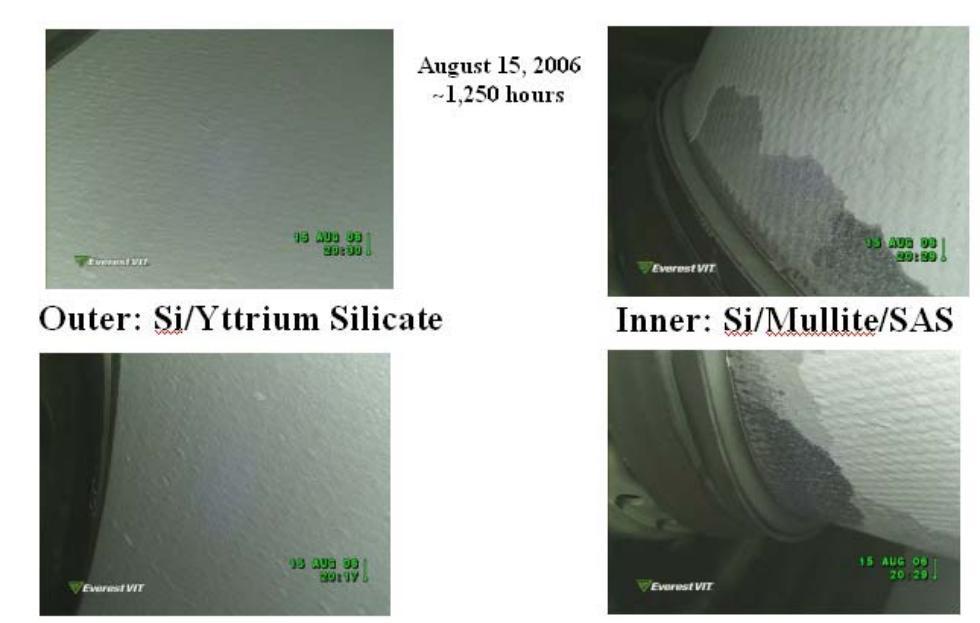
Figure 5.41 Borescope Images of TyZMI/BN/SiC-Si MI Liners After ~1,250 Hours of Engine Field Testing; Left: Outer Liner with Si/YS EBC, Right: Inner Liner with Si/mullite/SAS EBC

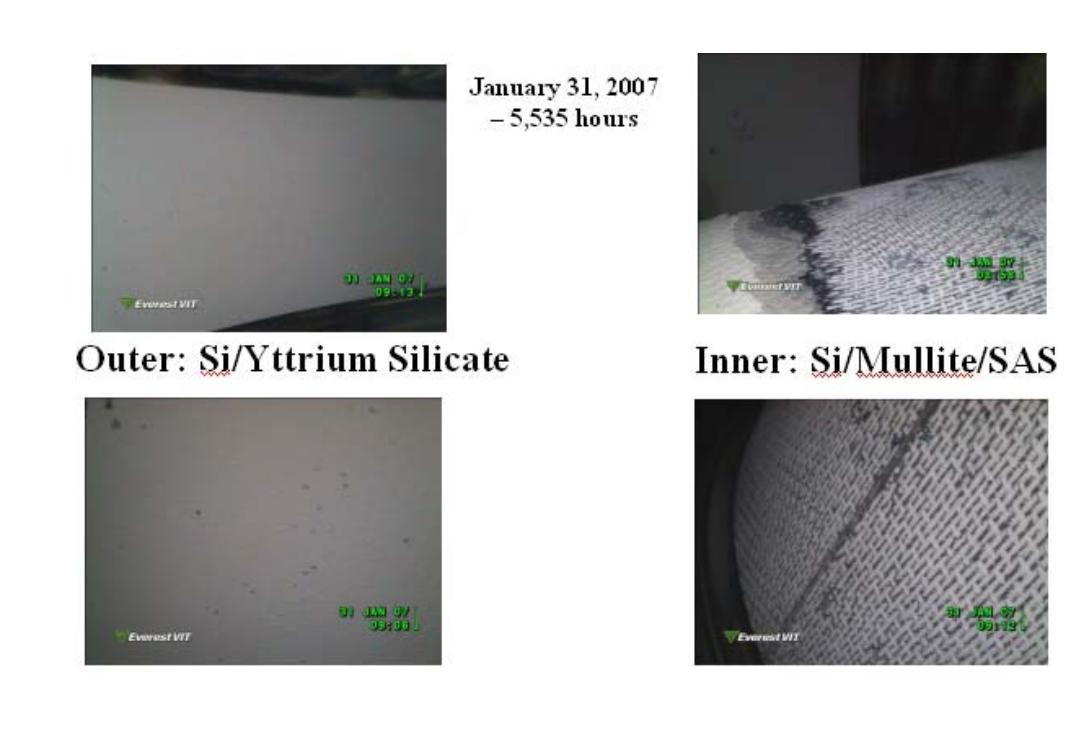
Figure 5.42 Borescope Images of TyZMI/BN/SiC-Si MI Liners After ~5,535 Hours of Engine Field Testing; Left: Outer Liner with Si/YS EBC, Right: Inner Liner with Si/mullite/SAS EBC
