Area in Need of Redevelopment Investigation for  
**Block 1002, Lot 2 and Block 5703, Lot 11**  
Township of Teaneck New Jersey

Prepared on behalf of the Township of Teaneck Planning Board  
by **PHILLIPS PREISS GRYGIEL LEHENY HUGHES LLC**  
Planning & Real Estate Consultants

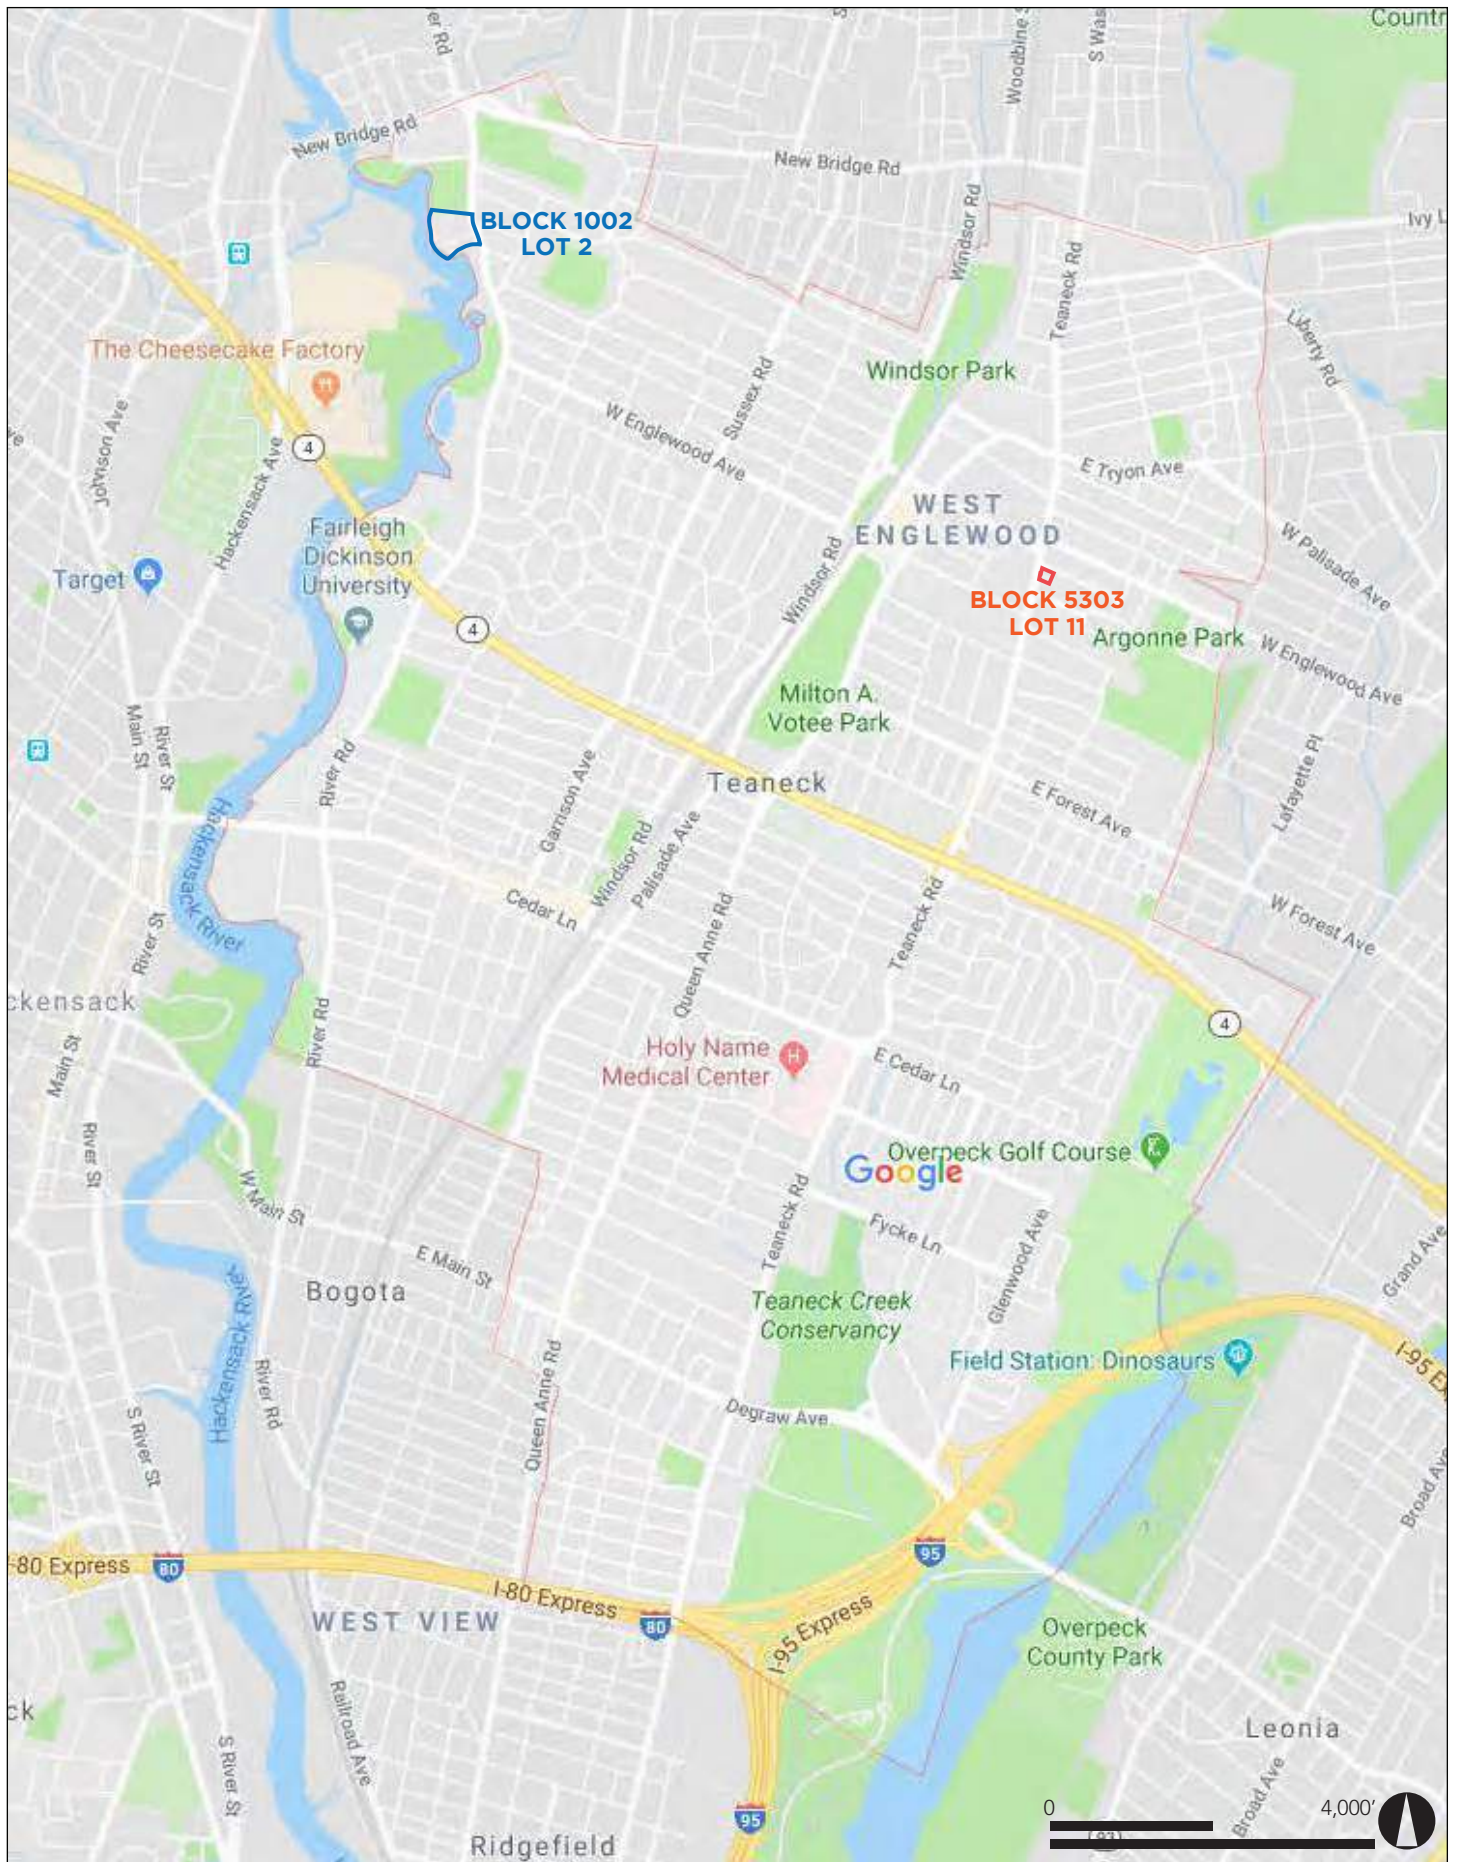
Figure 1: Location | AINR Investigation for Block 1002, Lot 2 and Block 5303, Lot 11 | Township of Teaneck, NJ  
 PHILLIPS PREISS GRYGIEL LEHENY HUGHES LLC 2019

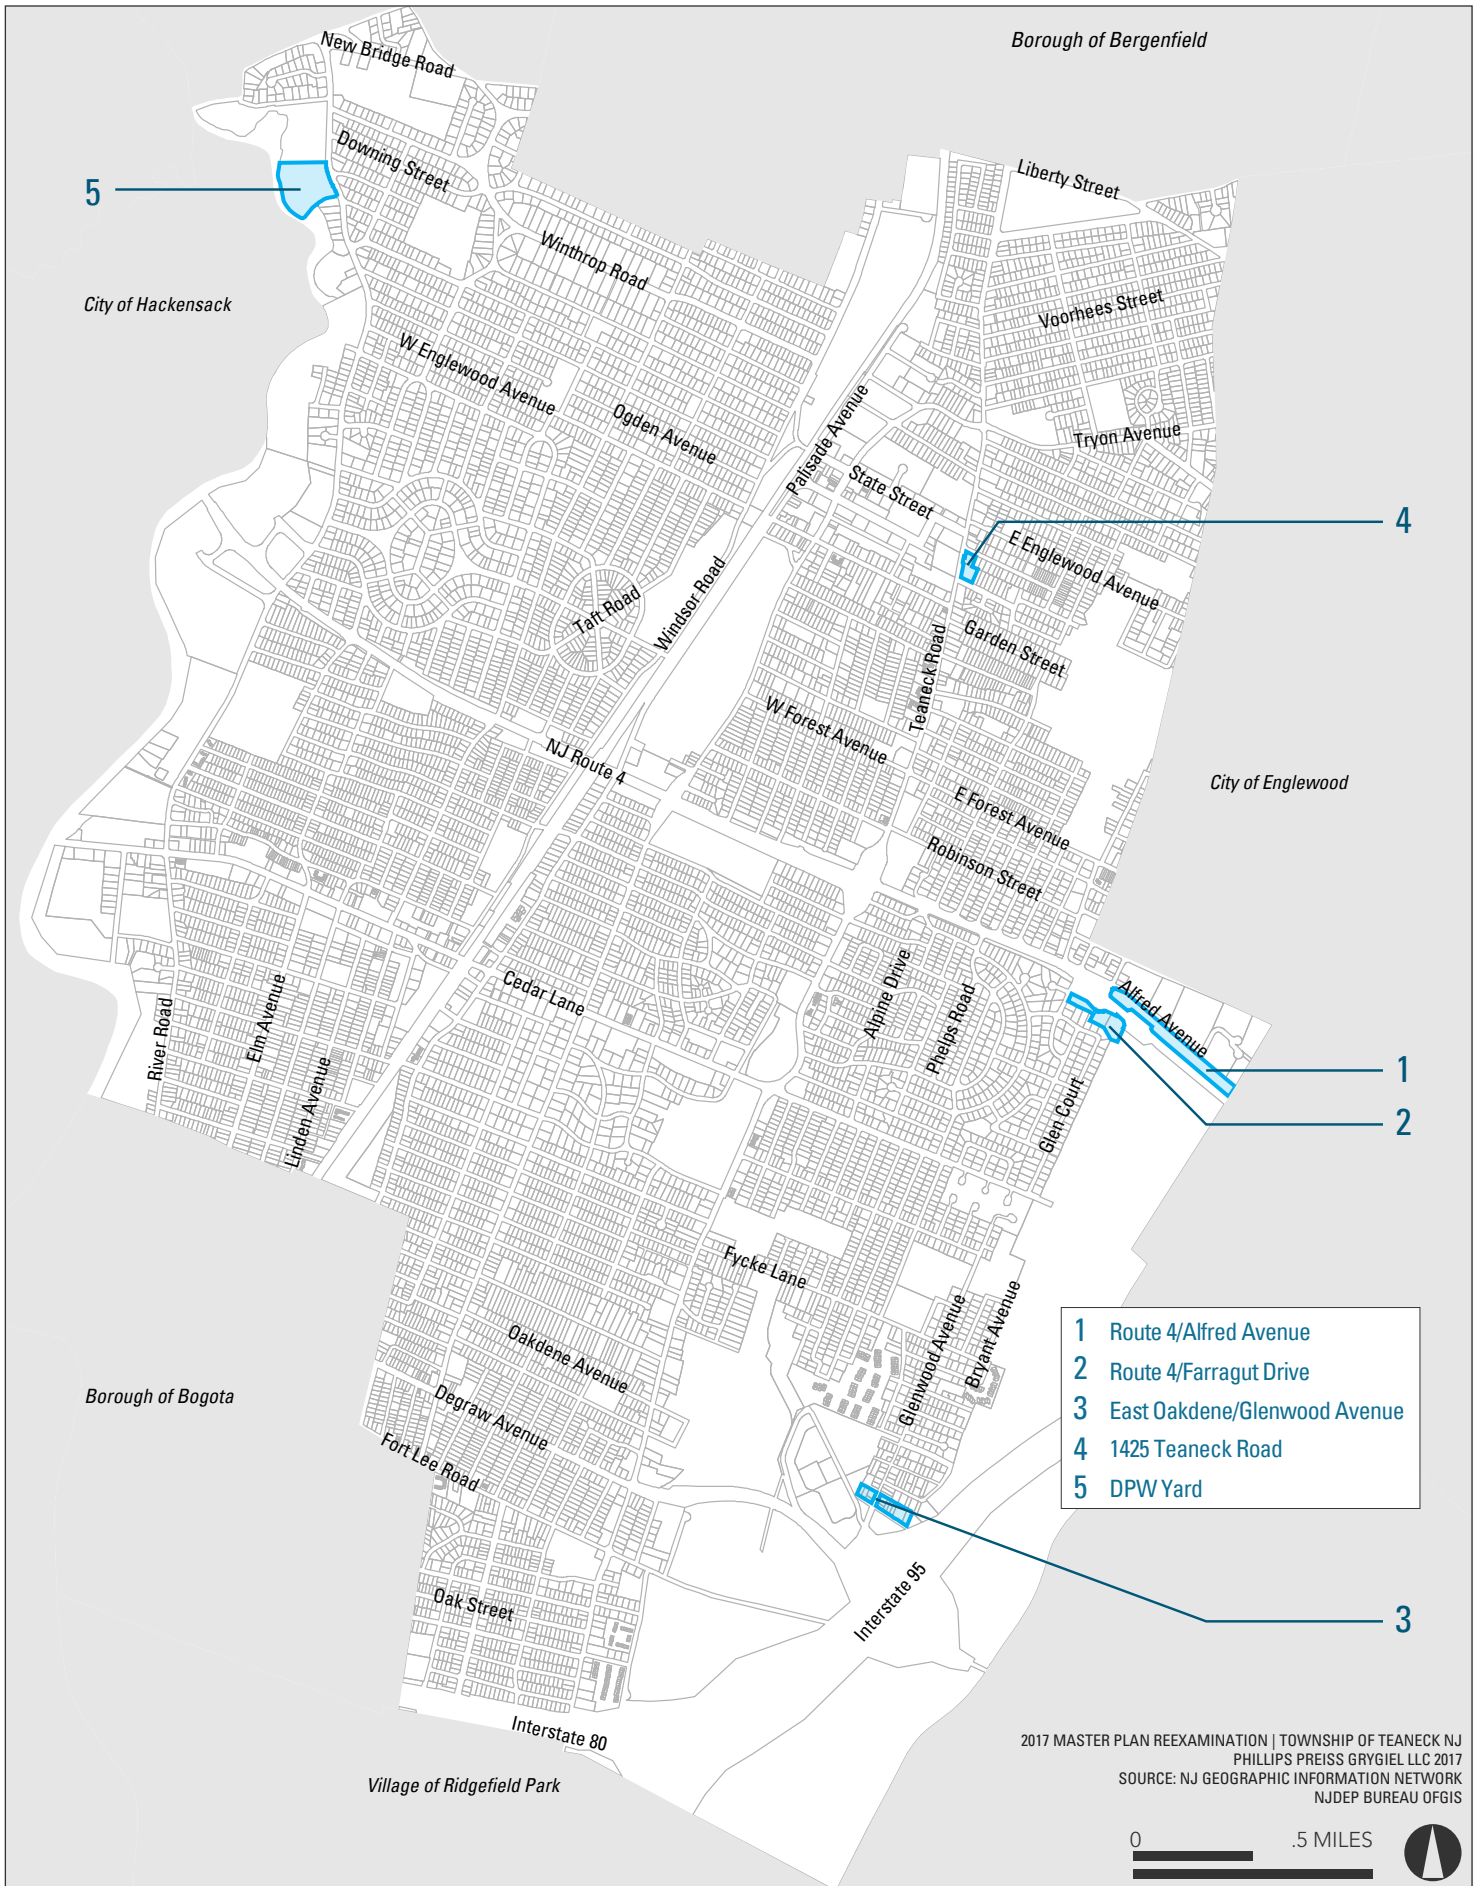
Figure 6: 2017 Master Plan Reexamination Recommended Rezoning  
 AINR Investigation for Block 1002, Lot 2 and Block 5303, Lot 11 | Township of Teaneck, NJ  
 PHILLIPS PREISS GRYGIEL LEHENY HUGHES LLC 2019

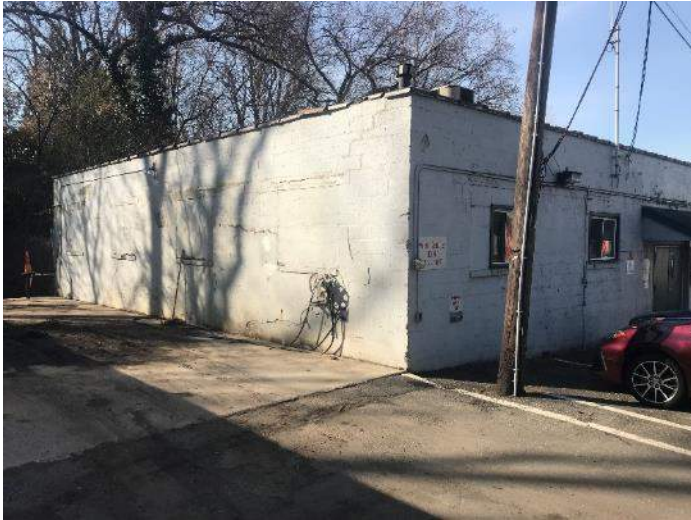
Exterior - Main office and garage building

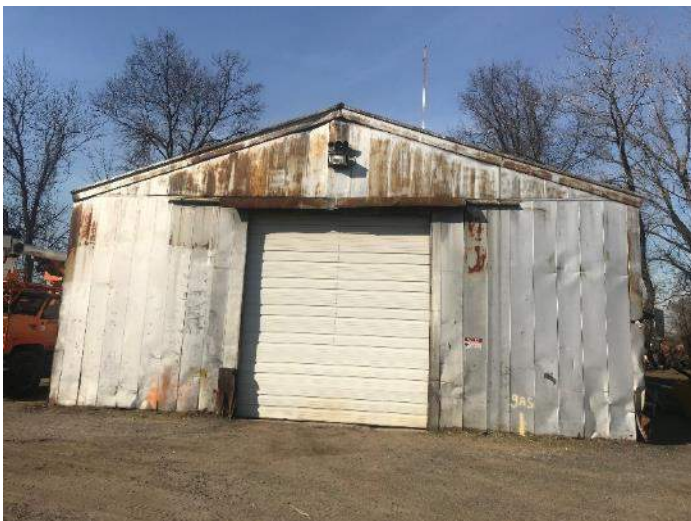
Exterior - Rusted garage storage structure

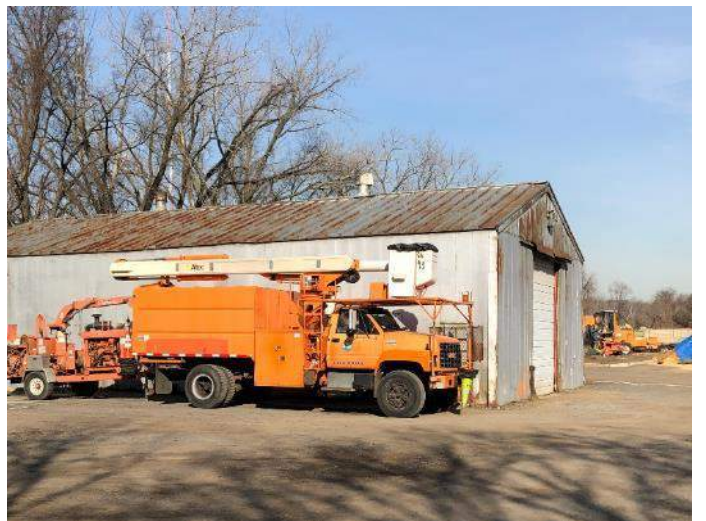
Exterior - Rusted garage storage structure

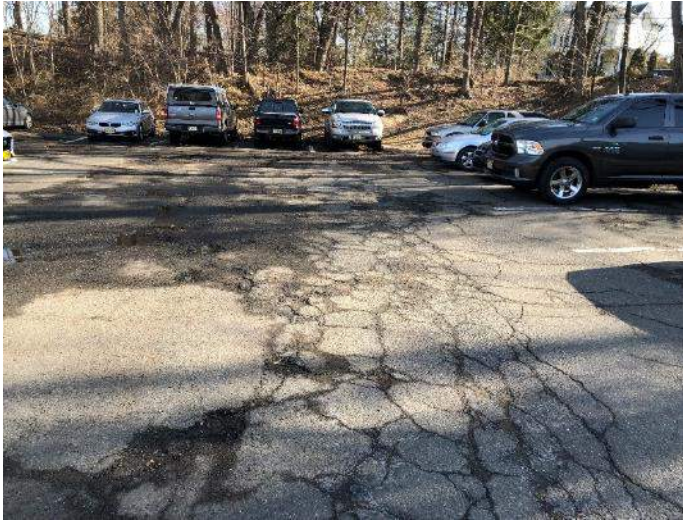
Cracked pavement and pooling in parking area

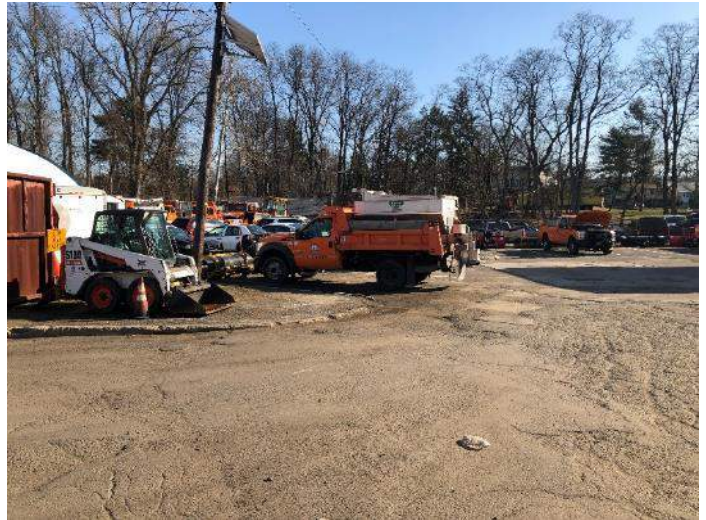
Haphazard parking of active and disabled vehicles

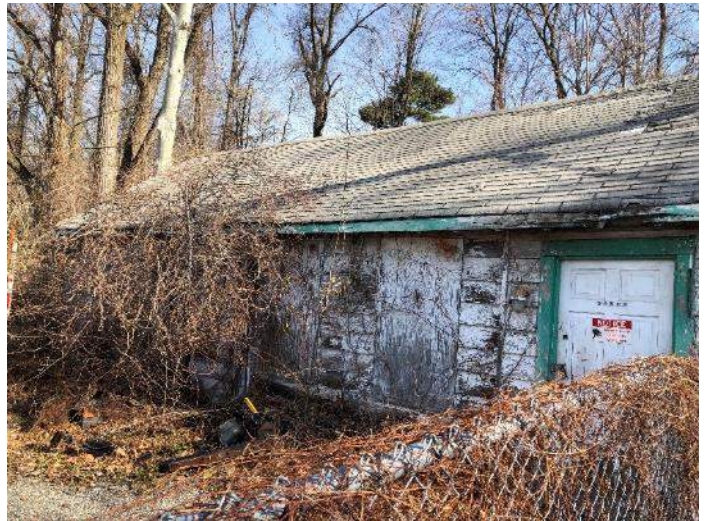
Wood frame structure in poor condition

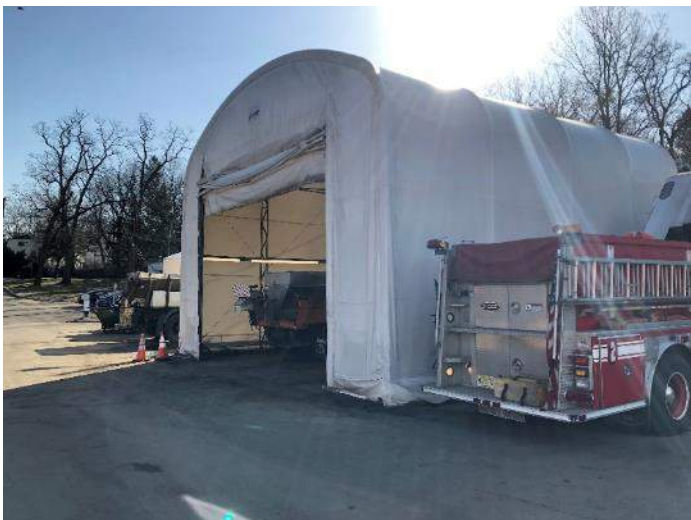
Temporary enclosure for vehicle washing

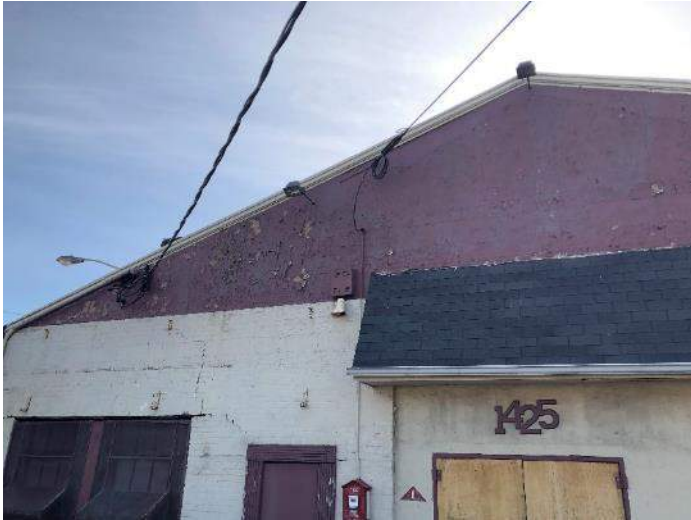
Exterior - Teaneck Road frontage

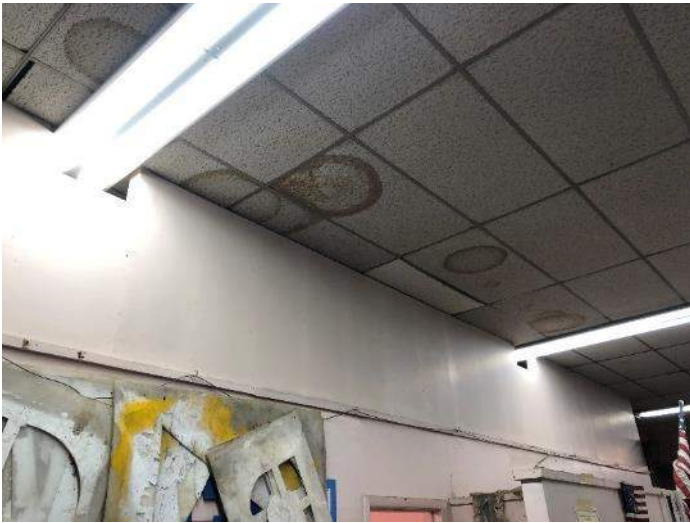
Interior - Water damage present on ceiling

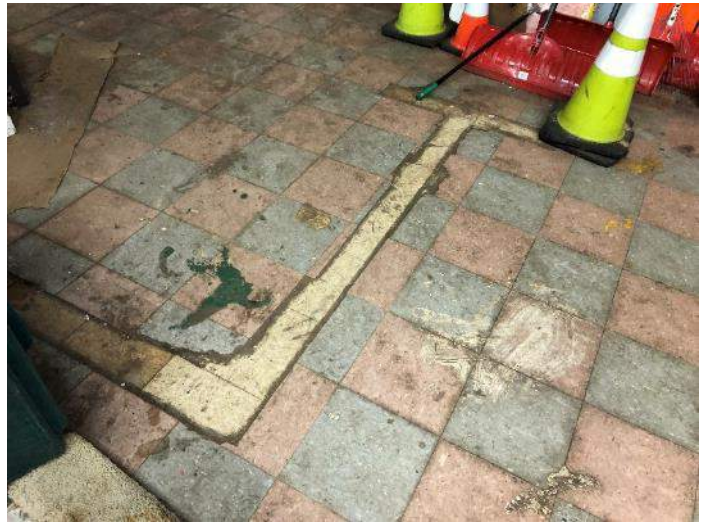
Interior: Cracked/dilapidated flooring

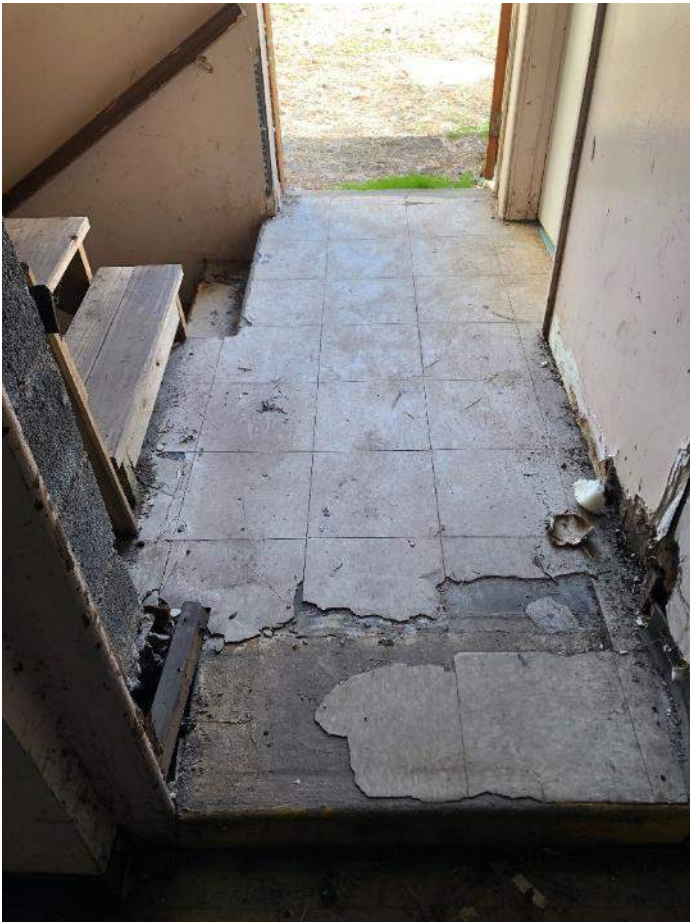
Interior - Cracked/dilapidated flooring

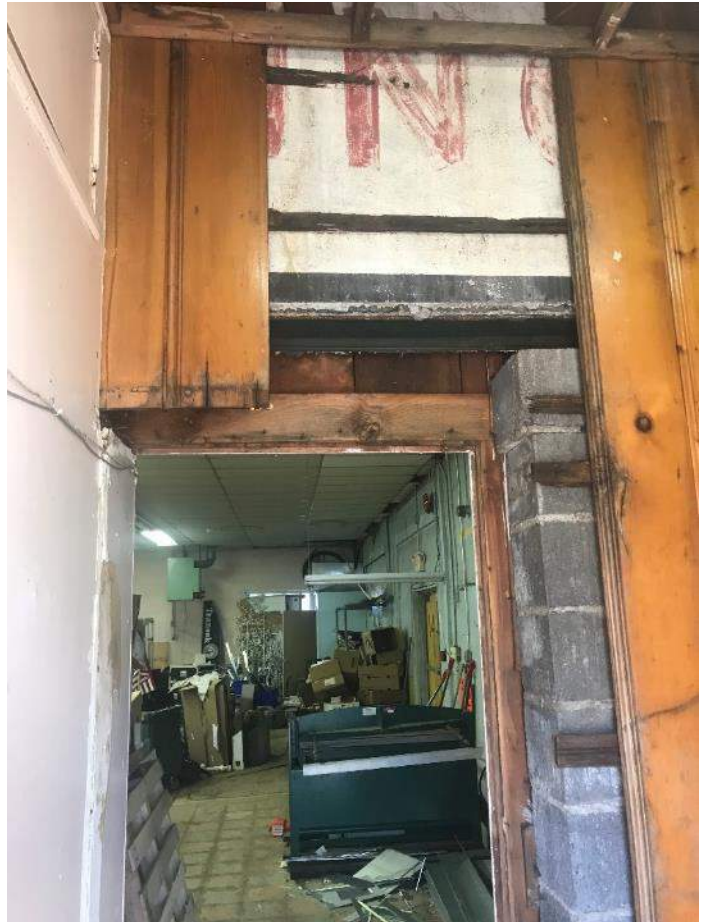
Interior - Substandard structural conditions
