CH-51450-A Oscilloscope Diagnostic Kit with NVH Released as Essential Tool

Techline News

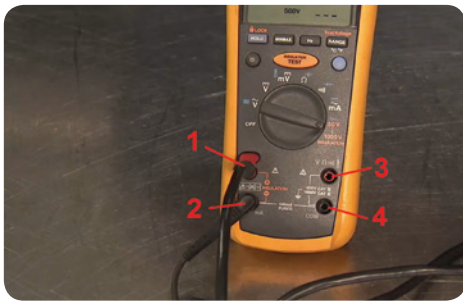
Plug into the insulation ports (1, 2)

TIP: It is critical that the correct ports (1, 2) are used for insulation testing. This is easy to get wrong, especially if the EL-50772 is used for standard DMM testing too. Do not use ports 3 and 4 for insulation testing. Also, if port 1 and port 4 are mistakenly used, continuity testing will still function, but the insulation test will always appear to pass.

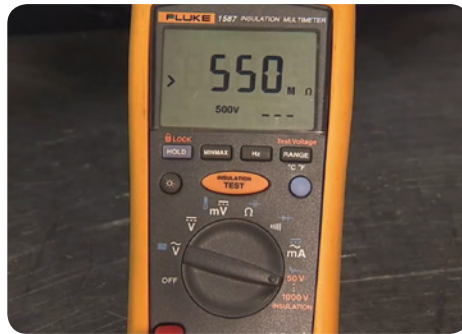
Set the meter to the 500V range.

- Always test at the 500V range.
- With the test leads not connected to anything, press and hold the insulation test button to know how your meter displays an infinite measurement. The EL-50772 will display 550M Ω when measuring an open circuit while set to the 500V range.

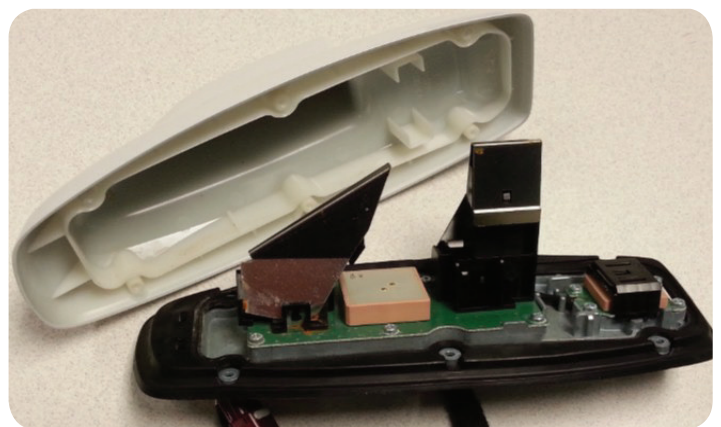
- Visible water leak or signs of water intrusion from the antenna base
- Red OnStar LED
- Unable to connect to OnStar
- OnStar unable to locate the vehicle
- OnStar has inaccurate GPS location
- No GPS or inaccurate GPS location on the navigation radio display

Water intrusion into the antenna assembly may result in any of the conditions listed above. If these conditions are encountered, replace the antenna and use the new updated antenna cover.

High-frequency painted antenna assembly and cover

Do not remove the cover from the base. Mask and spray paint the cover to match as necessary.

Do not use any sealants on the antenna or its seals/gaskets.

TIP: The painted antenna cover is not intended to be removed. Do not remove the antenna cover, as this may compromise the sealing performance. Do not reuse the original antenna painted plastic cover. The latest service parts include updated covers.
