RESEARCH ARTICLE

Comparison of nondestructive testing techniques for the inspection of wind turbine blades' spar caps

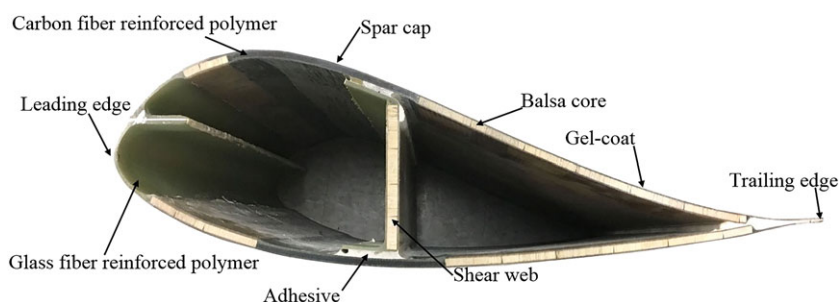
FIGURE 1 Cross section of a typical WT blade near the tip with subcomponents and materials highlighted [Colour figure can be viewed at wileyonlinelibrary.com]

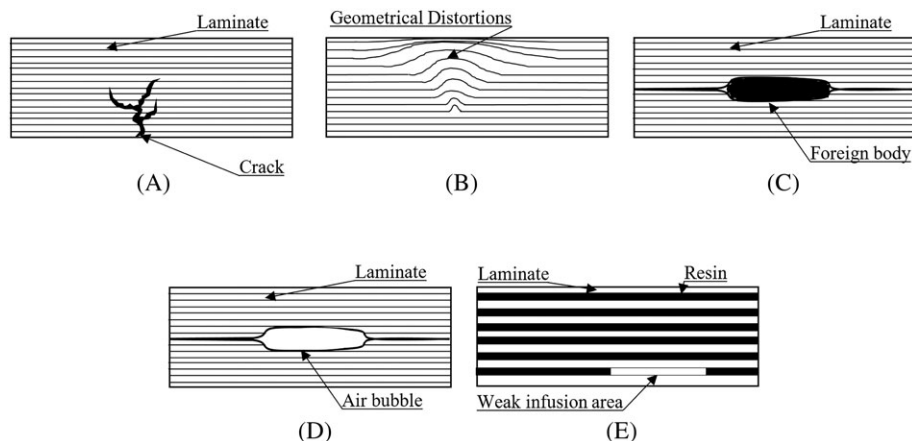
FIGURE 2 Illustration of the common manufacturing flaws in a WT blade. A, Delamination and cracks. B, Out-of-plane waves. C, inclusions. D, Voids. E, Resin dry regions

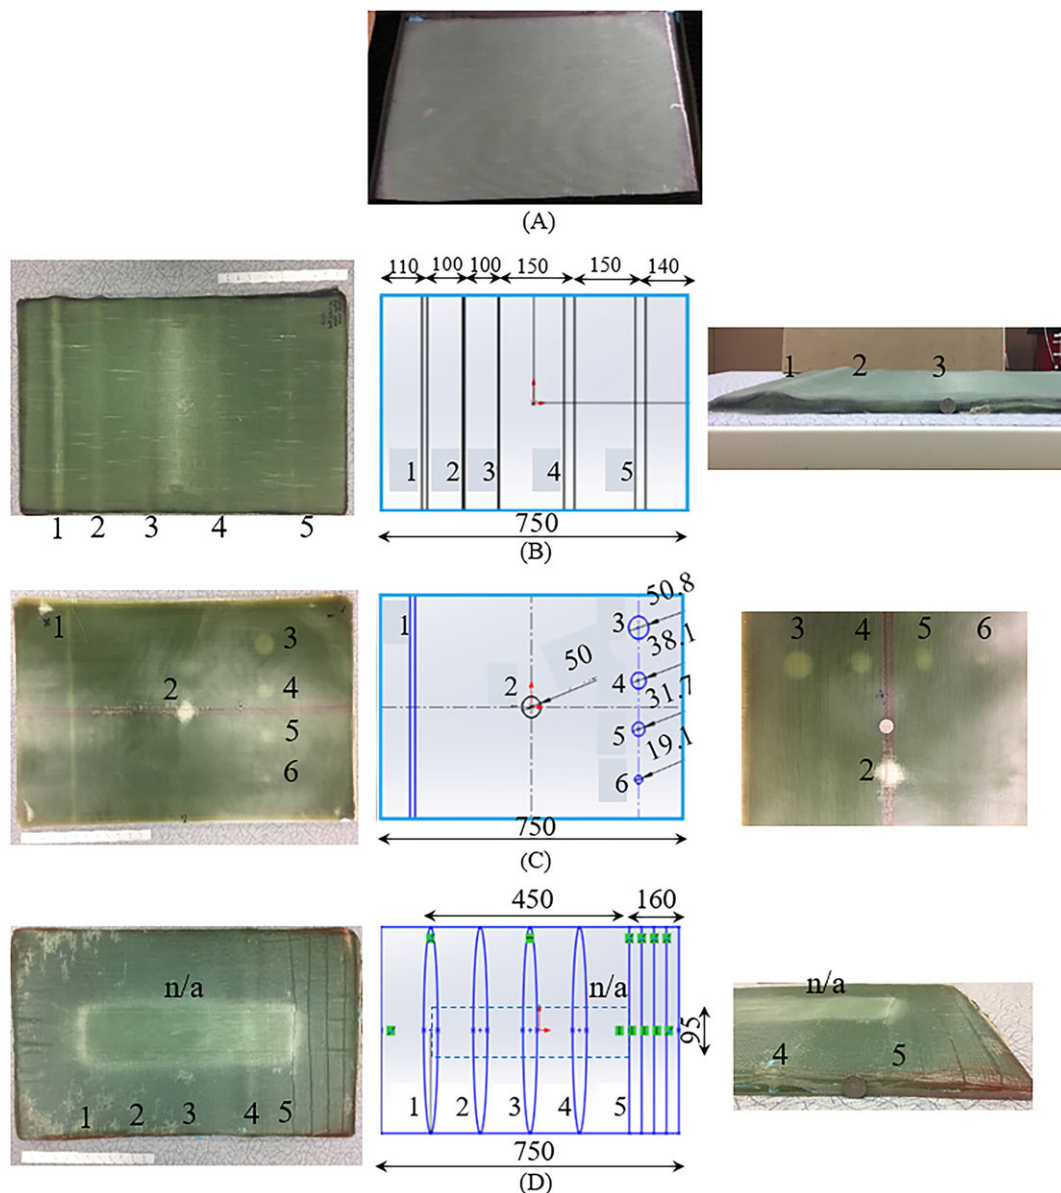
FIGURE 3 Photograph of fiberglass samples (left), schematic of defects embedded at the 10th plies (center), and detail of the defects compared to a US quarter dollar coin (right). A, Sample_1 baseline sample with no artificially induced defects. B, Sample_2 with out-of-plane wave defects. C, Sample_3 with silicon inserts and true de-wet defects. D, Sample_4 with out-of-plane fiber wave defects and thickness taper region. Dimensions in mm [Colour figure can be viewed at wileyonlinelibrary.com]

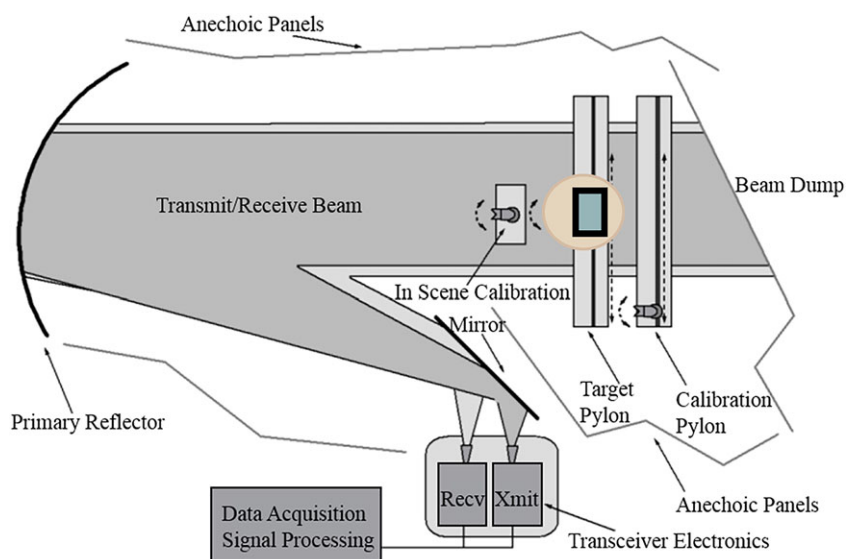
FIGURE 4 Diagram of the 100 GHz compact radar range used to collect scattering measurements. The system collects fully polarimetric scattering data across a bandwidth greater than 16 GHz⁸³ [Colour figure can be viewed at wileyonlinelibrary.com]

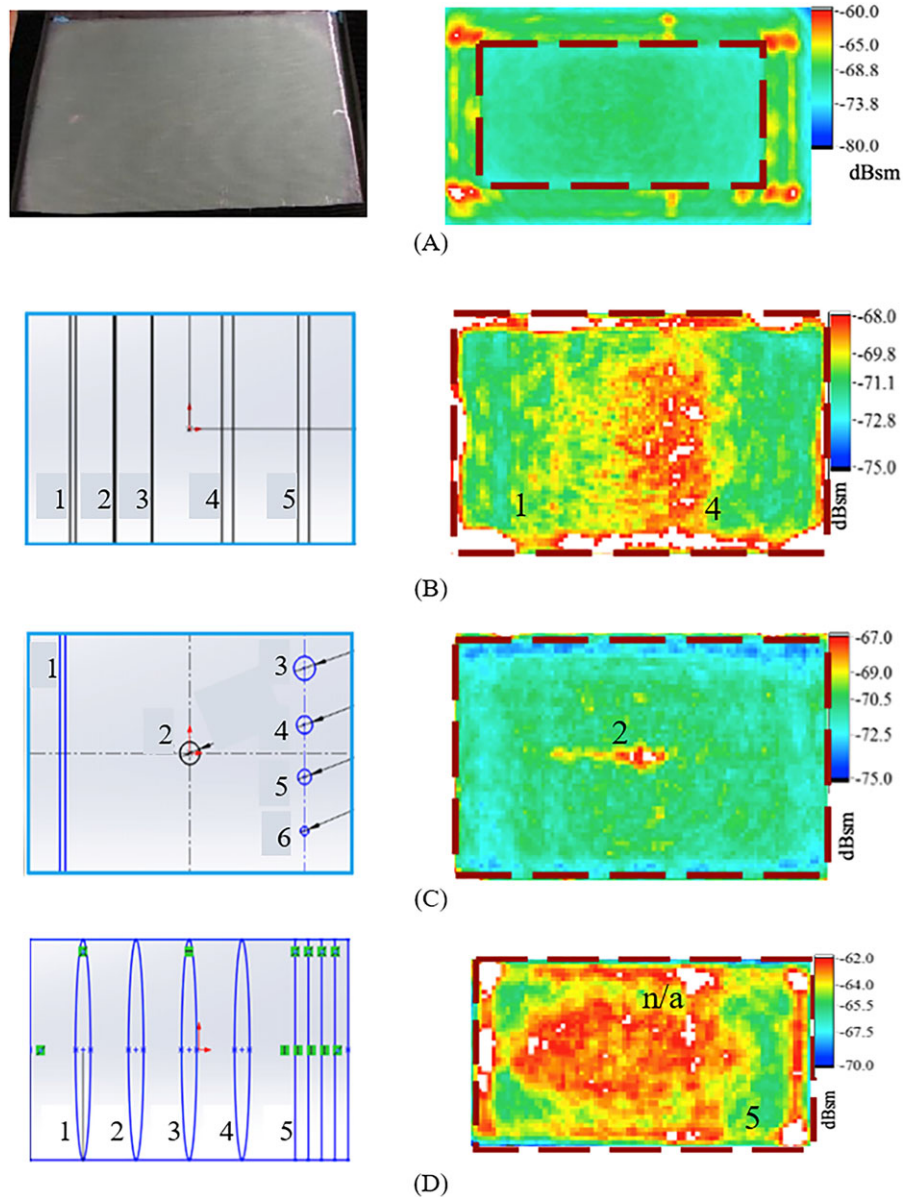
FIGURE 5 Composite m parameter ISAR images generated for the 3 panels analyzed (right) with the highlighted defects that can be identified and schematic of defects embedded at the 10th plies (left). A, Sample_1 baseline with no intentionally embedded defects. B, Sample_2 with out-of-plane wave defects. C, Sample_3 with silicon inserts and the true de-wet defect. D, Sample_4 with out-of-plane fiber wave defects and thickness taper region. Dimensions in mm [Colour figure can be viewed at wileyonlinelibrary.com]

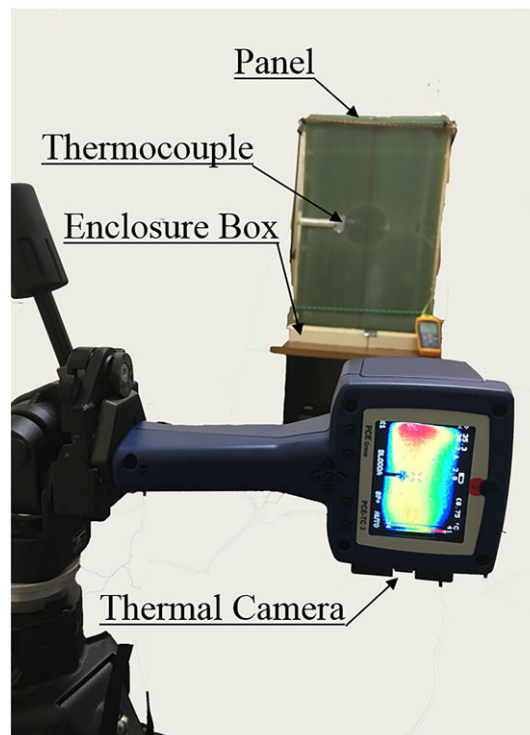
FIGURE 6 Thermal imaging test setup [Colour figure can be viewed at wileyonlinelibrary.com]

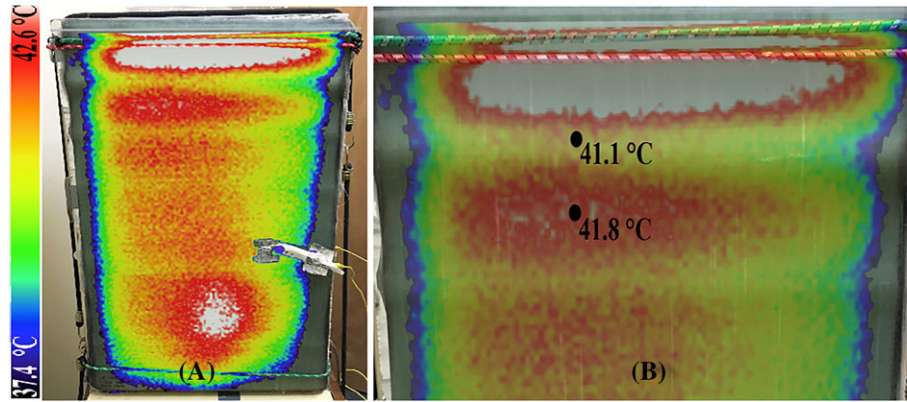
FIGURE 7 IRT recorded during the heating process of Sample_2 containing embedded out-of-plane wave defects. A, Temperature map superimposed to the test object. B, Detail of the recorded images with temperature measured in correspondence of a defect (26.5×10^{-3} m thick section) and in correspondence of a healthy area (25.4×10^{-3} m thick section) [Colour figure can be viewed at wileyonlinelibrary.com]

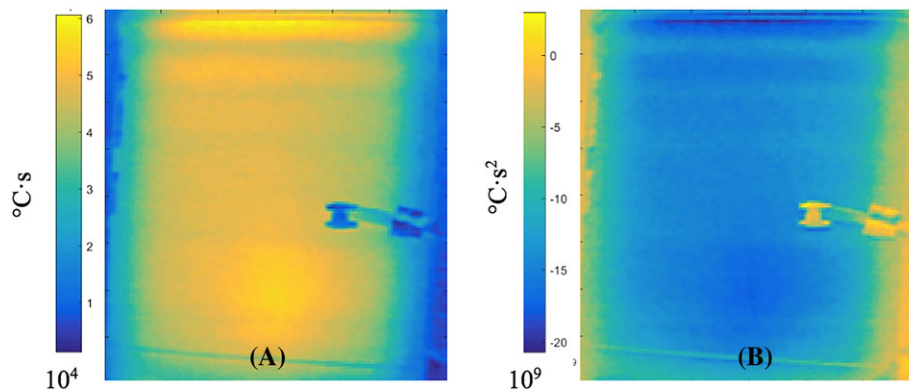
FIGURE 8 Postprocessed data from IRT analysis for Sample_2 containing embedded out-of-plane wave defects. A, First-time derivative of temperature. B, Second-time derivative of temperature [Colour figure can be viewed at wileyonlinelibrary.com]

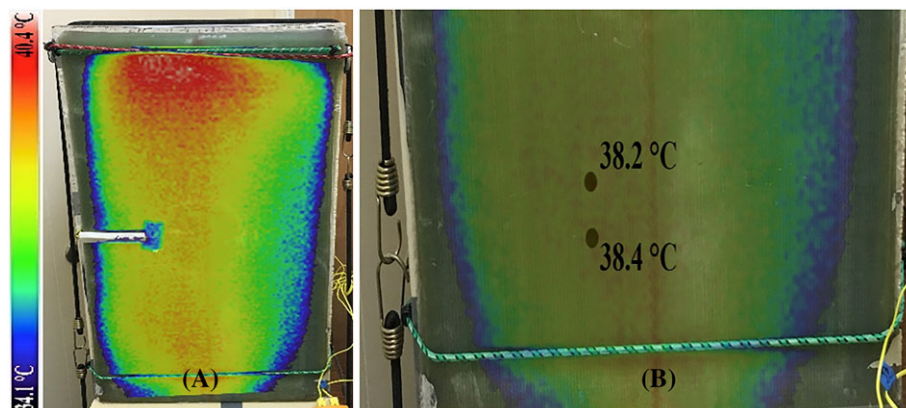
FIGURE 9 IRT recorded during the heating process of Sample_3 containing silicon inserts and the true de-wet defect. A, Temperature map superimposed to the test object. B, Detail of the recorded images with temperature measured in correspondence of a defect (1×10^{-3} m thick silicon insert) and in correspondence of a healthy area (fiberglass only, 25.4×10^{-3} m thick section) [Colour figure can be viewed at wileyonlinelibrary.com]

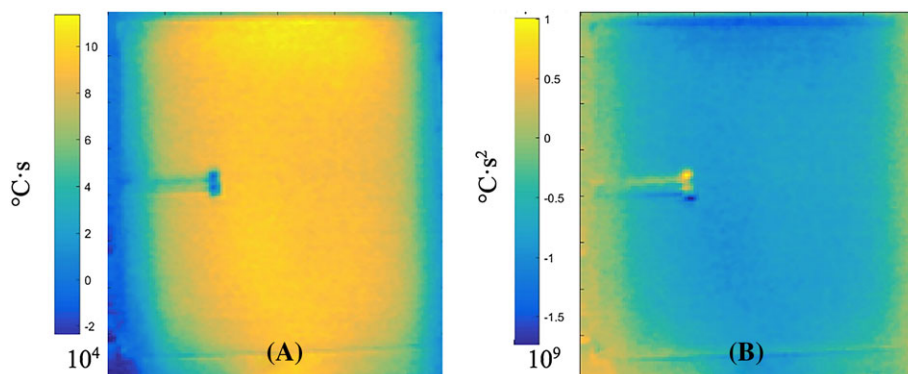
FIGURE 10 Postprocessed data from IRT analysis for Sample_3 containing embedded silicon inserts and the true de-wet defect. A, First-time derivative of temperature. B, Second-time derivative of temperature [Colour figure can be viewed at wileyonlinelibrary.com]

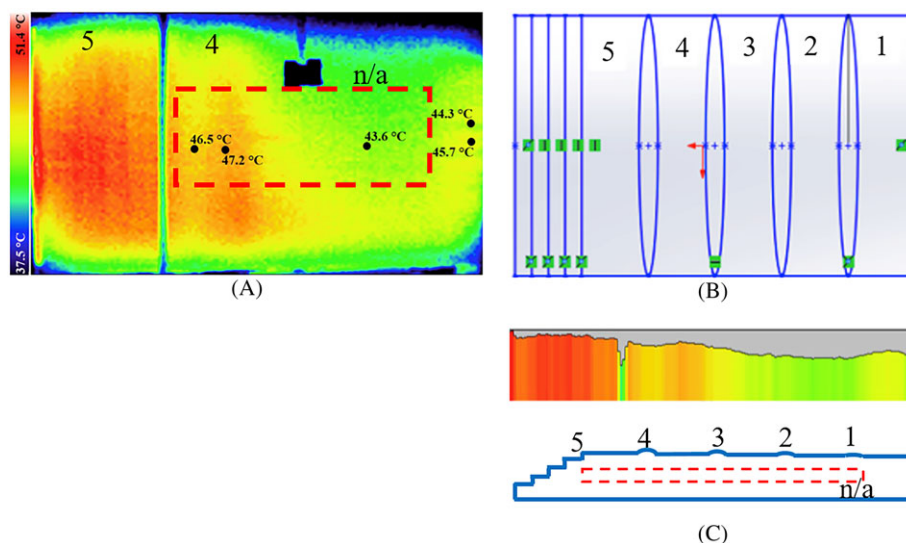
FIGURE 11 Results of the IRT tests performed on Sample_4 containing out-of-plane fiber wave defects and thickness taper region. A, IRT recorded during the heating process with temperature measured in correspondence of different areas with the highlighted defects that can be identified. B, Schematic of defects embedded in Sample_4. C, Temperature profile and longitudinal section of the sample. Dimensions in mm [Colour figure can be viewed at wileyonlinelibrary.com]

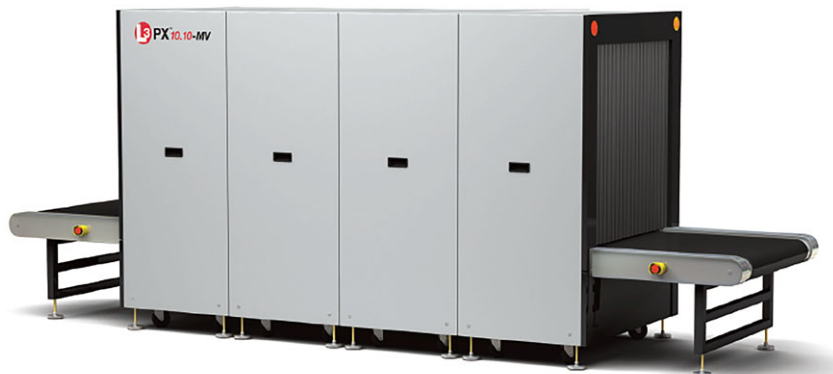
FIGURE 12 Photograph of the PX 10.10 MV nonpalletized freight X-ray model system⁸⁴ [Colour figure can be viewed at wileyonlinelibrary.com]

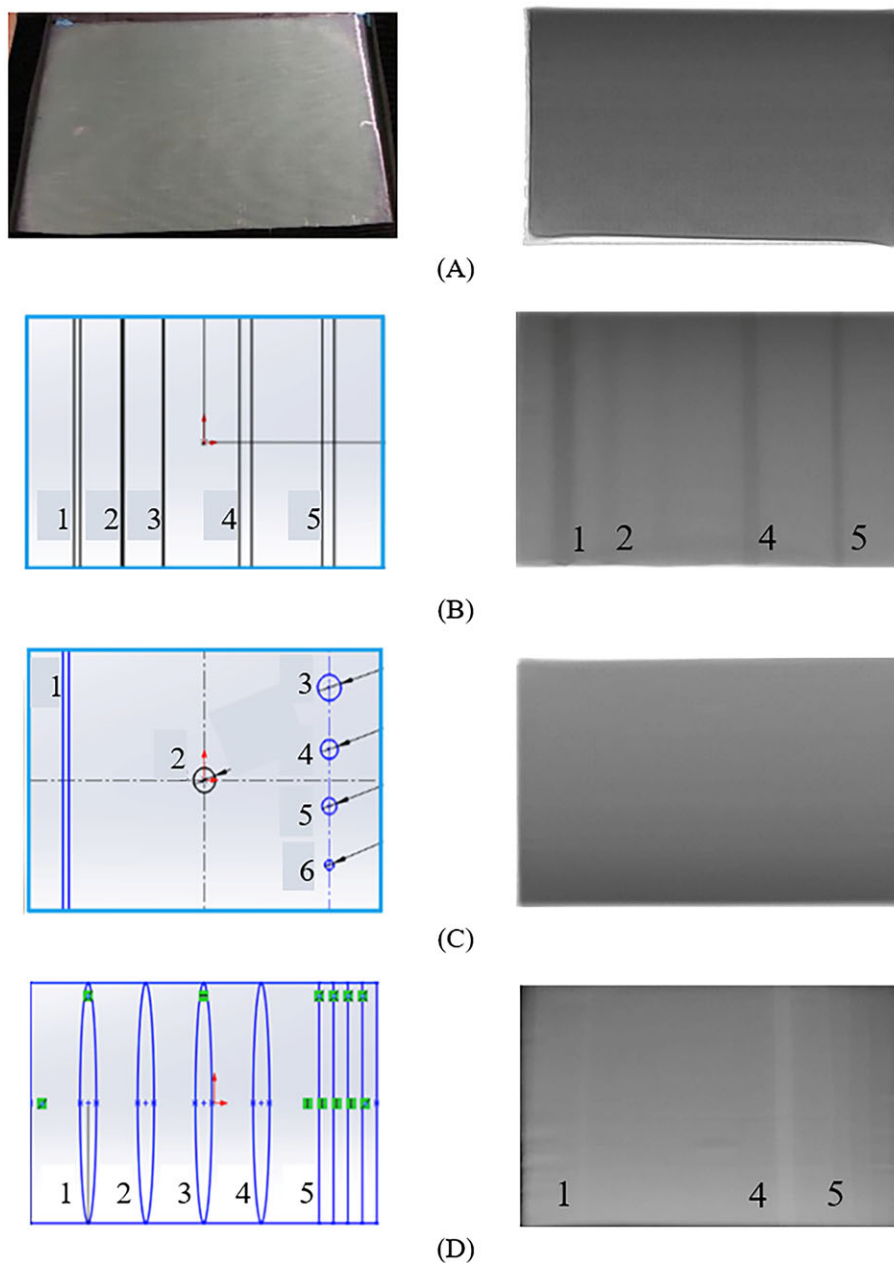
FIGURE 13 X-ray imaging generated for the 3 panels analyzed (right) with the highlighted defects that can be identified and schematic of defects embedded at the 10th plies (left). A, Sample_1 baseline with no intentionally embedded defects. B, Sample_2 with out-of-plane wave defects. C, Sample_3 with silicon inserts and the true de-wet defect. D, Sample_4 with out-of-plane fiber wave defects and thickness taper region [Colour figure can be viewed at wileyonlinelibrary.com]
