Field campaign

Торіс	New Continental GT and GTC - V8T Engine control module update (SC13/06)
Market area	Russische Föderation (5RU), China 796 VW Import Comp. Ltd (Vico), Beijing (6796), Russian Federation 935 Volkswagen Group RUS (6935), United Kingdom E01 Bentley UK (6E01), Germany E02 Bentley rest Europe (6E02), Australia E04 Bentley rest Asia and Australia (6E04), United States E05 Bentley USA and rest America (6E05), United Arab Emirates E06 Bentley Middle East and Africa (6E06)
Brand	Bentley
Transaction No.	2033405/3
Campaign number	E782
Note	
Туре	
US code	4 · · · · · · · · · · · · · · · · · · ·

New Continental GT and GTC - V8T Engine control module update (SC13/06)

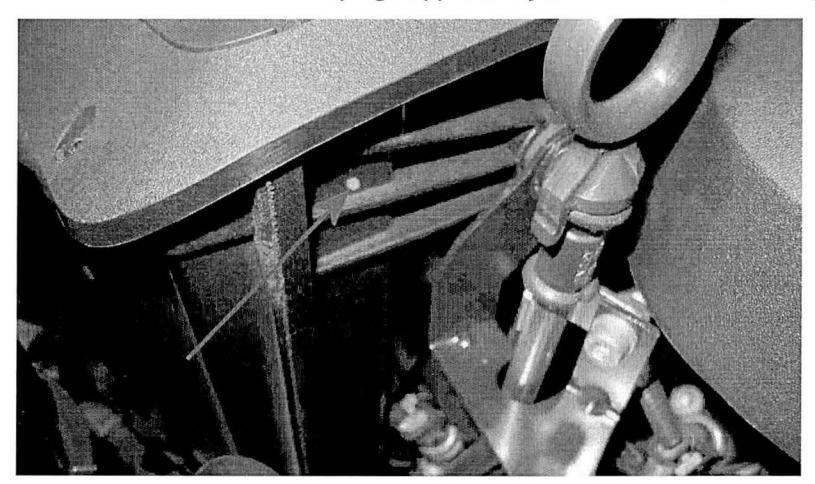
Figure 1

ATTENTION: Before commencing with this procedure please check the left hand air filter housing for a yellow paint mark (Figure 1) the paint mark signifies that the vehicle has already received a similar software update for a separate issue.

If the yellow mark is evident or TPI 2035573/3 has been conducted <u>do not</u> carry out this procedure please refer to the Warranty accounting instruction section of this procedure for labour claim instructions to allow the campaign applicability to be removed for the applicable VIN
