TEST REPORT

Cement Board Fabricators

Standard Fire Test Method for Evaluation of Fire Propagation Characteristics of Exterior Non-Load- Bearing Wall Assemblies Containing Combustible Components NFPA 285

Test Report No: EW-002
Assignment No: K-1239
Subject Material: Exterior Non-Loadbearing SILBONIT Panel Ventilated Wall System
Test Date: March 12, 2019
Report Date: March 18, 2019

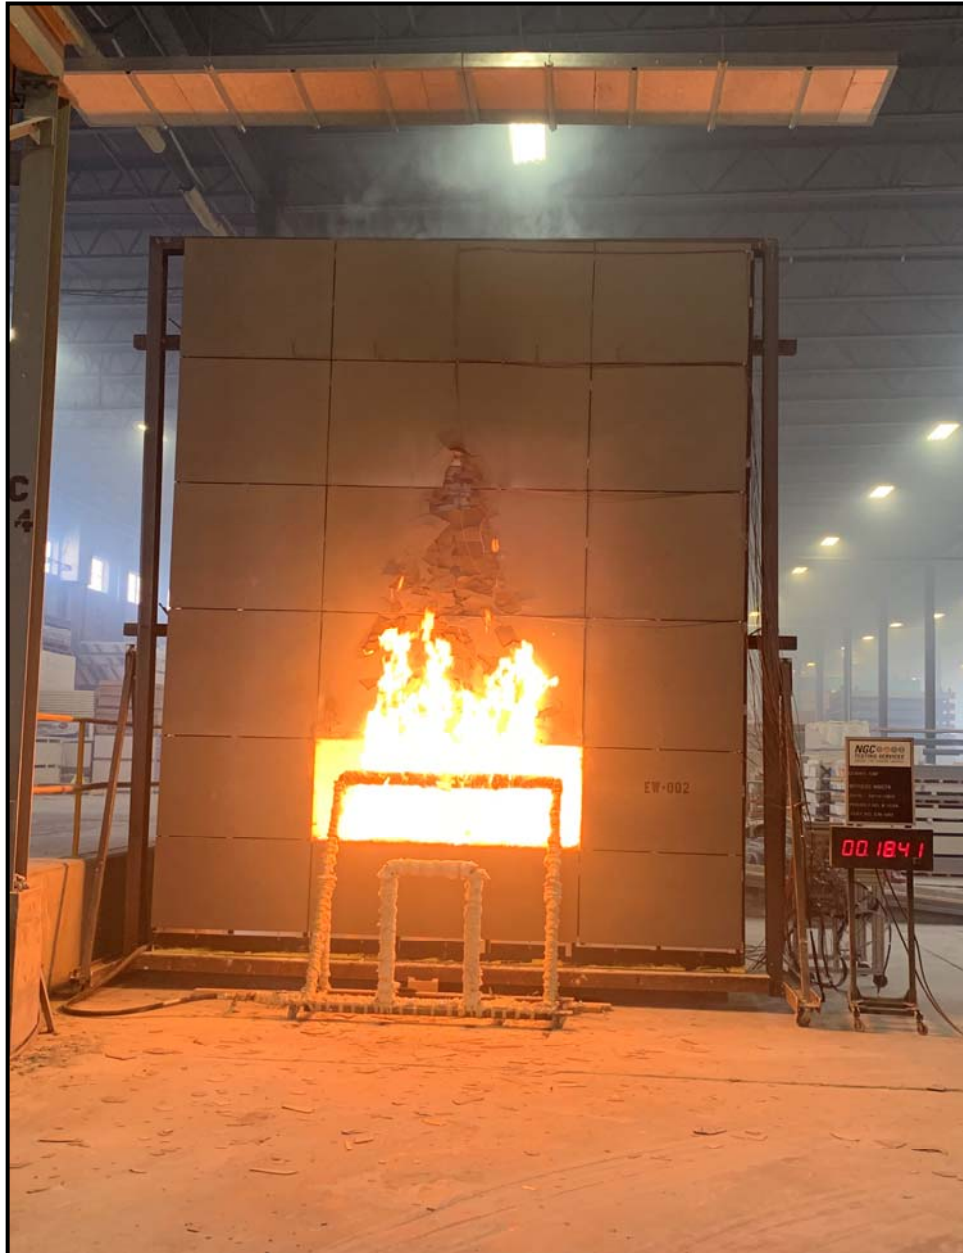
Cracking and spalling of the SILBONIT cladding panels were evident up to and including the fourth panel above the window opening. Lateral damage was evident across the entire width of the first panel above the window opening, narrowing on the way up to the fourth panel. Charring of the panels was evident up to the third panel above the window header.

Photo 3: Cracking and Spalling of SILBONIT Panels

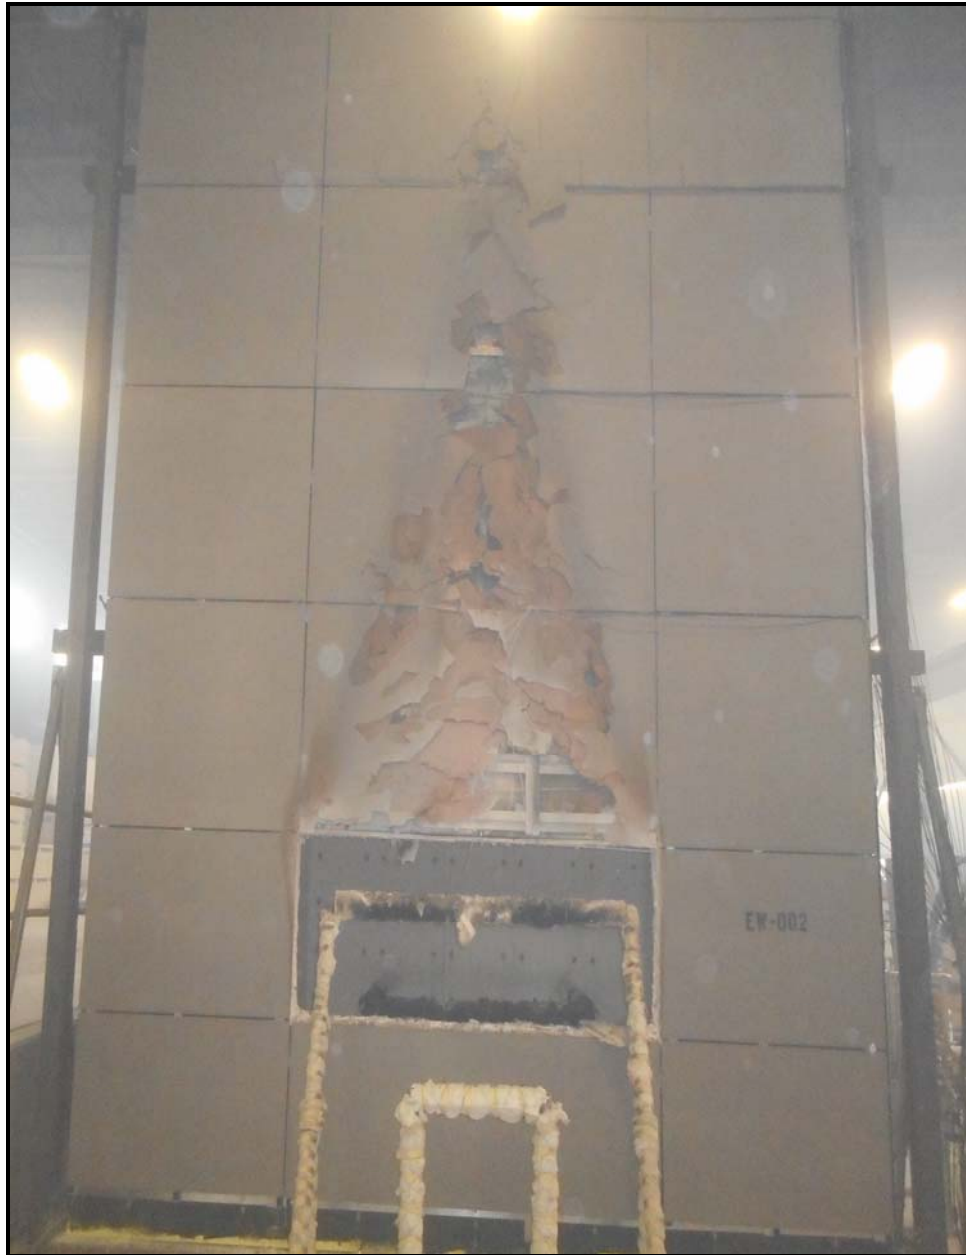
Photo 5: "Burn" Pattern of SILBONIT Panels

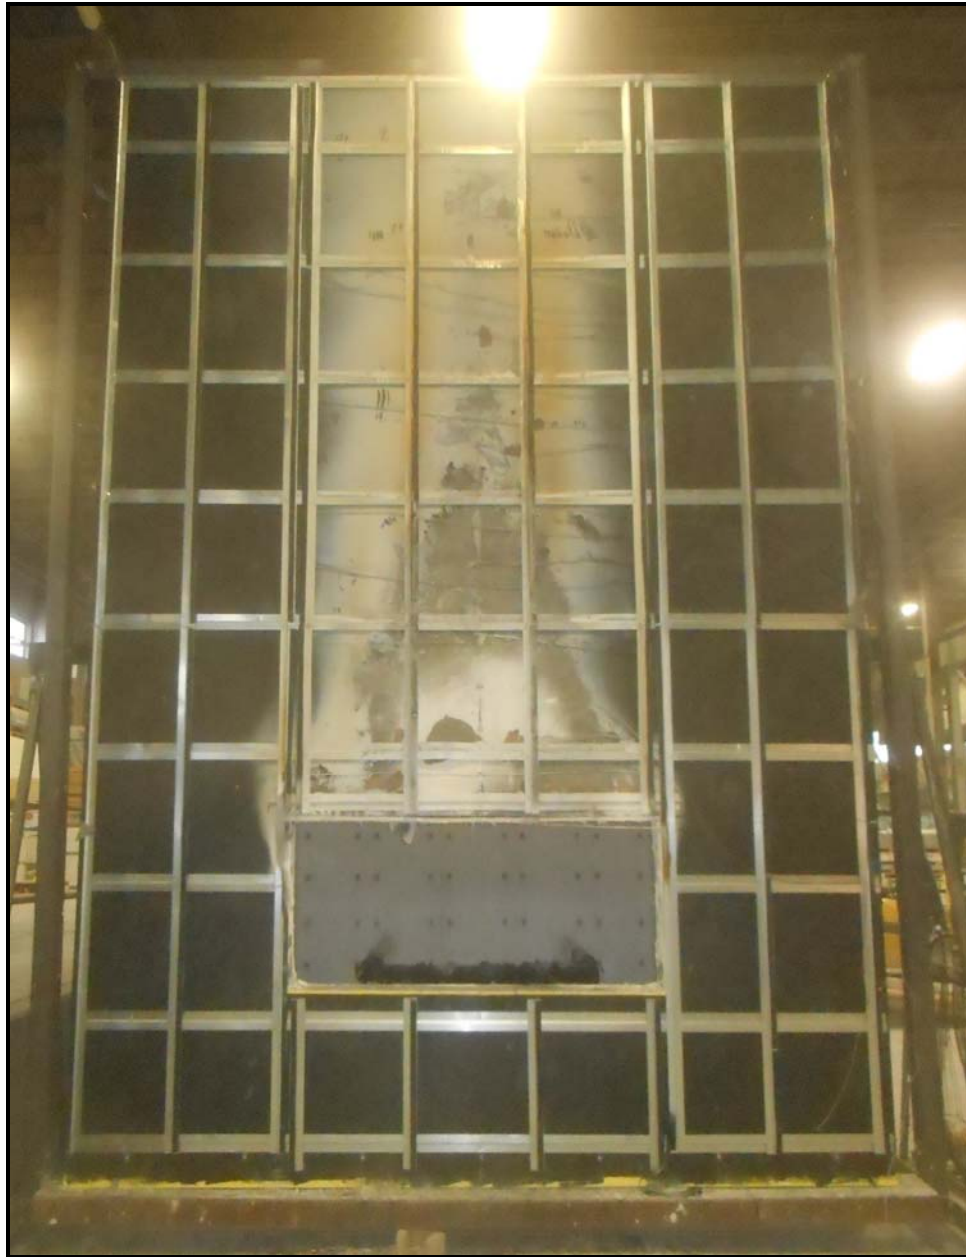
Charring of the GE Elemax* 2600 AWB and exterior sheathing was evident within the area of the flame plume up to 6 ft. above the window header. Lateral damage did not extend beyond the vertical plane of the window opening jambs. Discoloration of the AWB was evident up to the top of the assembly above the window opening header.

Photo 6: Burn Pattern of AWB After SILBONIT Panels Removed

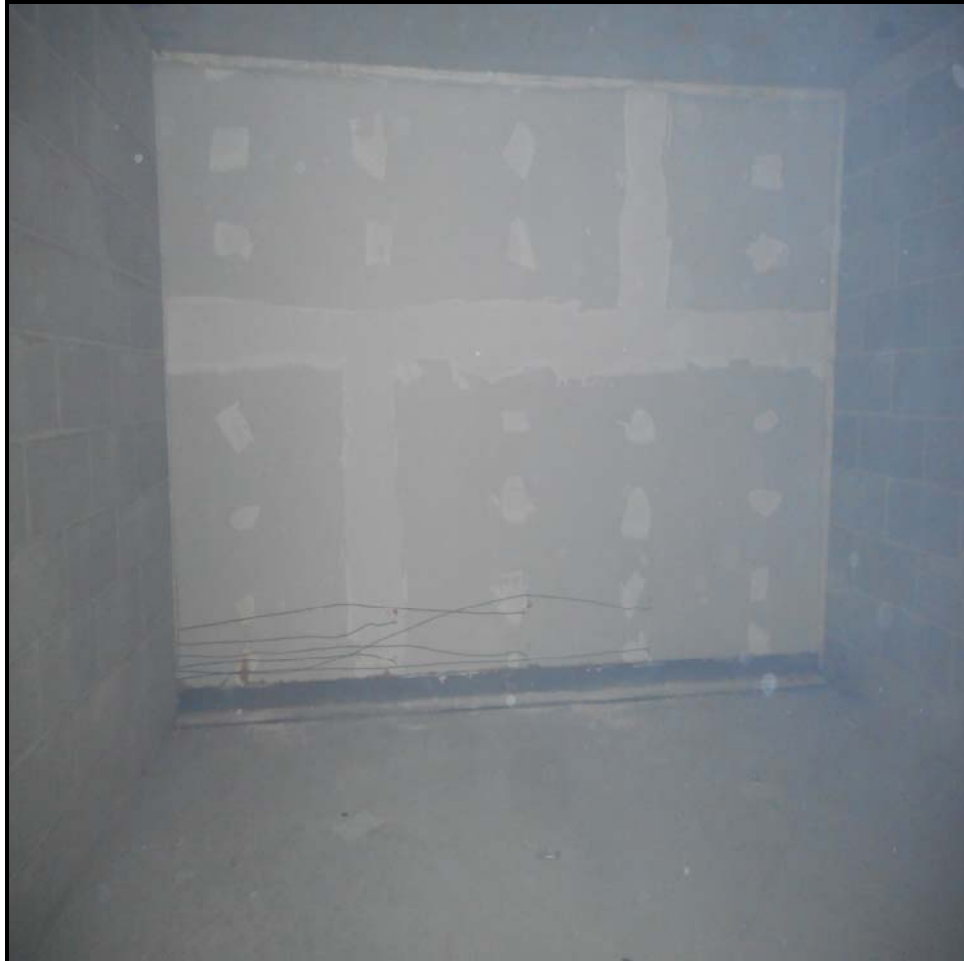
The interior gypsum was still intact after the test. The exposed gypsum in the first-story test room was heavily fatigued, showing signs of flame damage. The second-story interior gypsum was almost completely unblemished and showed no signs of flaming.

Photo 7: Interior Second-Story Test Room – Post-Test
