# Geotechnical Investigation: Moloka'i Flume, Irrigation Improvements

August 27, 2015  
AECOM Project No. 60429130

**SUBJECT: GEOTECHNICAL INVESTIGATION:  
MOLOKA'I FLUME, IRRIGATION IMPROVEMENTS  
KAUNAKAKAI, MOLOKA'I, HAWAII'**

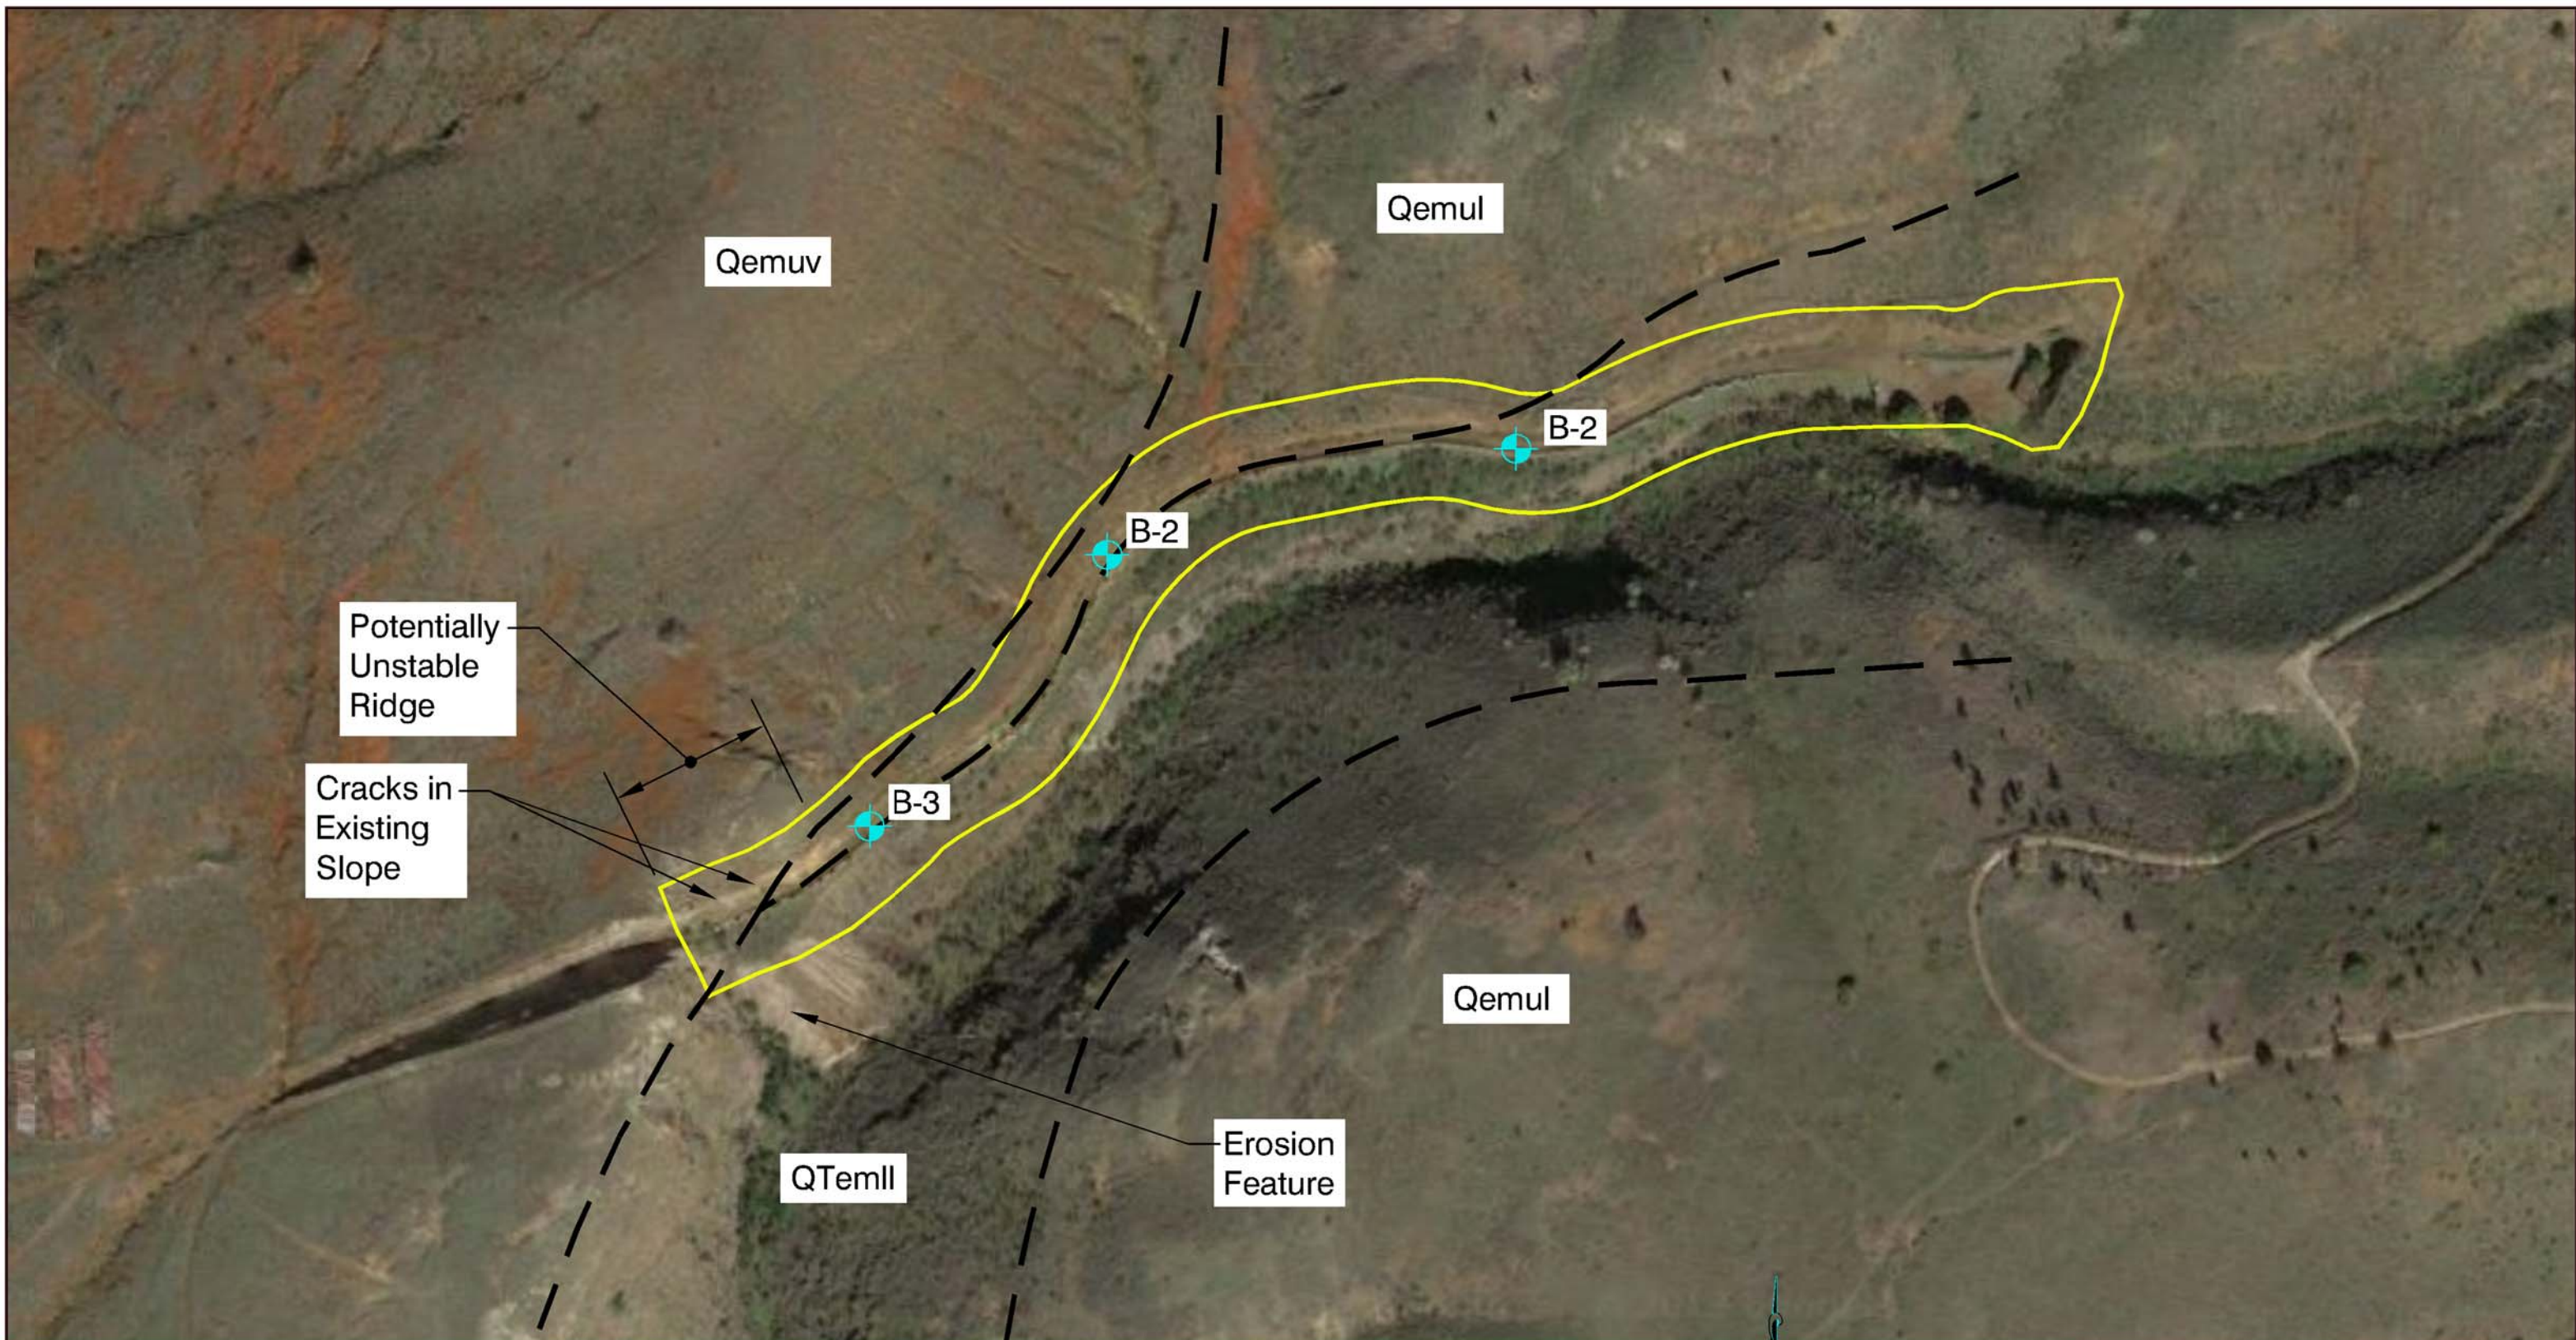
Moloka'i Flume  
Moloka'i, Hawai'i  
**Geologic Plan and  
Boring Location Map**

In general, the road cut upslope of the road appear to be in adequate shape. However, the westernmost 80 longitudinal feet of slope contains large, open vertical cracks, about where shown on Figure 3, for much of the slope height. These cracks are present in a

The vertical cracks noted in the cliff upslope at the west end of the alignment are typically a precursor to a failure. For safety reasons, particularly for construction personnel working directly below, but also for maintenance personnel driving to the site after construction, mitigation of the slope instability should be considered before start of the utility replacement.
