Re: Historic Preservation Report for
McIndoes Academy, Academy Lane, McIndoe Falls (Barnet), VT
Feasibility Study for Renovation & Adaptive Re-use Project

McIndoes Academy – Historic Preservation Letter, April 25, 2018

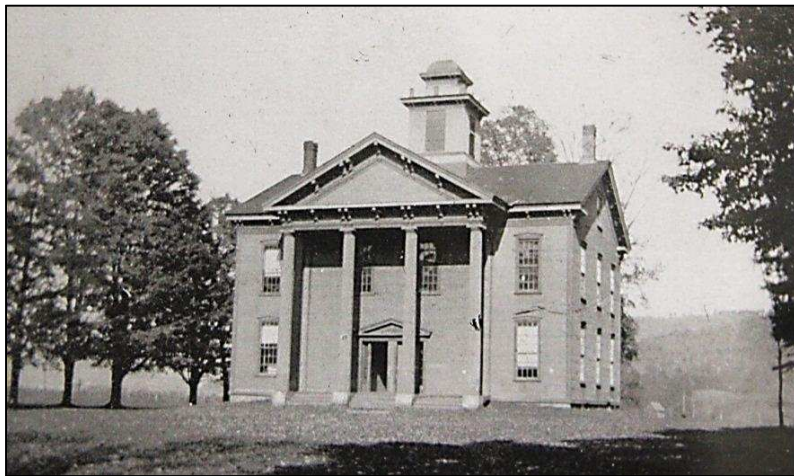
Historic view (n.d., courtesy Barnet Historical Society)

Another change is the roof which, as noted above, now has standing seam roofing and no longer has the southern (right) of the two symmetrical ridge chimneys seen in the historical view at left. The current north chimney is in fact just down from the ridge on the front slope. The remnant of the southern chimney is a brick chimney mass of only a few feet in height in the attic just under the roof but now supported in the air by some stout beams.

A possible change may be the 19th or early 20th century re-siding of the front façade with clapboards – the undated historic view above appears to show flush board siding on the front only – typical of many monumental Greek Revival public buildings. An historic class photo identified as taken in 1916 shows a close up of the front façade which was clapboarded as it is today.

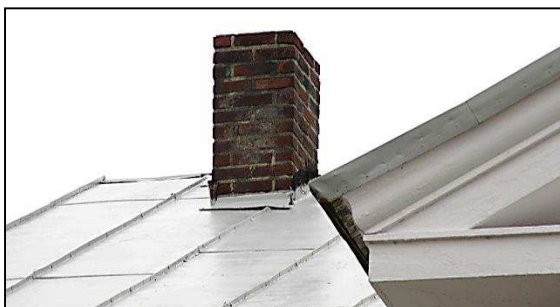
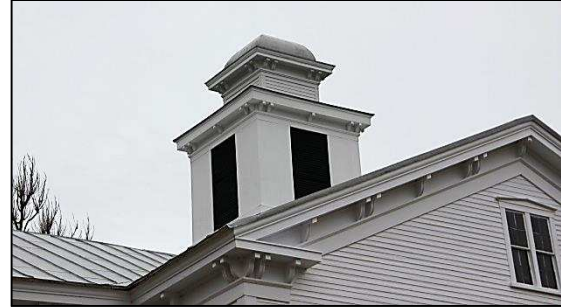
Another prominent feature is the central two tiered belfry. The square base has flush board siding and a rectangular louvered opening on each elevation. It is crowned by a bracketed cornice. The top tier is much smaller and also square with clapboard siding and bellcast roof. The historic view below shows what appears to be a railing around the top of the bottom tier that is no longer extant. The belfry appears to be in very good condition from the ground and looks fairly recently restored.

Two rows above (clockwise from upper left): (9) Detail of front pediment; (10) detail of front entry and doors; (11) Detail of cupola/belfry and gable raking cornice; (12) Detail of northern chimney on standing seam roof

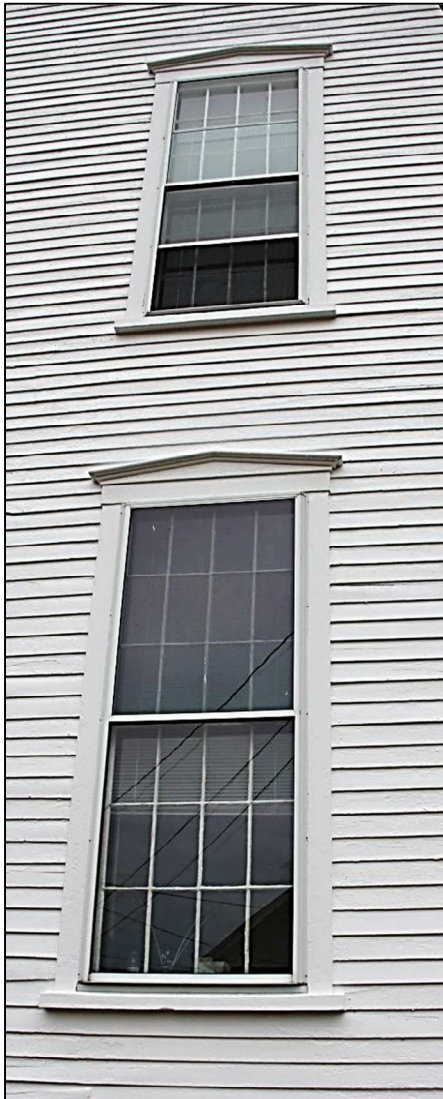
The 12/12 light window sash appears to be original and intact in varying degrees of condition from poor to good. Modern exterior triple track storm windows protect all the windows.

Left: (15) Detail of first and second floor windows; Upper right: (16) Detail of rear second floor fire stair; Lower right: Existing rear (east) elevation (Arnold & Scangas Arch.)

The proposed project will construct a compatible, two-story rear addition to achieve the program goals while preserving the existing historic character of the main building. The new addition will be narrower and slightly lower than the main building and set off of the main block by a hyphen connection that attaches to the center two bays while leaving the outer two bays untouched. The addition will provide a vault, restrooms, elevator and fire stair as well as a new history room on the second floor. A new rear ramp will be built onto the new rear (east) elevation of the addition. The current rear ramp and metal fire escape will be removed and except for the two center rear window bays, the exterior of the historic main block will be preserved - repaired, and painted where needed. The historic windows will be refurbished and new storm windows applied.

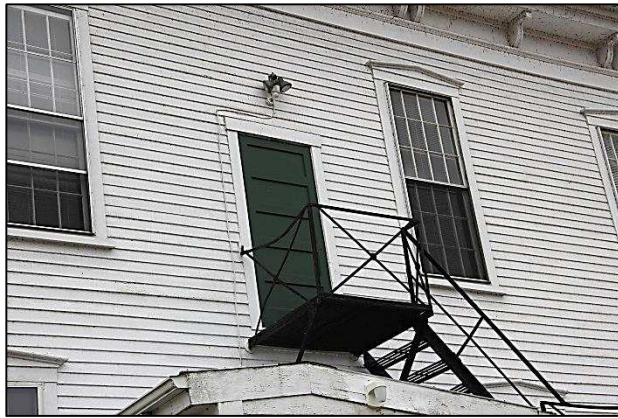
The rear (east) elevation has undergone the most alteration by the addition of an early 20th century metal fire escape from the second floor – through a door that appears to have been added between the center two window bays. The wooden door has 5 stacked panels, typical of c. 1900 – 1920 doors. The open tread metal stair leads down to the north with one landing that crosses a first floor window. A rear, off-center new ground floor entrance doorway has been added in the late 20th century along with a large wooden ramp and gable canopy over an entrance deck. The door is metal with a small off center window. Neither doorway on the rear façade has the peaked lintel trim of the windows but rather plain board trim.

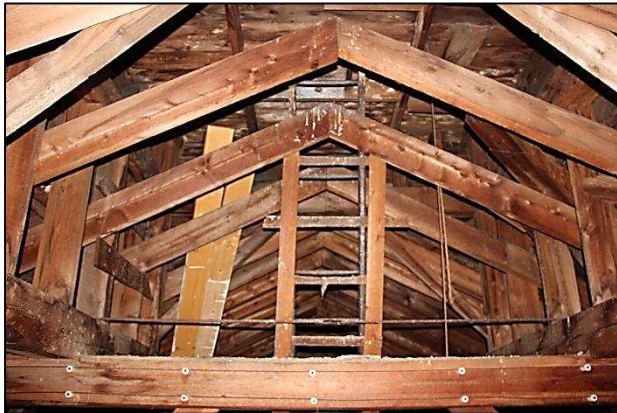
Center left: (58) Attic roof framing with ladder to belfry; Center right: (59) Attic detail of chimney remnant supported on beams (south end)

and two windows will be infilled. In addition, the original roof trusses that support the large open span will be repaired and the modern posts removed. The northwest room will expand a bit into the adjacent small vestibule and capture the space of the stage area closet as well. The appearance of the original vestibule door from the main room will be unchanged. The stage area will only change in that the closet wall will extend forward and be solid.

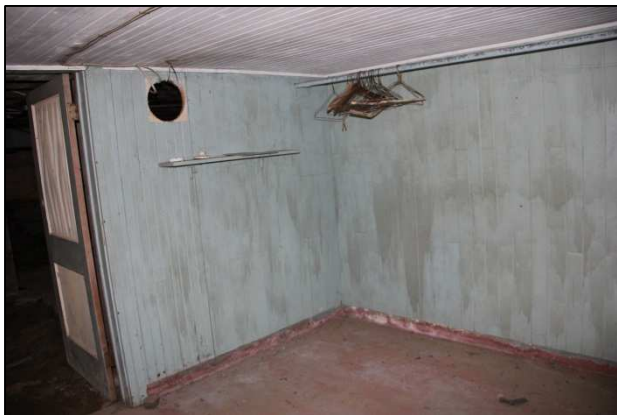
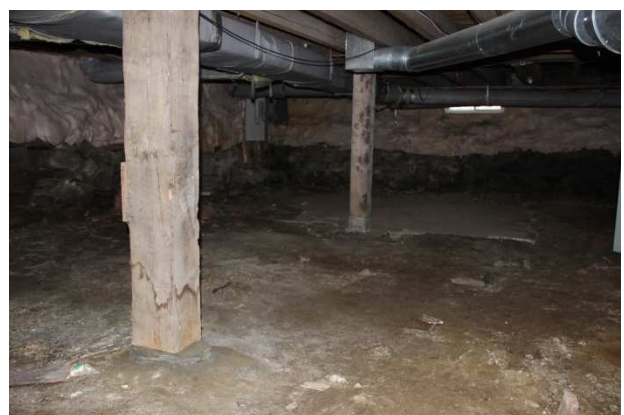
for the McIndoes Academy Museum and has a door directly from the main room. The northern front room is entered by a vestibule, as noted above, to the left of the stage. The main room, stage area, and the two front rooms all have a low wainscoting of horizontal, wide flush boards. The main room and museum room have narrow board wood floors and tin ceilings while there are plaster or sheet rock flat ceilings in the stage area and northwest room. The stage area floor is plywood or masonite and the northwest room has painted wider board flooring. The main room has pebbled tin sheeting covering all the walls above the wainscoting. There is an older cast iron radiator in the northwest room. The attic is unfinished and accessed by a ladder-like stair off the second floor stair landing. The basement has two finished rooms and a former restroom and then larger unfinished areas. The basement rooms are unused and in deteriorated condition.

Bottom left: (60) One finished basement room with board walls; Bottom right: (61) Rest of unfinished basement, typical
