MICROMASTER (MM4): What are the possible causes of F0070 on MICROMASTER 4, and how do I avoid them?

FAQ • November 2013

Causes and avoidance of F0070 / 223

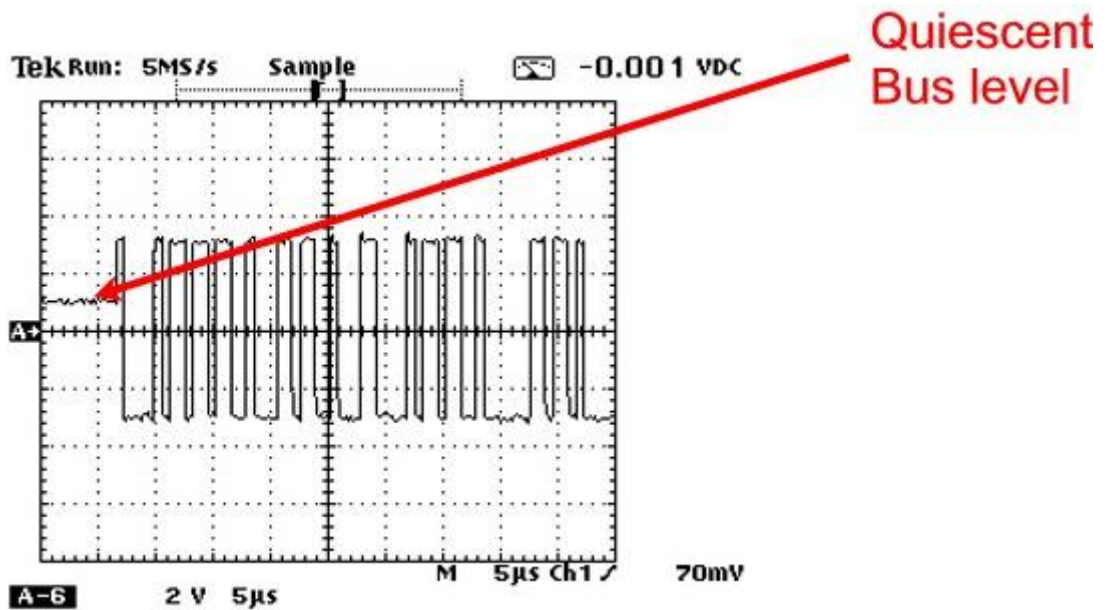
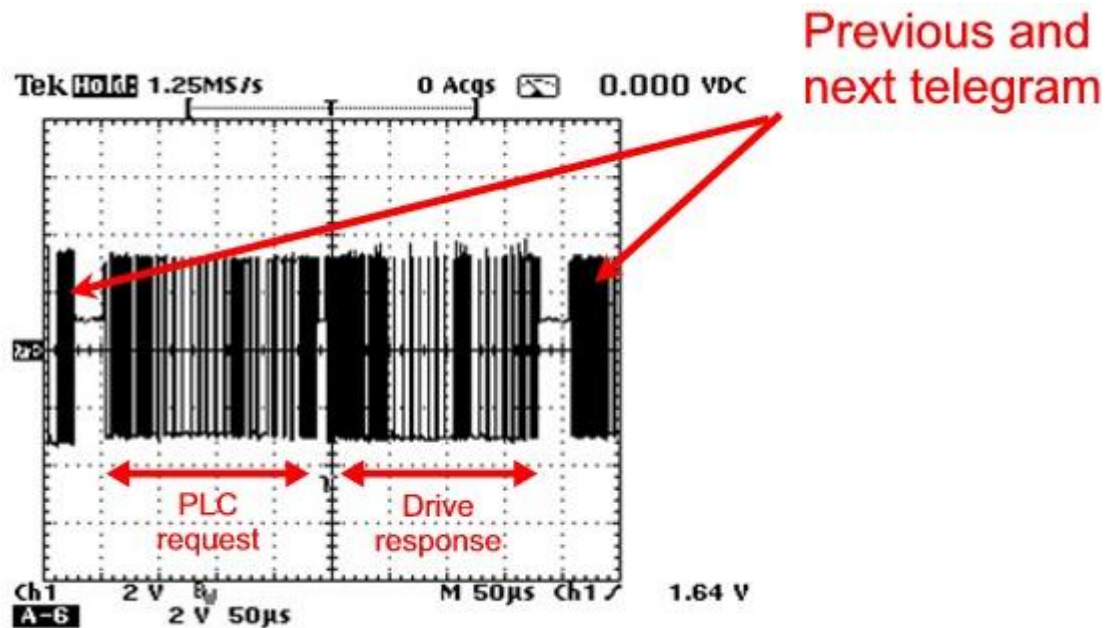
Figure 1-1

Possible causes are electrical interference (EMC), signal attenuation due to excessive cable lengths, reflections due to cable joints or incorrectly installed connectors, incorrect bus termination, or inadmissible spurs on the bus (T-offs). Check the PROFIBUS with an oscilloscope, an example of a good waveform is shown below (1.5 Mbaud). The BT200 PROFIBUS Tester (6ES7181-0AA01-0AA0) is also useful for checking PROFIBUS hardware.
