A Resource of the State of Florida

Hurricane Loss Reduction

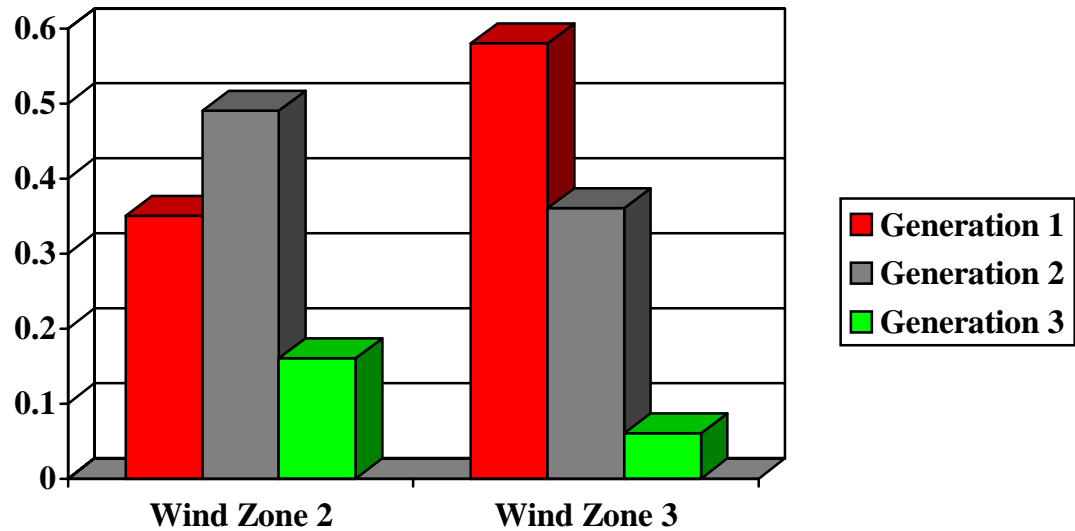
The data highlighted in Figures 2 and 3 emphasize that both zone 2 and zone 3 counties have a problem with generation 1 mobile homes; however, proportionately, the problem appears to be even more significant for those counties also considered the most at risk for high wind events. However, emphasis must again be placed on the damage that occurred to mobile homes in inland counties during the 2004 hurricane season. It appears that mobile homes are vulnerable regardless of their location in Florida.

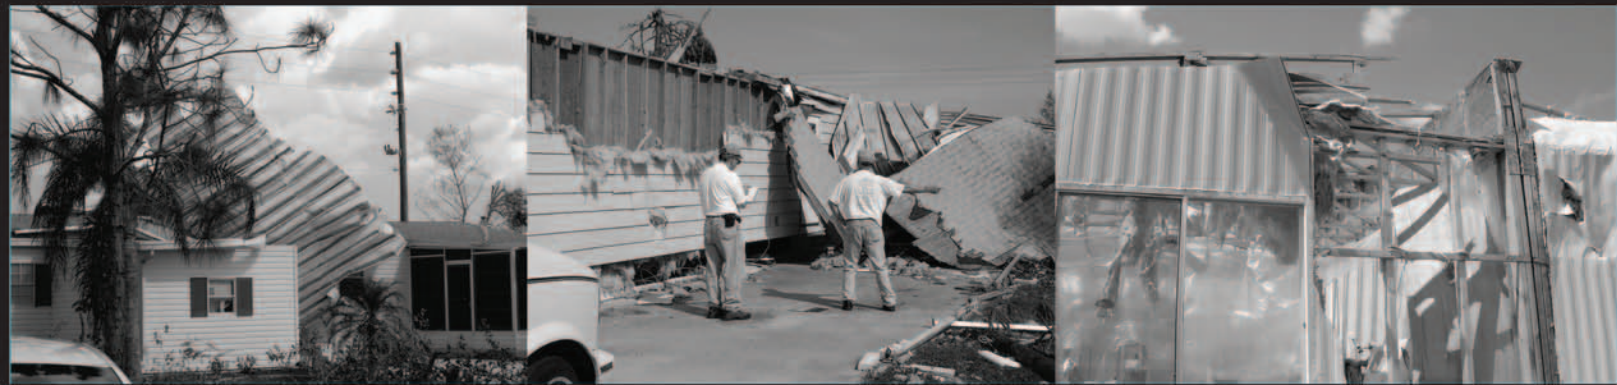
AN ASSESSMENT OF DAMAGE TO MANUFACTURED HOMES CAUSED BY HURRICANE CHARLEY

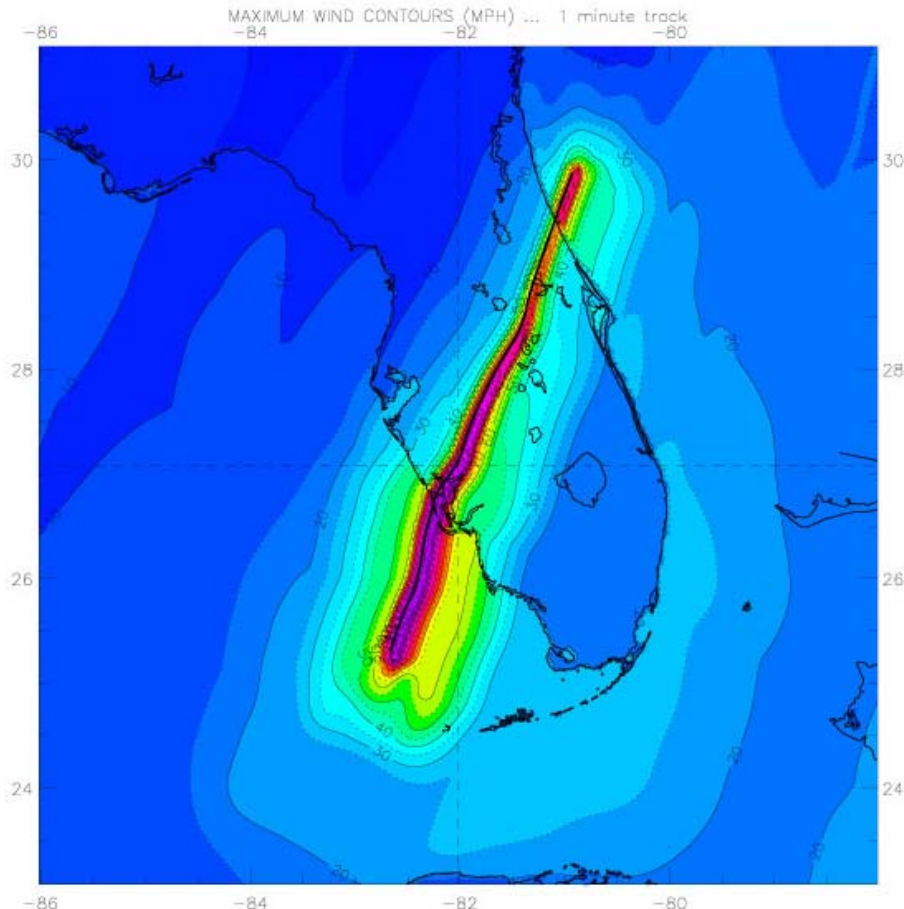
Figure 2. Maximum Wind Speed Contours for Hurricane Charley's Track [MPH, 1-minute sustained, over-sea or over-land exposure, 10 m elevation]

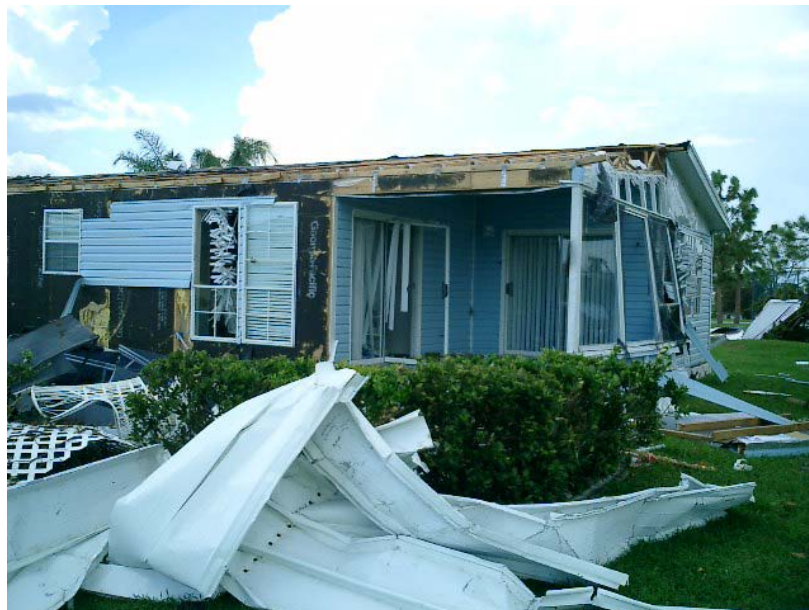
Figure 4.1: An Example of Level 3 Roof System and Level 2 Wall System Damage
[Note: In this case, the roof rating was primarily associated with extensive roof sheathing loss; the wall rating was based on some localized structural damage to sheathing in addition to extensive siding damage, even though the walls were essentially structurally intact.]

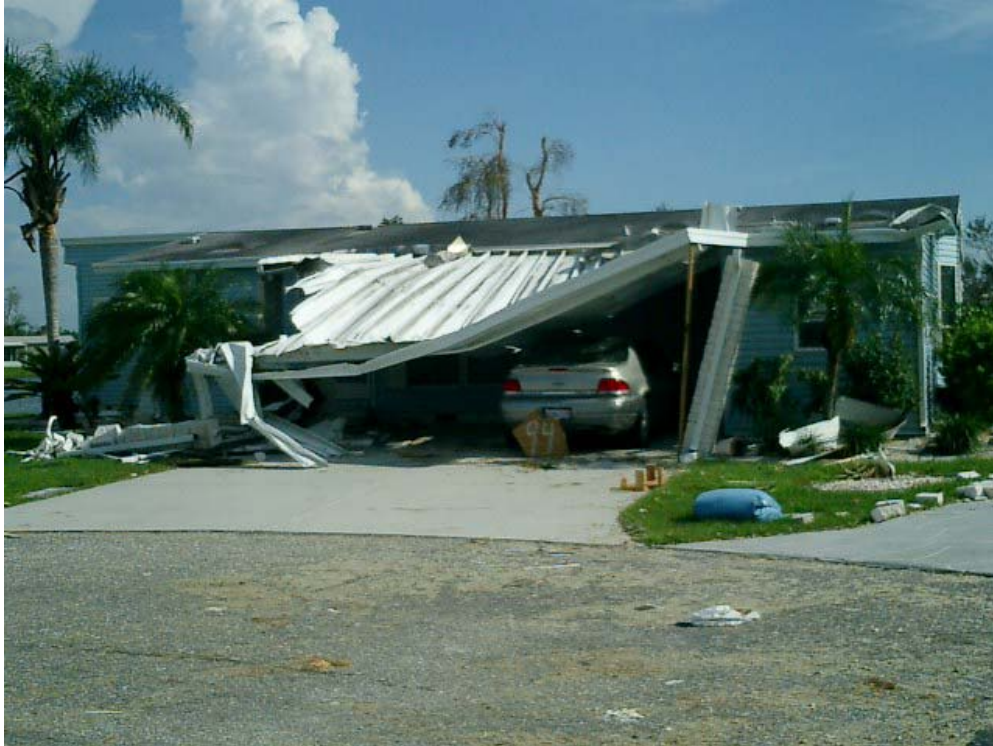
Figure 4.2: An Example of Level 3 Add-On Damage

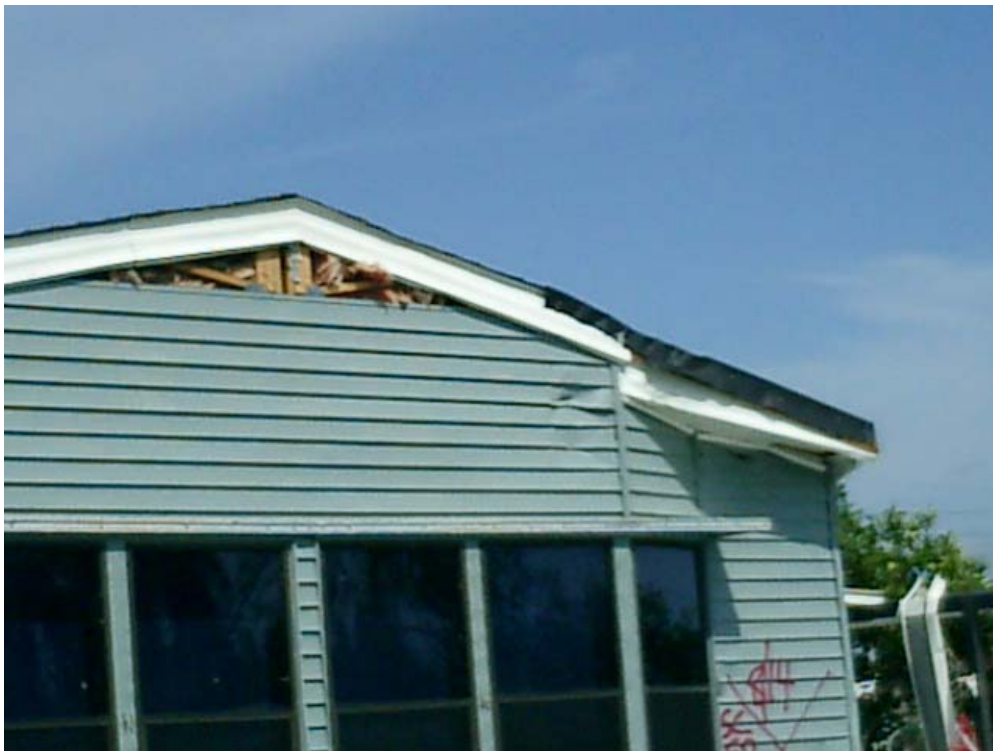
Figure 4.3: An Example of Level 1 Wall System Damage
[Note: Damage was limited primarily to wall finishes, i.e. vinyl siding damage]

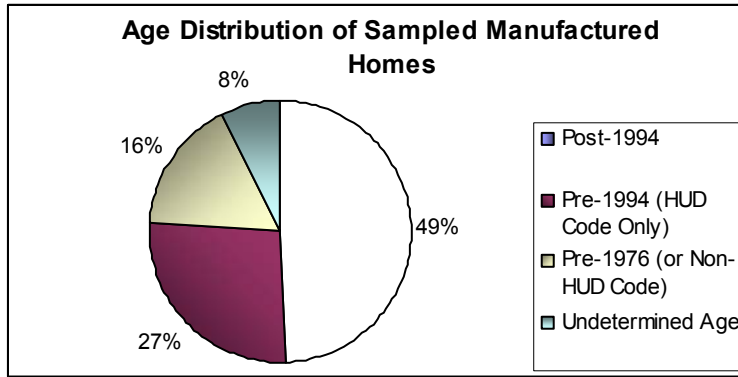
Table 7 summarizes the construction characteristics that were readily observed and documented for the different age categories of homes. Bold entries indicate the typifying characteristics for each age category. Concealed construction materials and methods are not reported due to the limited amount of destruction where such features could be readily observed. Also, the statistics of Table 7 have varying sample sizes due to the ability to collect each type of data. In particular, the sample size for wall sheathing type is relatively small due to the many occasions where siding damage was insufficient to make a non-destructive observation of the underlying sheathing type.

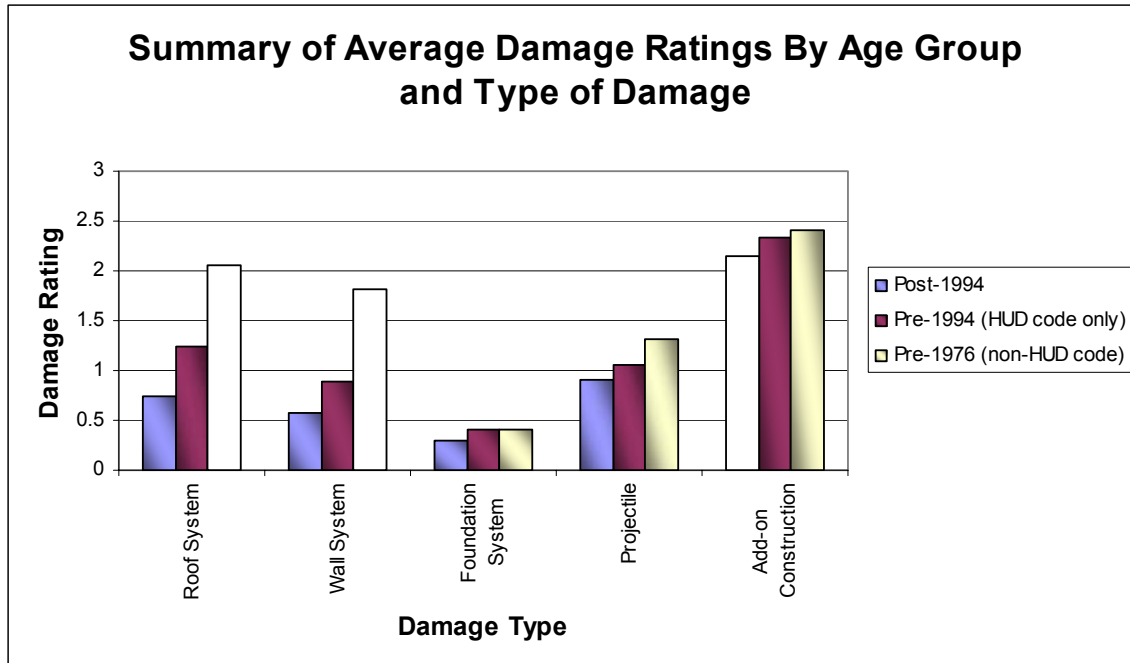
Damage Type	Post-1994	Pre-1994 (HUD Code only)	Pre-1976 (non-HUD Code)
Roof System	0.75 ± 0.12	1.25 ± 0.33	2.06 ± 0.64
Wall System	0.58 ± 0.14	0.88 ± 0.29	1.82 ± 0.64
Foundation System	0.29 ± 0.17	0.40 ± 0.32	0.41 ± 0.48
Projectile	0.91 ± 0.19	1.05 ± 0.30	1.31 ± 0.38
Add-on Construction	2.14 ± 0.33	2.33 ± 0.48	2.41 ± 0.55

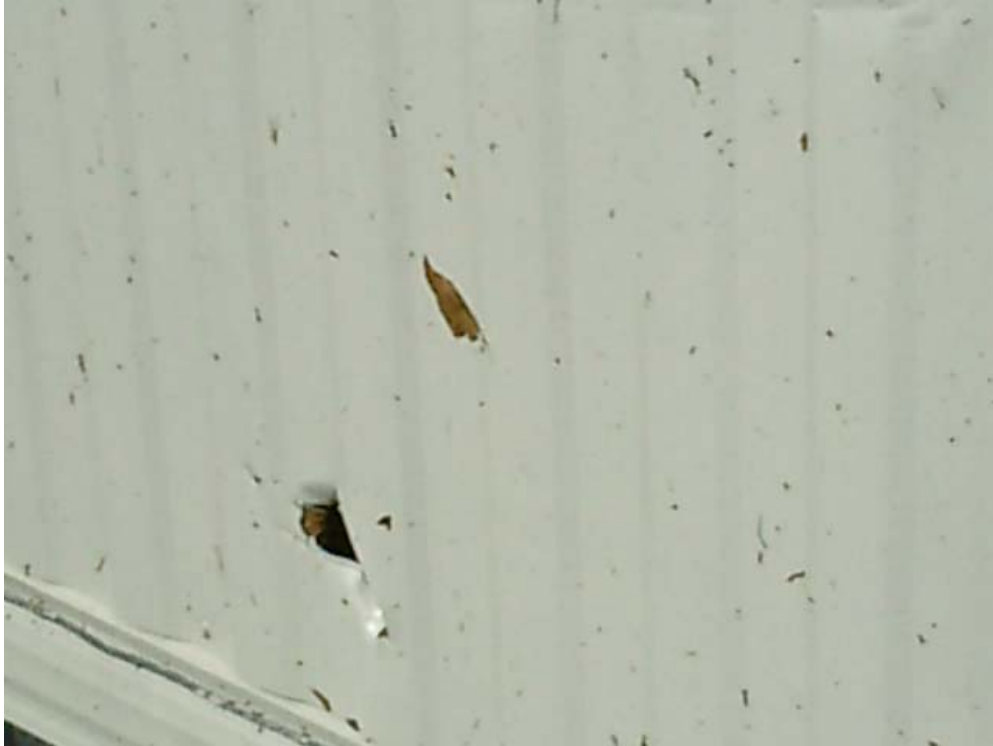
Figure 5.1: An Example of Debris Penetrating a Wall

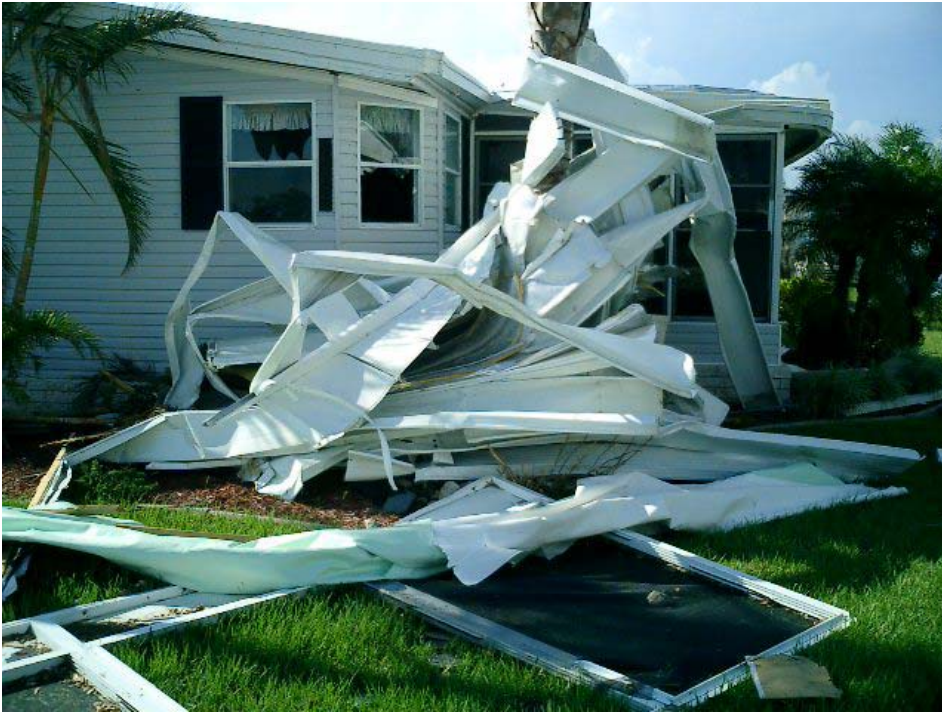
Figure 5.2: An Example of Substantial (Level 3) Add-On Damage

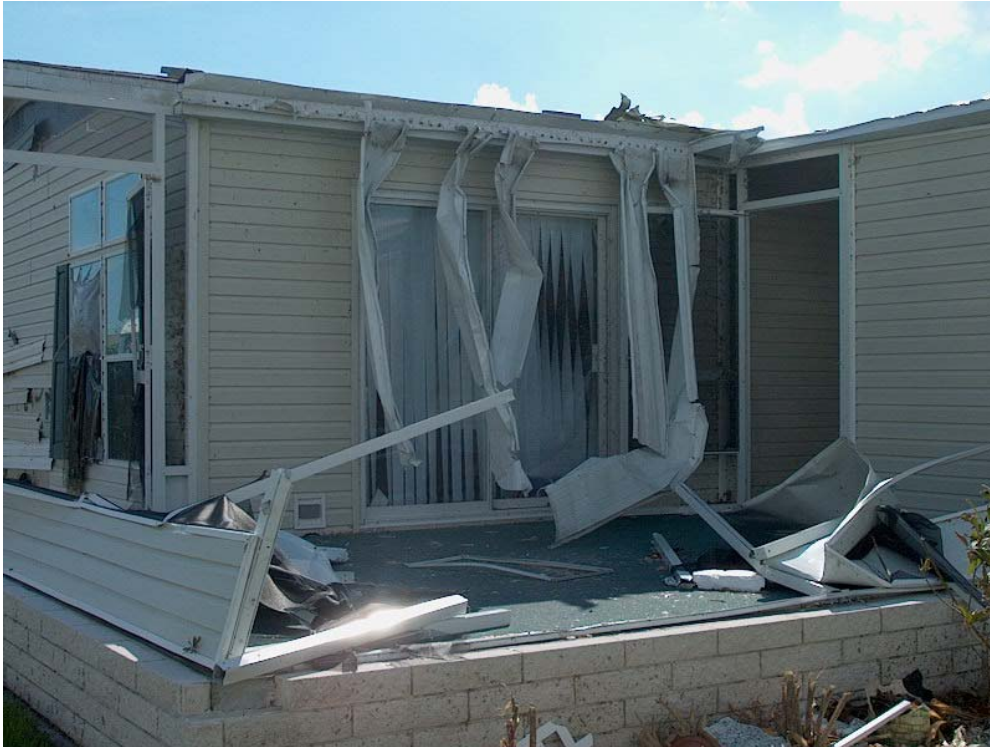
Figure 6.1: Destroyed Add-On Construction

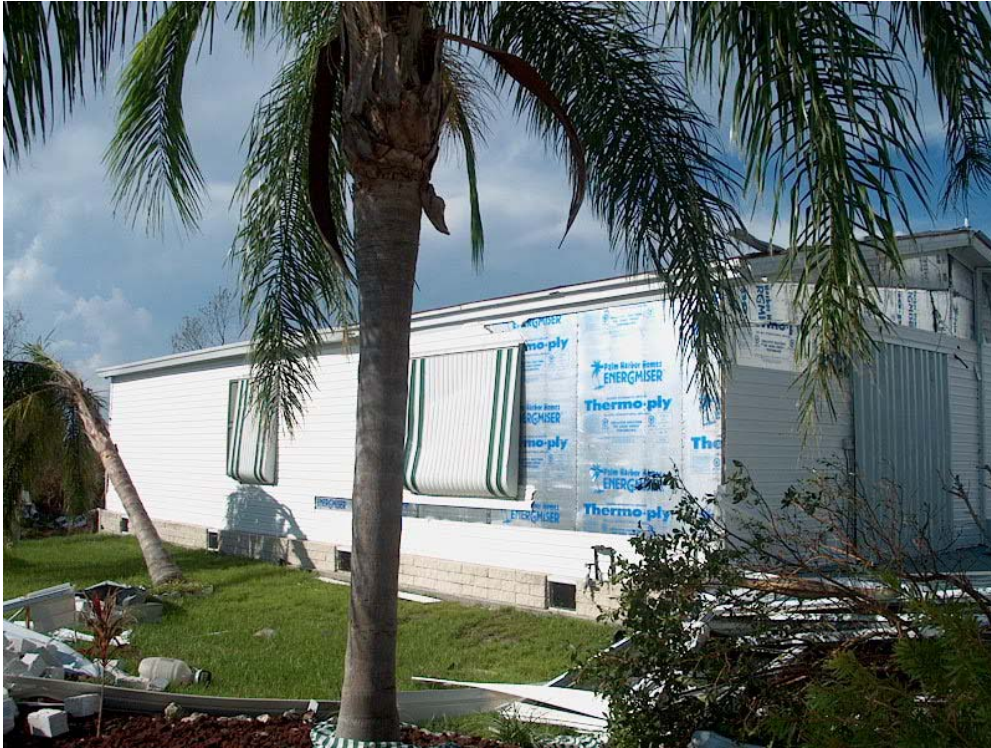
Figure 6.7: Damaged Sidewall and Endwall Siding

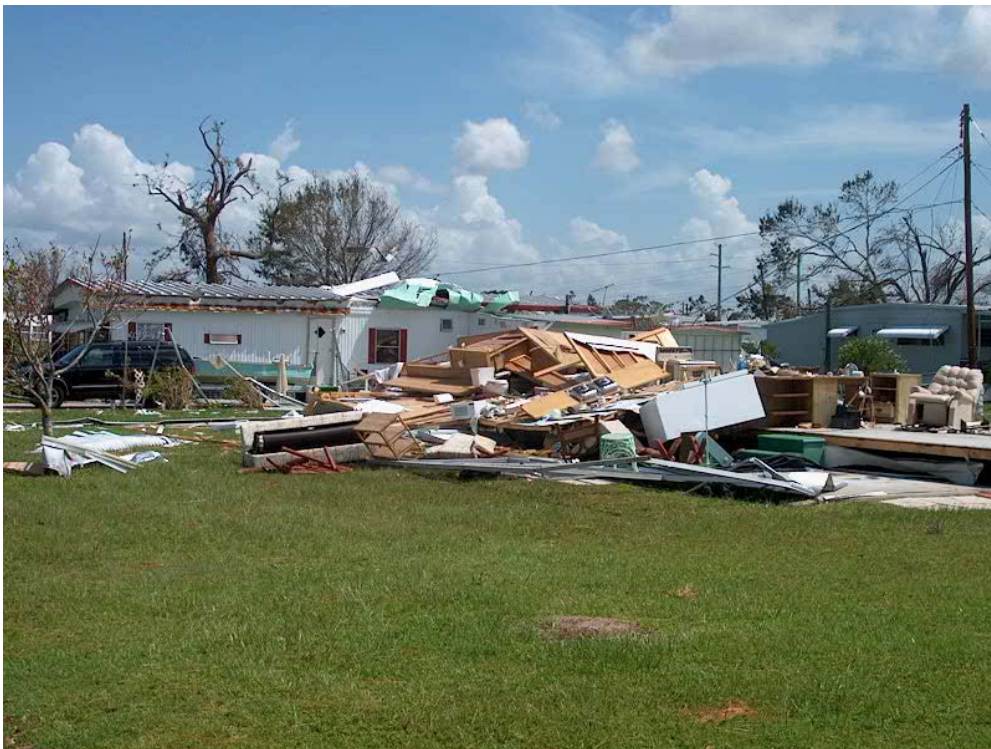
Figure 6.8: Destroyed Manufactured Home Built Prior to 1976

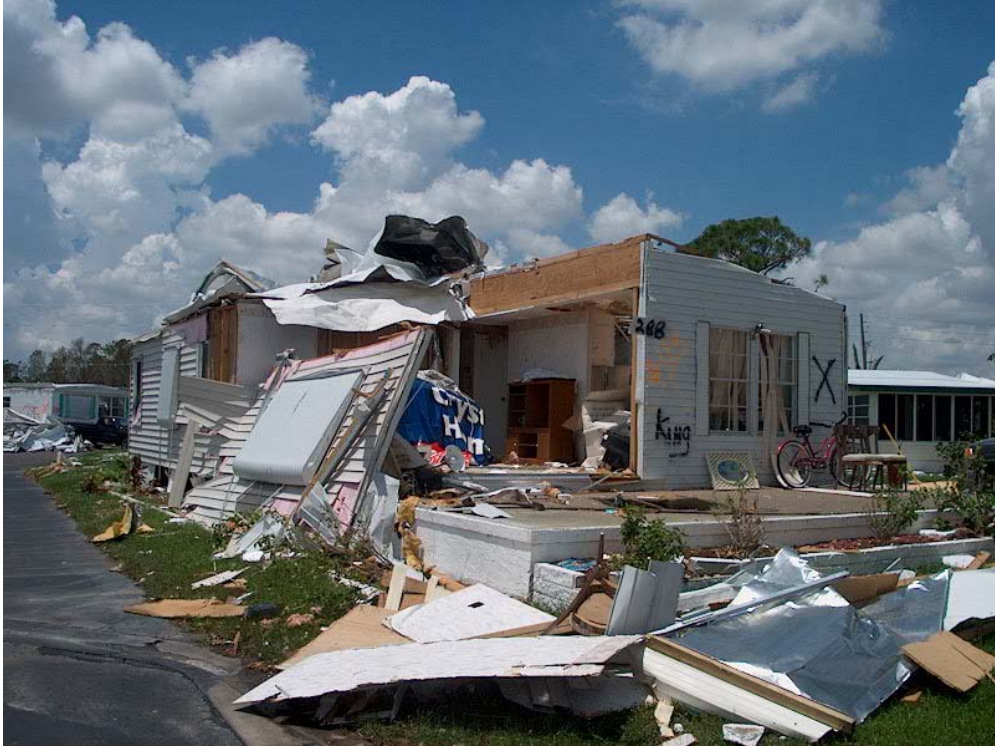
Figure 6.11: Failure of Wall and Roof System

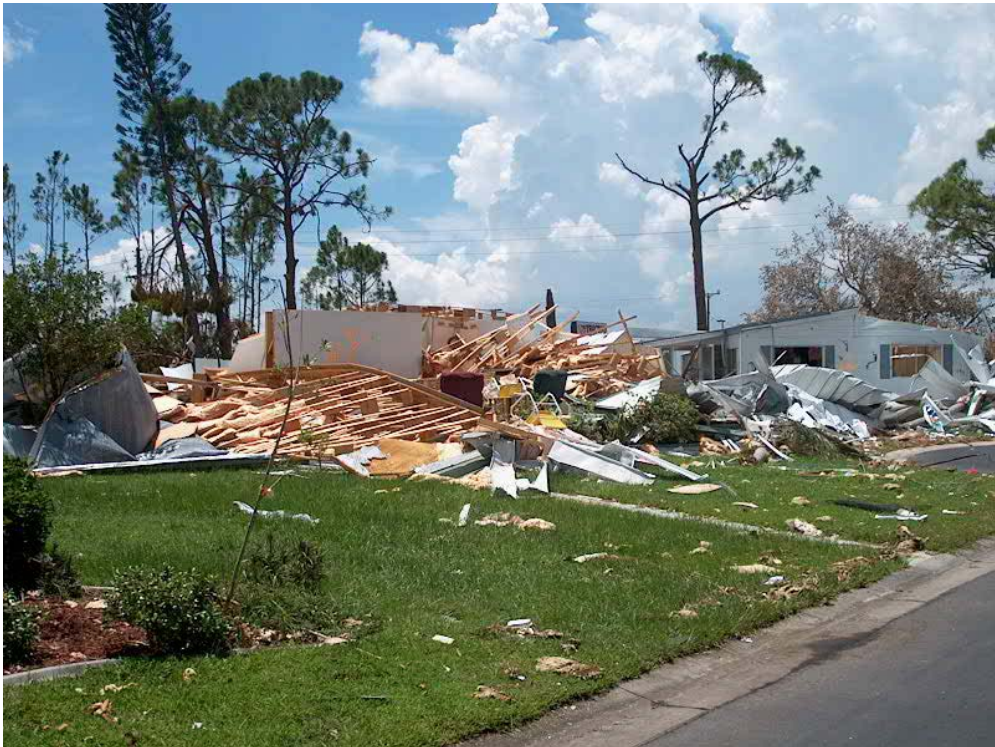
Figure 6.12: Destroyed Manufactured Home

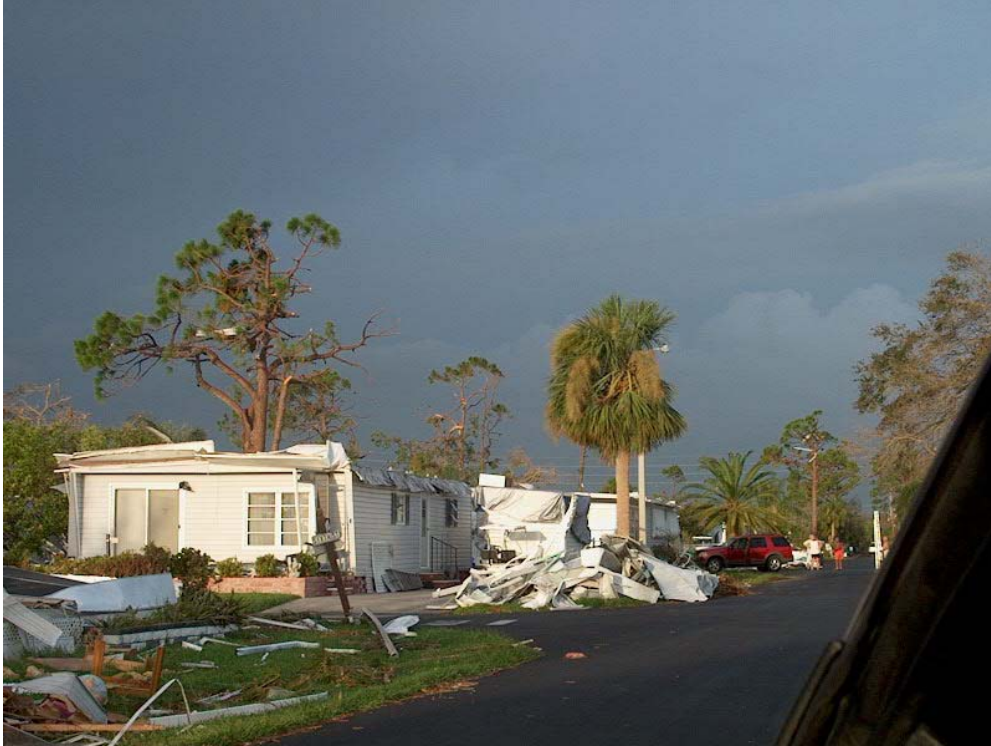
Figure 6.17: Failure of Roof System

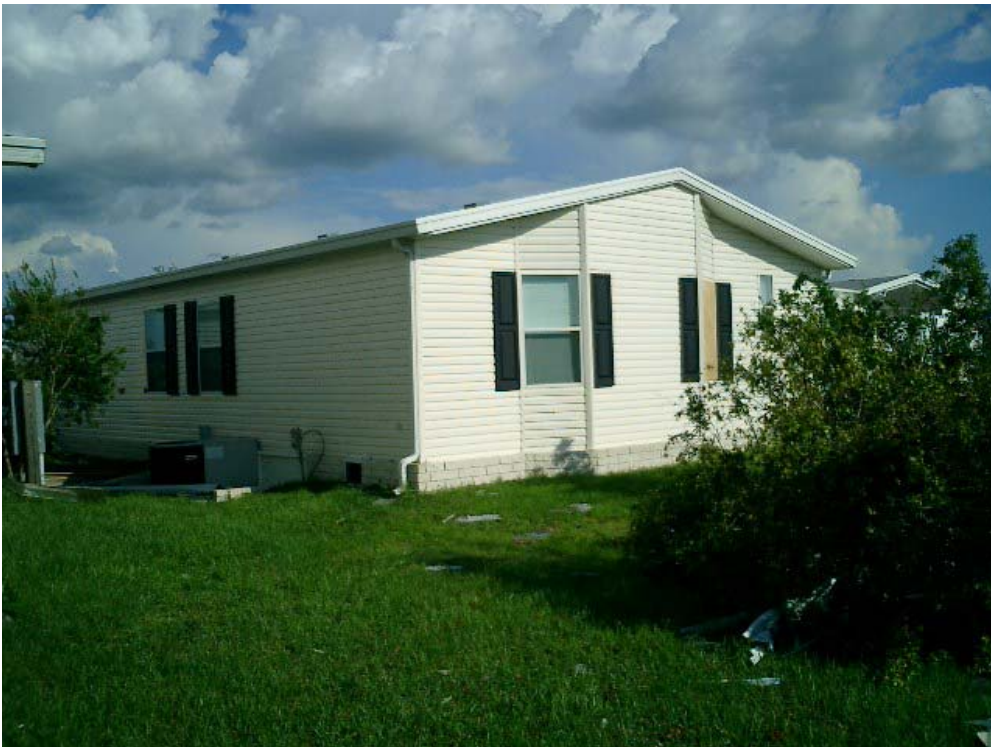
Figure 6.18: Manufactured Home Survived the Hurricane Wind Forces

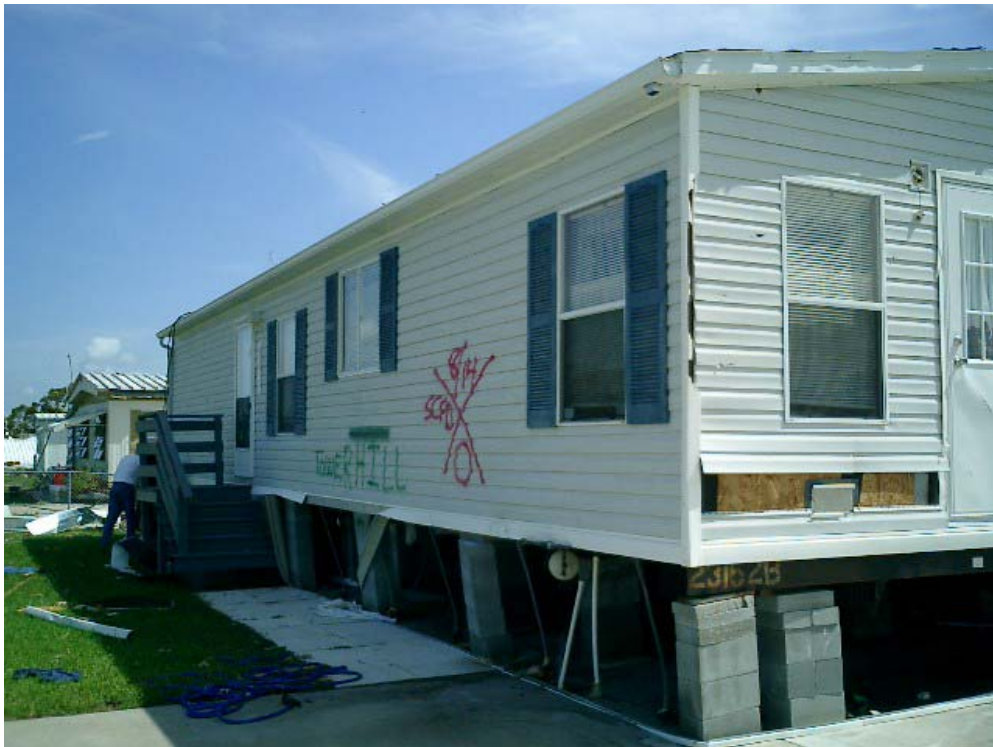
Figure 6.22: Manufactured Home Slightly Shifted from its Foundation

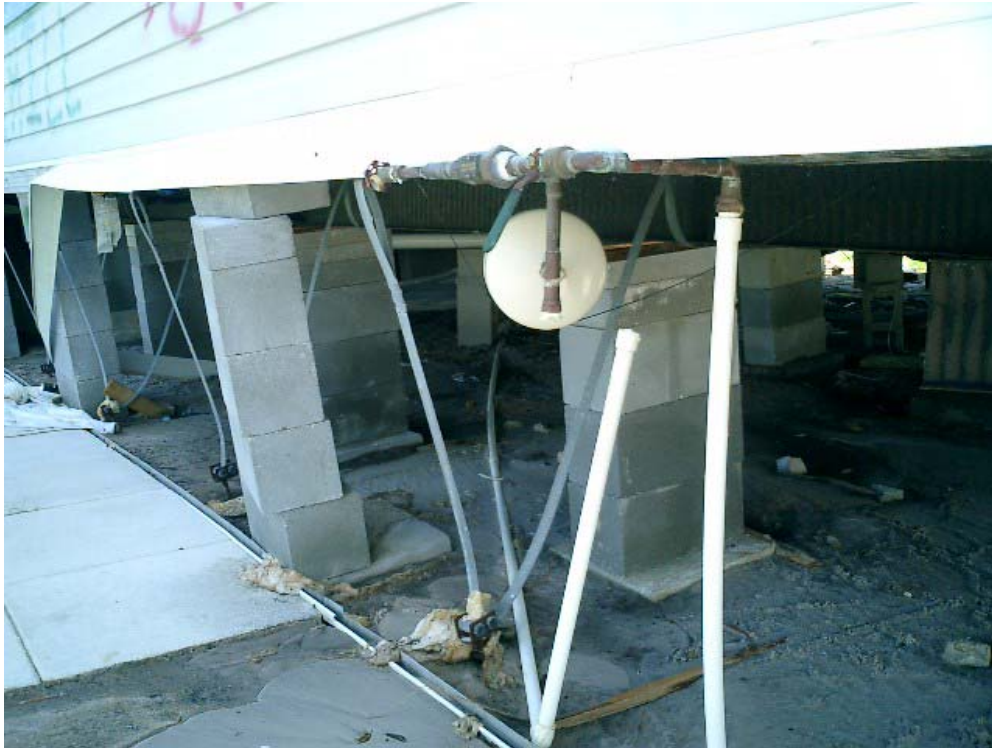
Figure 6.23: Manufactured Home Slightly Shifted from its Foundation

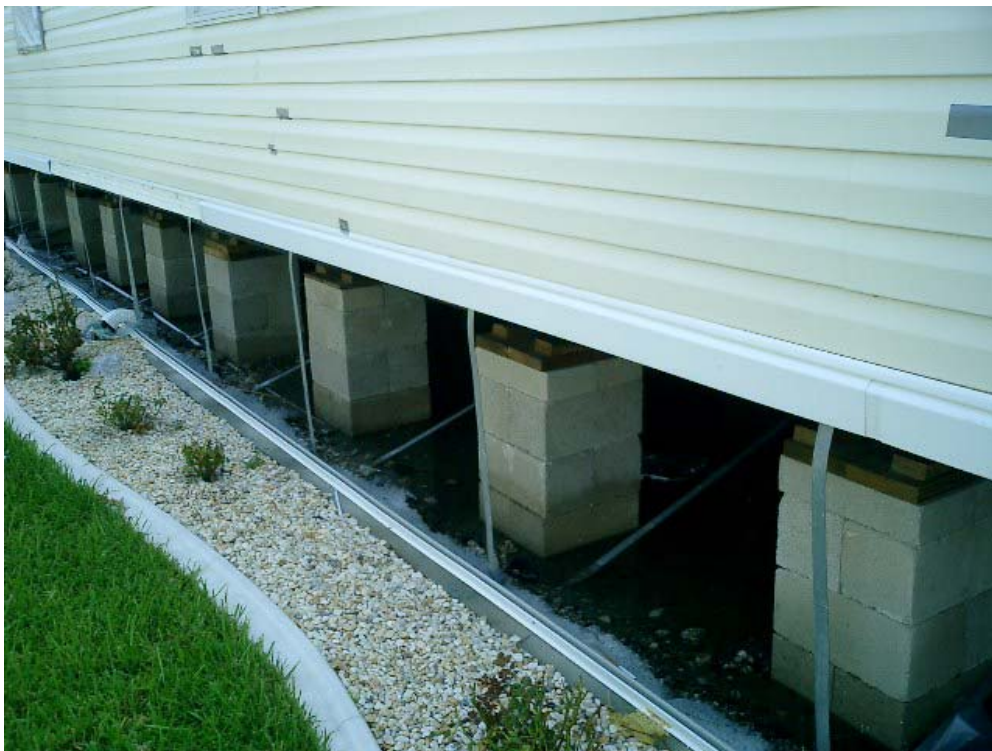
Figure 6.24: Manufactured Home Installed in Accordance with Florida Installation Law with Anchors at about 5 ft. on Center.

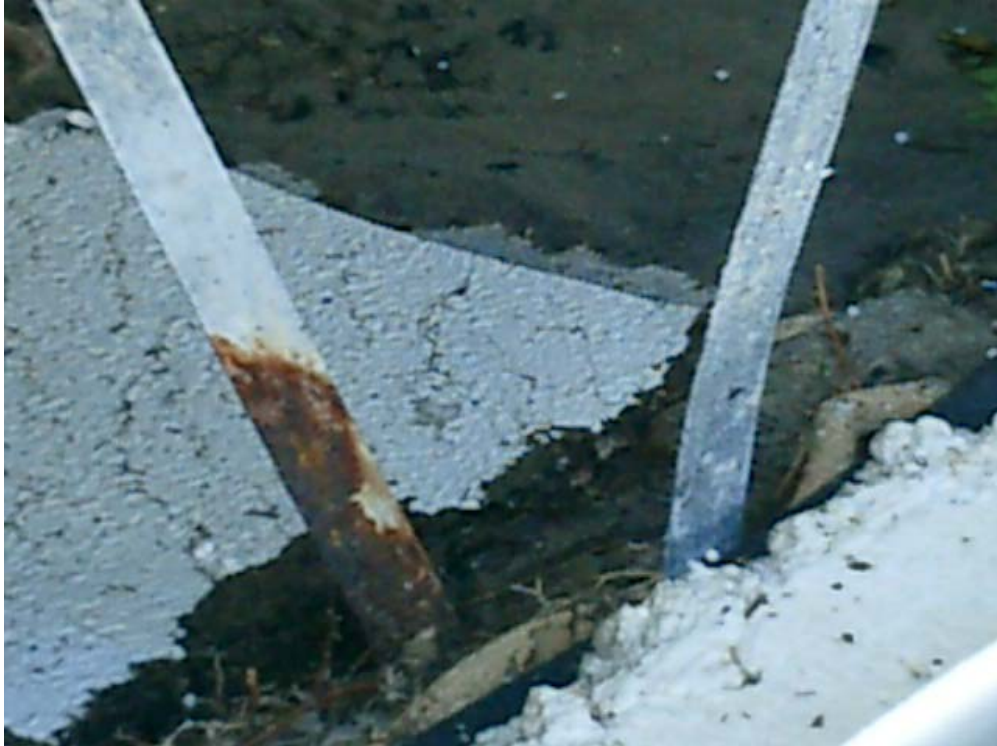
Figure 6.27: Corroded Ground Anchor Strap

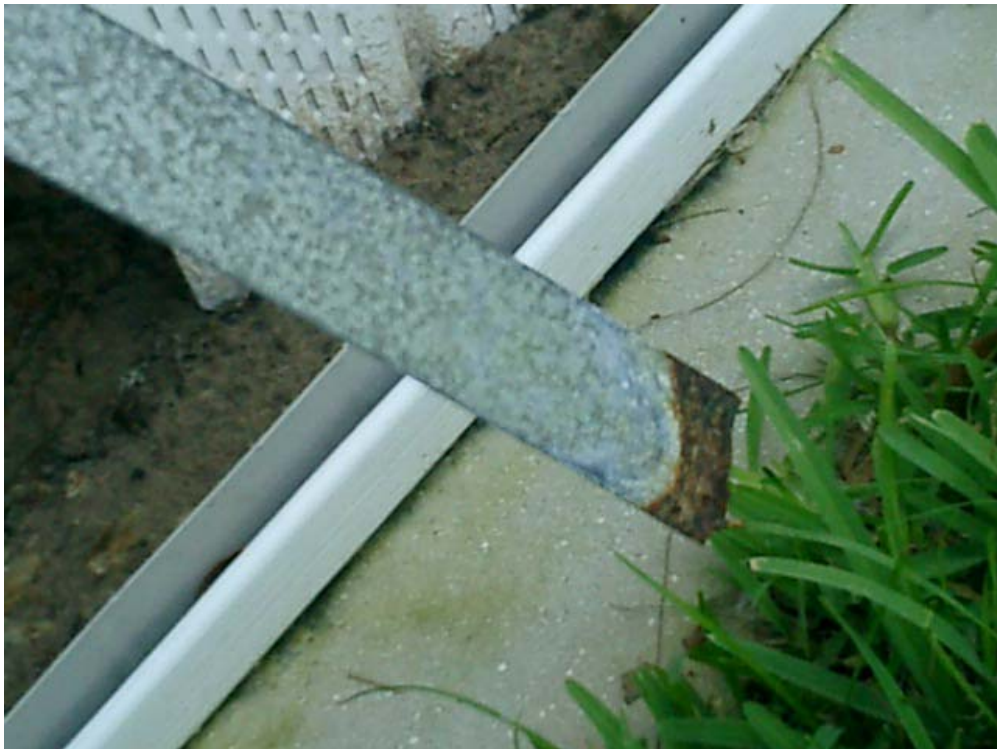
Figure 6.28: Corroded Ground Anchor Strap

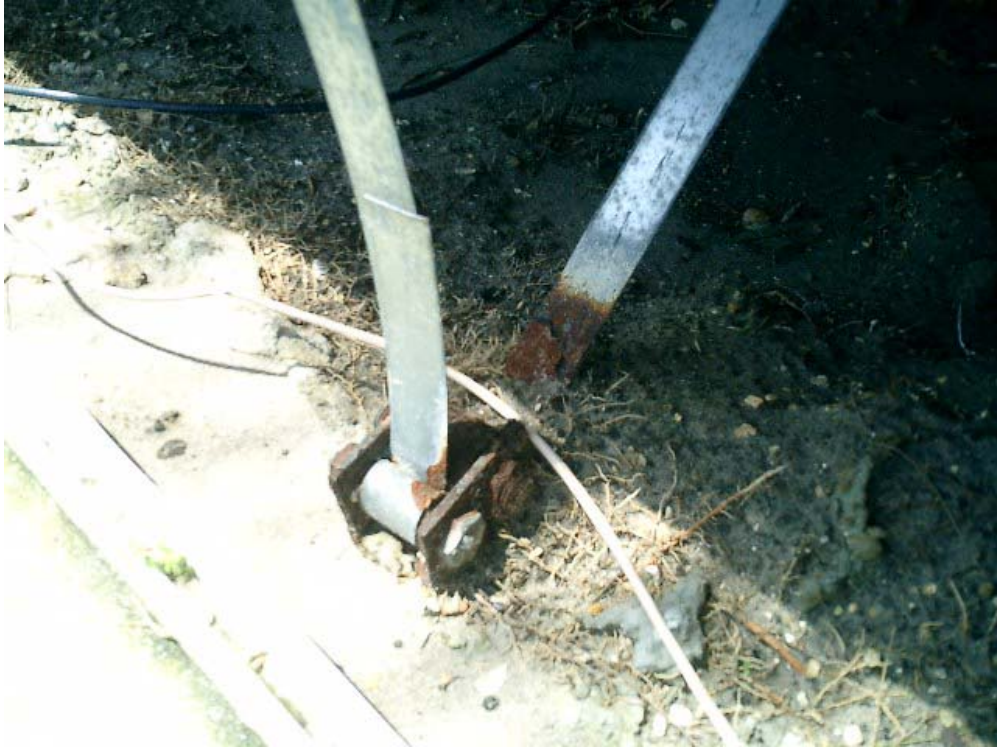
Figure 6.29: Corroded Ground Anchor Strap

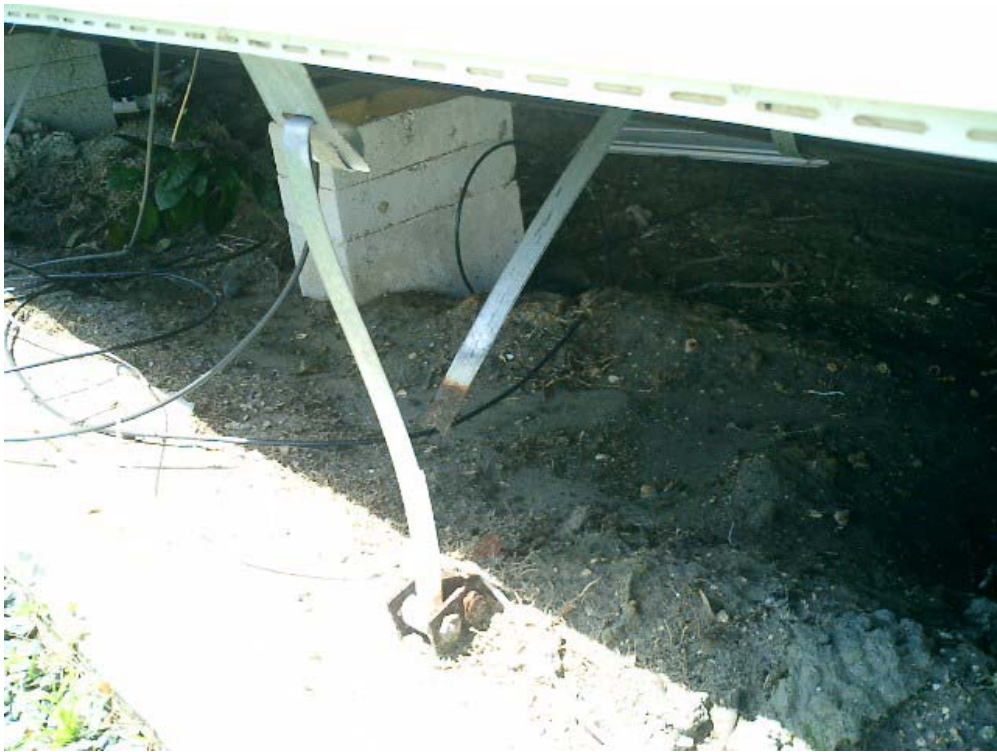
Figure 6.30: Corroded Ground Anchor Strap

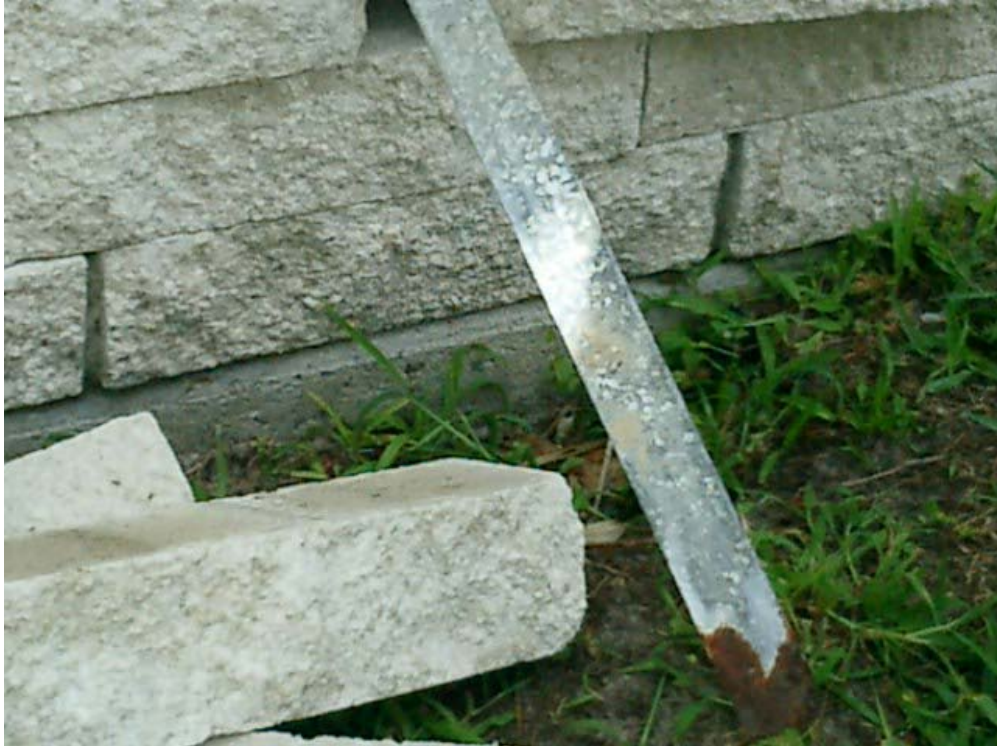
Figure 6.31: Corroded Ground Anchor Strap

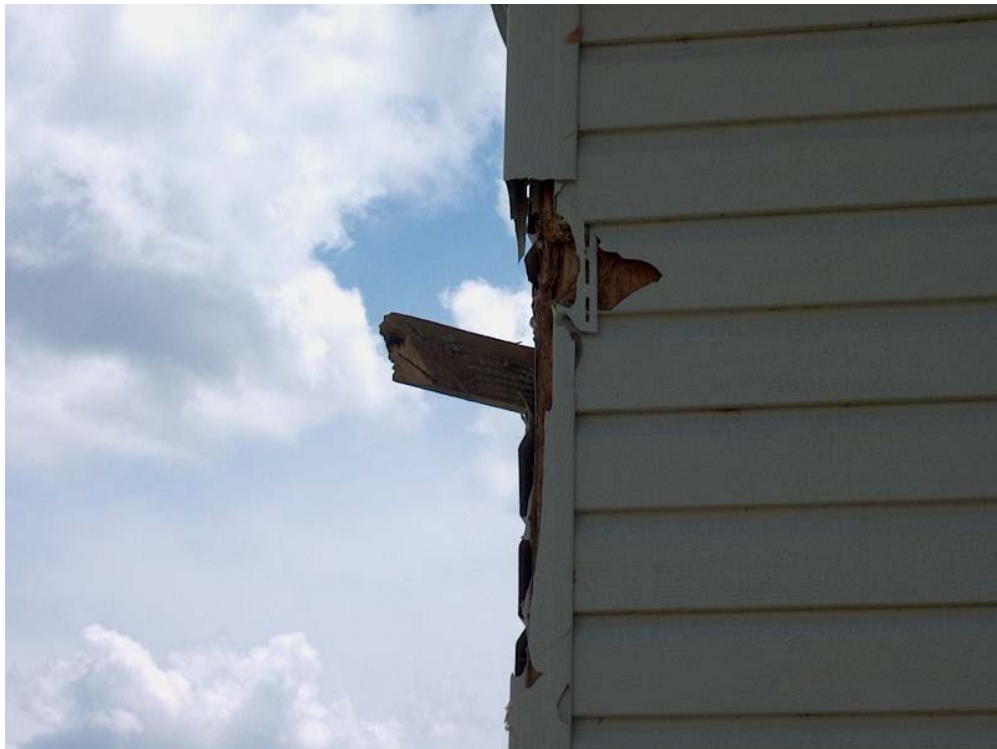
Figure 6.32: Damaged Corner Part of the Home

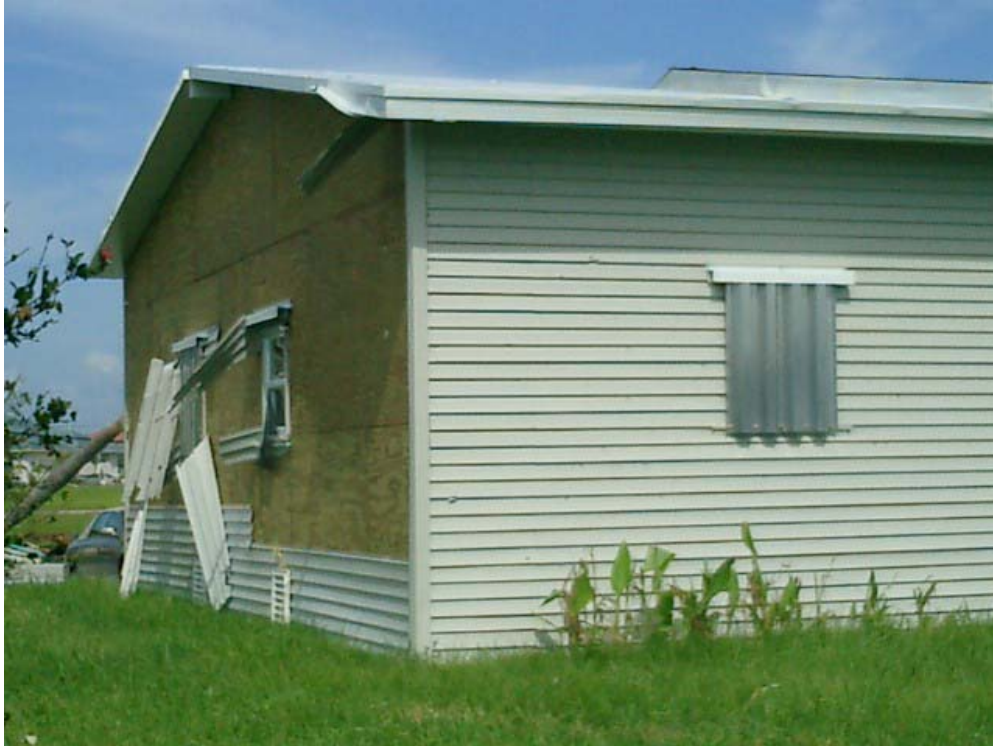
Figure 6.33: Damaged Endwall Siding

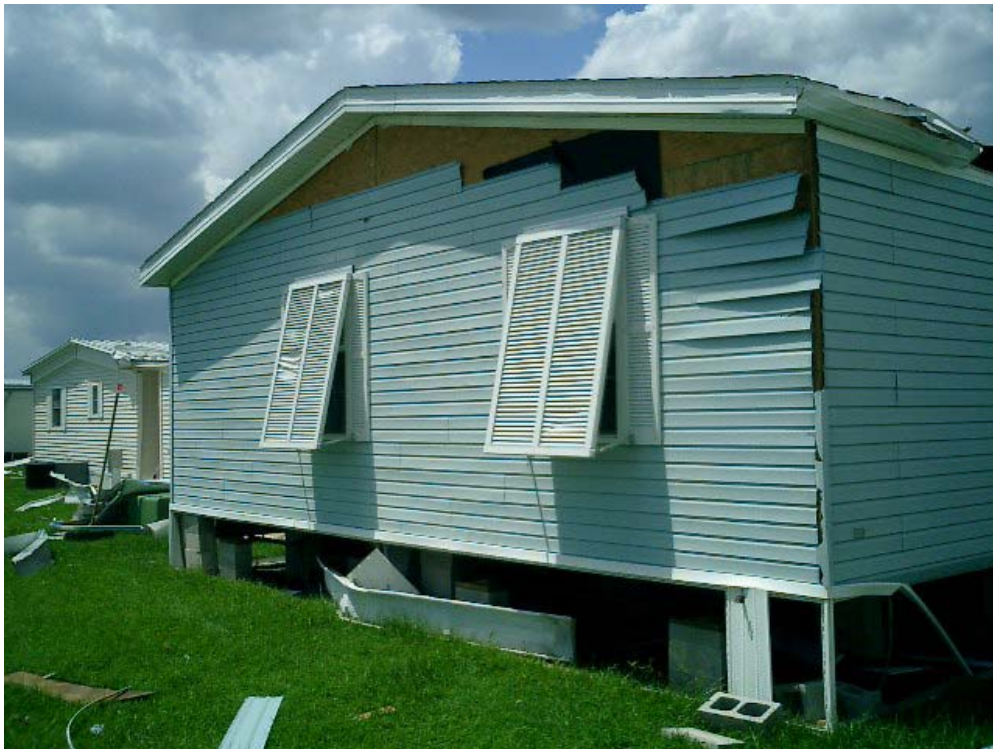
Figure 6.34: Damaged Endwall Siding

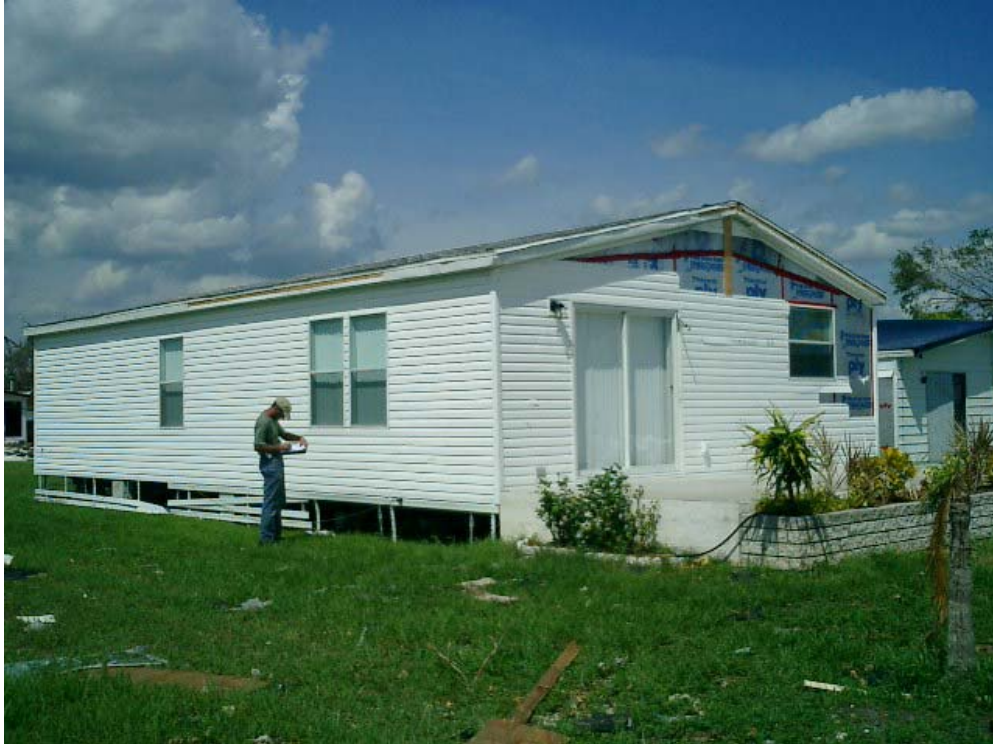
Figure 6.35: Damaged Endwall Siding

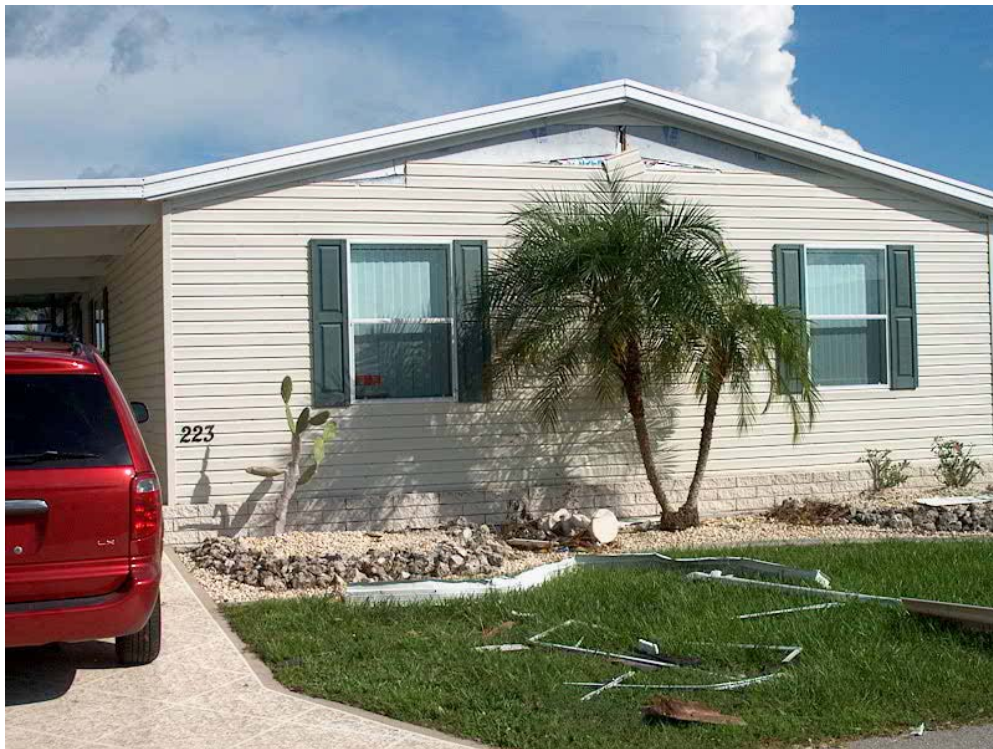
Figure 6.36: Damaged Endwall Siding

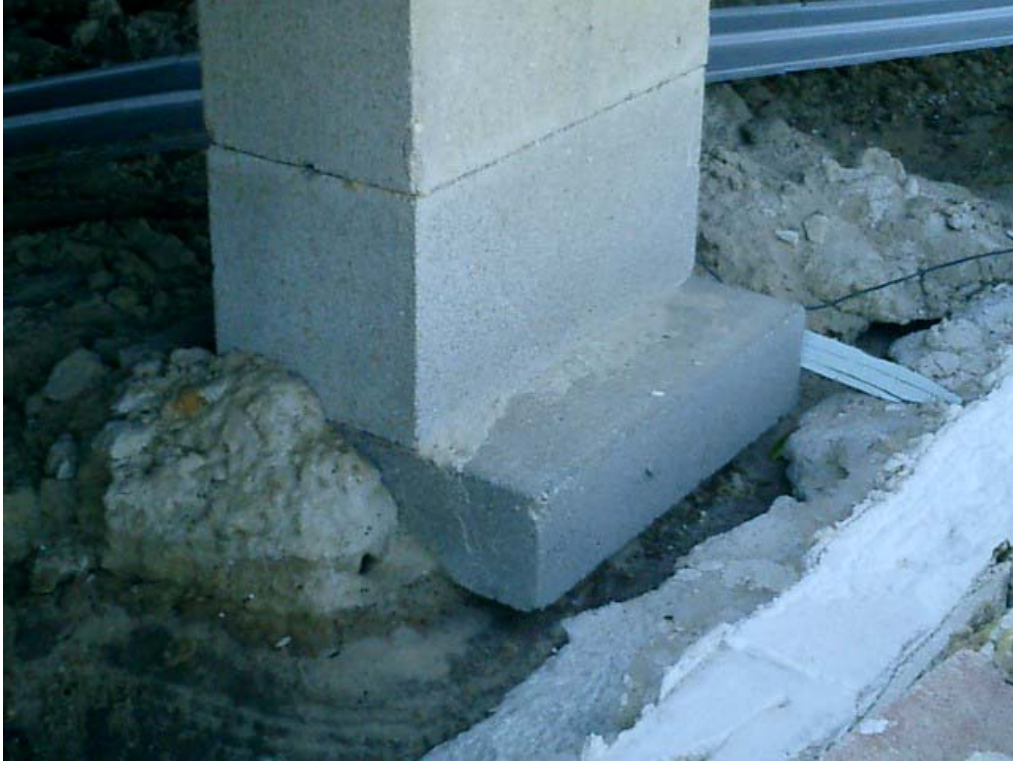
Figure 6.37: Scouring Action of Wind and Rain Water Runoff
