[Picture\(s\) of Kenwood - TS-830](#)

## **TS-830S Frequency Shift**

Service Bulletin no. 840 (14-4-1982)

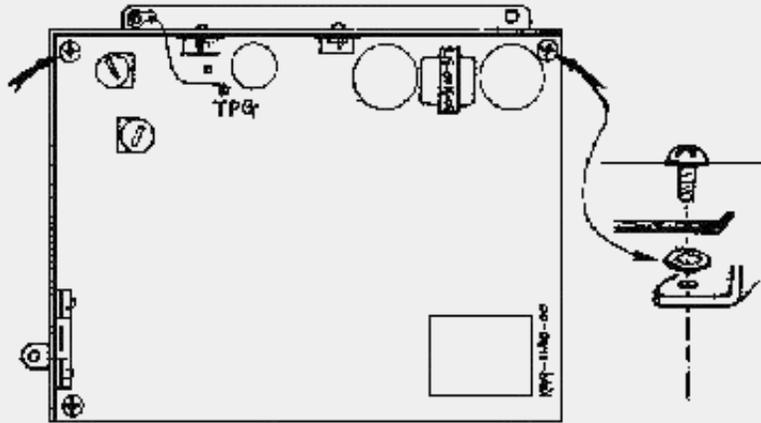
Some users may report an intermittent shift in the display and operating frequency. This may typically be a 1 to 4 kHz random shift. Cause will be a loose grounding screw on the AF/AVR unit heat sink.

On the AF/AVR unit X49-1140-00, there are three self-tapping screws holding the aluminum heat sink to the PCB. These also supply the ground connection to that section of the board. Between the heat sink and PCB foil, add a tooth-lockwasher N17-1030-41 at the two self-tapping screws on the side of the heatsink that has the two transistors attached. (The remaining screw already has a lock washer.)

When replacing the board to the chassis, add a solder lug E23-0420-05 to the heat sink mounting screw as shown, and tighten all screws for this board. Solder an insulated lead between the TPG (Test Point Ground) wrap post adjacent to C81, and the added solder lug.

1. Remove the top cover (8 screws) and unplug the speaker.
2. Remove the bottom cover (8 screws).
3. Remove 5 screws holding the AF/AVR unit and swing the board over. Leads do not have to be unplugged.
4. Add two tooth-lock washer as shown.
5. Replace the circuit board and heat sink to the chassis, adding the solder lug as shown.
6. Solder a jumper between the TPG wrap post and the added solder lug.
7. Replace the top and bottom covers.

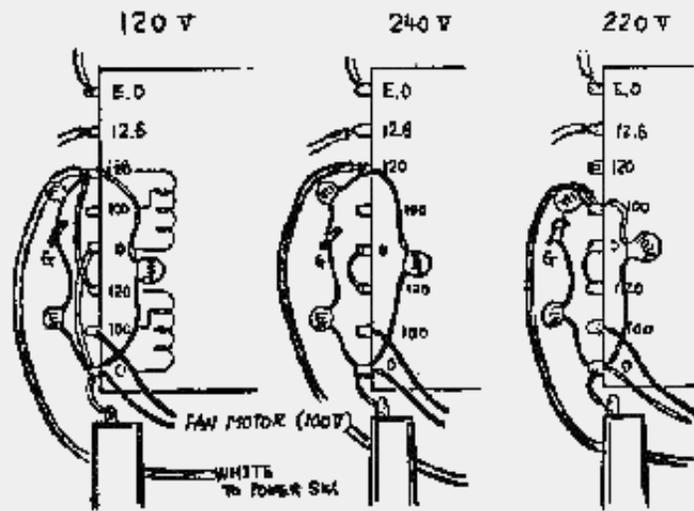
To operate the TS-830S on 240V AC, the power transformer split primaries must be rewired from parallel to series connection.

1. Unplug the AC power cable.
2. Remove the bottom cover.
3. Remove the jumper wires between the two  $\emptyset$  terminals and two 120 terminals on the bottom of the power transformer.
4. Connect the adjacent 120 and  $\emptyset$  terminals at the middle of the transformer. This will provide 240V AC operation.

For 220V AC operation, connect the adjacent 100 to  $\emptyset$  winding.

5. Change the AC fuse from 6A to 4A. Tag the power cord at the back of the radio to indicate that the transformer is strapped for 240V AC, and the power fuse should be 4A, and not 6A.
6. Replace the bottom cover and reconnect power to verify your work.

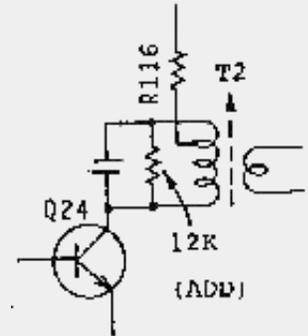
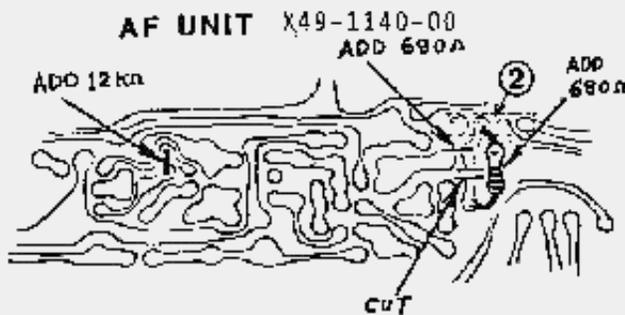
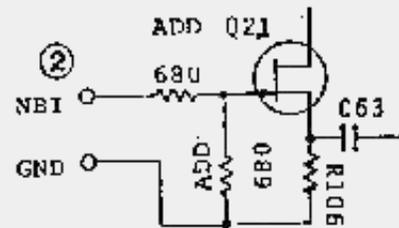
Receiver Cross-modulation while using the noise blanker may be improved by these optional component changes and additions. Realignment is not required.

Across T2, (Fig. 1) add a 12 Kohm (RD14CB2E123J)\*

At Q21 (Fig. 2,3) add 2 pcs. 680 ohm (RD14CB2E681J) \*

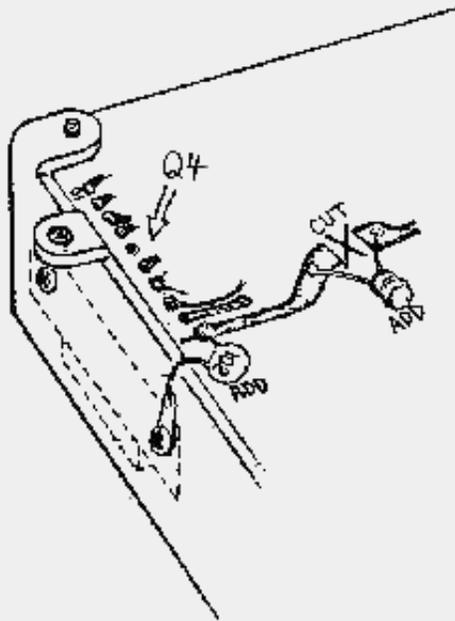
Transmitter "talkback", either with or without a linear amplifier, may be eliminated by adding a filter at

the receiver audio power amplifier.

On the AF unit X49-1140-00 at Q4, cut the 12V DC B+ line between R47 and C28, and add a 1uH choke (L40-1092-02) in-line. Add a .01uF cap (C52-1710-36) from the IC pin 1 to ground, as shown using a 3 mm lug (E23-0015-04) under the IC mounting screw on the Heat Sink.
