Software Update 2009-2

Release Notes

These are the Release Notes for the July 2009 release of GreenStar™ 2 Display 2600 software version 2.4.1156, GreenStar 2 Display 1800 software version 2.0.705, and the Original GreenStar display software version 1.97B.

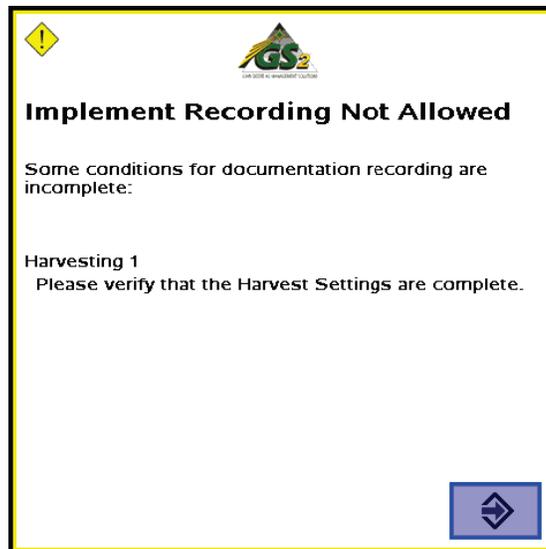
“Implement Recording not allowed” message needs to be more specific

Previous Software: If task operation information (harvest, product application, etc.) is not complete an “implement recording not allowed” message will appear. The message provides little information as to what is incomplete or needs to be entered.

Software Update 2009-2: A message, similar to the one below, will inform the operator if the task operation information is not complete.

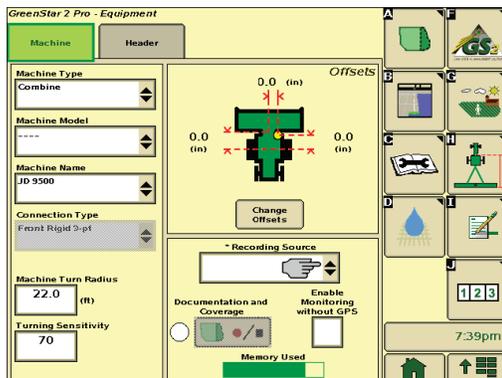
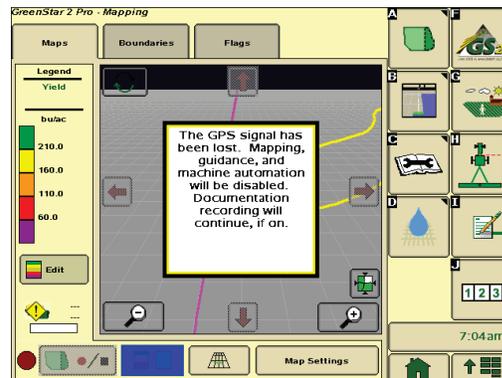
"Enable Monitoring without GPS" is no longer available - In previous software, an operator could choose to monitor operational information without the use of a GPS receiver. The ability to select this item has been removed. In current software, the GS2 2600 display will now document information with or without the use of a GPS receiver. It will use the wheel speed and implement width to perform calculations.

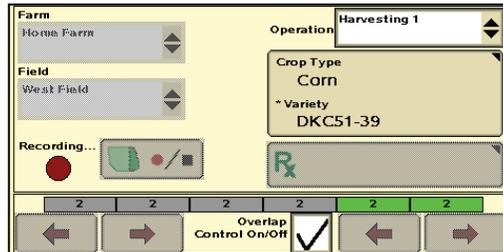
“Overlap Control Disabled” warning turns off Overlap Control - Following an “Overlap Control Disabled” warning message, the Overlap Control check box will become unchecked, turning it off. To enable Overlap Control, the check box can be located and turned back on via *GreenStar 2 Pro* >> *Softkey “H” (Equipment)* >> *Header Tab* >> *Overlap Control On/Off check box*. To more quickly identify if Overlap Control is enabled, it may be configured on one of your run pages.
