The Grapevine Hill Fault - A New Fault Discovered During Preliminary Geotechnical Exploration For Route Construction

Route US 50, Osage County
Missouri

Presented to the 50th Annual Meeting of the American Institute of Professional Geologists

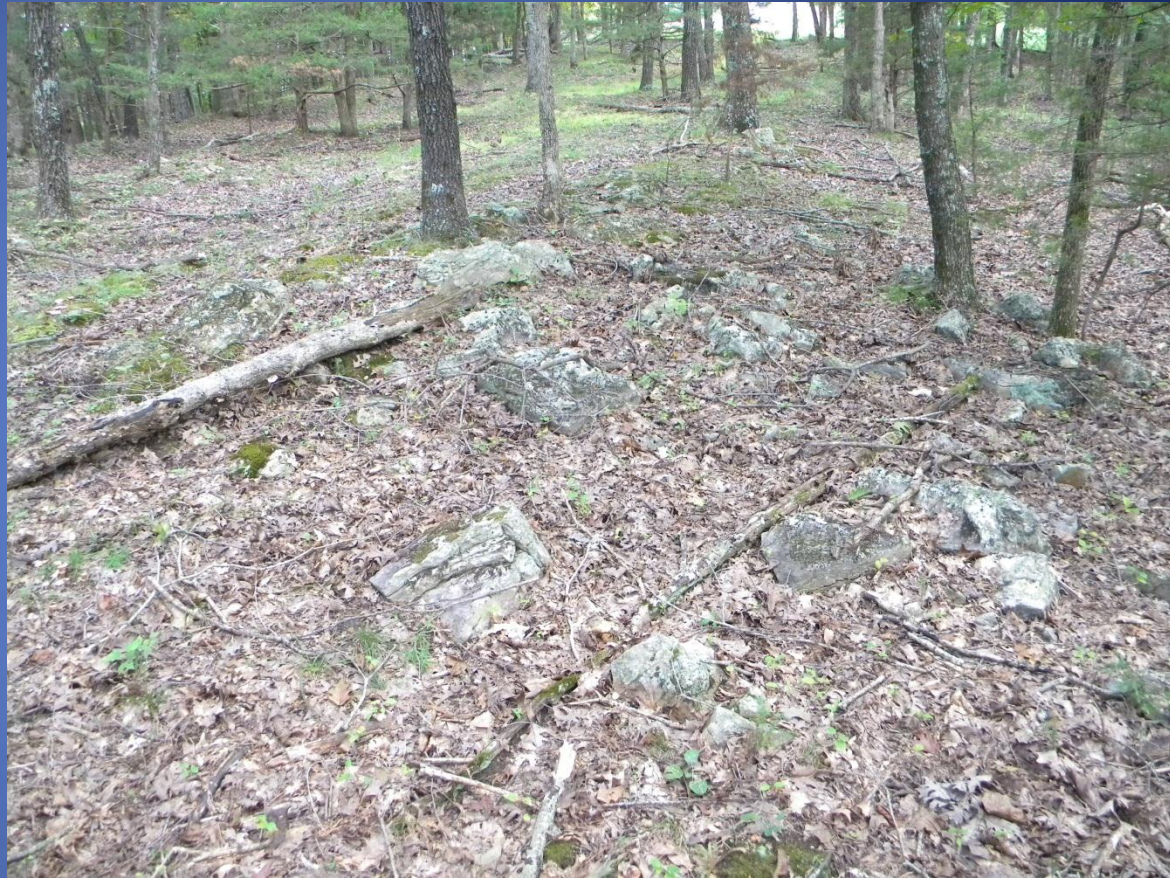
“Filled-sink” structures are known to occur in the survey area. Some are mined for refractory clay. This particular sink occurs on Grapevine Hill, and is unique in that it possesses quaquaversal bedding dipping towards the center.

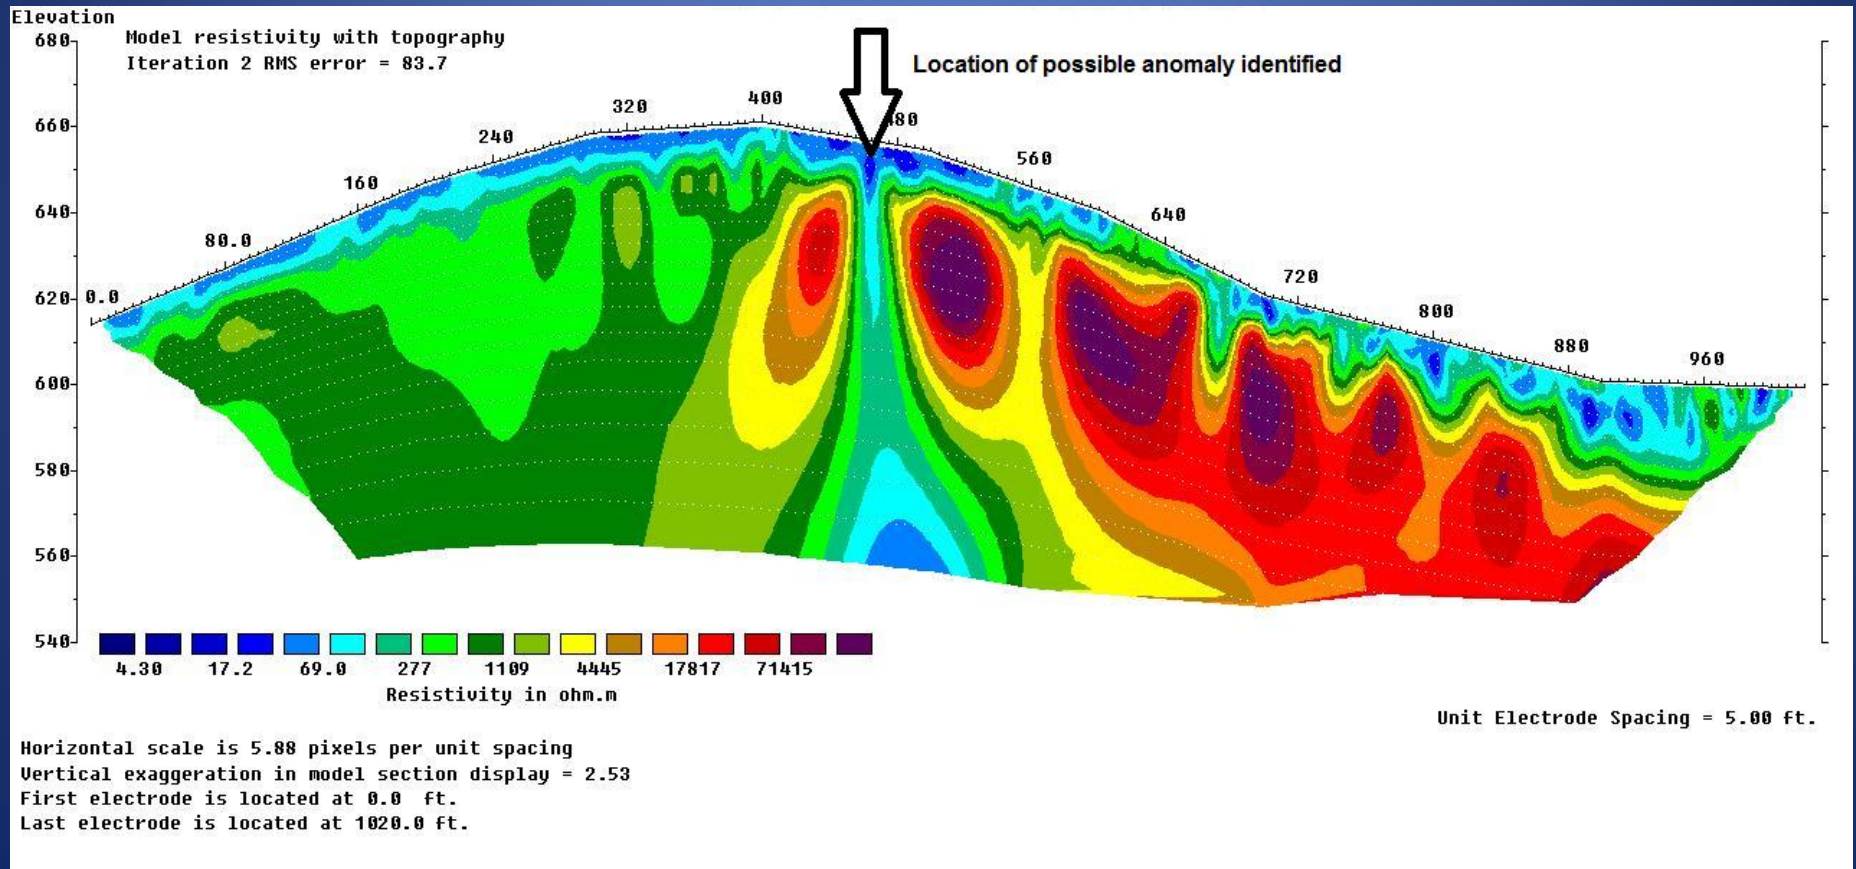
Grapevine Hill Traverse Locates possible anomaly

Grapevine Hill was the most important location

- Adjacent bridge would possibly be affected by any negative rock feature.
- Approximately eighty feet of cut adjacent to two lanes of highway would be exposed.
 - Depending upon the feature, rockfall could be disastrous at this location, requiring expensive mitigation or redesign of the roadway.

1. The anomaly may be interpreted as a 'filled-sink' structure
 - favored since filled-sink already found on Grapevine Hill.
2. The anomaly may be interpreted as another structural feature.
 - Thus, the first task was to prove or disprove the first hypothesis so that it could be validated or rejected.*

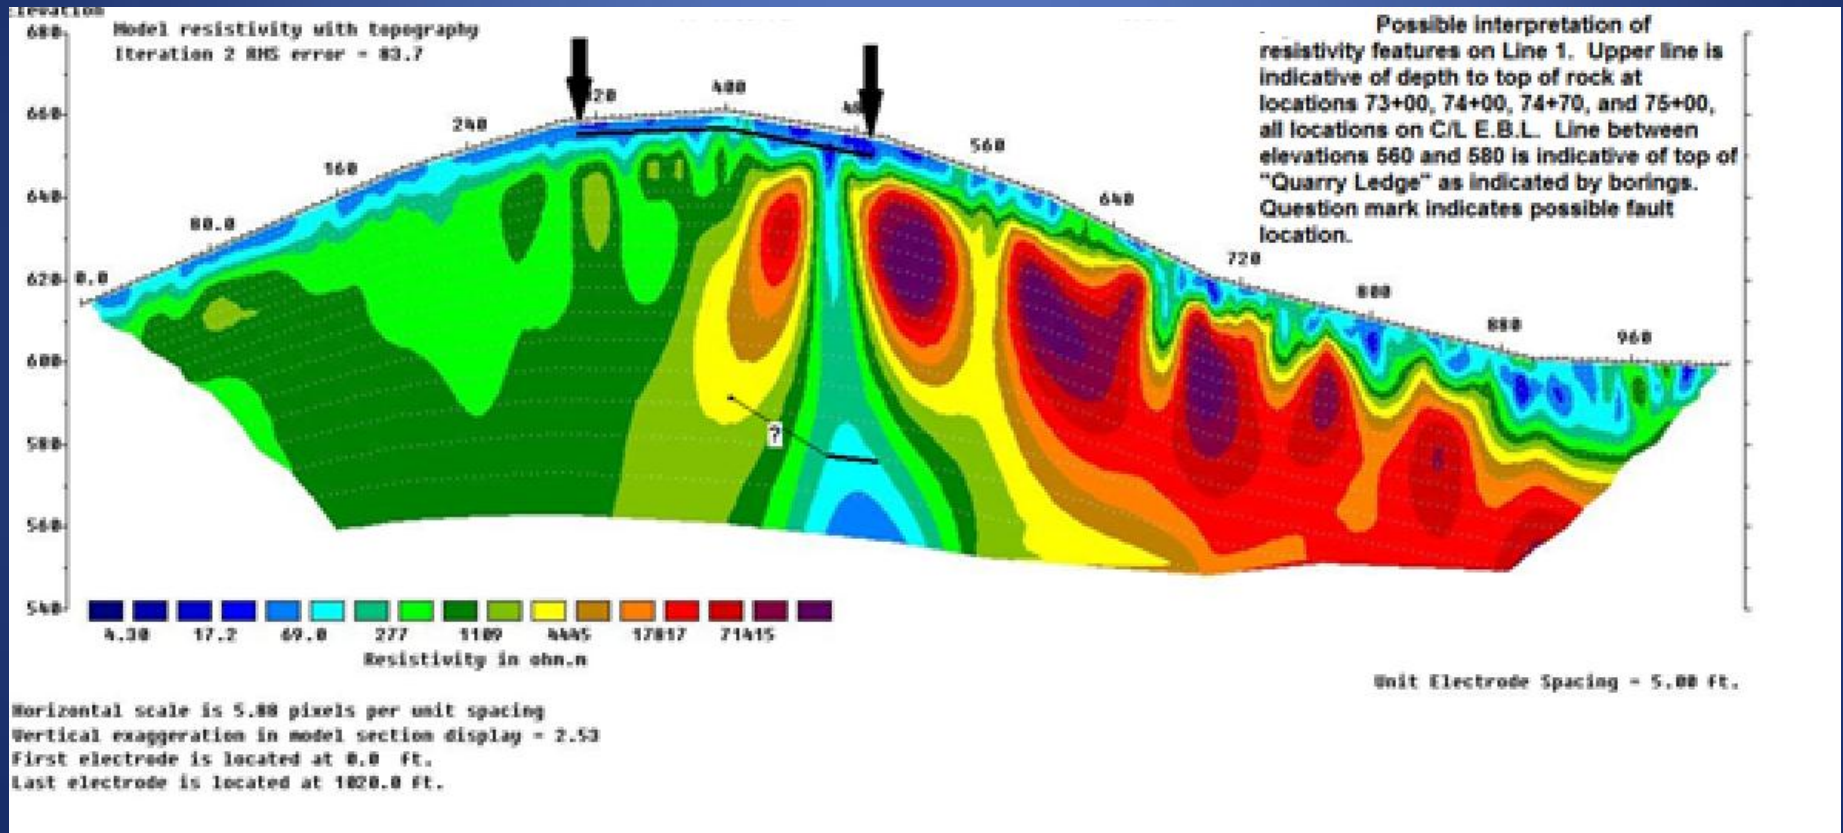
The Interpretation

What's this? A 10-FOOT DIFFERENCE?

Strike and dip of the rock units is nearly level.

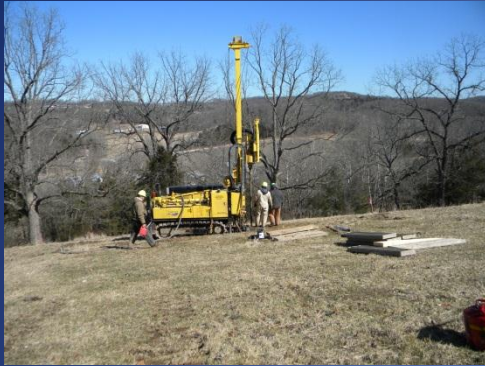
VERIFIED!

Drilling the feature
in 2010

The Grapevine Hill Fault
Exposed during construction 2013

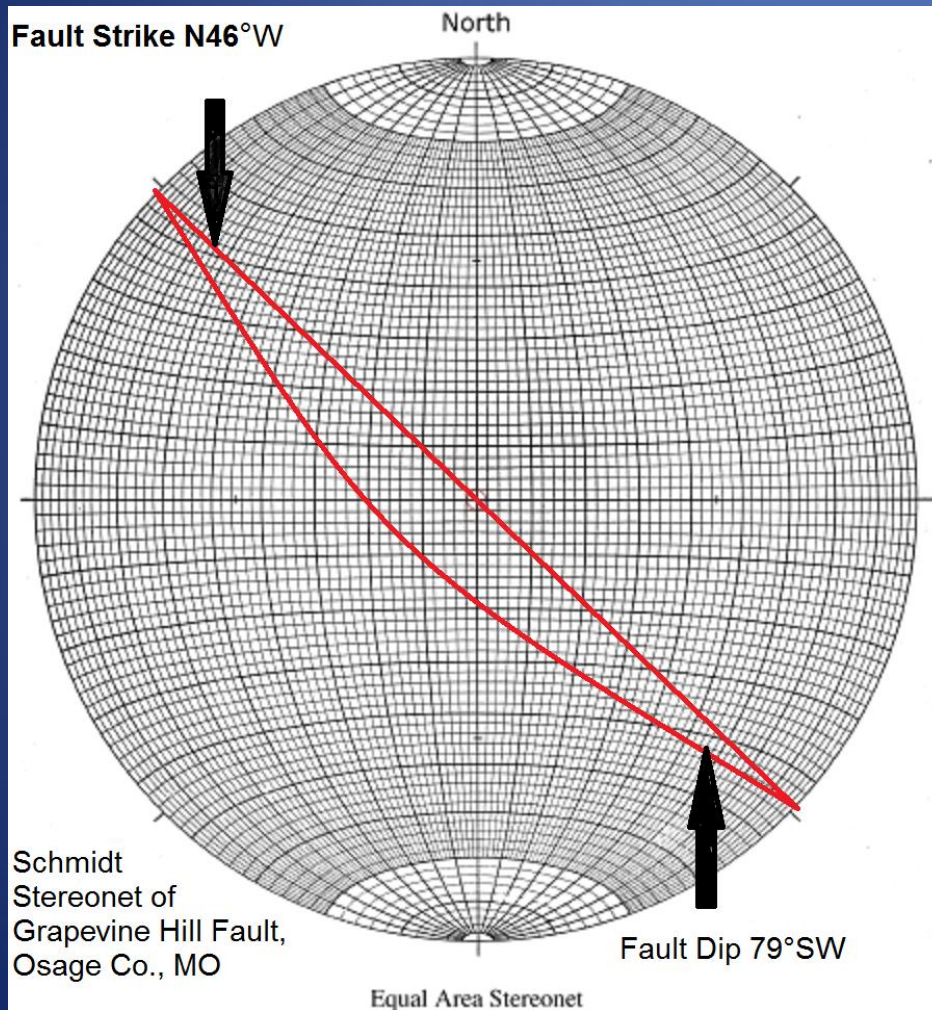
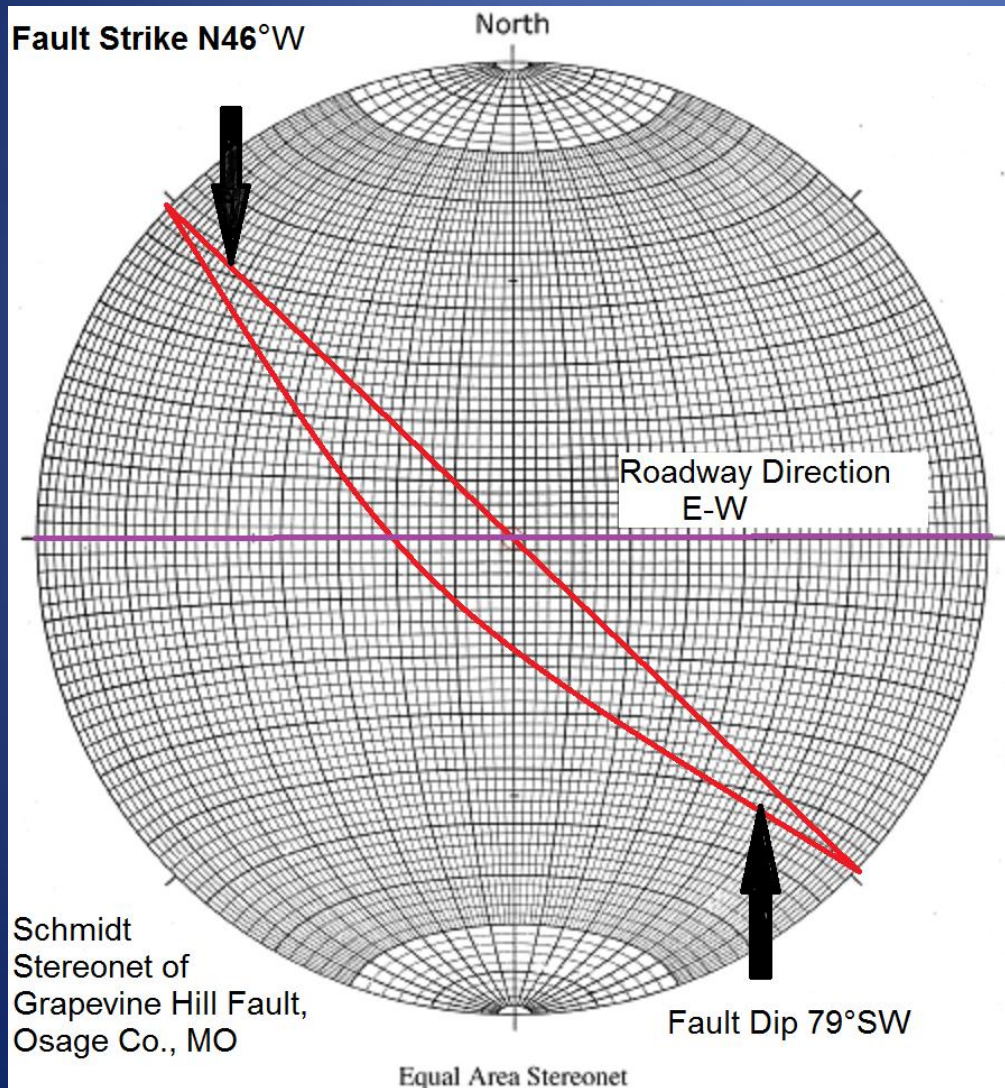
Equal-Area Stereonet Projection

Analysis indicates no problem.

- The dip of the fault doesn't 'daylight' to the north where the cut is, so we anticipate few problems, if any.
