The Olympia 465

A Brief History by Mark Wills.

A brief history of the EoN Olympia 465.

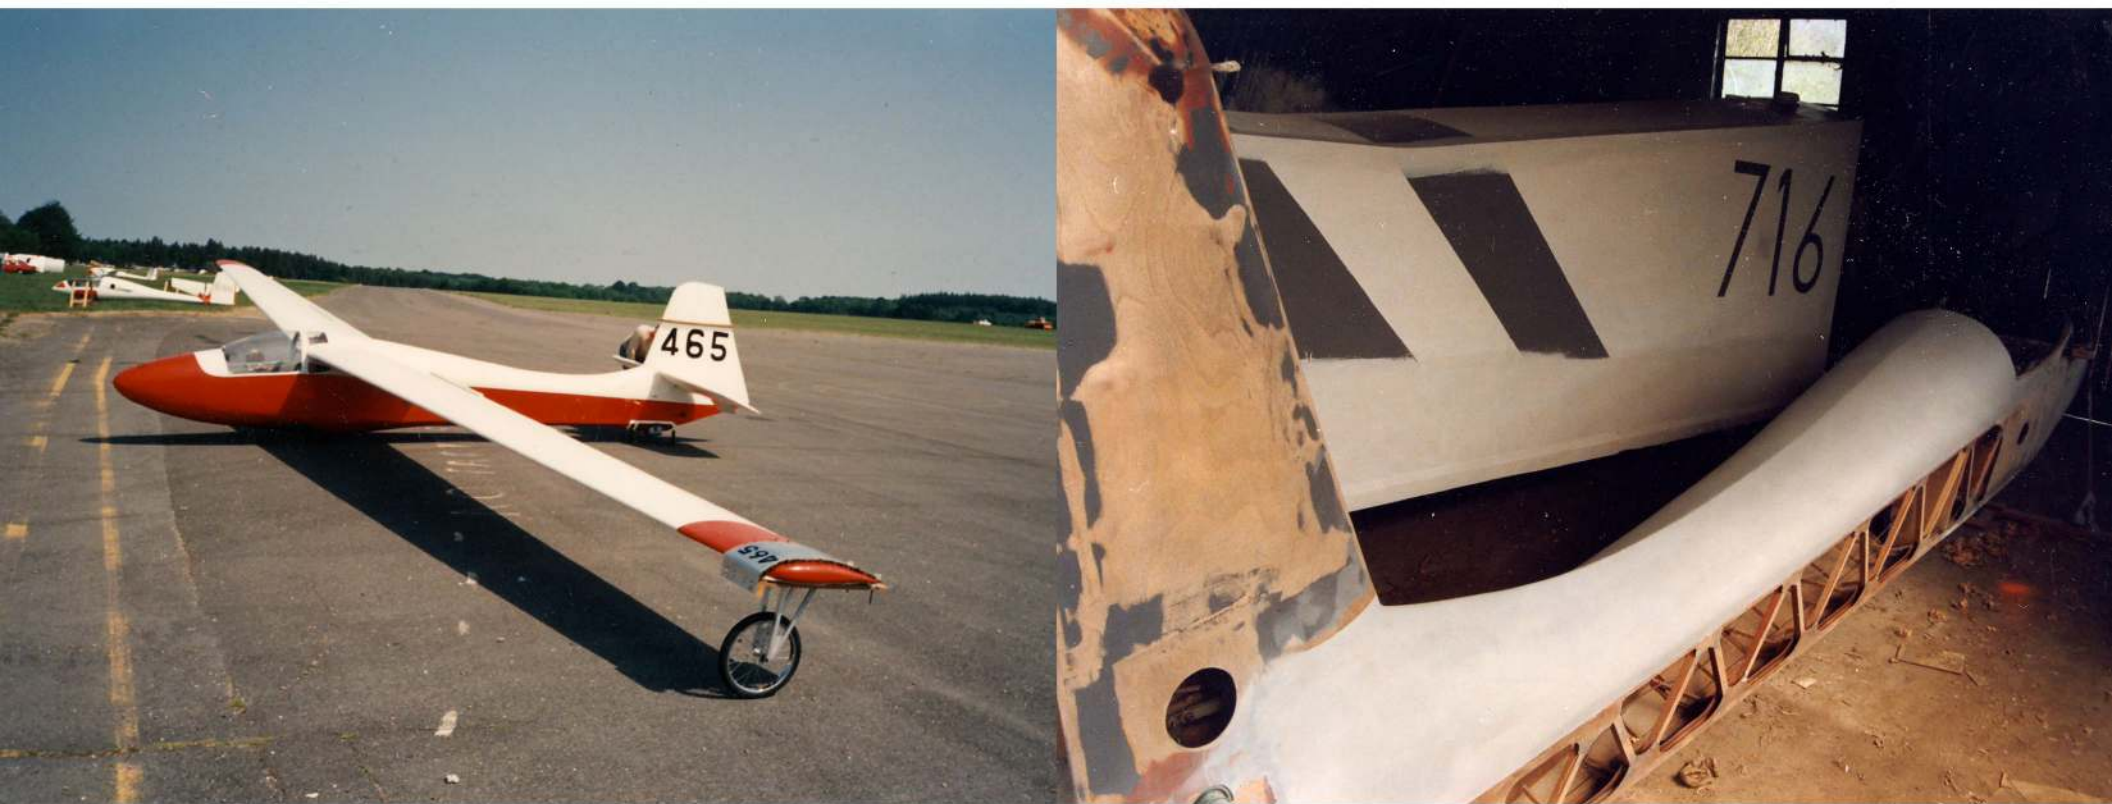
Left photo shows the 465 2 at Lasham shortly after it was purchased by Keith and myself. Note the transparent fairing in the centre section fairing. The glider was in very tatty condition. Right photo shows the fuselage stripped of fabric and filled ready for re covering.

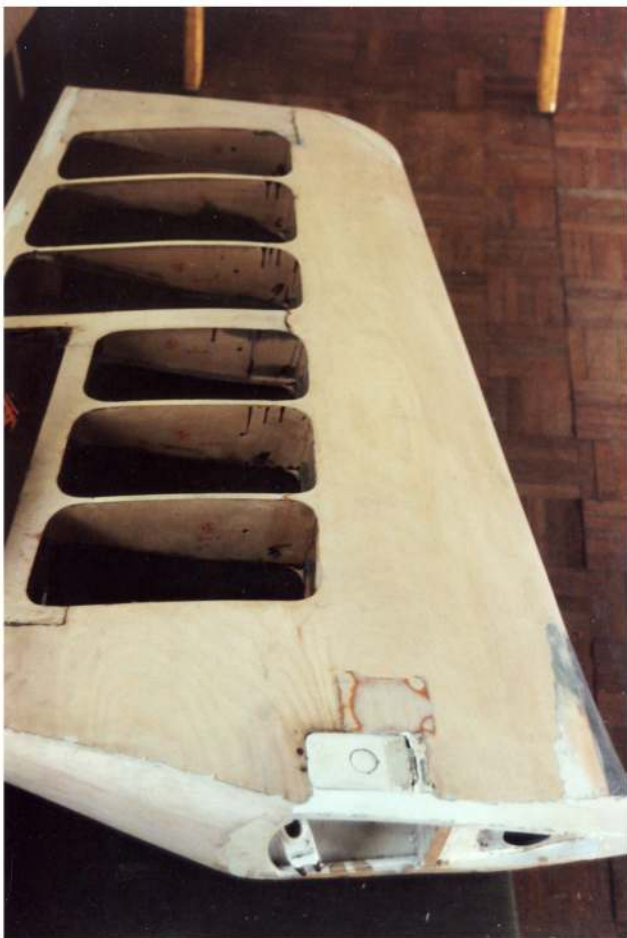
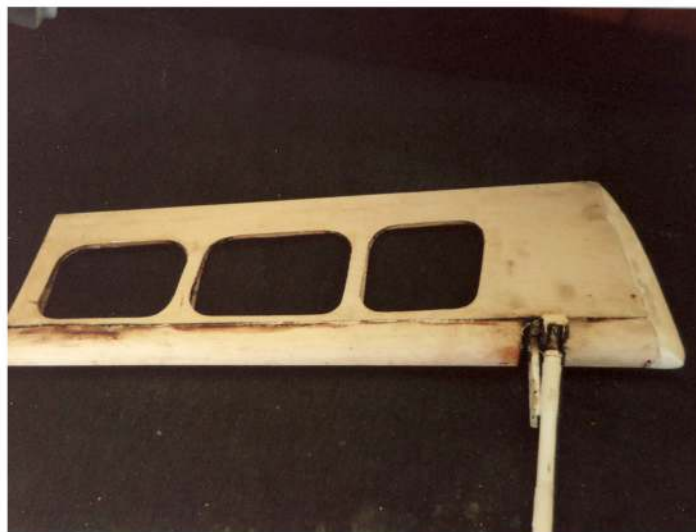
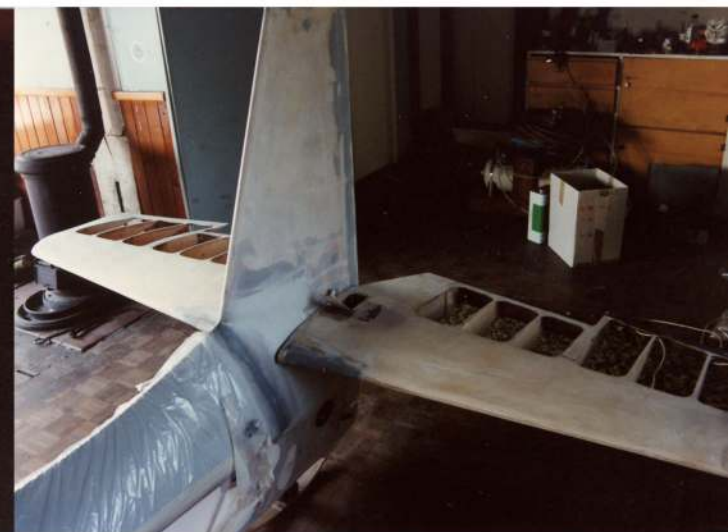
Left to Right. Port tailplane uncovered showing large lead balance weight in root of leading edge. One of the very large anti balance trim tabs. The uncovered tailplane half's in position.

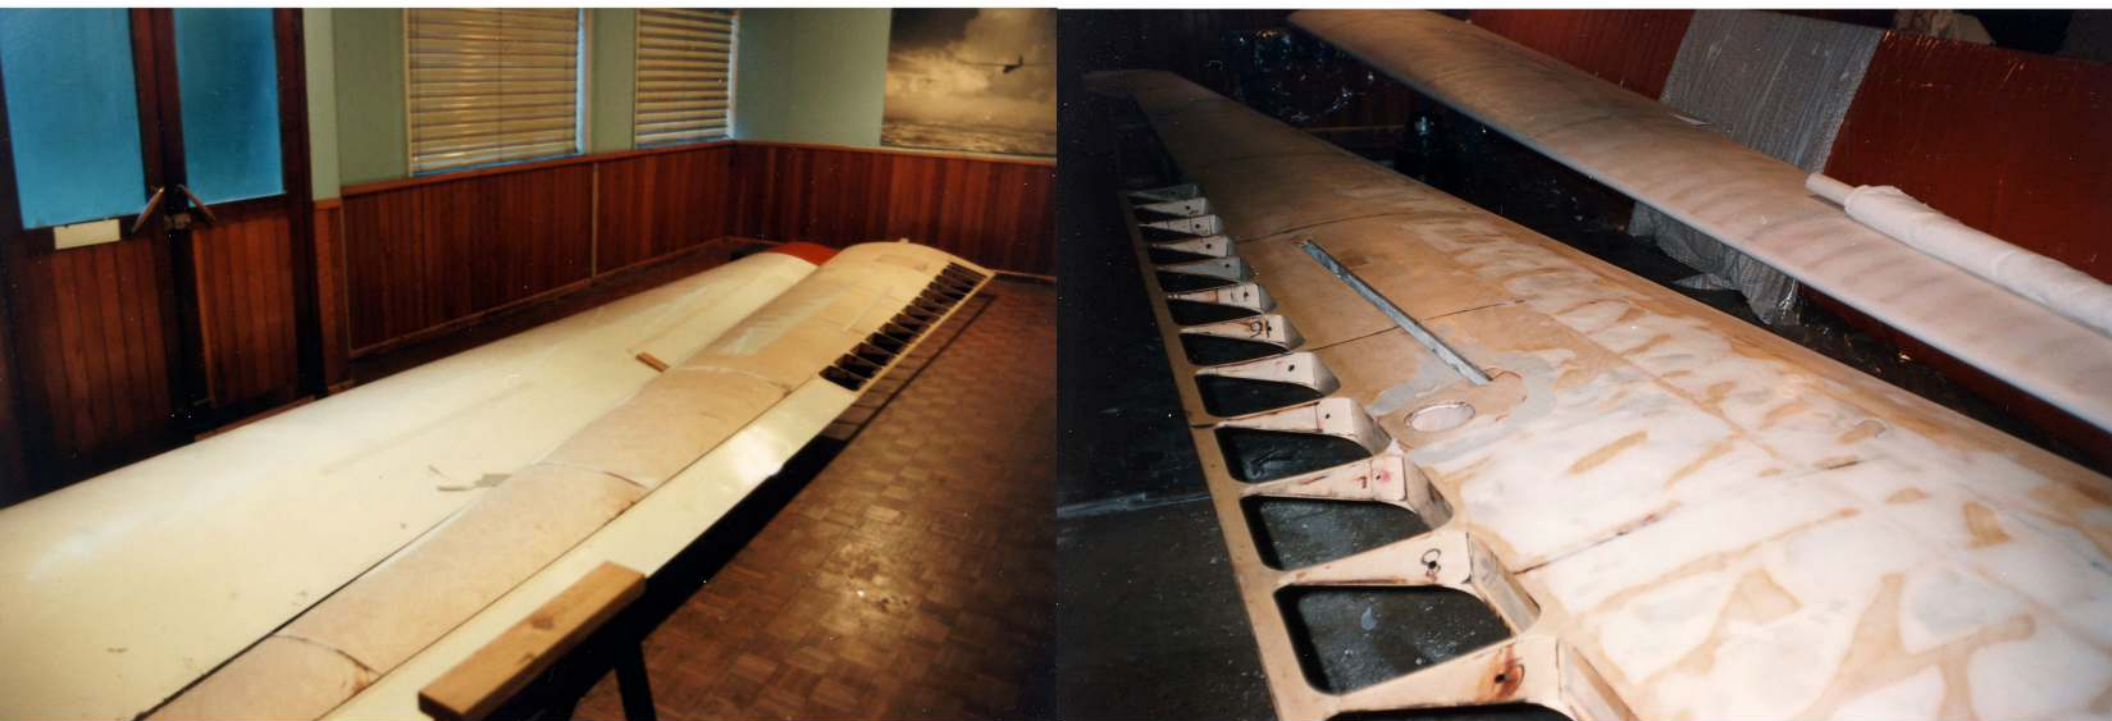
Left the wings in the process of being stripped of old fabric. Some re profiling under the leading edges was found, near the wing root. Right the white areas are micro balloon and epoxy resin filler to remove the rippling of the 1.5mm ply between the ribs.

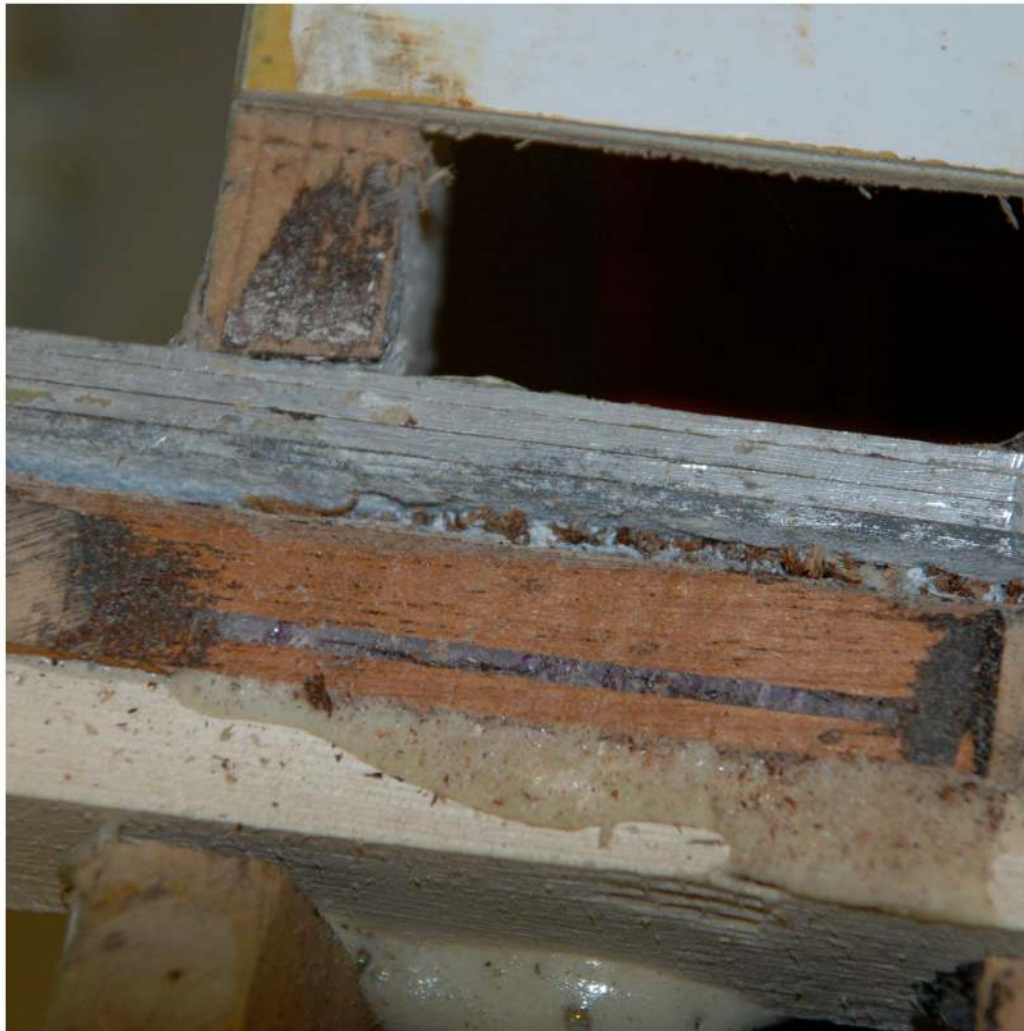
The Photo's and descriptions in this book include a range of pictures from the full restoration which was undertaken in the 80's by Keith Green and myself. The aircraft is now un-airworthy due to corrosion in the aluminium parts of the main spar. This problem was not known about until after the restoration.
Mark Wills.

The reason for the gliders downfall. The thin white line between the metal and mahogany sections of the main spar is anaerobic inter-granular corrosion. This problem was discovered after a fatal accident to a 463. The corrosion on the 465 was worse than the glider which broke up. This is un economical to repair.
