COMPLETION REPORT

**TRANSUCER CALIBRATION  
PLATFORM (TCP) MOORING  
NAVAL UNDERWATER SYSTEMS CENTER,  
SENECA LAKE DETACHMENT  
DRESDEN, NEW YORK**

Completion Report for Transducer Calibration Platform (TCP) Mooring Naval Underwater Systems Center, Seneca Lake Detachment Dresden, New York.

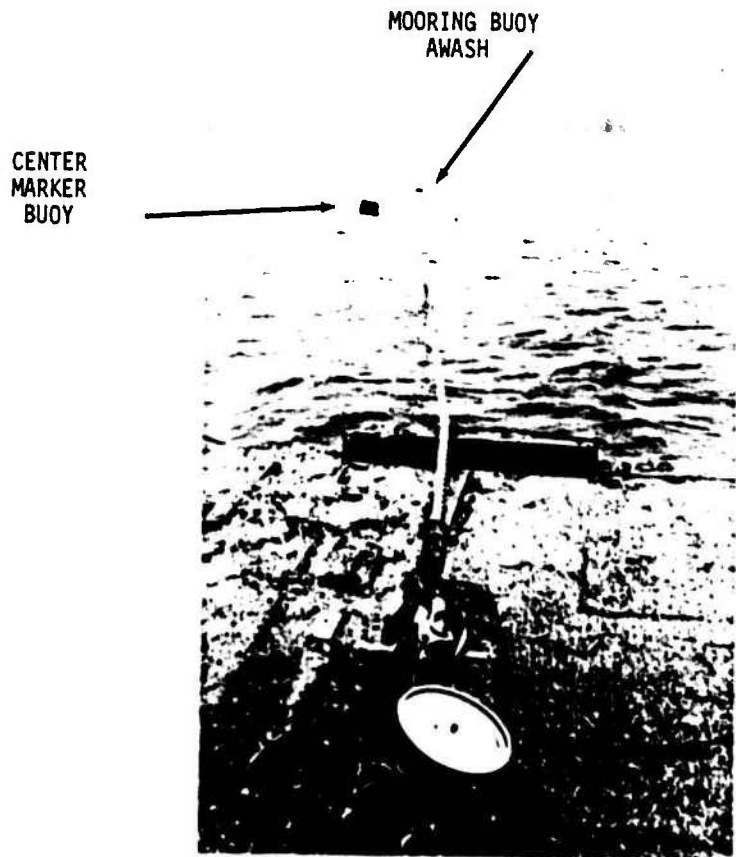
**FIGURE 30**  
**BUOY RESPONSE AT SPECIFIED**  
**LOAD OF 30,000 LBS**

Before applying the full test load of 30,000 pounds, a tension of 6,000 pounds was applied to the buoys to determine the barge and buoy positions under load. While the mooring lines were in tension, fixes were taken on references ashore. During this phase of the testing, it was determined that the northeast buoy's mooring line was 85 feet short of the on-deck connection. This discrepancy was corrected as described in paragraph 4.2 below.

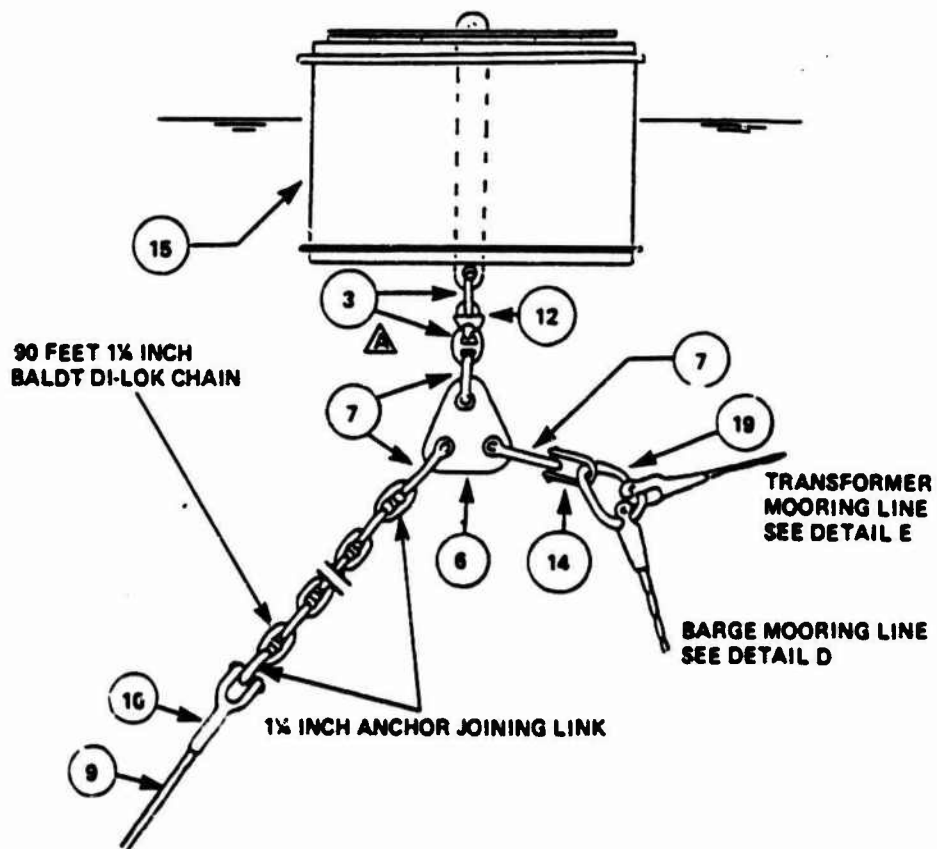
FIGURE 31

However, due to the northeast mooring being an estimated 85 feet short, the contractor was instructed to add one shot (90 feet) of 1 1/4-inch Baldt D1-Lok chain between the towing plate and the open swage fitting on the buoy end of the 1,100-foot length of riser wire (see Figure 31 and Detail G of the "as-built" drawing).

"AS BUILT" DETAIL SKETCH  
OF MOORING BUOY LEG NO. 2
