USE OF CATENARY CABLES TO PREVENT PROGRESSIVE COLLAPSE OF BUILDINGS

FINAL REPORT

**REPORT NUMBER: UCB/CEE-STEEL-2001/02
DEPARTMENT OF CIVIL AND ENVIRONMENTAL ENGINEERING
COLLEGE OF ENGINEERING
UNIVERSITY OF CALIFORNIA AT BERKELEY**

Report to the Sponsors: General Services Administration / Skilling Ward Magnusson Barkshire

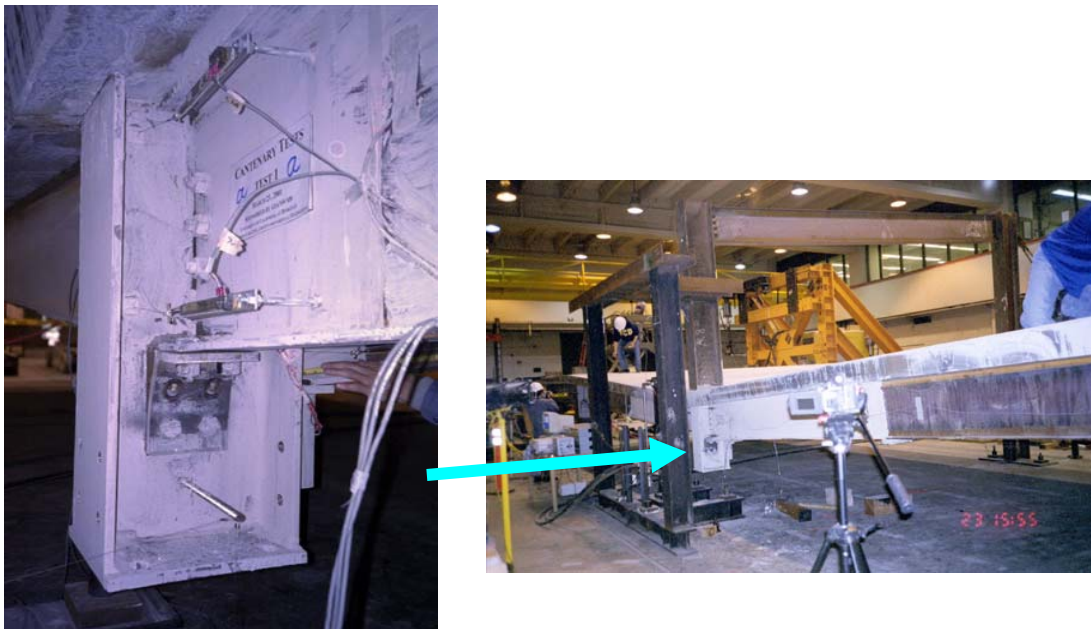
The seat angles on both sides of the column web deformed away from the column. The angle attached to the web also pulled away from C1 as the bare face of the column web was exposed from behind it in Figure 4.5. The beam seat stayed connected to the longitudinal beam by two vertical bolts. However, of the four horizontal bolts connecting the longitudinal beam seats to the column, the top two bolts failed as seen in Figure 4.5. Yielding occurred in horizontal streaks across the bolt lines. Both the west and east beam seat at C1 underwent heavy deformations.

Figure 4.5. Bending of Seat Angle and Bolt Failure, Connection at top of Removed Column

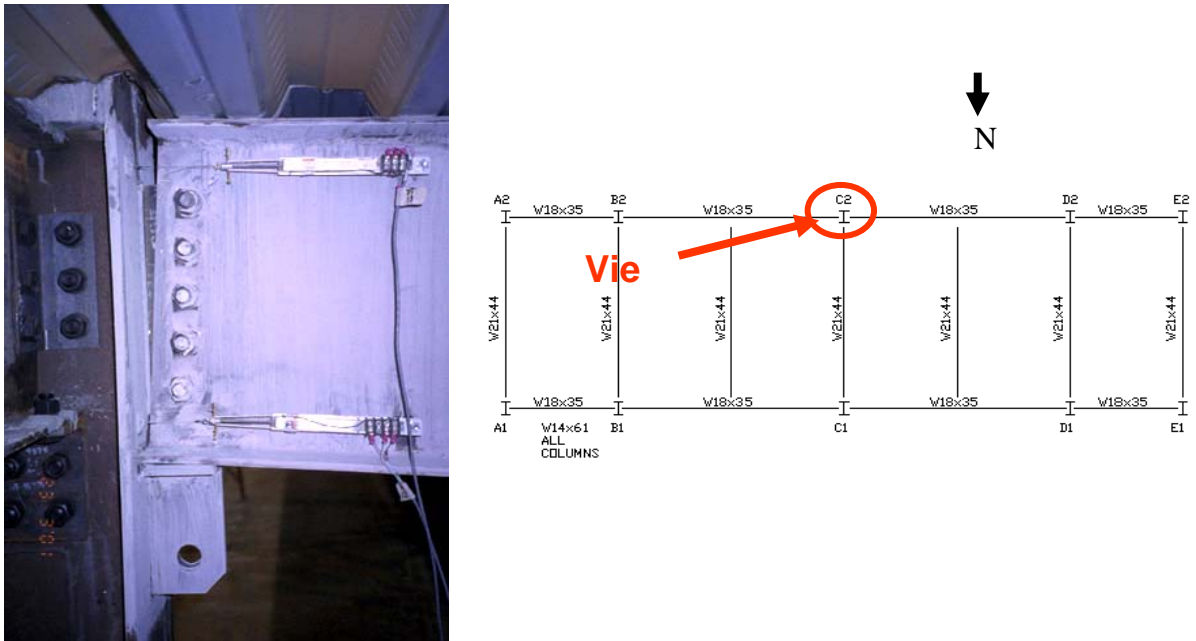
No deformation was seen in the longitudinal beams framing into the column, or in the column itself. At the shear tab connections of the transverse beam the bolts slipped inside the horizontal long slots in the shear tab. The shear tab itself underwent slight deformations, if any, while the transverse beam buckled slightly around the beam seat. The web of the transverse beam also exhibited yielding around the base of the shear tab. This yielding was not as noticeable on the other side of the girder. Figure 4.6 shows this detail.

Figure 4.6. Rotation of End of Transverse Beam at Column Location C2

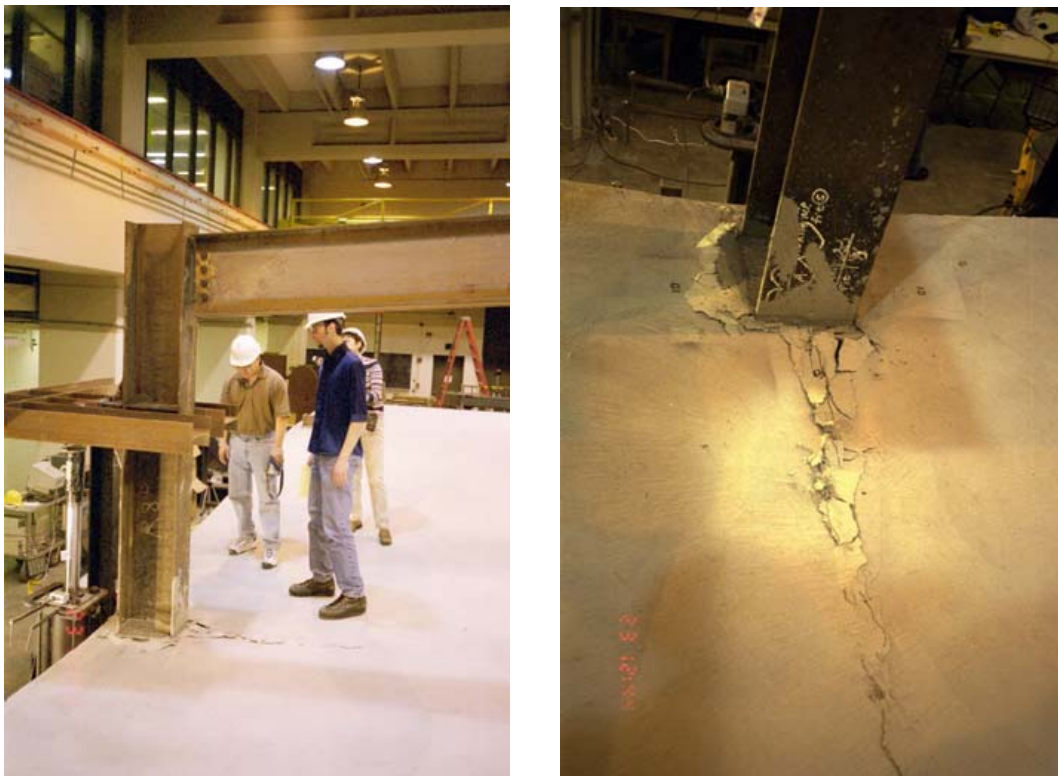
As expected, the concrete on the composite deck underwent a high degree of cracking with compressive crushing occurring above the transverse beam up to three feet away from the test column. Tension cracks occurred in a semicircular pattern around the test column often framing from sides B1 and D1 and flaring out towards C2. The concrete separated away from column C2 and cracked at least 1 inch deep for several feet on either side. Over columns D1 and B1, the concrete appeared to crack off the top of the saddle boxes. The deck also split and bowed out away from the structure at C1 as the concrete crushed slightly. Figure 4.7 shows the damage at this location on top of the deck.

Figure 4.7. Slight Damage Top of Floor Deck at Location of Removed Column

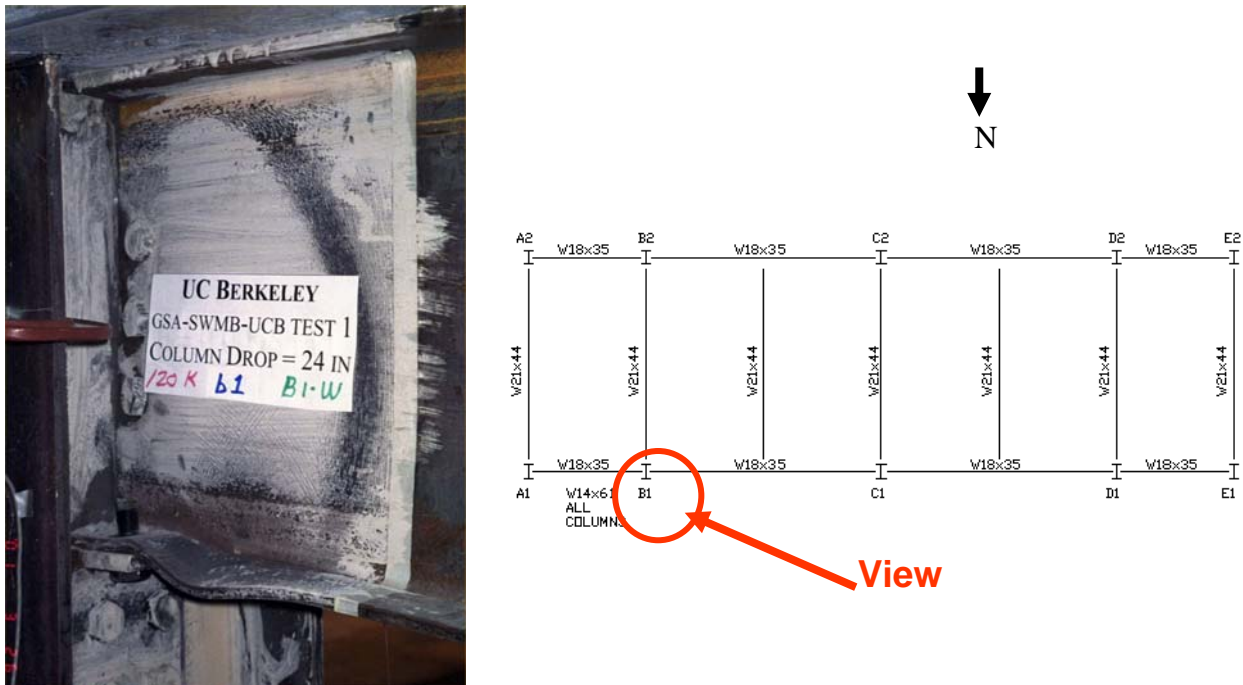
Figure 4.8. Girder Web and Flange Buckling at Location of Column B1
After 24 inches of Floor Drop

Starting at connection B1, the yielding in the bottom flange due to the beam seat has clearly increased significantly. There is also considerable yielding in the web because of the heavy flange deformations, which is indicated by the dark spot just above the bottom flange and continues with criss-crossing striations up towards the center of the web. Although it is a little difficult to view, the web has actually buckled outward towards the camera between the long vertical crescent yield and the angle, predominantly underneath the sign. The area of a web between the bolts and the column has also been stressed as the dark spot shows. Finally,

there has also been much more deformation in the beam seat as the whitewash has come off in the horizontal line along the top horizontal bolts in the seat. All these deformations are even more noticeable when compared with the picture from Figure 4.8 of the same connection at Column B1 just after Test 1-19.

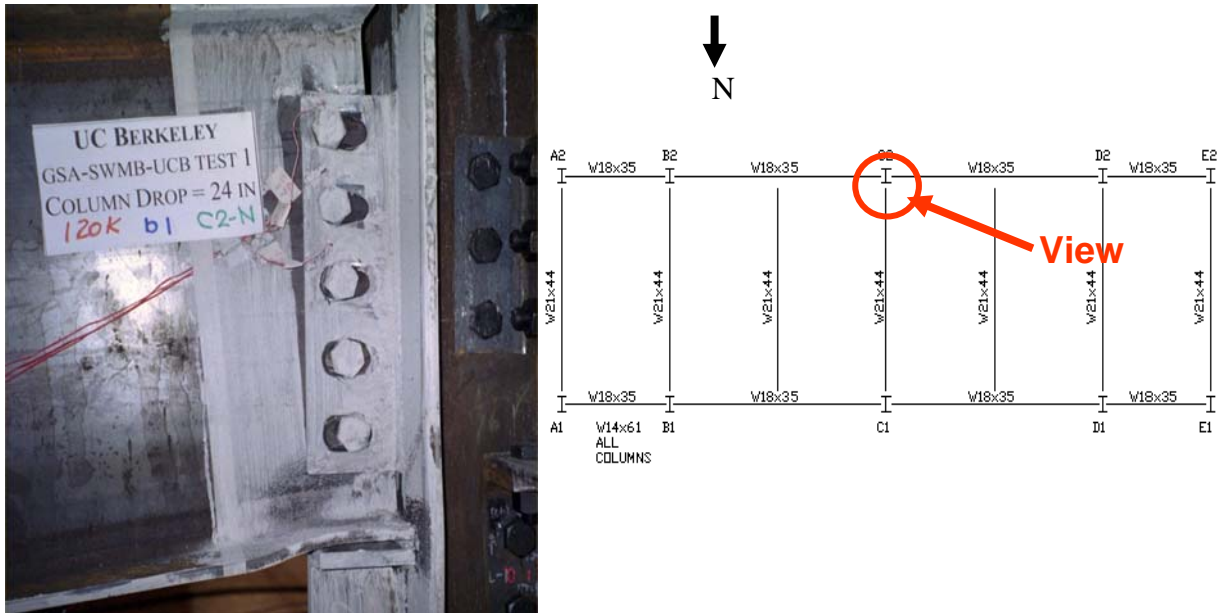
Figure 4.9. Rotation of Beam at Location of Column C2

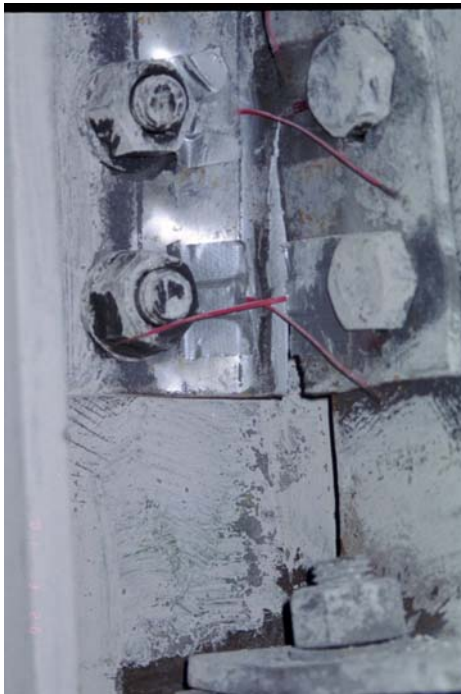
On Figure 4.10 we can see the fracture traveled halfway up the angle. Excessive yielding had occurred in the angle in Test 1-19 well before this test. As can be seen in the data in Appendix D3, two of the gauges on the angle, SG7 and SG8, failed close to the time of the failure of the angle. SG7 was at the top of the angle and therefore it is apparent that the localized strain caused the failure of that gauge and not a separation of the steel underneath it.

Figure 4.10. Close up of Web Connection

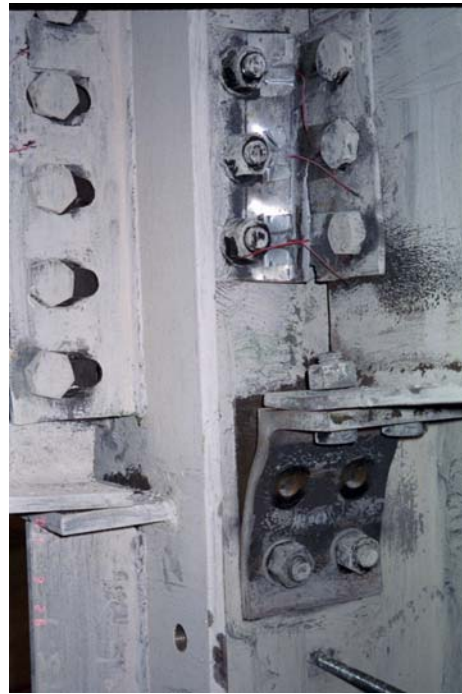
Figure 4.11. Connection at Location of Column C1

load in catenary action. The vertical bolts on the west side failed during the test. The angle went through extreme deformation, however, no tearing or separation of the steel was visible.

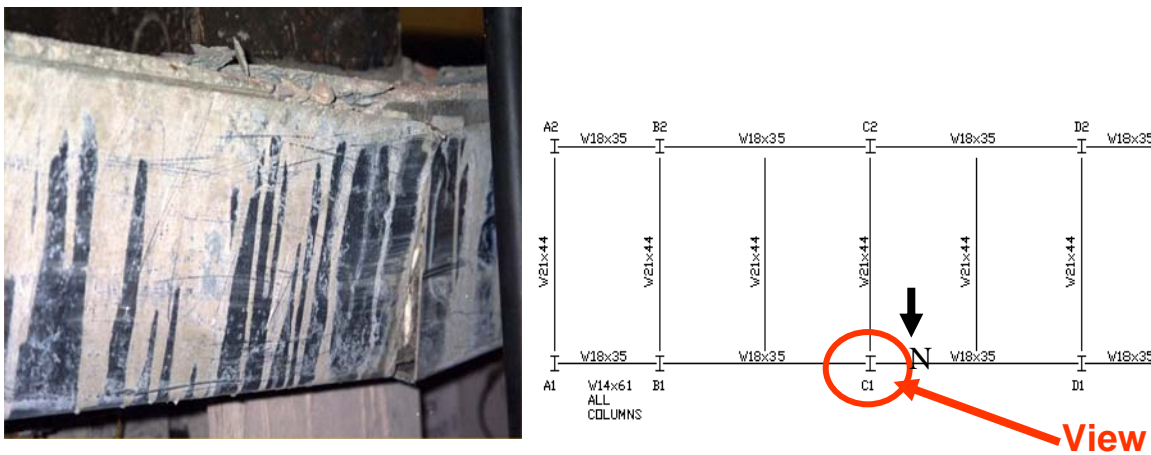
Cracking was greater between Tests 1-21 and 1-24, (as could be expected), than between Tests 1-19 and 1-21. The existing cracks expanded further and many new tension cracks were formed upon the deck. Compression crushing of concrete was quite extensive along both the north and south sides of column C1. The north side can be seen in Figure 4.12.

Figure 4.12. Deformation of Edge Beam on Top of Removed Column

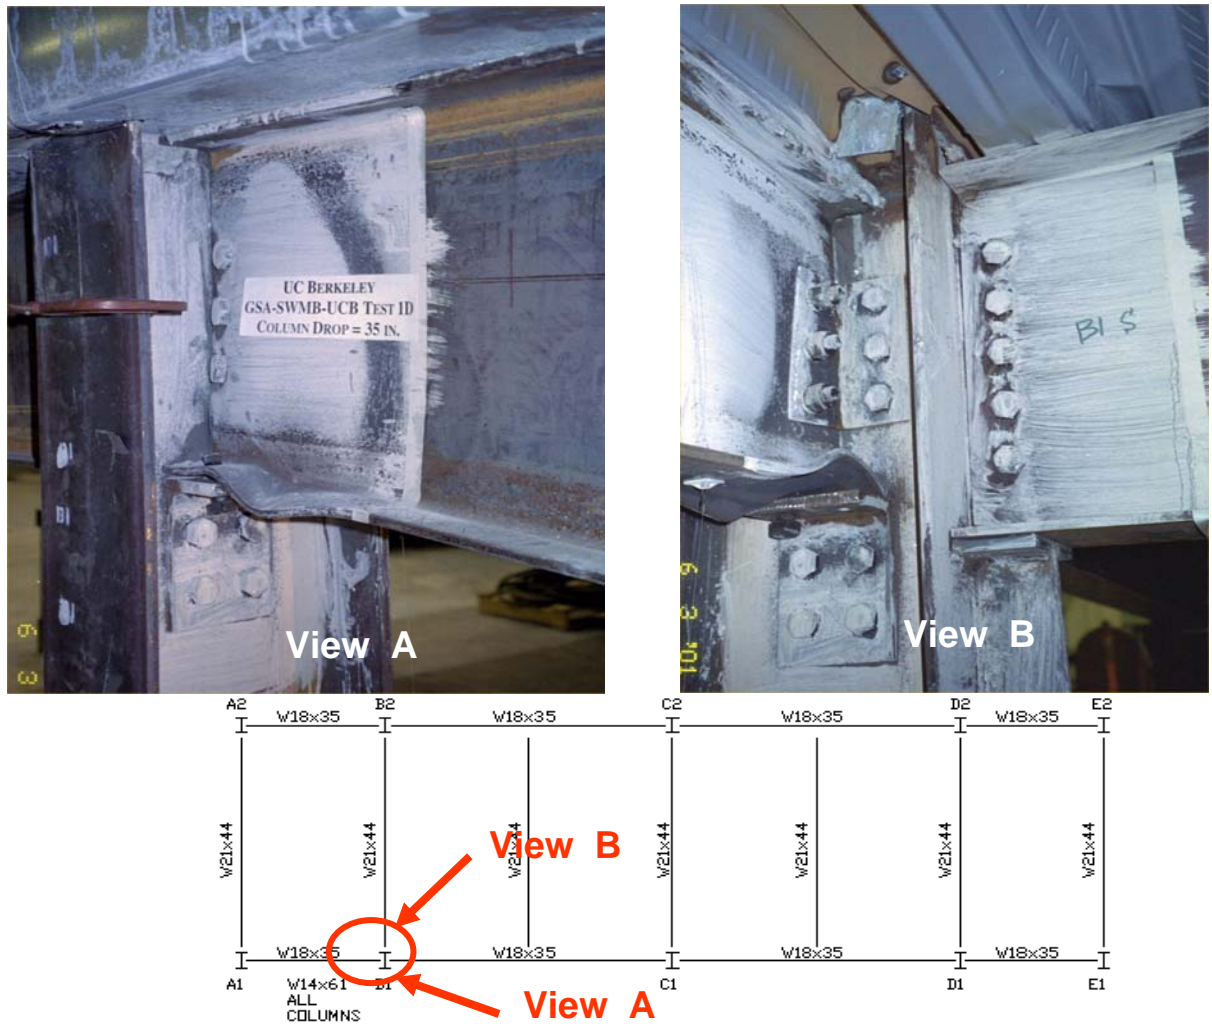
At B1, considerable deformation was found. First, was the high level of damage incurred by the longitudinal girder between C1 and B1 as shown in Figure 4.13. Both bolts were lost during the experiment. The bolt pictured was not used as a functioning bolt during the experiment. Heavy bending of the beam flange and yielding of the web is evident. Yielding can be seen also on the web as well as all around the beam seat. In Figure 4.13 (right), this yielding can be seen more clearly.

Figure 4.13. Two Views of Connection at Location of Column B1

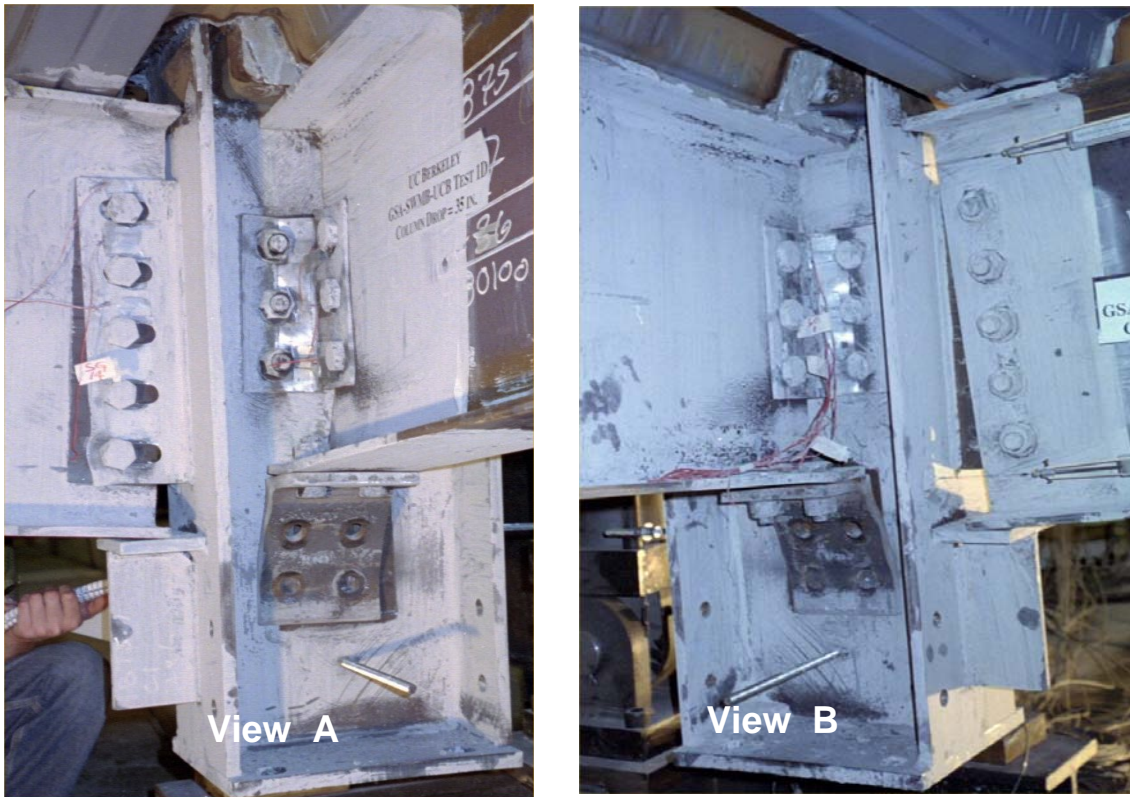
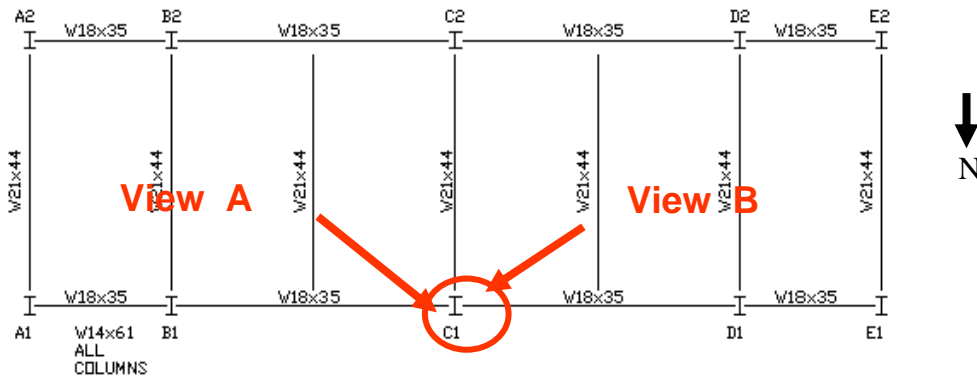
From the other side of the connection (View B in Figure 4.14) a little more of the connection is seen to be intact. The angle in Figure 4.14 (View B) did not separate from the column, though tearing began (only an inch in the center of the angle pulled apart). Therefore, this angle was still able to transmit stress to the beam. Yielding patterns on the west longitudinal beam seem similar to those on the east beam. There is very heavy yielding stemming from the bottom corner of the angle, and additional yielding above the top of the angle. The patterns on both sides of column web are the same, just mirrored. An interesting

Figure 4.14. Views of Connection at Location of Removed Column

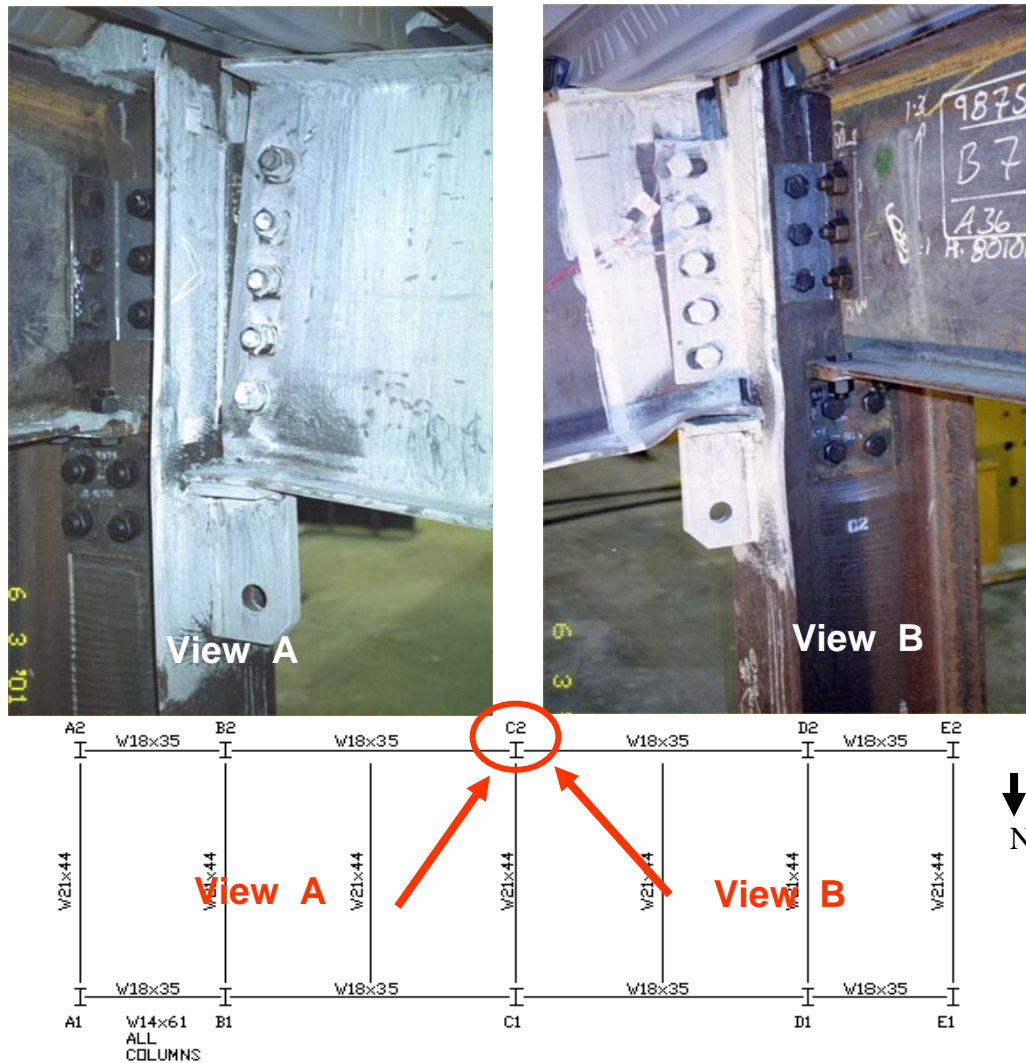
The transverse beam, in Figure 4.15 below, appears to have undergone much larger deformations at this end than Column C1. Yield lines extend horizontally in both directions from the bottom bolt and down to the flange. The flange itself has bent around the seat beneath it, which is clearly apparent on the other side in Figure 4.15 (View B). The shear tab underwent opposite, but similar deformations to its counterpart at the opposite (North) end. Here the top bolt pulled the tab outwards to allow more rotation in the connection.

Figure 4.15. Views of Connection at Location of Column C2 at the End of Test 1-35

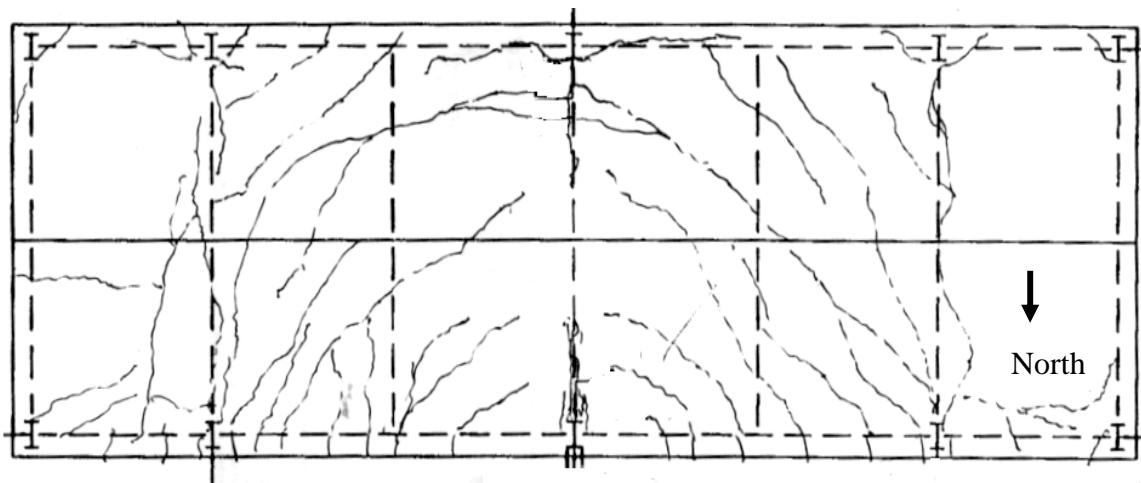
Heavy compression crushing of the concrete was seen stemming from Column C1 towards Column C2 in the center of the structure. The crushing extended for approximately four to five feet from Column C1. Crushing was also very heavy on the overhang of the structure.

Figure 4.16. Plan View of Cracks on the Floor Slab at the End of All Tests
