A report from the NIOSH Fire Fighter Fatality Investigation and Prevention Program

Volunteer Fire Fighter Dies After Running Out of Air and Becoming Disoriented in Retail Store in Strip Mall Fire—North Carolina

Report # F2016-07

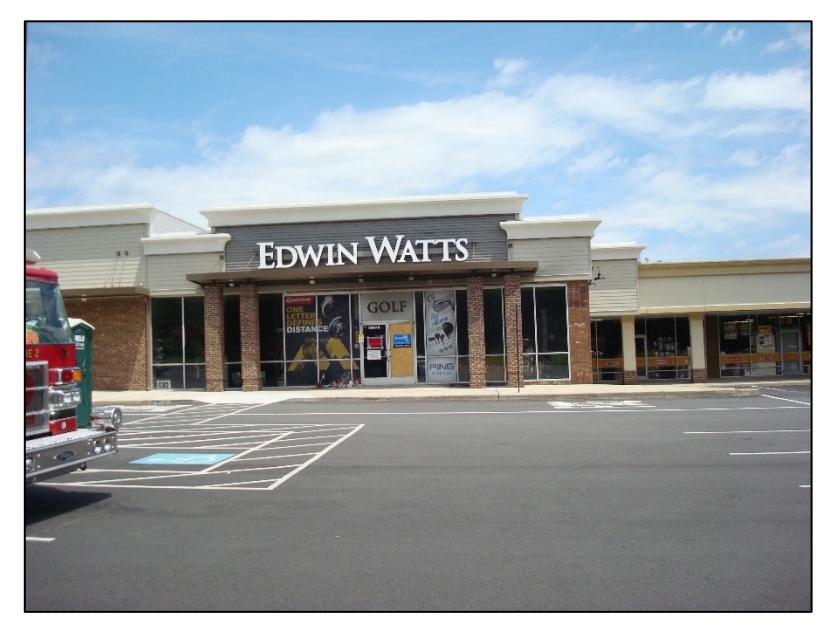
Retail golf store in middle of commercial strip mall where 20-year-old fire fighter was fatally injured. (Photo NIOSH.)

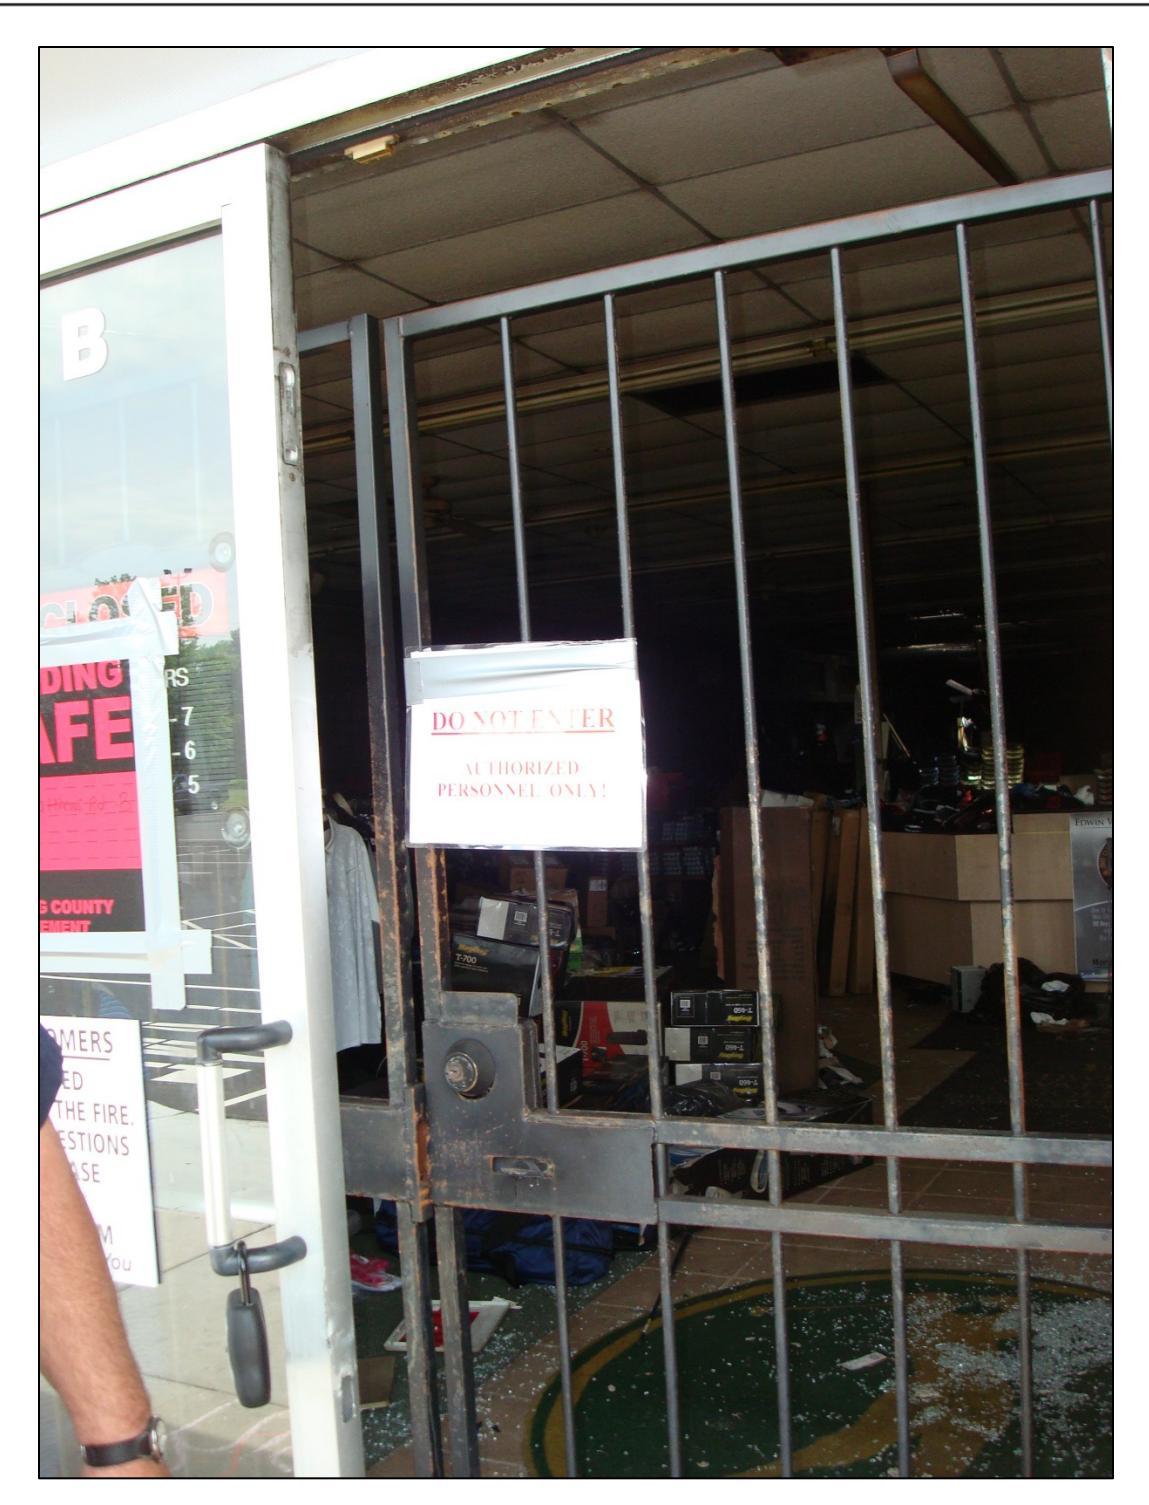
Photo 2. Photo shows sliding plate-glass entrance door and metal security gate. (*NIOSH photo.*)

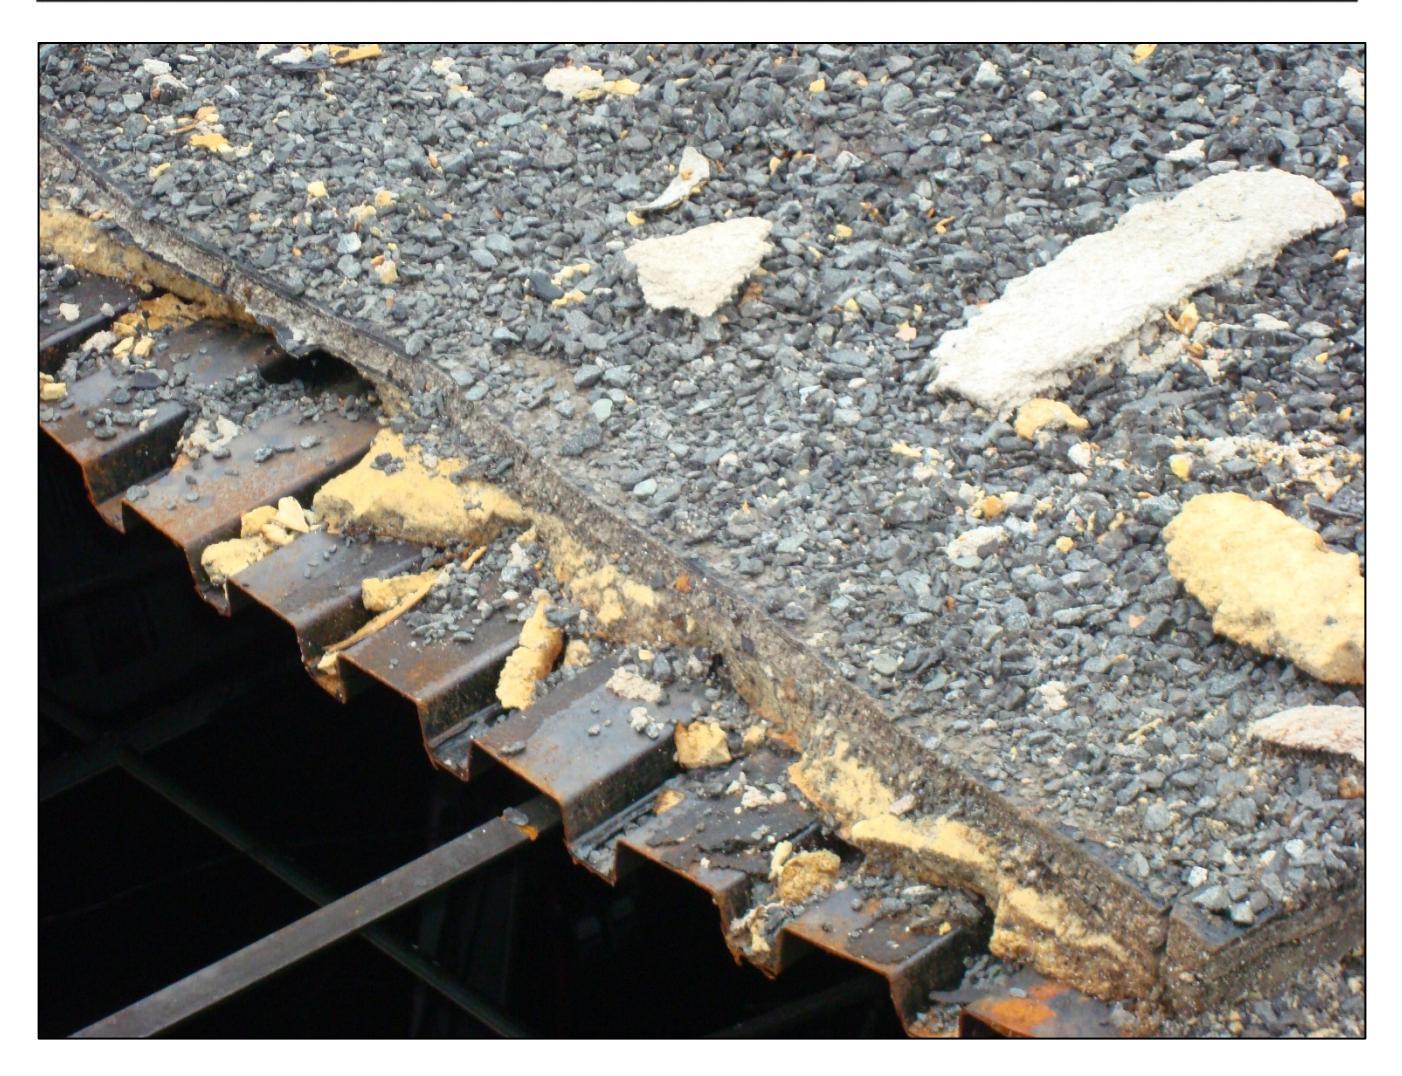
Photo 3. Photo shows construction of flat metal roof covered with asphalt, foam insulation, and gravel. Chain saws were initially used in an effort to open the roof for vertical ventilation but would not cut through the metal deck. K12 saws with metal cutting blades had to be retrieved to cut through the roof deck. (NIOSH photo.)

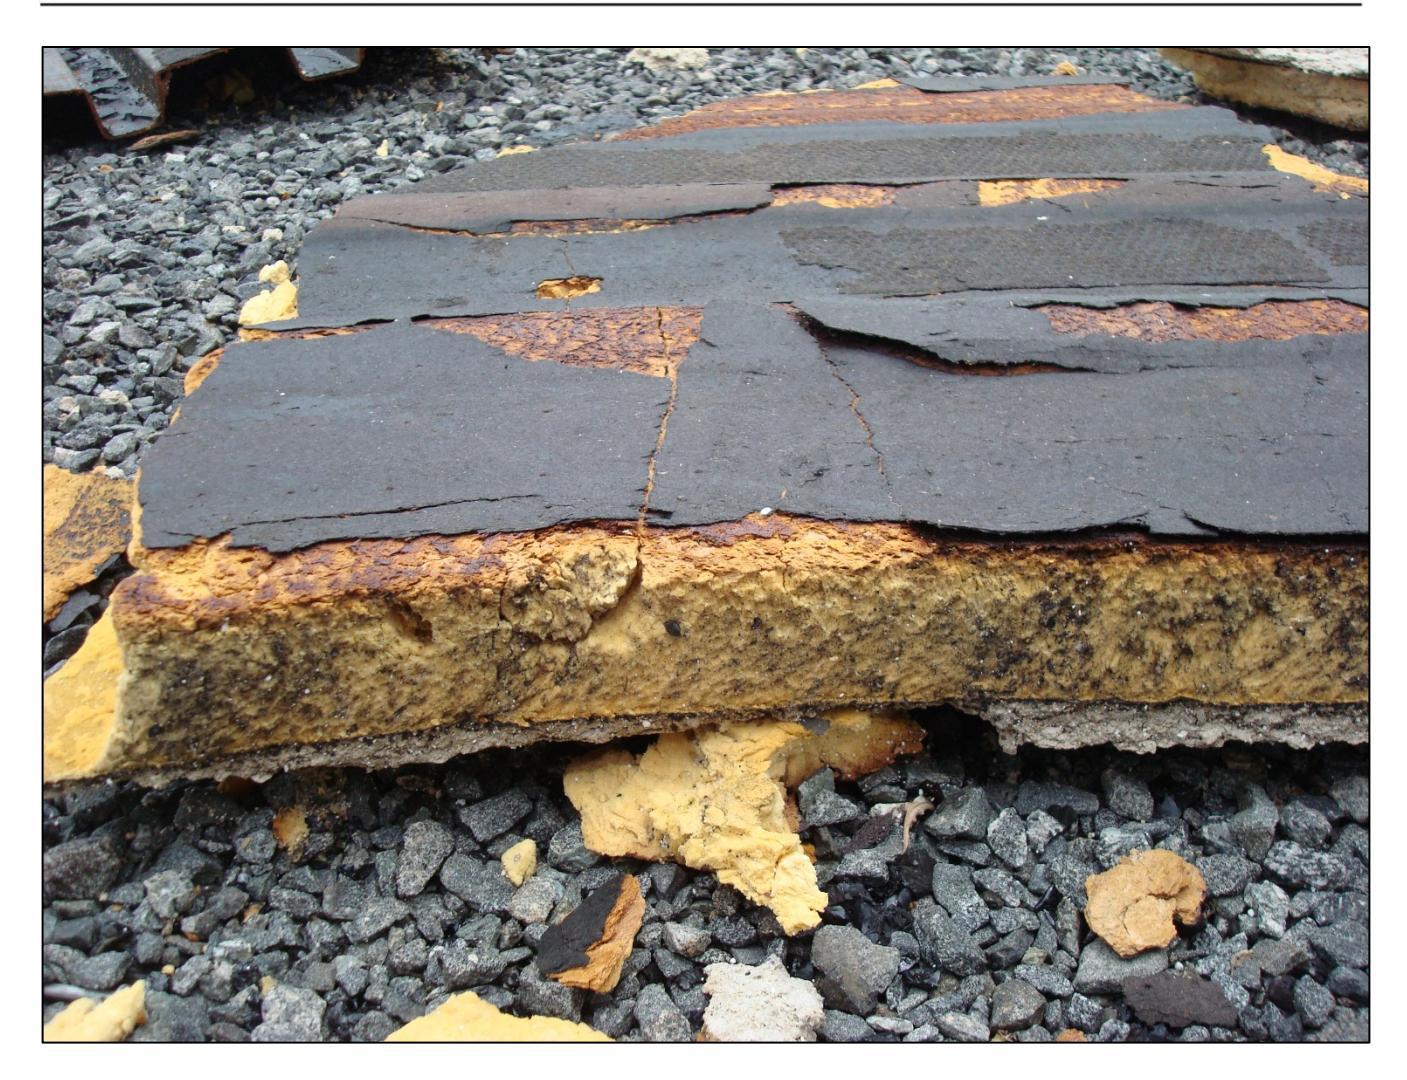
Photo 4. Photo shows close-up of asphalt and foam insulation covering metal roof deck. Note that the section of roof has been flipped upside down as a result of roof ventilation work. (NIOSH photo.)

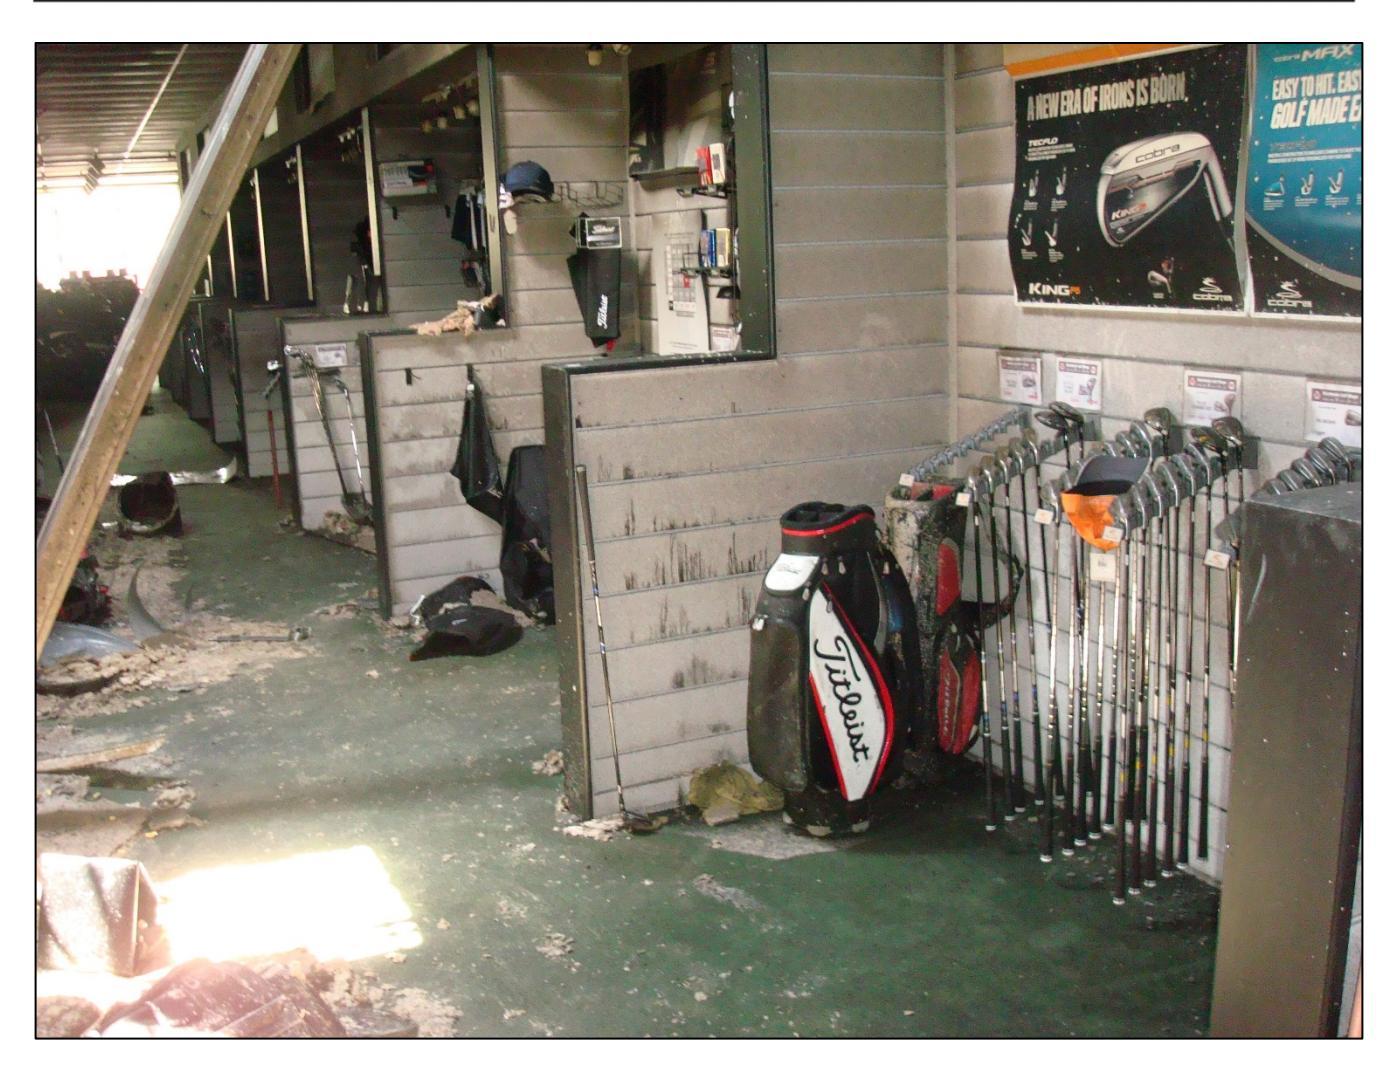
Photo 6. Photo shows U-shaped display racks built out from the Side Bravo wall that housed golf clubs and other golfing articles. The Engine 3 lieutenant reported becoming entangled in golf clubs in this area in near-zero visibility. (Photo NIOSH.)

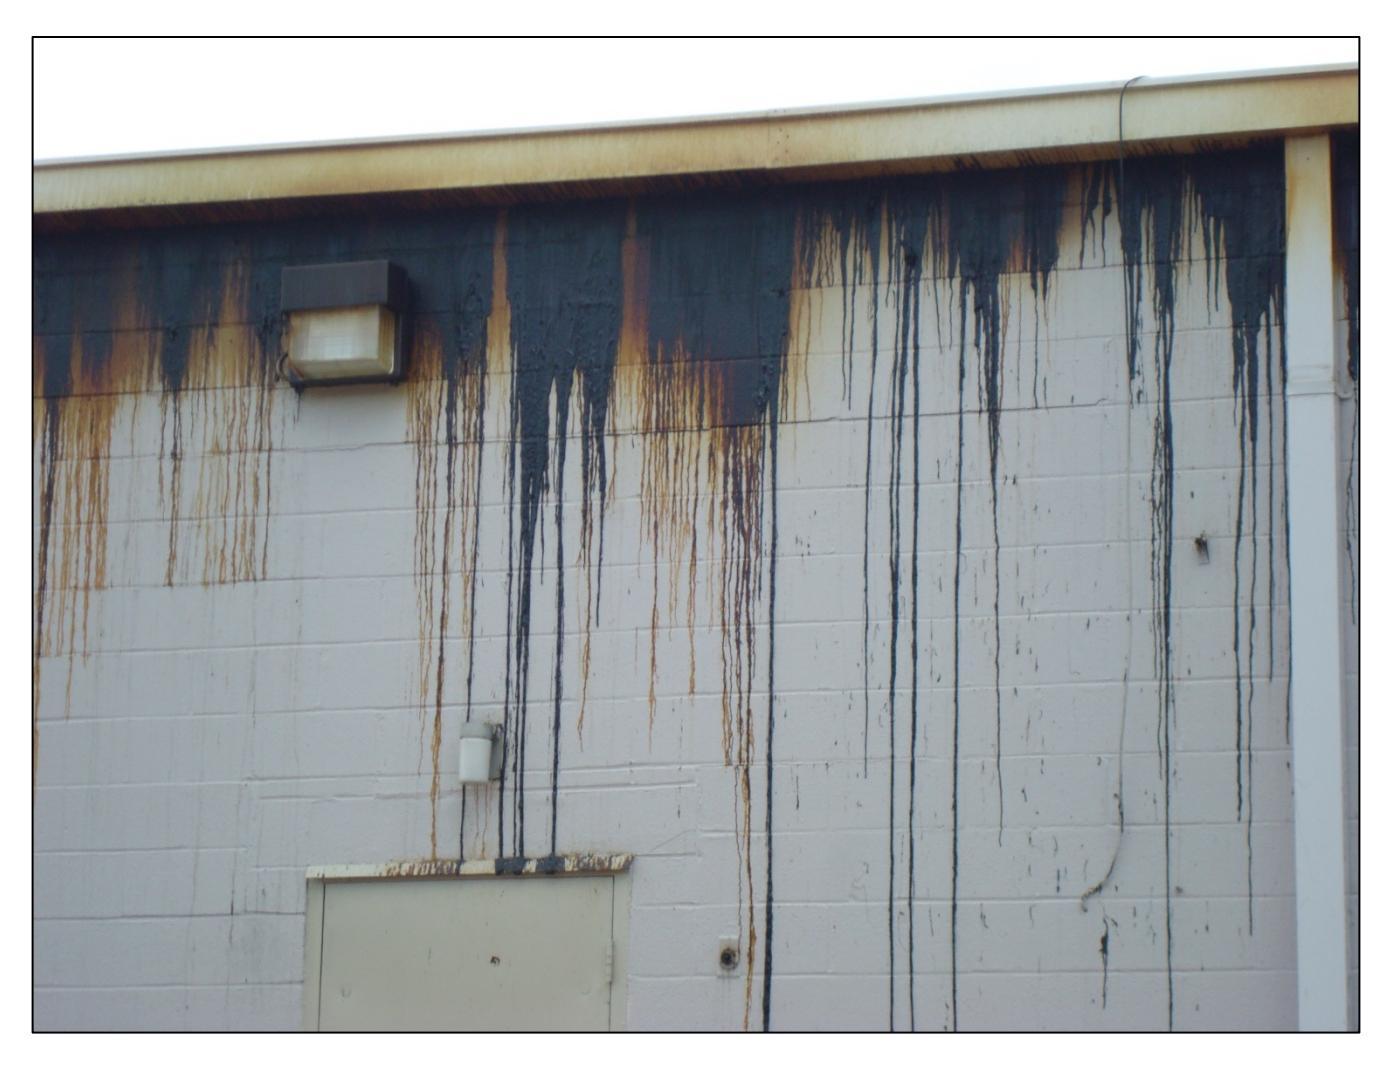
- Evidence shows a combustible metal deck roof fire (see Photo 7).

Photo 7. Side C exterior wall above the rear entrance door. Note the melted asphalt that ran down exterior wall from the roof. This is consistent with a combustible metal deck roof fire. *(NIOSH photo.)*

The commercial strip mall involved in this incident was constructed in 1978. The fire and building codes at that time did not require a sprinkler system. The fire started due to a lightning strike to the roof. The fire burned in the void space between the metal roof deck and the drop ceiling for some time. While a sprinkler system in the golf store protecting the store contents would not have initially contained the fire, a quick-action sprinkler system in the void space above the drop ceiling would have significantly reduced the risk to all by containing the fire to the area of origin, if not extinguished the fire completely.

Recommendation #3: State, local, and municipal governments, building owners, and authorities having jurisdiction should consider requiring the use of sprinkler systems in commercial structures.
