MECHANISM OF CORROSION OF STEEL STRANDS IN POST TENSIONED GROUTED ASSEMBLIES

Alberto Sagüés^{*}, Rodney G. Powers⁺, Hongbin Wang^{*}

ABSTRACT

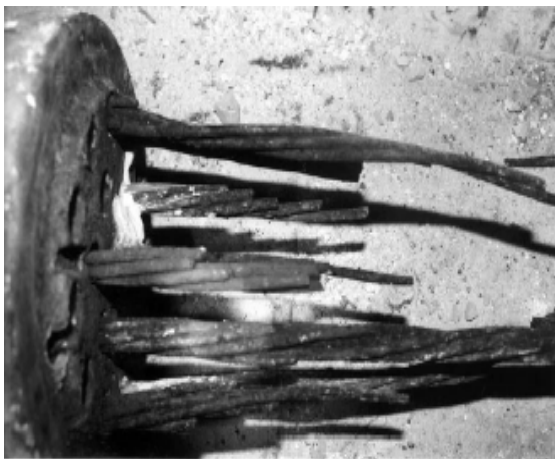
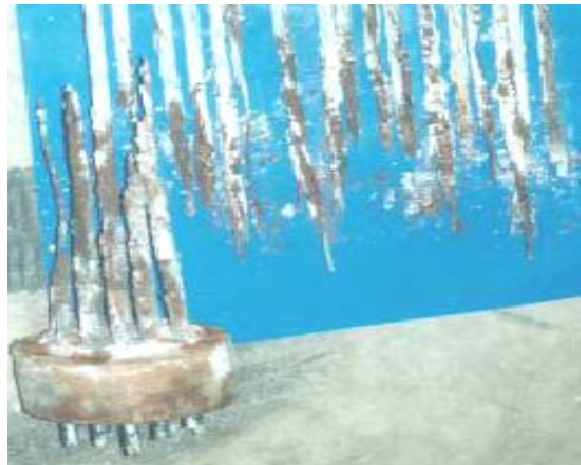
FIGURE 2 Severe Failure of Post-Tensioning Tendons near Cap Region (Corven, 2001)
 a) Failed tendon at Niles Channel Bridge
 b) Failed tendon at Column 133 NB of Sunshine Skyway Bridge

The observed damage consisted, in each of the three bridges, of one completely separated tendon plus one to several partially detensioned tendons. The completely separated tendons had failed in the anchorage region following severe corrosion of many of the strands, as illustrated in Figure 2. Mechanical failure appears to be the result of simple overload due to locally reduced cross-section, usually in the form of generalized corrosion along several cm with occasional pitting. In the partially detensioned tendons severe corrosion and mechanical failure had affected some but not all of the strands. In one instance the area of severe corrosion was about 2-3 m away from the anchorage. All cases of severe corrosion were associated with large void areas that should have been filled with grout. Significant chloride contamination of the remaining grout was observed at the corroded regions. In nearly all cases the affected anchorages were at bridge expansion joints, or underneath horizontal surfaces, where salt and moisture availability was significant. Additionally, HDPE duct cracks were commonly encountered in MBB. Corrosion was not unique to any particular anchorage manufacturer.

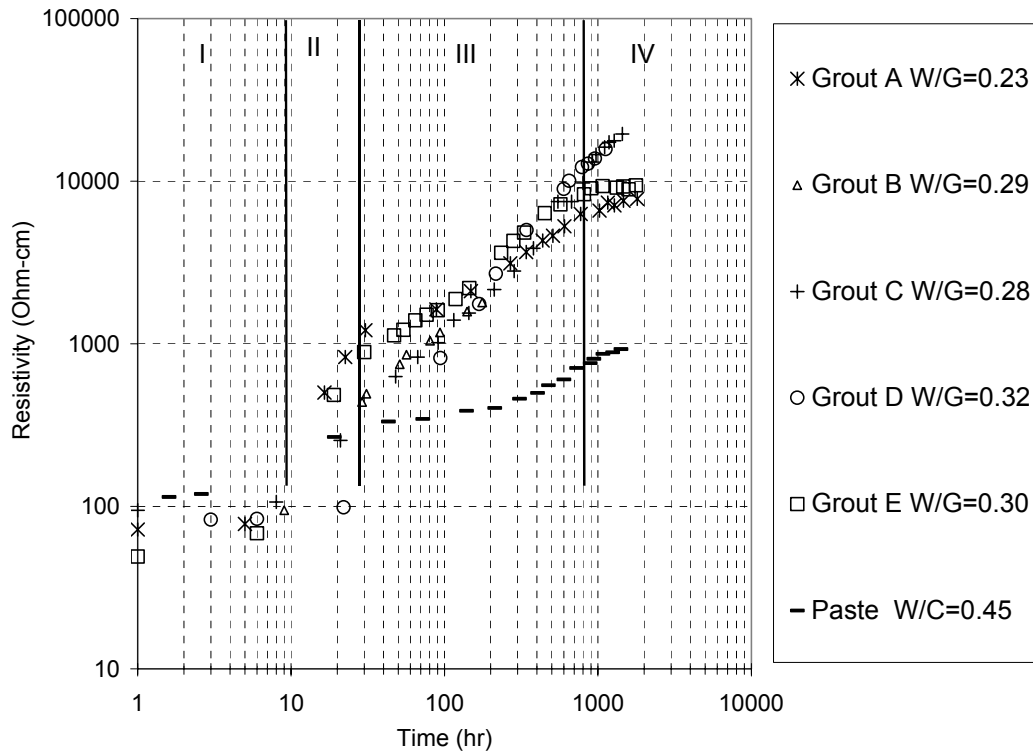
FIGURE 3 Grout Resistivity as a Function of Time
(W/G: water to grout ratio; W/C: water to cement ratio)

Electrical Resistivity: As shown in Figure 3, the change of resistivity with time (average of multiple specimens of each type) can be divided into four zones according to the slope in a log-log diagram. All the newly-cast grouts, although with different water to grout ratios (W/G), had a similar low resistivity value (~ 100 Ohm-cm) during the first 10 hours (Zone I), followed by a sharp increase to ~ 1000 Ohm-cm during the next 20 hours (Zone II). In Zone III (from 30 to 1000 hr), all the grout resistivities kept increasing, reflecting the continuing hydration process with corresponding self-desiccation and reduced connectivity of the pore network. In Zone IV, the resistivity of some of the grouts began to give signs of approaching a terminal value of ~ 10 KOhm-cm while resistivity kept increasing for other grouts. The electrical resistivity of the paste, with a water to cement ratio (W/C) of 0.45, was much lower than that of the commercial grouts (W/G 0.23 to 0.30) in Zones III and IV.

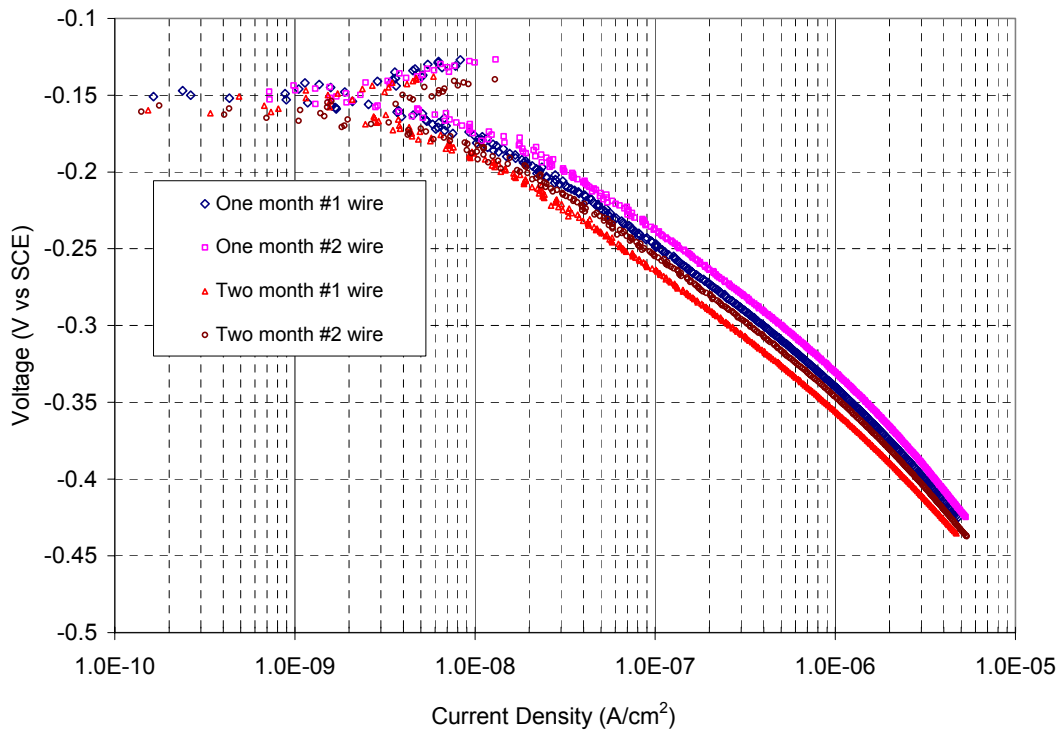
FIGURE 4 Oxygen Reduction Polarization Curve of 0.2'' Post-Tensioning Wire (SCS, scan rate=0.167 mV/s, open to air)

Cathodic efficiency tests: Figure 4 shows an example of oxygen reduction characteristics on duplicate PT wires at two immersion times in SCS. Similar cathodic polarization curves were obtained at 1 and 2 months, indicating a steady state had been reached. From these curves, an idealized Tafel slope value of 100 mV/decade was abstracted, together with a nominal exchange current density of 10^{-5} $\mu\text{A}/\text{cm}^2$ at a nominal equilibrium potential of 160 mV (SCE). The corresponding cathodic polarization line approaches the average trend (away from the open circuit potential) of the curves in Figure 4. Comparable results were obtained for SCS, SPS and the hardened grout, indicating relatively small variation of cathodic efficiency within the pH range present. The polarization behavior observed is also comparable to that seen for plain steel in similar environments [Li, 2001].

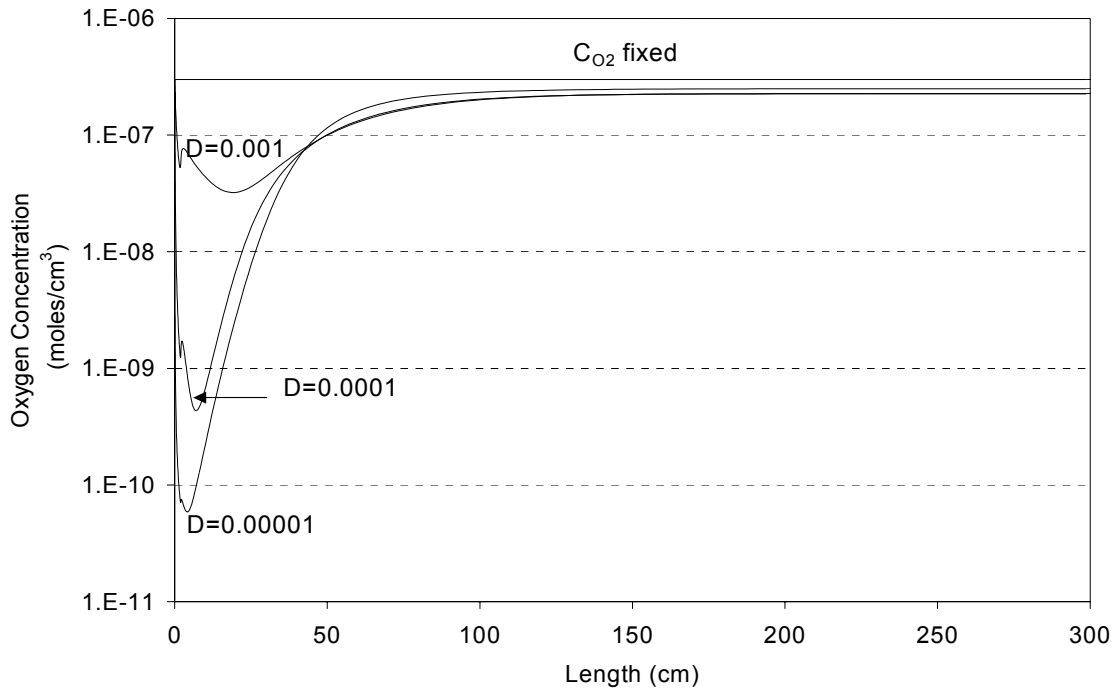
FIGURE 6 Longitudinal Distribution of Oxygen on the Grout Next to the Strand Surface (Resistivity= 10^5 Ohm-cm). Values of oxygen diffusivity, D , for the case A series are in cm^2/sec . C_{O_2} is fixed for the case B series.

Modeling results: Figure 6 illustrates the resulting oxygen concentration along the strand surface for the 10^4 Ohm-cm resistivity calculations. Oxygen concentration drops greatly in the active region due to the high consumption of oxygen associated with high local corrosion rate. At points far enough away from the active region, the oxygen demand decreases dramatically and the small flux through the HDPE duct wall (or alternatively through any minor leaks) is sufficient to finally maintain the surface concentration close to the atmospheric value. As expected, the oxygen concentration at the steel surface at or near steel surface becomes much lower for the lower grout oxygen diffusivity values. As seen in Figure 7, the active and passive regions are distinctly separated due to the model assumptions which cause those regions to behave as a net anode and a net cathode respectively. Two opposite factors influence the anodic current density profile in the first 2 cm (the active region): 1) decreasing oxygen concentration in the case A series and 2) increased coupling between the active and passive region as distance from the origin increases. Therefore, for the case A series where diffusivity is finite, the magnitude of the anodic current density in the active region first decreases with depth and then increases closer to passive steel zone. For the case B series with unrestricted oxygen access, the anodic current density does not experience an initial decrease. These trends are reasonably as expected and suggest that the model, despite its simplicity, may provide useful insight for understanding the otherwise complex conditions in an actual grouted anchorage system.

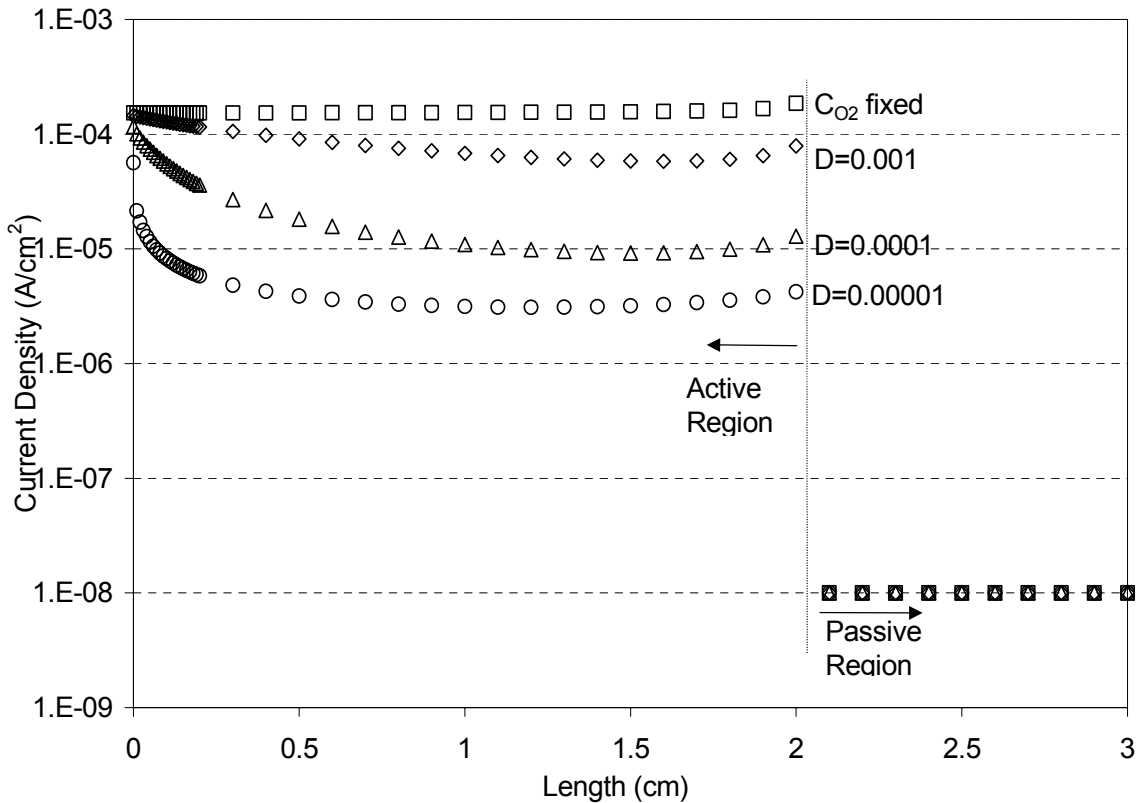
FIGURE 7 Longitudinal Distribution of Anodic Current Density (Region near active spot, Resistivity= 10^5 Ohm-cm). Values of oxygen diffusivity, D , for the case A series are in cm^2/sec . C_{O_2} is fixed for the case B series.

be further localized as suggested by the results in Figure 7, or due to the development of small pits, failure could occur even earlier. These simplified model projections are in agreement with the range of times to failure observed in the field, as well as the observations made in one preliminary laboratory study [Powers, 2001].
