100 Years of Concrete Pavement In Iowa

Final Report
For
MLR-07-01

By
Todd D. Hanson
PCC Engineer
515-239-1226
Fax: 515-239-1092

Office of Materials
Highway Division
Iowa Department of Transportation
Ames, Iowa 50010

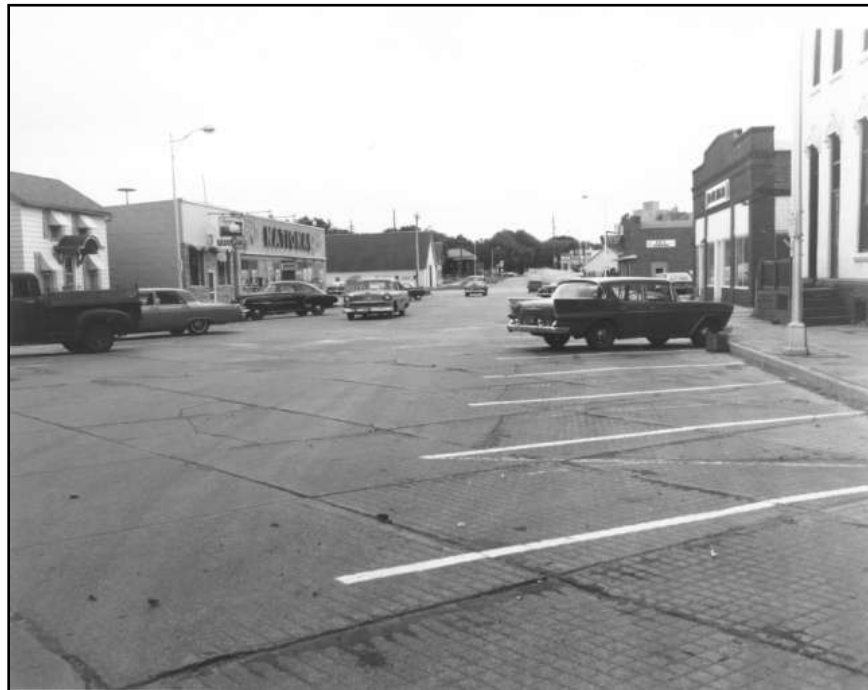
Figure 1 Le Mars city street built 1904 - picture 1950s

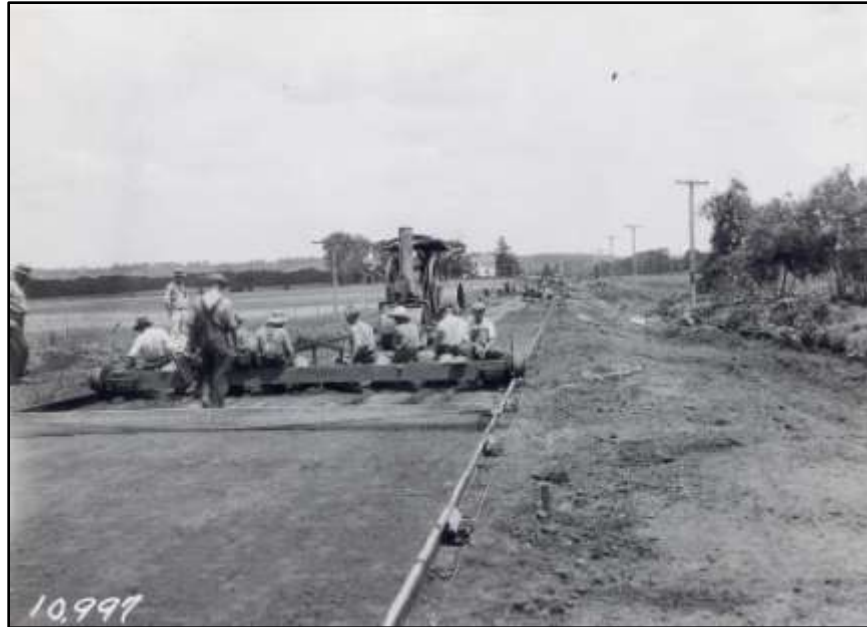
Figure 3 – Subgrade trimmer and template – Polk County 1926

Before the placement of a concrete pavement can begin, a well compacted subgrade of uniform density is required. Prior to the 1960s, all concrete pavements were placed on natural subgrade. The subgrade was required to be constructed to a uniform density and width plus one foot. Sprinkling and wetting of the finished subgrade was required to ensure reasonable moisture content at time of placement.

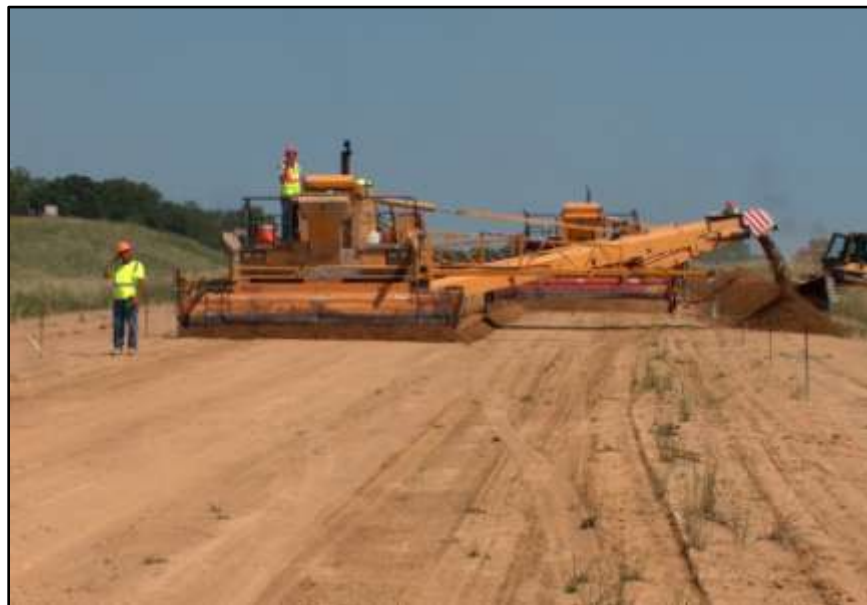
Figure 4 – Modern subgrade trimmer

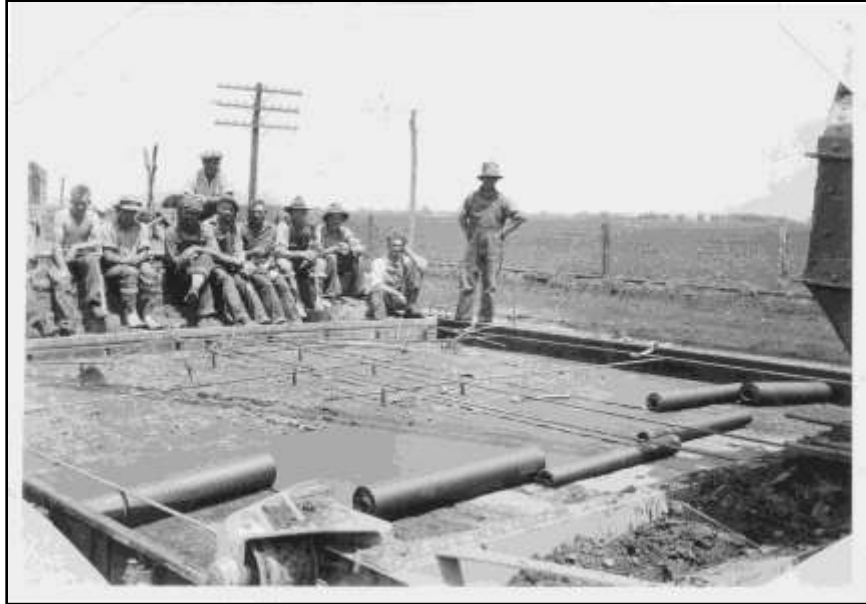
Figure 5 - Placing tar paper on subgrade - Story County 1926

In order to prevent moisture loss from the pavement, bituminous paper, lapped not less than 4 inches, was required on the subgrade. In 1960, plastic sheet, lapped not less than 12 inches, was also added as an option. In 1964, natural subgrade was required to be uniformly moist, but not muddy, to a depth of not less than 1 inch, or be covered with bituminous paper or plastic film.

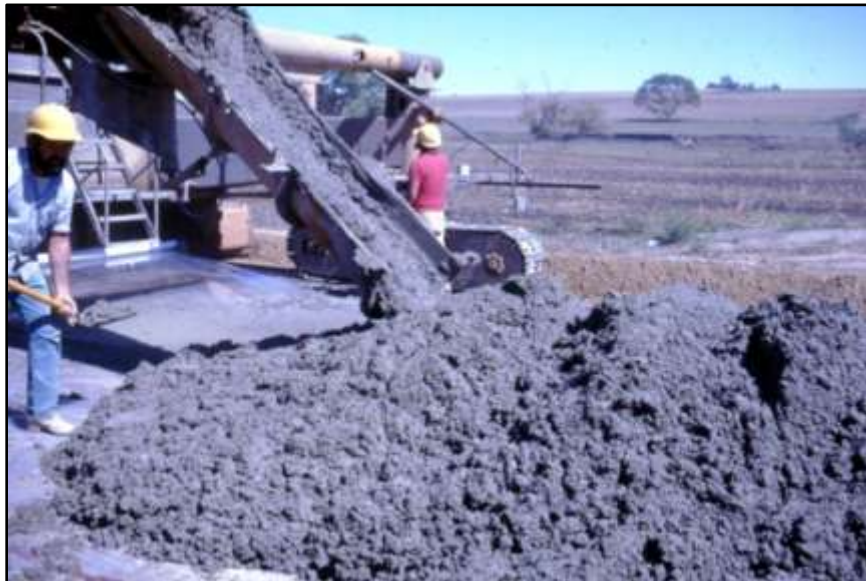
Figure 6 - Plastic sheet placed on subgrade behind Iowa Special paver – Lyon County 1977

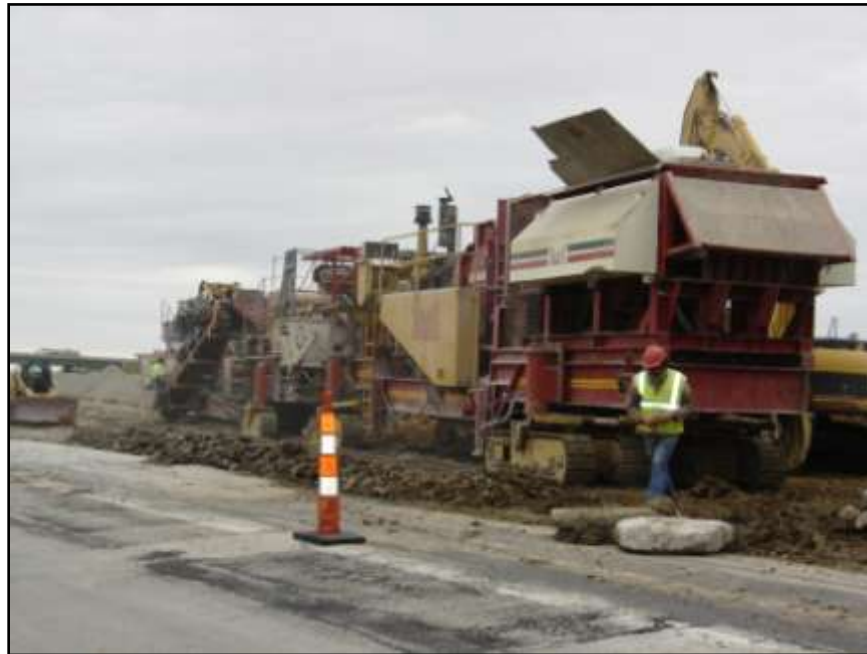
Figure 7 - "Paradigm" Mobile Crushing Equipment

Recycling concrete pavement into granular subbase was a time consuming process. First, the pavement was broken with a pavement breaker. Next, the rubblized pavement was hauled to a plant site, crushed and then hauled back to the project site. In 1993, Manatt's Inc., Duit Construction and Wendling Quarries developed a concept to break, crush and recycle the pavement on site utilizing a mobile crushing operation. This concept, known as the "Paradigm", reduced construction costs, reduced haul road maintenance and increased safety because dump trucks were no longer hauling in and out of the construction zone. The mobile crushing operation was first used in 1993 on a section of I-80 in Jasper County. Two years later, an estimated \$800,000 was saved on the 14 mile interstate reconstruction on I-80 in Jasper County.

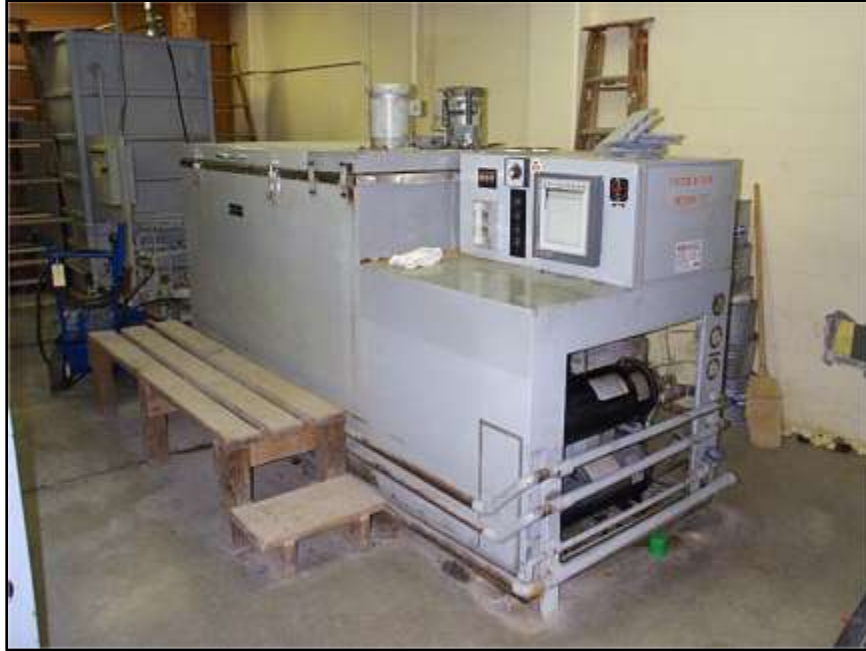
Figure 8 - Method "A" aggregate freeze-thaw equipment

When larger freezing equipment was acquired, it was designed to cool a nonfreezing solution in which pans containing the samples could be placed and cooled quickly. A solution of water and methyl alcohol was used as the cooling medium. When results obtained from freezing in air were compared with results obtained from freezing samples by placing the containers in a solution of water and methyl alcohol, those frozen in the sample pans in the water alcohol solution were more seriously disintegrated compared to those frozen in air. It was noted that some of the alcohol fumes were being condensed in the sample container. After some investigation, it was proved that the small amount of alcohol entering the water was responsible for the difference.

A large number of samples were tested with 25 freeze-thaw cycles with samples surrounded by pure water and duplicate samples tested with 16 freeze-thaw cycles surrounded by 99.5 percent pure water and 0.5 percent methyl alcohol. A shaly limestone disintegrated 30 times greater in the water alcohol solution compared to the pure water. In 1948, the alcohol method of freeze-thaw testing aggregates (Method A) was adopted in the specification and had become a fairly reliable method relating service behavior of concrete pavements. This has led to the elimination of a number of quarries used for concrete work. However, there were still a few aggregates that passed the alcohol freeze-thaw test, but did not exhibit good service history. At the time, other work was being done studying the clay minerals in limestone. Results of this work indicated the type and percentage of clay minerals present has a considerable effect on the durability of the concrete with the limestone.

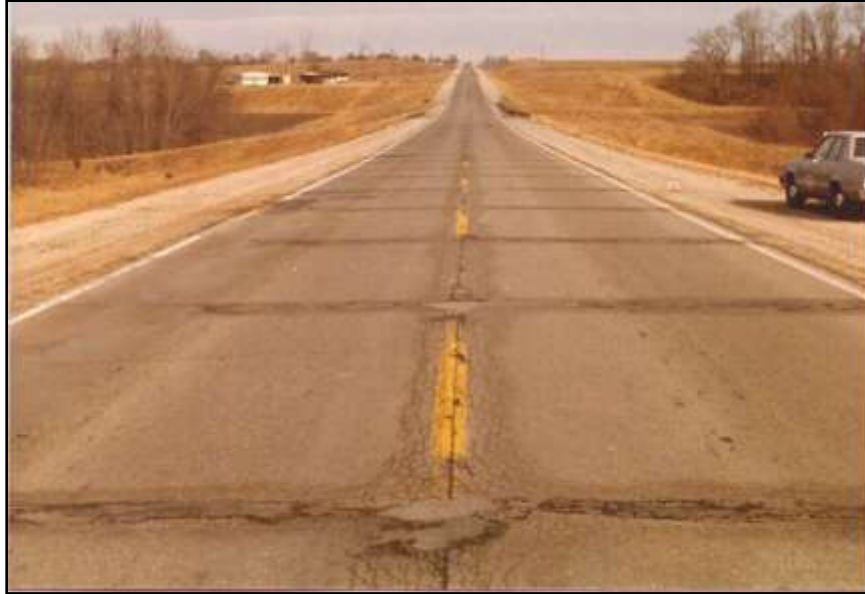
Figure 9 - D-Cracking on U.S. 218 MP 46 - 1970s

Within three to five years, extensive cracking was noted at the joints in these pavements. In 1964, the producer was informed they could no longer supply Argentine stone for interstate pavements. A limited amount of pavement had been placed on the interstate and primary system using the Winterset ledges and the D-cracking had not begun to appear at this time. It was suspected that D-cracking would occur at a slower rate. In 1965, the Winterset stone was limited to a maximum of 1 inch top size to delay D-cracking. D-cracking did occur a few years later with the Winterset stone and, in 1967, it was no longer acceptable for use on the interstate system.

In 1967, a study¹ of D-cracking pavements revealed the Argentine and Winterset members of the Pennsylvanian age formation, Otis member of the Wapsipinicon formation and Coralville member of the Cedar Valley formation were showing significant D-cracking within five to 10 years during this time. Other sources, such as the Maynes Creek member of the Hampton formation, had exhibited D-cracking in the late 1930s. The Argentine and Winterset stones were basically calcitic limestone, while the Otis and Coralville stones were calcitic dolomites or dolomitic limestones. Satisfactory service history had been obtained with aggregates containing less than 5 percent or more than 16 percent MgO content. Satisfactory performance was also obtained from a mix of limestone and dolomite as separate distinct rock in a working face.

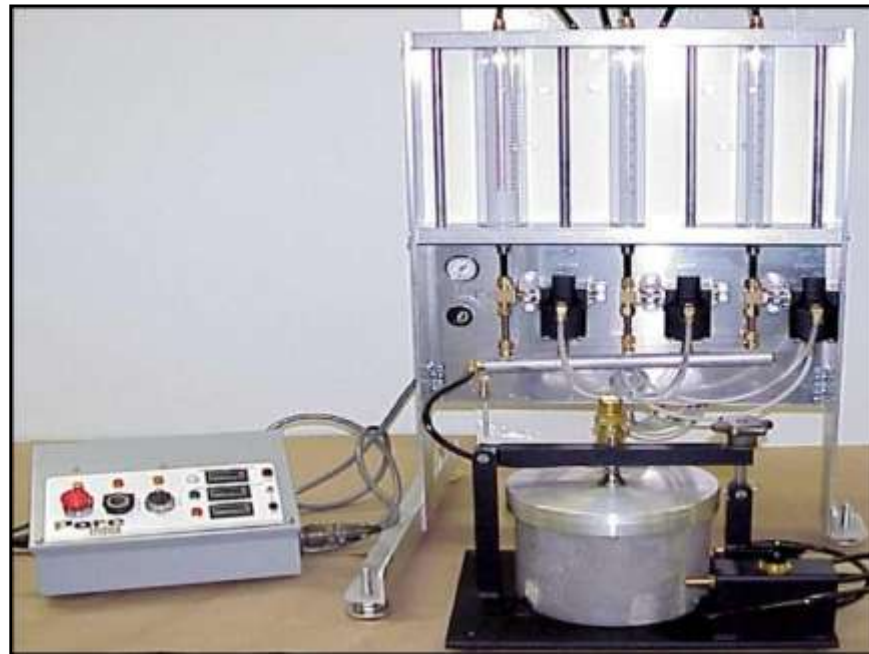
Figure 10 - Iowa Pore Index test equipment

been in use since 1978. The test uses 9000 grams of one-half inch material in an airtight pot filled with water and pressurized to 35 psi to force water into the pore system of the aggregate. At one minute, the primary load is recorded by the milliliters of water entering the large pores. At 15 minutes, the secondary load is recorded as the milliliters of water to fill the small capillary size pores. The secondary load is the pore index number and gives an indication of long-term freeze-thaw durability of the capillary pore system. A lower number indicates better freeze-thaw performance. For Class 3-I, 3 or 2 the pore index should be less than 20, 25 and 30, respectively.

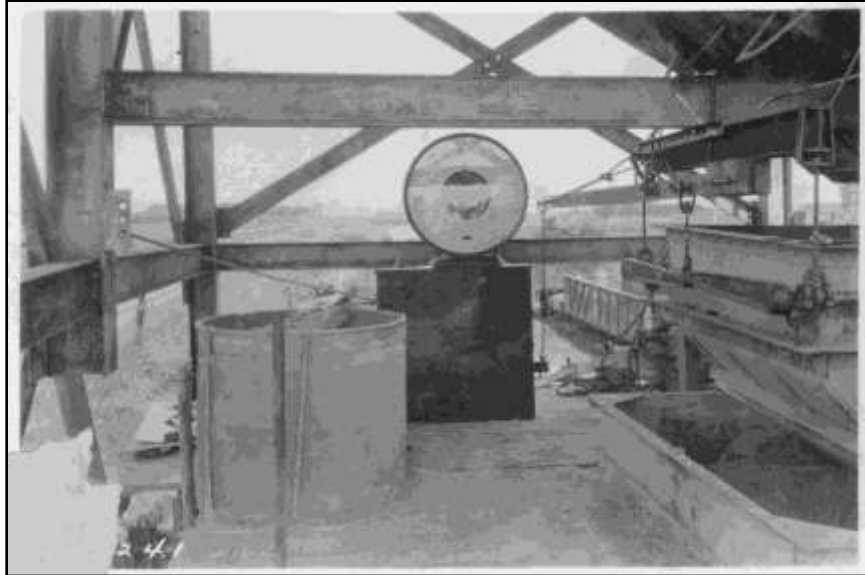
Figure 11 - Weigh scale and aggregate hopper – Woodbury County 1921

Prior to 1924, proportioning of concrete was based on volumetric method. R. W. Crum, Iowa Highway Commission's materials and tests engineer at the time, developed the method of batching by weights to account for variation in cement content due to variation in aggregate moistures based on volumetric batching. Duff Abrams, Portland Cement Association (PCA), presented his paper⁶ at a 1927 conference in Amsterdam, and this method became the standard method of batching worldwide.

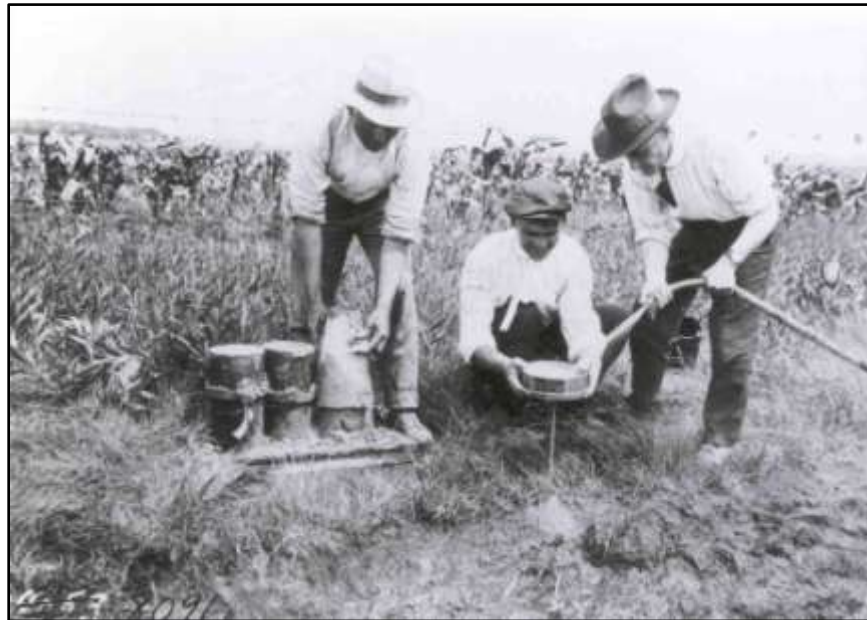
Figure 12 - Testing slump and cylinders – Dallas County 1921

Slump requirements, when mechanical finishing was used, varied from 1½ inches in 1925, to 1 inch in 1930, and then increased to 2 inches in 1933. In 1948, the slump range became one-half inch minimum to 1½ inch maximum. The maximum was raised to 2 inches in 1964, 3 inches in 1984 and reduced to 2½ inches in 1992. Slump requirements were eliminated in 1998 for slipform paving.

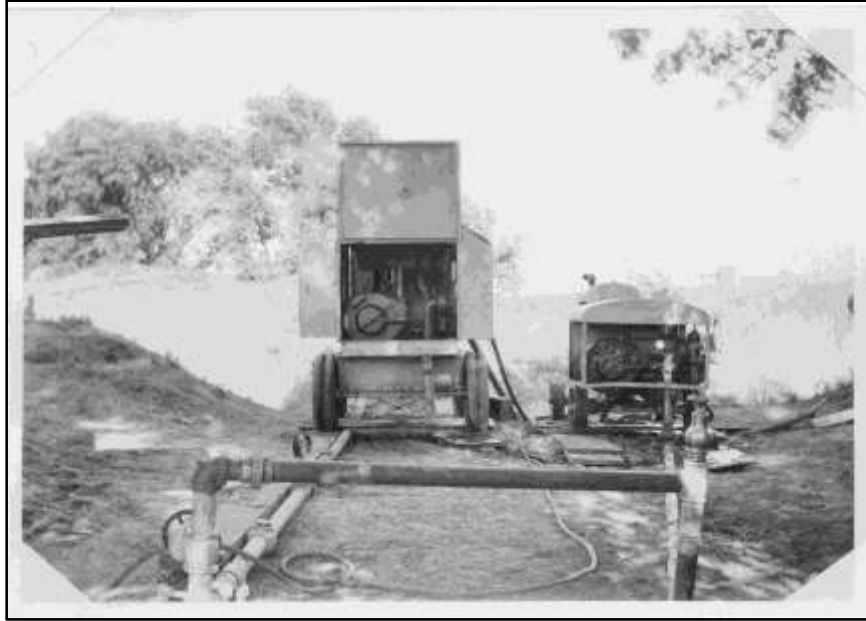
Figure 14 - Water lines and pumping equipment – Shelby County 1930s

A water pipe with multiple outlets was laid the entire length of the project to provide water. Duplicate pumping equipment was required to ensure against breakdowns.

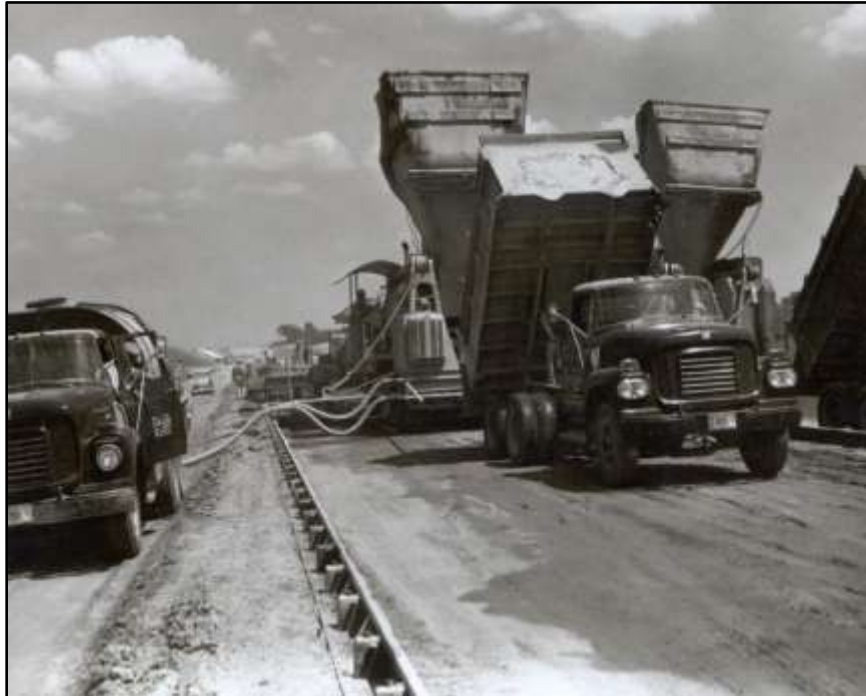
Figure 22 - Twin 34E mixers - Story County U.S. 30 1964

As capacity of dump trucks increased larger batches could be mixed. The limiting factor was the mixer which slowly grew from 11 cubic feet to the 16E (17.6 cubic feet), then to 27E (29.7 cubic feet) and then to the 34E (37.4 cubic feet) mixers. Utilizing twin or triple batch mixers greatly increased production.

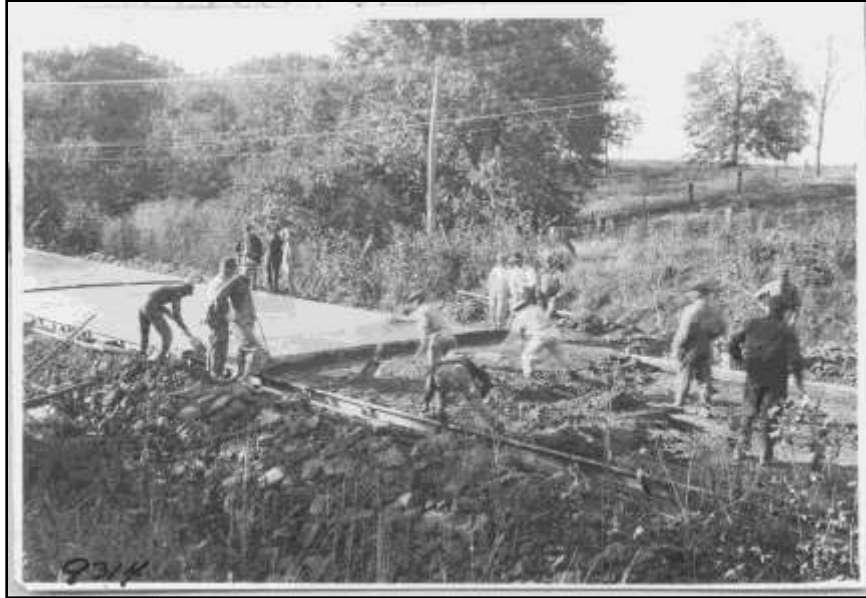
Figure 26 - Striking off concrete by hand – Story County 1922

Early pavements were struck off using a strike board cut to crown and proper length to span the full width between forms. The strike board was 2 inches thick with iron bound to the lower edge.

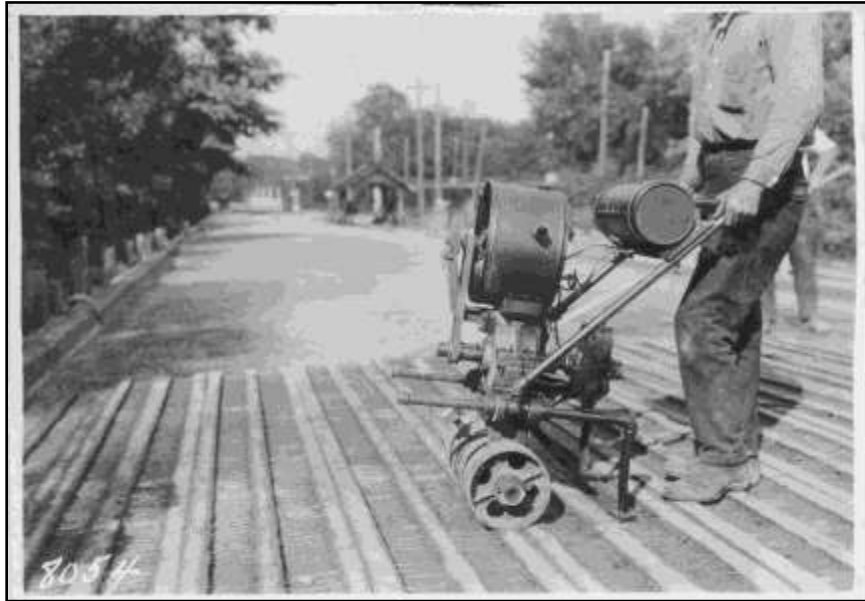
Figure 28 - Mechanical tamping and boards – Blackhawk County 1921

Until 1930, after the concrete was leveled off to an elevation above that shown on the plans, the concrete was required to be tamped by hand or mechanical tamper until thoroughly compacted.

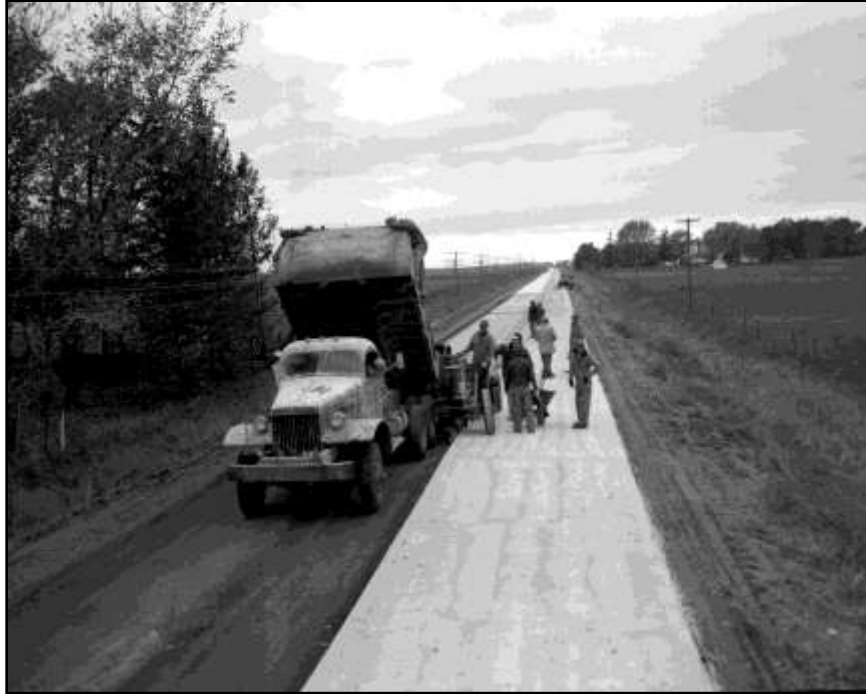
Figure 29 - Johnson slip form paver Greene County 1954

There was little advancement made with the slip form paver the next five years. The Greene County engineer wanted to try the slip form paver and secured permission to rent the pilot model to place a two mile project. In 1954, the slip form paver was leased to Ray Andrews Sr., Andrews Concrete, to pave a road near Churdan in Greene County. This project utilized PCC to fill the 3- to 4-inch gap immediately following construction of the second lane.

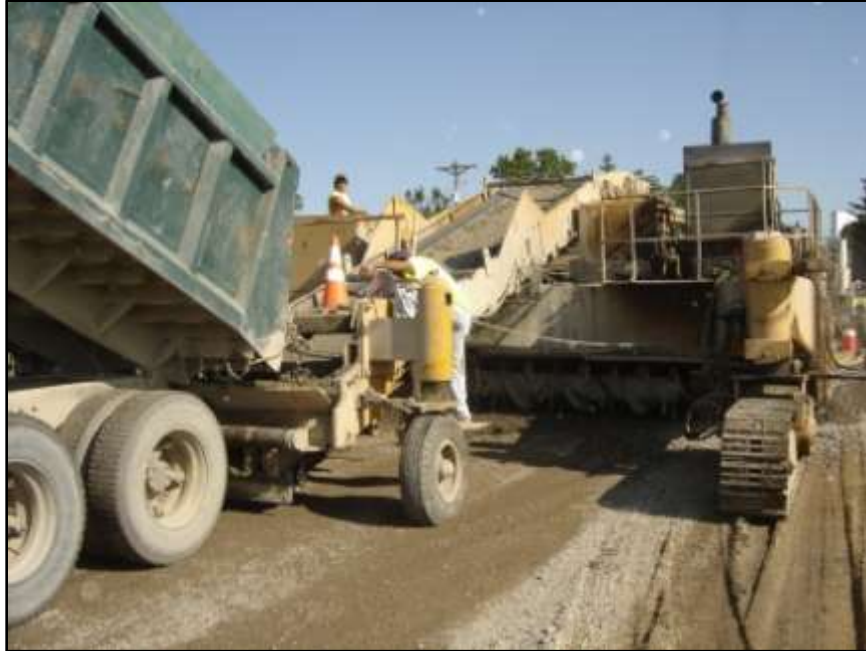
Figure 32 - Iowa Special trimmer/placer - Dallas County 2009

In the mid-to-late 1960s, another significant improvement to allow full-width concrete placement on secondary roads was the Iowa Special. A conveyor was attached to the front of the subgrade trimmer to allow the contractor to bring concrete delivery vehicles down the grade in front of the trimmer to place material on the conveyor while trimming the subgrade or subbase immediately before the material was deposited on the grade.

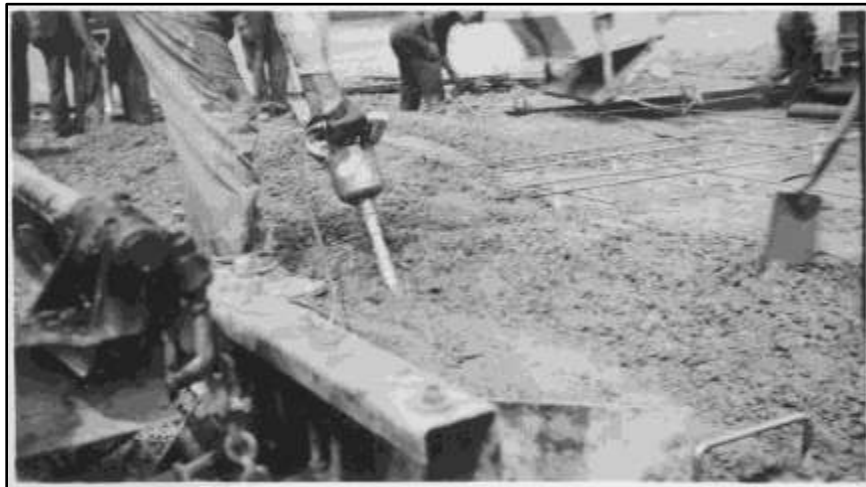
Figure 36 - Vibration near expansion joint - Bremer County 1936

In 1937, internal vibration was required within 18 inches of all expansion, contraction, and construction joints, including the center parting strip. All vibrators were to be operated at not less than 3500 vibrations per minute.

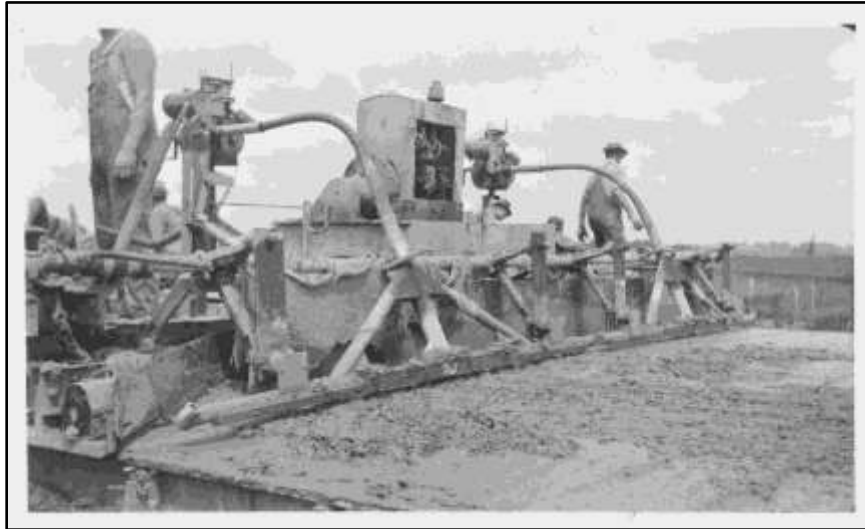
Figure 37 - Vibrators and tubes – Fayette County 1936

In the 1948 specification, vibration on the mechanical finishing machine replaced the requirement for tamping. Concrete being struck off shall be consolidated by means of a vibrating screed or pan operating on the surface of the concrete or by means of a vibrating tube or assembly of tubes. Vibration rate was required to be not less than 3500 vibrations per minute.

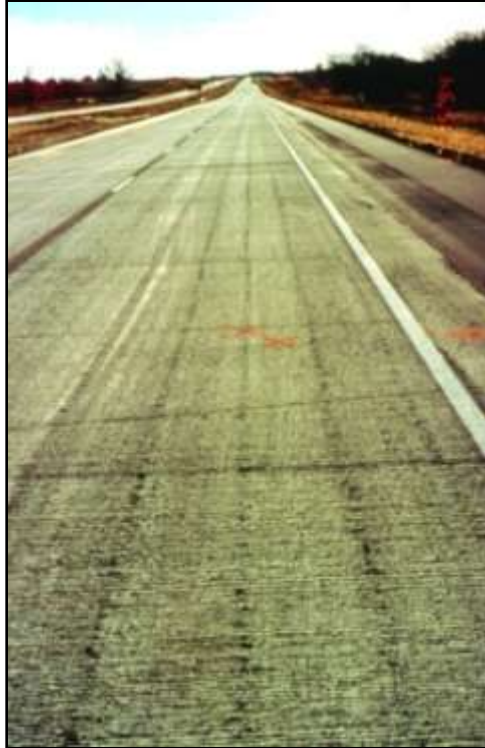
Figure 38 - Vibrator trails in pavement - Dallas County

In 1991, a section of U.S. 20 in Hamilton and Webster counties placed in 1987, began to show visible deterioration along vibrator trails and at the joints. This type of deterioration began to appear on several other paving projects placed between 1986 and 1994. Several research projects^{9,12,19} noted the loss of air in the vibrator trails and at the joints increasing the exposure to freeze-thaw damage.

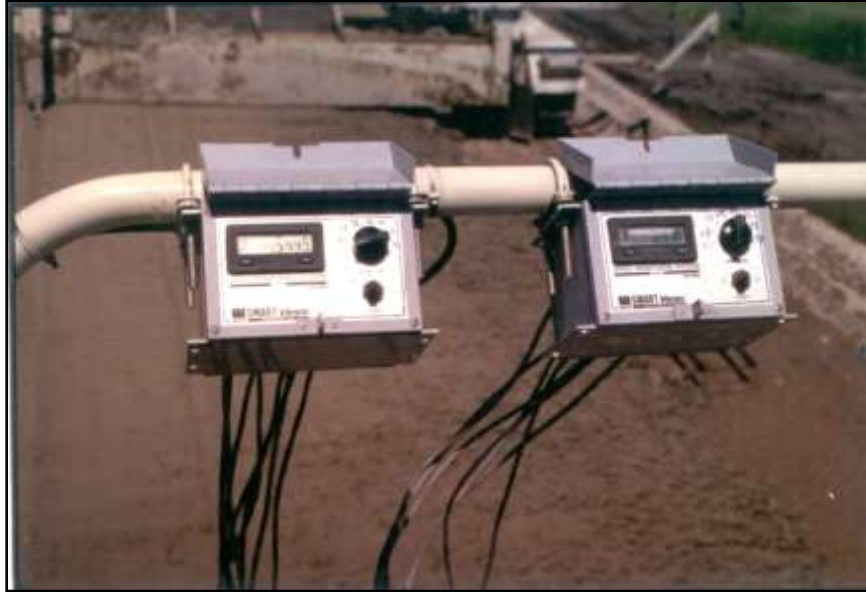
Figure 39 - Vibration monitoring equipment

In 1995, supplemental vibration at the dowel baskets was eliminated and the vibration rate was changed to a range of 5000 to 8000 vibrations per minute. A 1995 research project²⁰ validated this vibration range. In 1997, the requirement of vibration monitoring²¹ equipment was included on paving projects greater than 50,000 square yards. As contractors gained experience with well graded paving mixtures, they indicated the mix workability would allow lower vibration. In 2001, the vibration rate was changed to a range of 4000 to 8000 vibrations per minute.

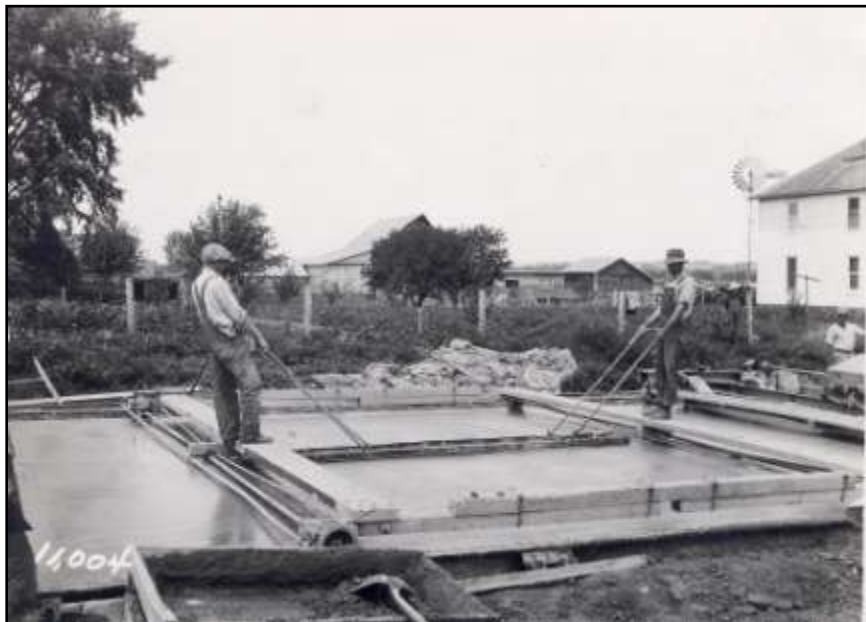
Figure 40 - Longitudinal finishing – Polk County 1926

Longitudinal finishing was accomplished by a 12-inch by 3-inch by 12-foot wood float. Immediately after longitudinal floating, the surface was struck off by heavy 10-foot straightedges set parallel to the centerline.

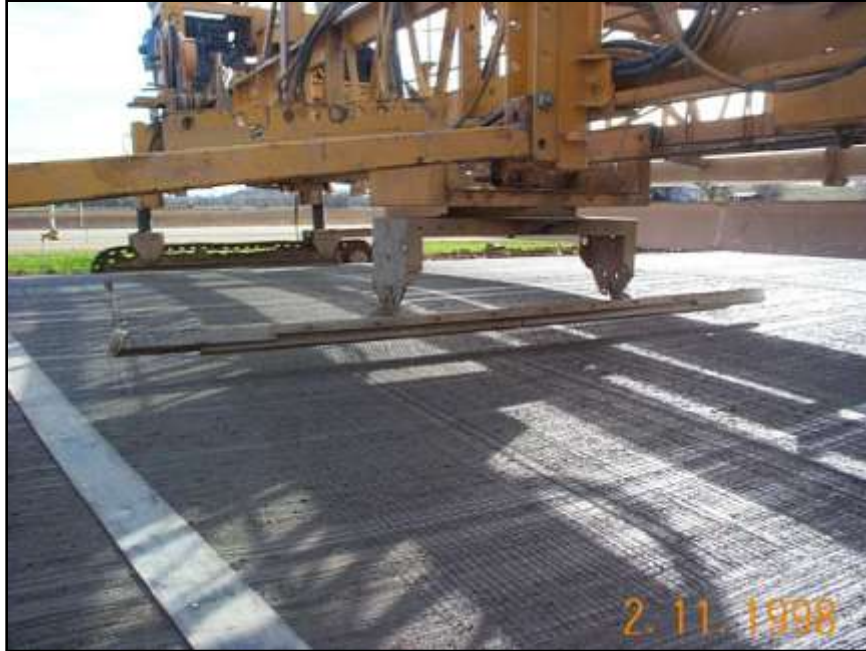
Figure 42 - Transverse tining - 1998

In 1976, *Guidelines for Skid-Resistant Pavement Design* was published by American Association of State Highway Transportation Officials (AASHTO). In order to ensure safe wet friction, Iowa implemented turf, coarse carpet or burlap micro texture and a three-quarter inch spaced transverse tining macro texture in 1976. In 1988 to 1989, the spacing was increased to 1½ inch centers. The 1½ inch wide tining proved to be very noisy and was changed back to three-quarter inch spacing in 1990. In 1992, burlap was deleted as a micro texture option. In 1993, a research project²² was implemented to determine noise, friction, and ride values on a variety of texture test sections on Iowa 163 in Polk County.

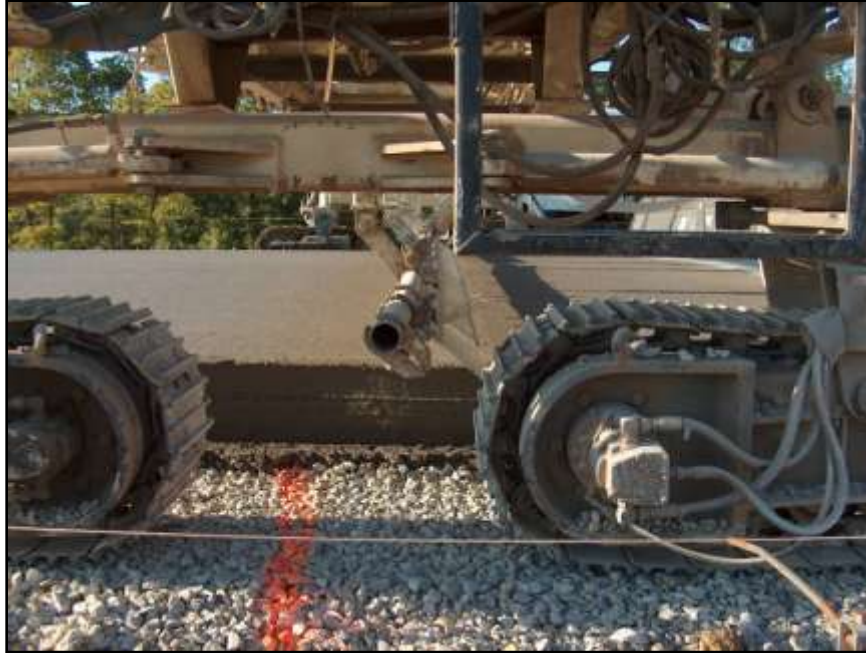
Figure 43 - Longitudinal tining - 2002

In 1999, in order to improve noise characteristics, the contractor was given the option of either a uniformly spaced three-quarter inch longitudinal tining or a randomly spaced, three-eighths inch to 1 $\frac{5}{8}$ inch, transverse tining. The majority of the contractors opted to utilize longitudinal tining which also expedited placement of curing compound after final finishing. In 2005, burlap was again added as a micro texture option to improve the surface on zero blanking band smoothness projects.

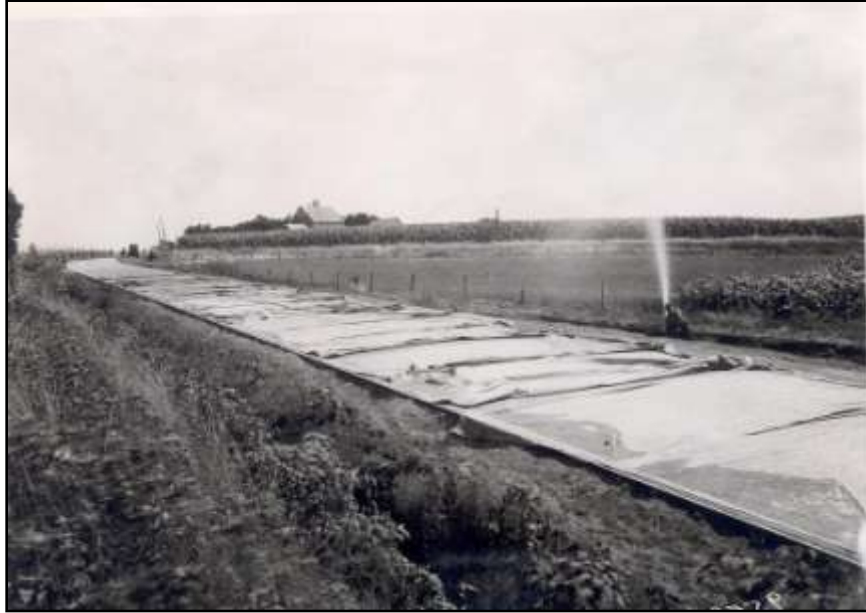
Figure 44 - Burlap and water curing – Woodbury County 1921

The 1925 specifications allowed curing by ponding with a minimum depth of 2 inches of water was allowed in lieu of earth cure. In 1948, curing by ponding was added back to the specifications. Ponding was achieved by earth dikes to cover the pavement with a minimum of one-half inch water depth for 48 hours after the burlap was removed.

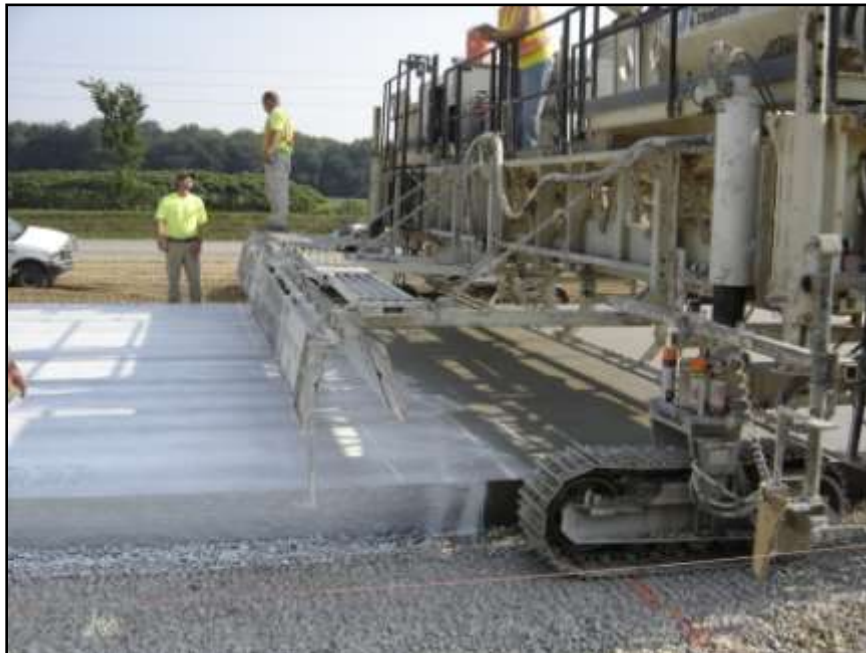
Figure 49 - White pigmented curing - Tama County 2005

As the slip form paver gained more widespread acceptance, white pigmented curing compound applied after final finish was the method most generally used. This was because water trucks could not be used along the edge of the pavement. Also, white pigmented curing did not break down the fresh pavement edge as water curing would.

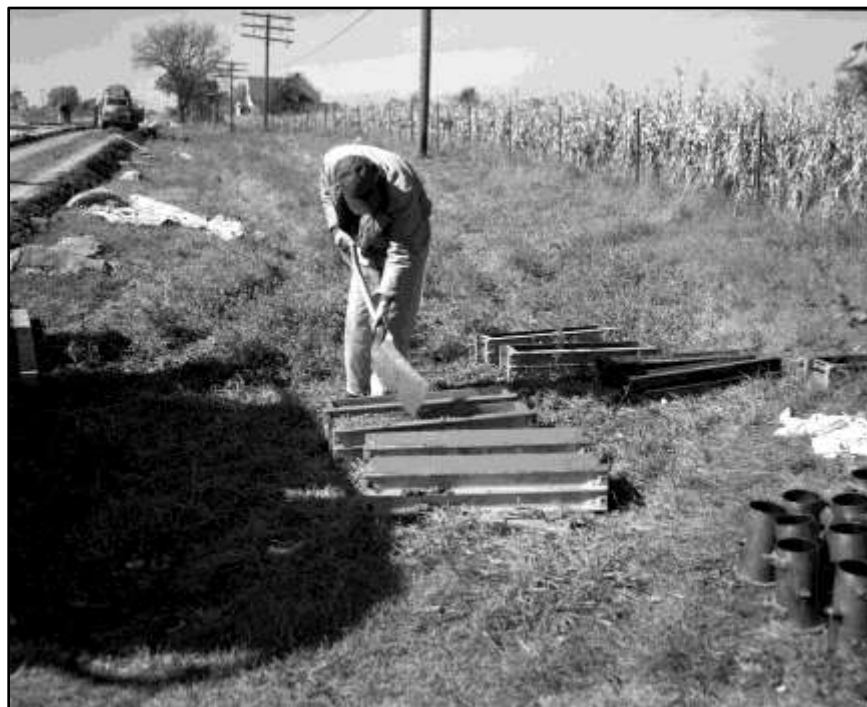
Figure 50 – Worker casting flexural strength specimens

Since 1937, the time for opening has been based on a flexural strength of 500 psi, modulus of rupture center-point loading (MOR-CPL). Contractor forces were allowed on the pavement after the minimum age period of seven days for standard Class C concrete. In 1972, the minimum age period became five days for pavements 9 inches or thicker.

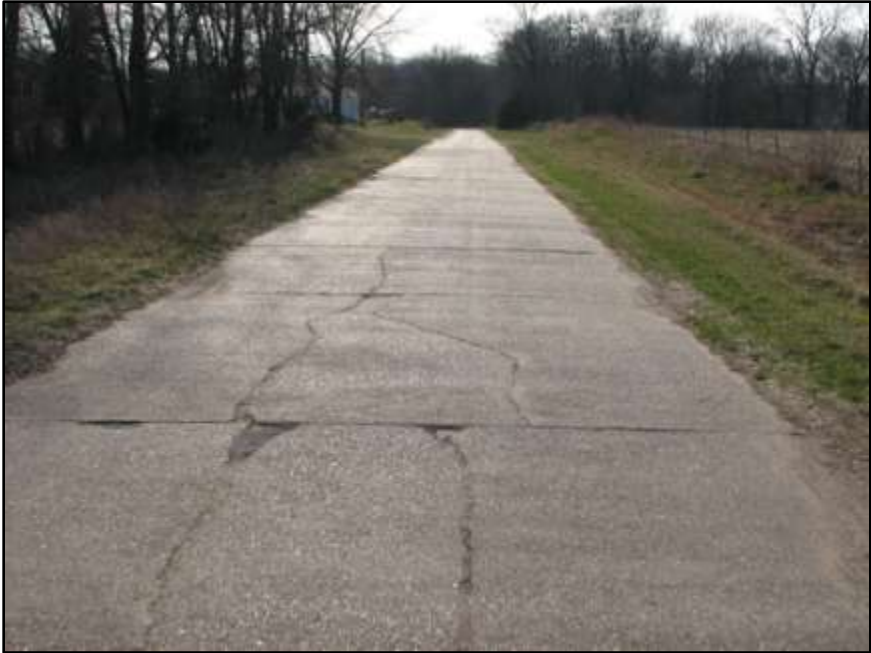
Figure 51 – Moscow Road Muscatine County 1914 - formed transverse joints at 25 foot intervals

1920 and 1925, transverse or longitudinal joints were not placed. Between 1925 and 1930, the longitudinal joint was steel or mastic, but no transverse joints were placed. In 1930, premolded bituminous expansion joints were placed above the dowel bars with expansion tubes, typically at 80 to 100 feet intervals, and finished by hand.

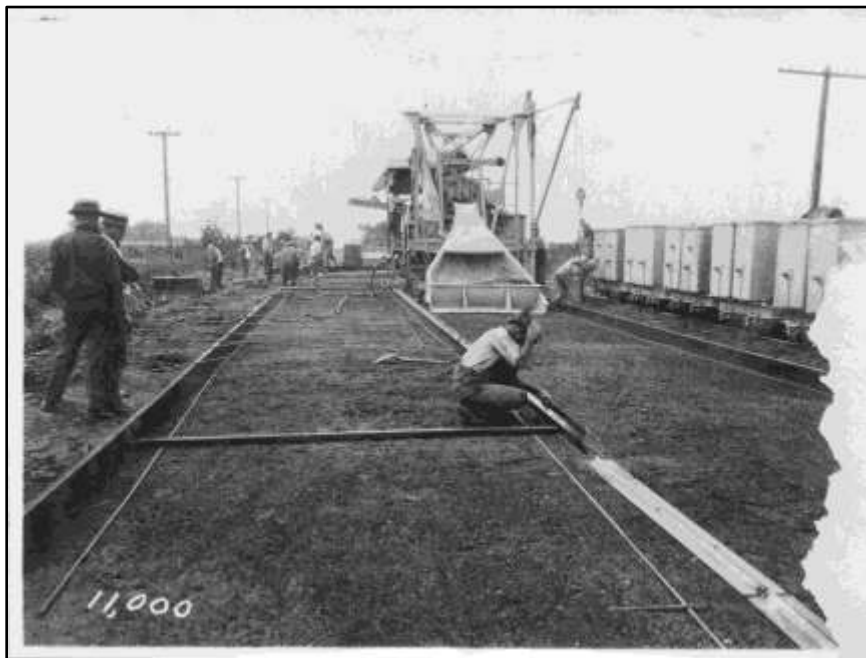
Figure 56 - Placing metal parting strip – Polk County 1926

In 1933, longitudinal joints were constructed with a metal parting strip with a plane of weakness at 2½ inch from the surface or a premolded bituminous strip installed with continuous operation.

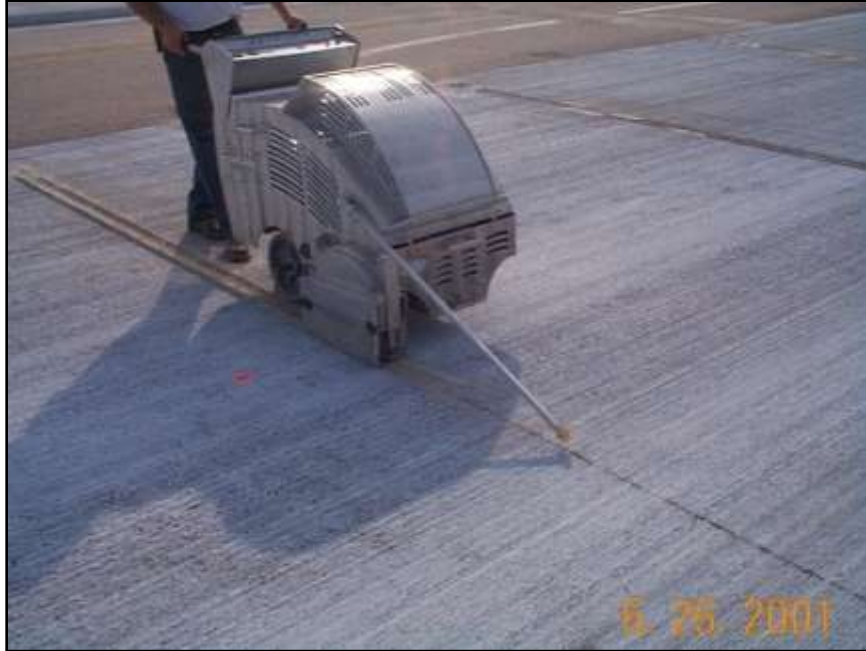
Figure 60 - Early entry sawing transverse joint

In 1990, the early entry saw was used on several nonprimary pavements in Story City, Cedar Rapids, Boone County, Airport Road in Nevada, and Dubuque. Experimental sections were also sawed on Iowa 13 in Coggon, Iowa 17 north of U.S. 30 and I-35 at Milepost 141. In 1992, test sections of transverse joints were sawed utilizing the early entry saw on Iowa 163 in Polk County. On these projects, Bob Steffes, Office of Materials, noted that within 72 hours every second to fifth joints had cracked. Between 72 to approximately 200 hours, no additional joints cracked until construction traffic was placed on the pavement. Early entry sawing has become common practice for sawing of transverse joints.

Early entry sawing was utilized on the longitudinal joint on I-80 in Jasper County in 1993 and on Story County Road E-63 in 1994. Both pavements developed random longitudinal cracking. Based on the random cracking, an investigation²⁵ determined that the early entry saw was not developing a sufficient weakened plane on the longitudinal joint and that a saw depth of one-third the pavement thickness ($T/3$) was required to prevent random cracking.

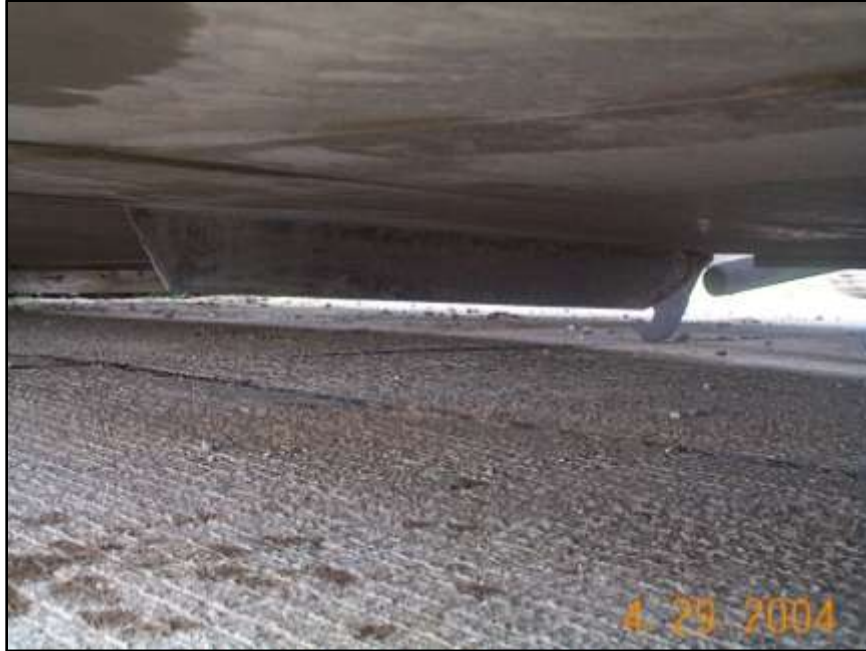
Figure 61 - Longitudinal joint forming knife on paver pan

In 2001, Bob Steffes, Office of Materials, developed a concept to form the longitudinal joint in the plastic concrete²⁶. A knife mounted on the slip form paver pan was first used on the U.S. 34 Mount Pleasant bypass. The knife was one-eighths inch wide and 3 inches deep produced a plane of weakness in the plastic concrete. As the concrete matures and shrinks, a hairline crack developed along the plane of weakness. The crack remains very tight and eliminating the need for sawing and sealing.

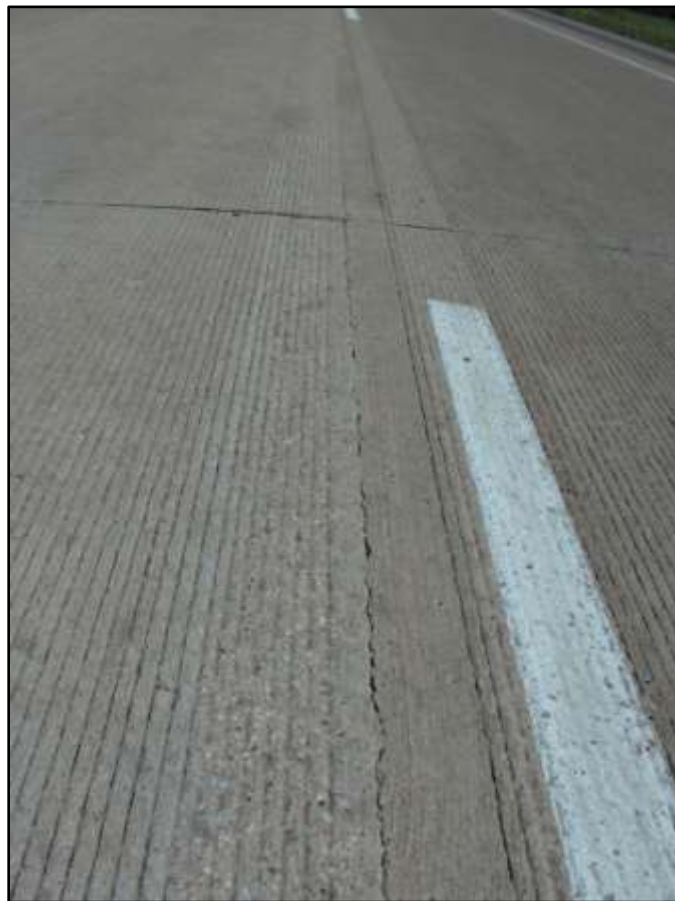
Figure 62 - Hairline crack on knifed joint

This process was used on a number of projects from 2001 into 2005 with mixed success. Within a couple years, random cracks began to develop at various locations along the longitudinal joint. It was noted that wet loads combined with excess finishing, including the oscillating screed, possibly worked the plastic concrete to a point that the weakened plane no longer existed. Due to problems with random cracking, the joint forming knife has not been used since 2005, although other states have continued use of the knife.

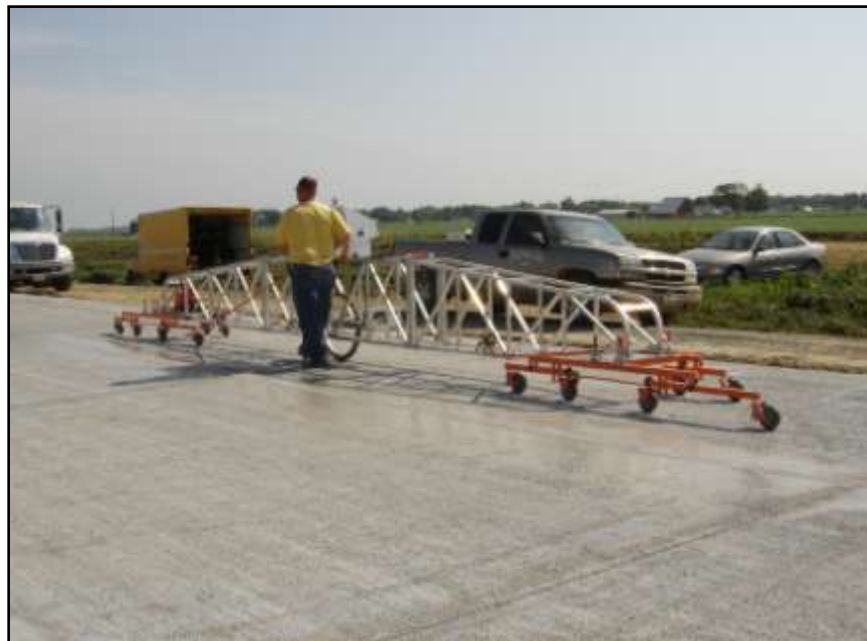
Figure 66 - 25 foot California type profilograph

In the early 1970's, it was noted that a one-eighth inch in 10 foot criteria for smoothness was no longer adequate in determining the ride of new pavements. With the need for driver safety and comfort at higher speeds, a testing machine capable of detecting with longer profile undulations was required. A 1974 research report²⁷ recommended the 25-foot California profilograph to determine pavement smoothness variations and also develop a specification to help obtain safe, smooth riding pavement for the public.
