100 Years of Concrete Pavement In Iowa

Final Report
For
MLR-07-01

By
Todd D. Hanson
PCC Engineer
515-239-1226
Fax: 515-239-1092

Office of Materials
Highway Division
Iowa Department of Transportation
Ames, Iowa 50010

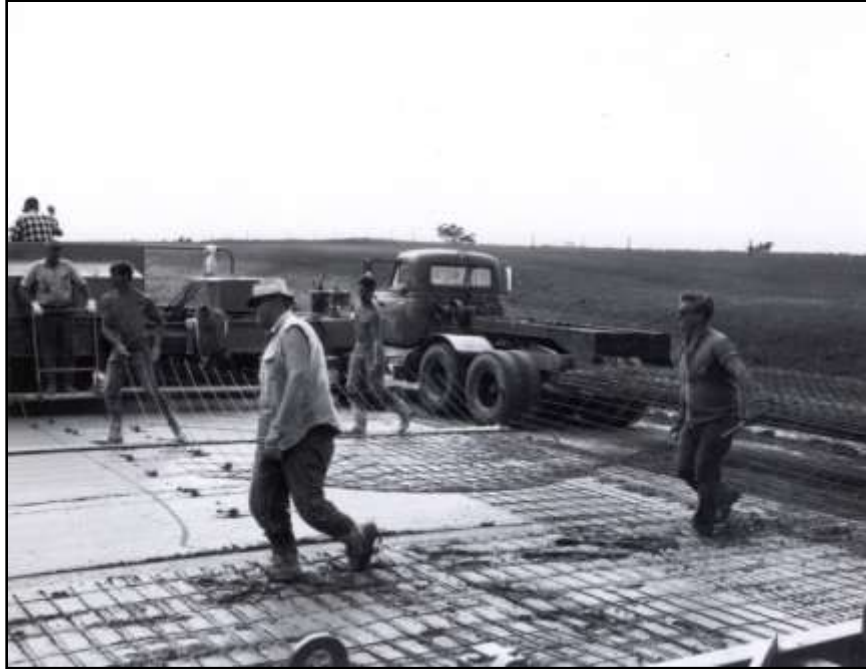
Figure 71 - Mesh reinforcement - Dallas County I-80 1966

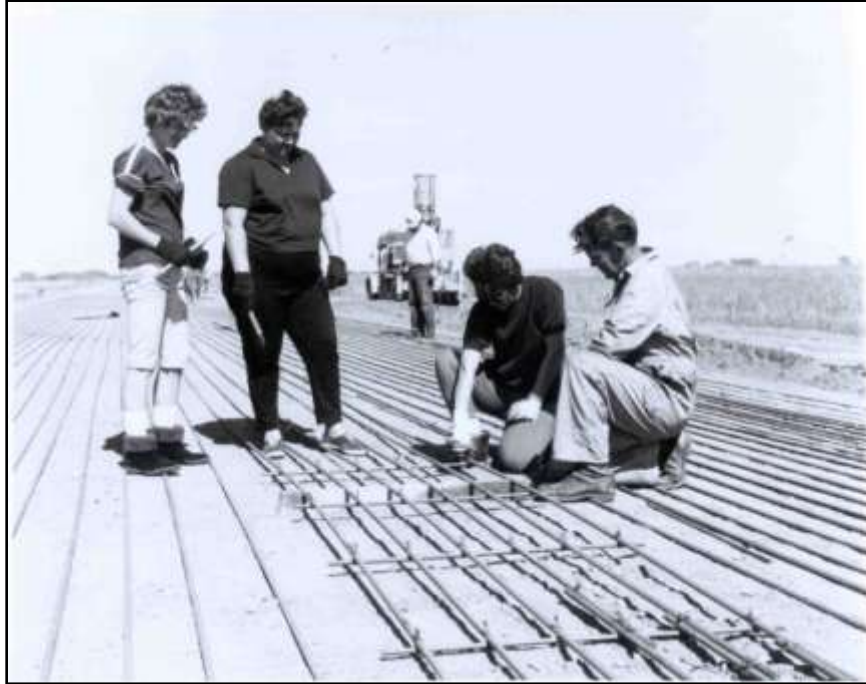
Figure 72 - Continuously reinforced concrete (CRC) steel placement on chairs

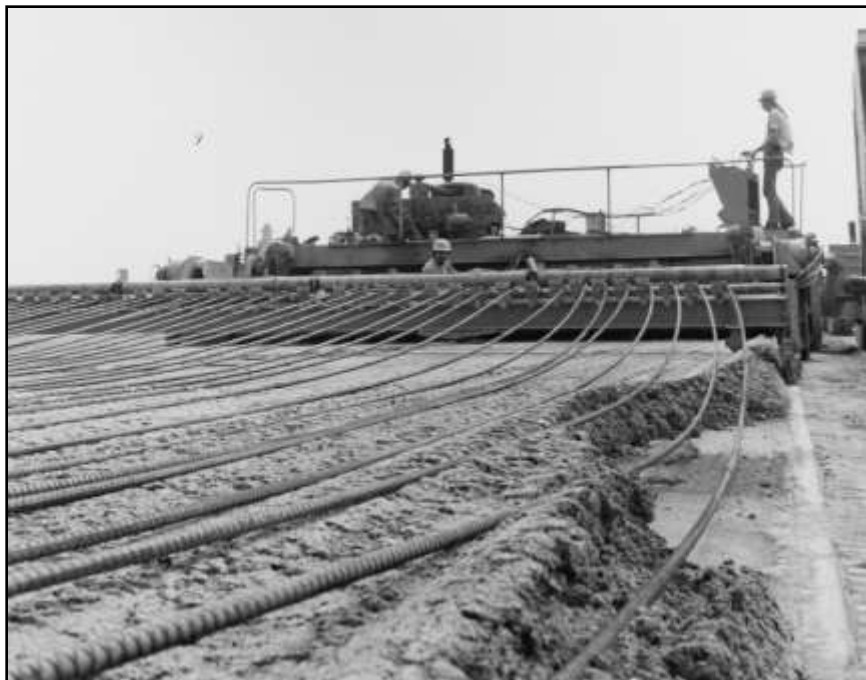
Figure 73 - CRC steel fed through machine - Franklin County I-35 1976

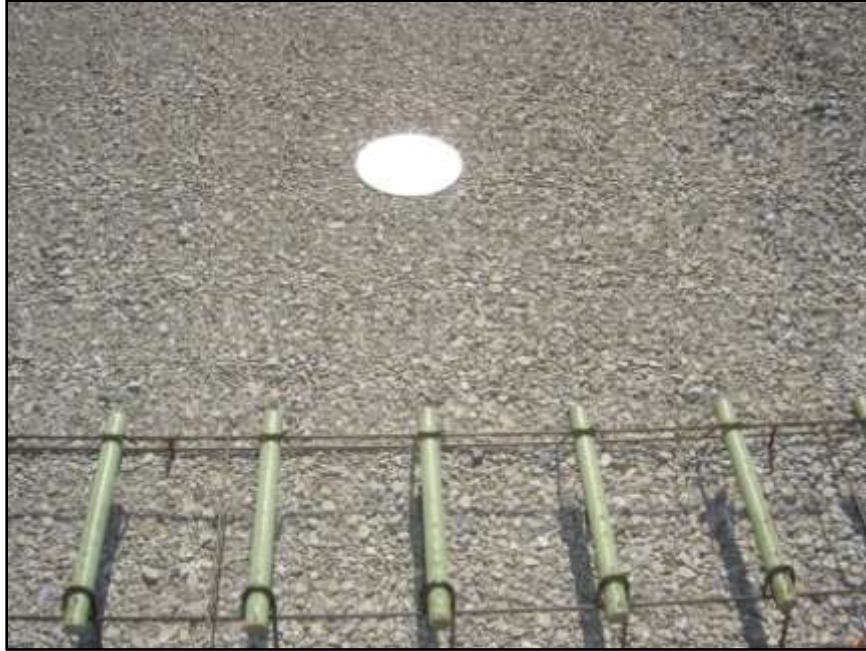
Figure 80 – Metal target before placement to test pavement thickness

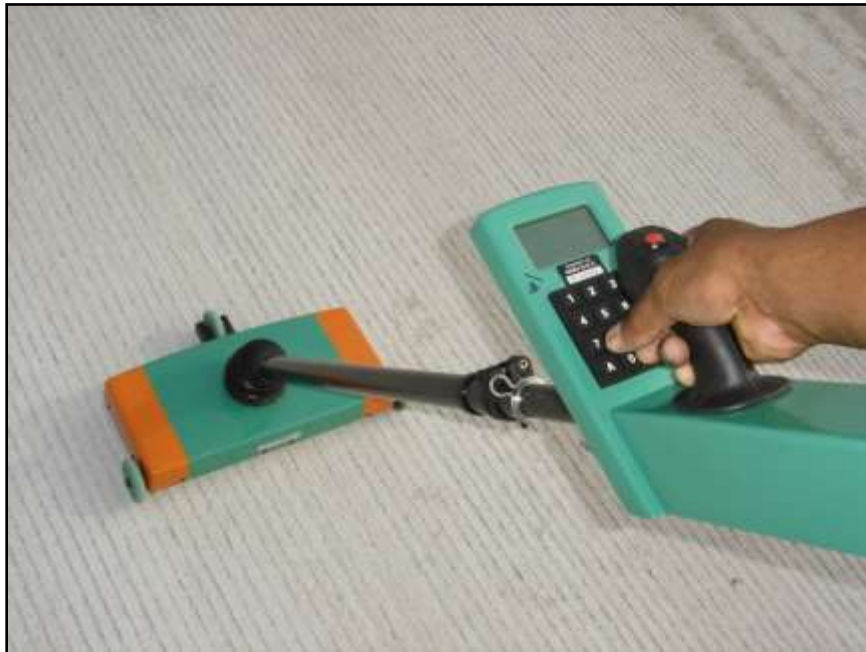
Figure 81 – Nondestructive pavement thickness equipment (MIT-SCAN-T2)
