134 SPRING STREET / 84 WOOSTER STREET

EXISTING STOREFRONT PHOTOGRAPHS

EXISTING VS PROPOSED WOOSTER STOREFRONT

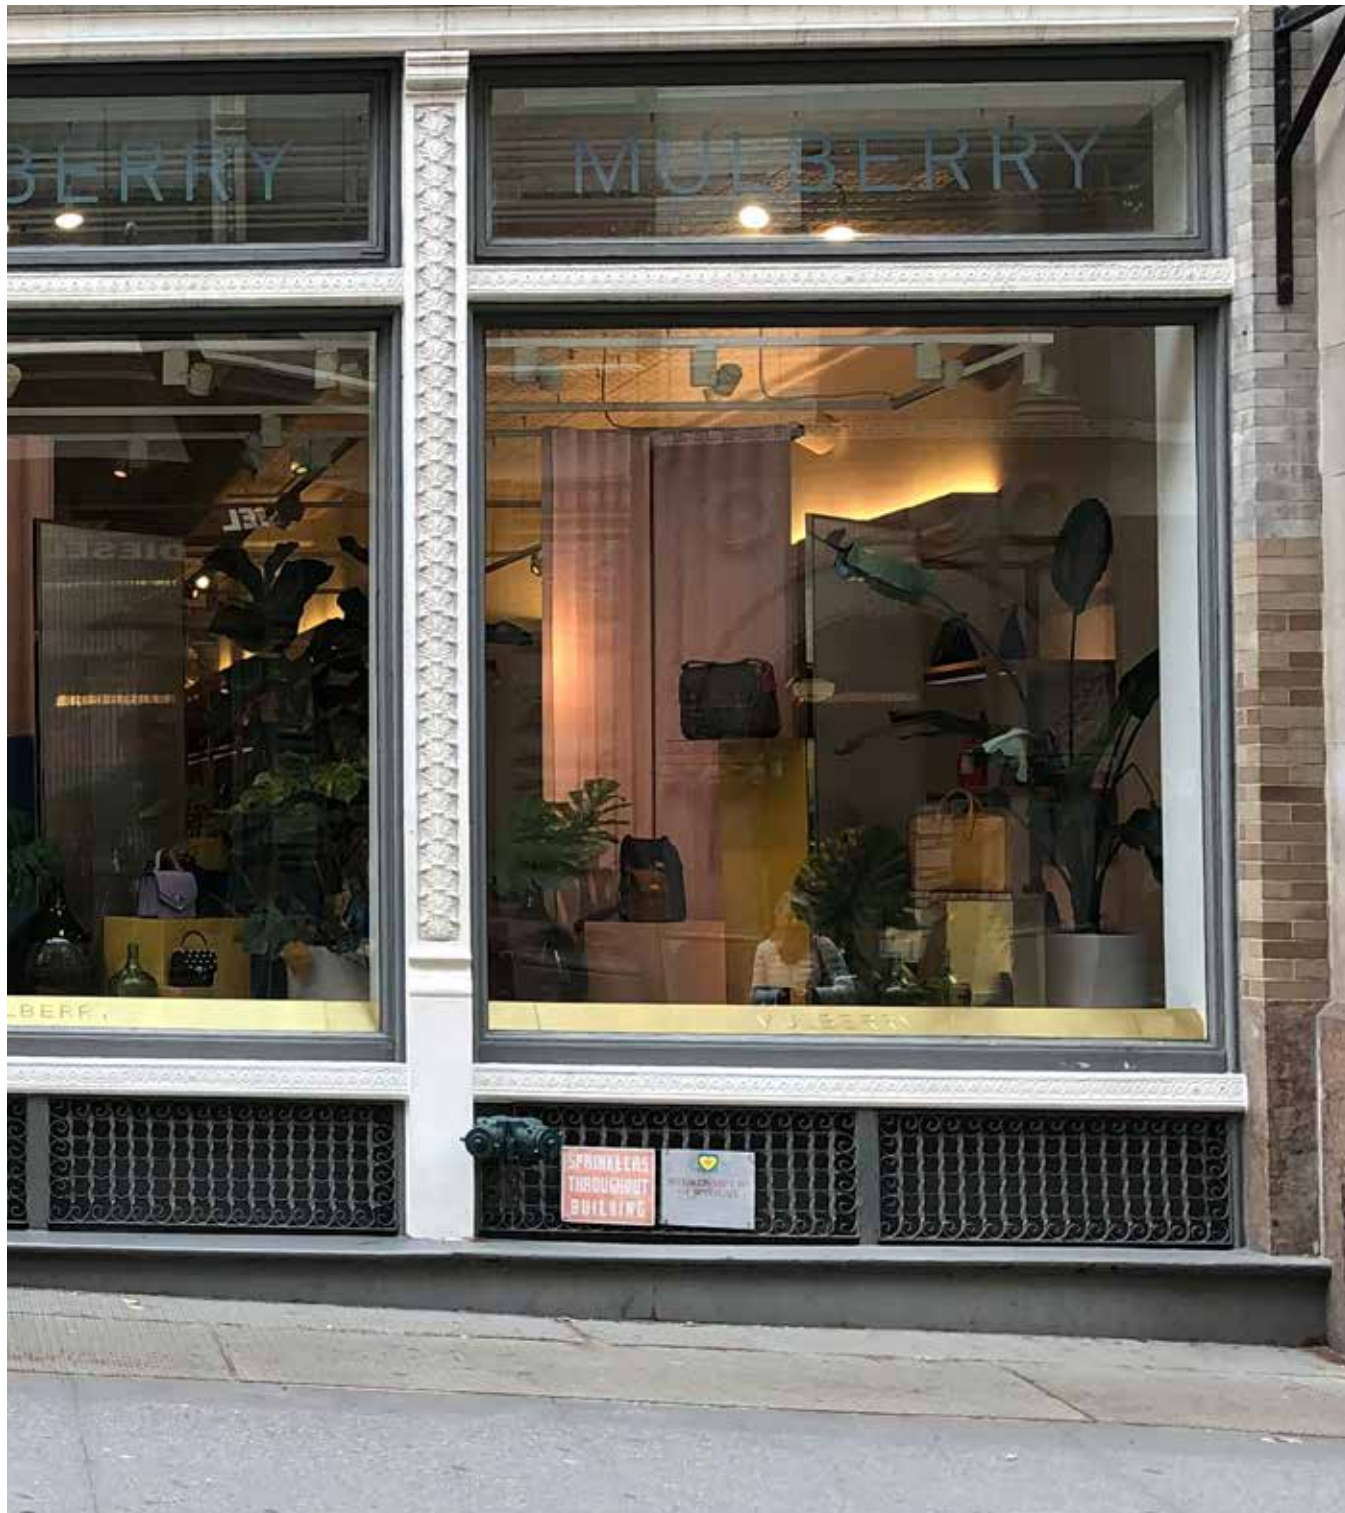
134 SPRING STREET
SINGLE PANEL BULKHEAD

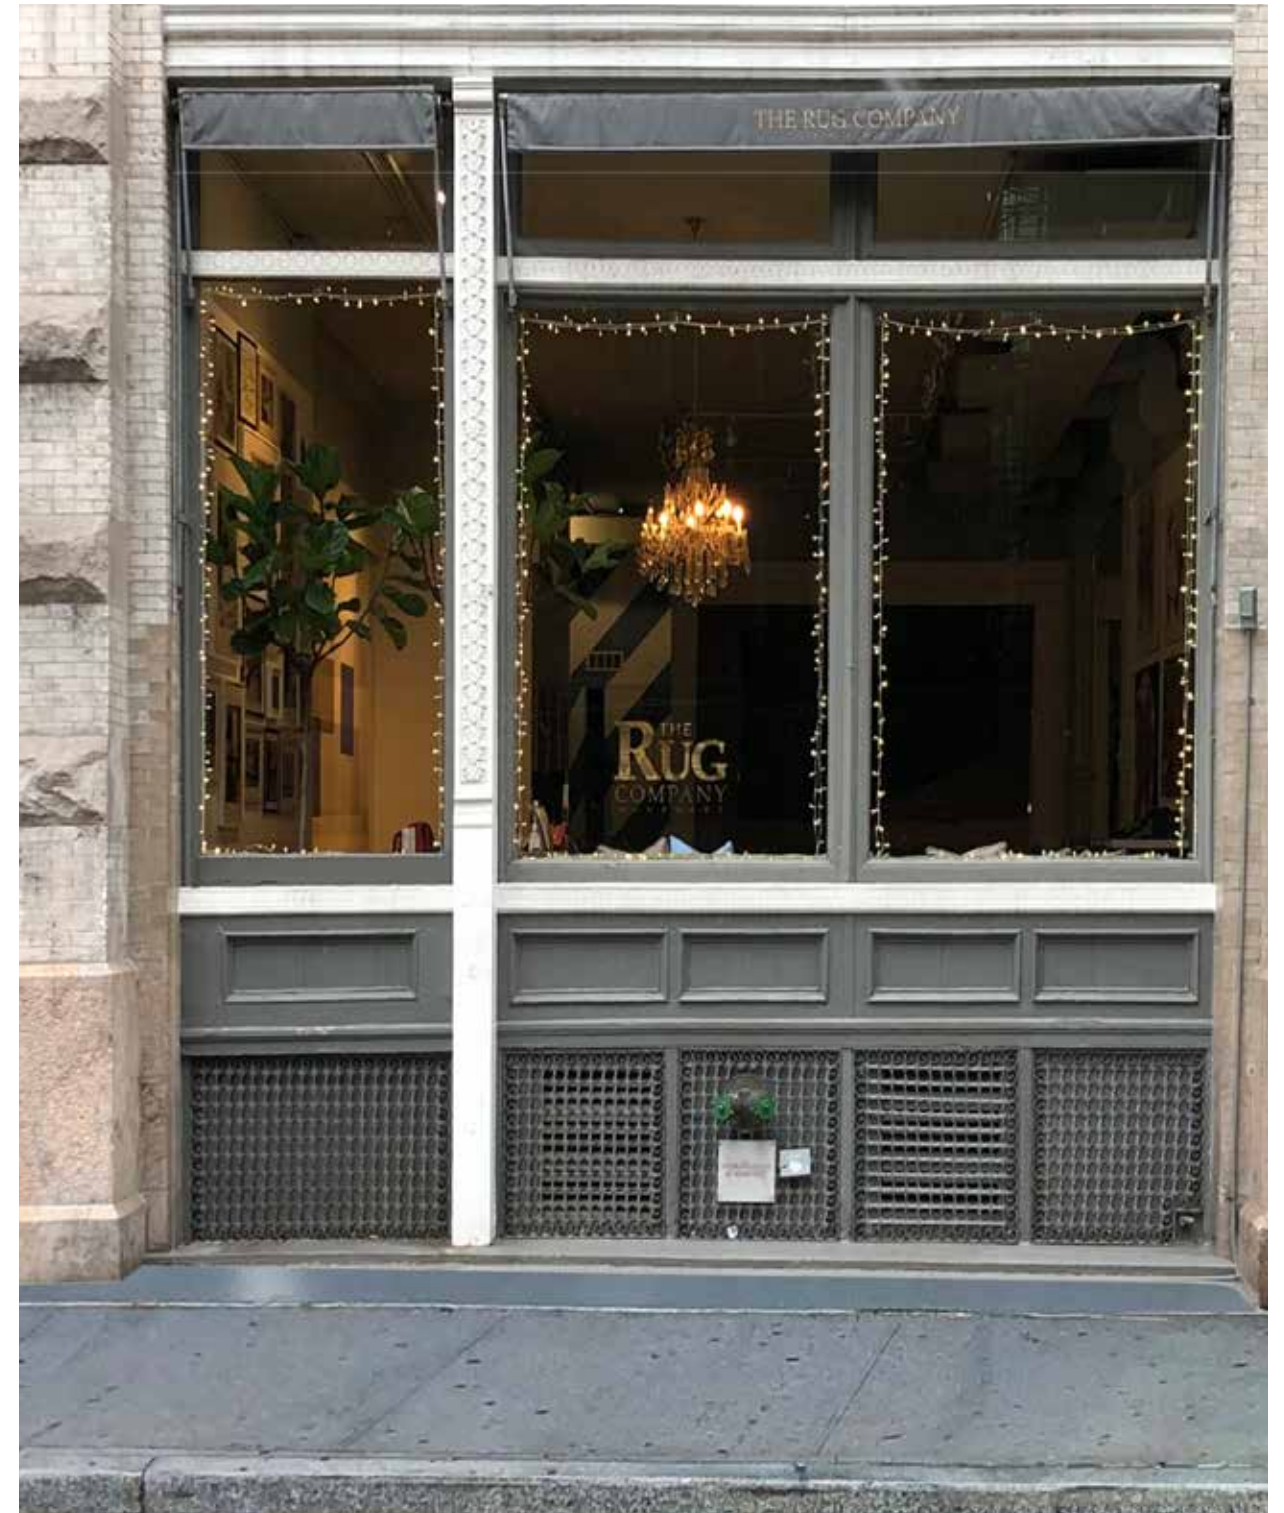
84 WOOSTER STREET
DUAL PANEL BULKHEAD

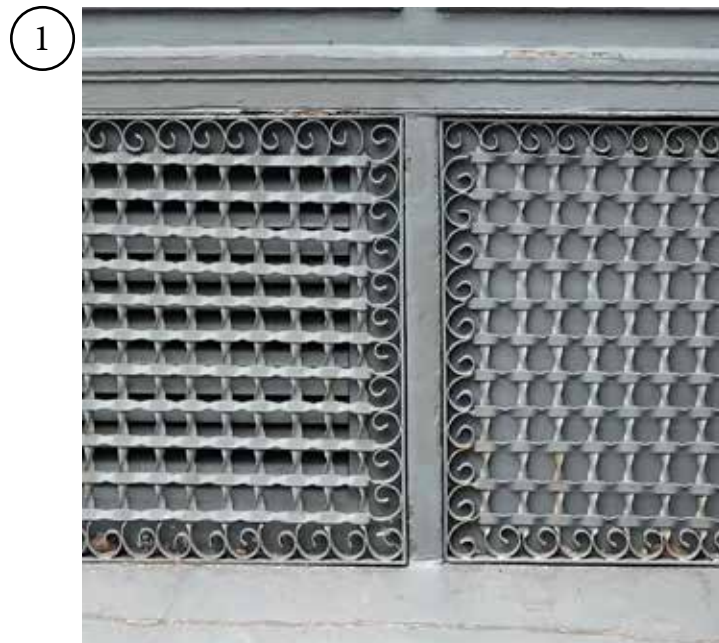
EXISTING PAINTED BULKHEAD LOUVER/METAL GRILL WITH PLYWOOD OR DIAMOND PLATE BACKER TO REMAIN

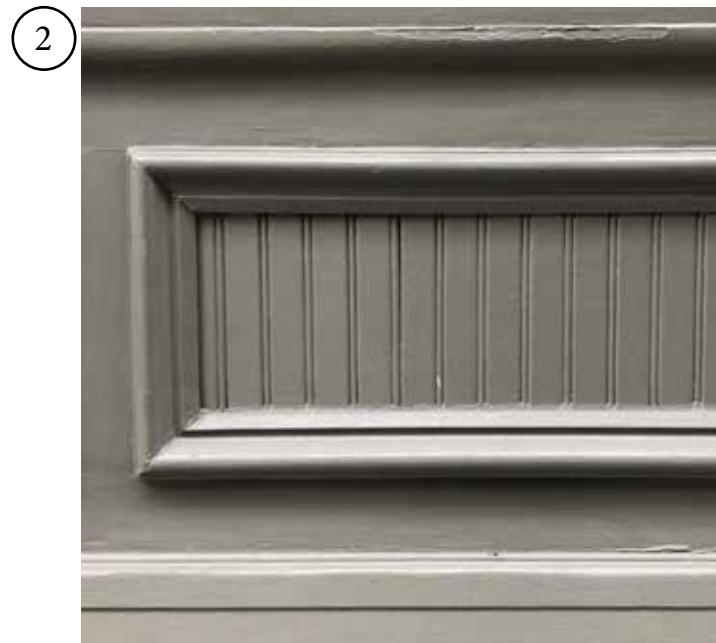
EXISTING WOOD/PLYWOOD BULKHEAD PANEL (NOT HISTORICAL. TO BE REMOVED)

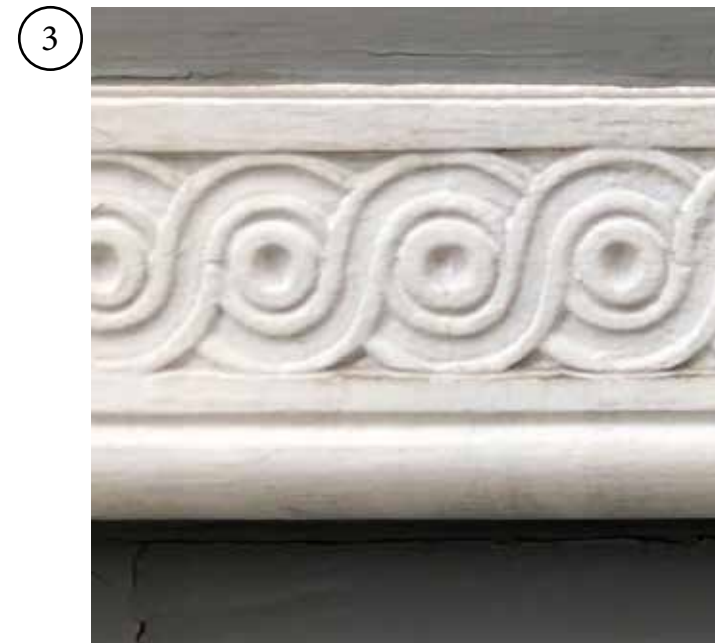
EXISTING HORIZONTAL CAST IRON DETAIL

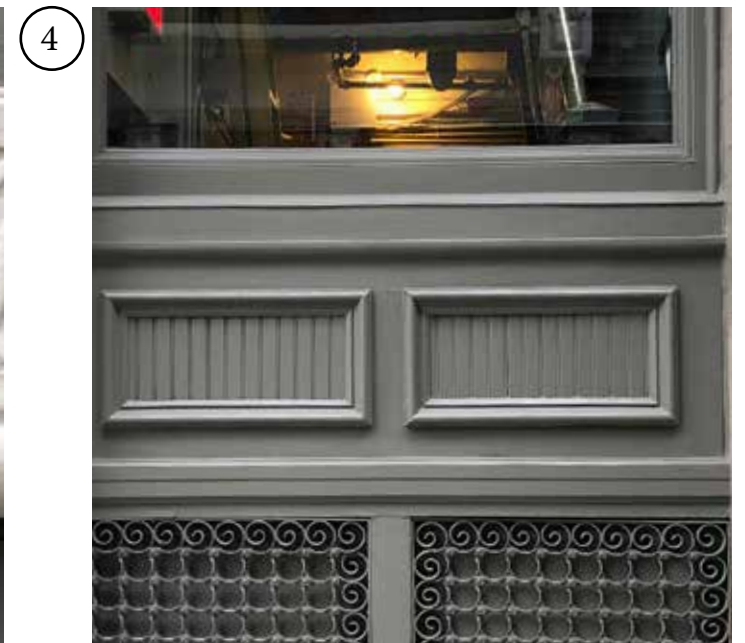
EXISTING BAY AT 84 WOOSTER - MISSING DECORATIVE CAST IRON SILL. TO BE REPLICATED IN LIKE KIND OUT OF WOOD

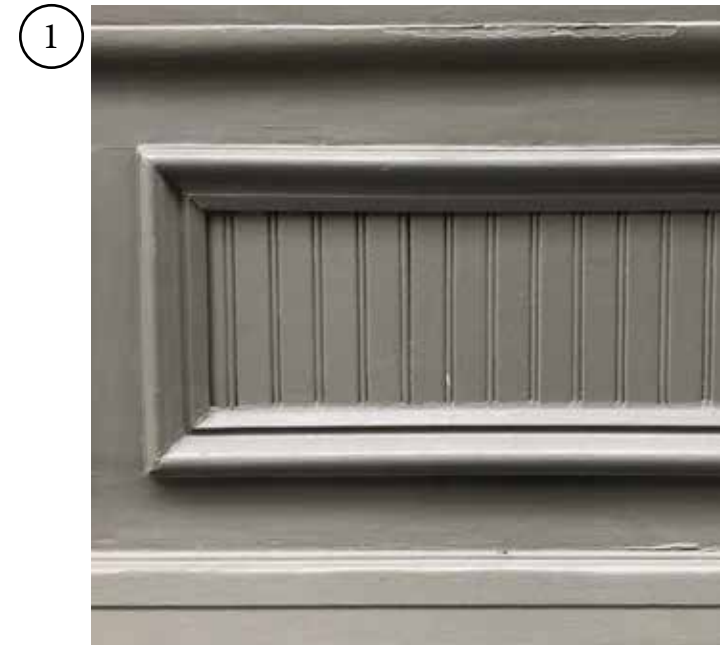
EXISTING WOOD BULKHEAD PANEL (TO BE
REMOVED)

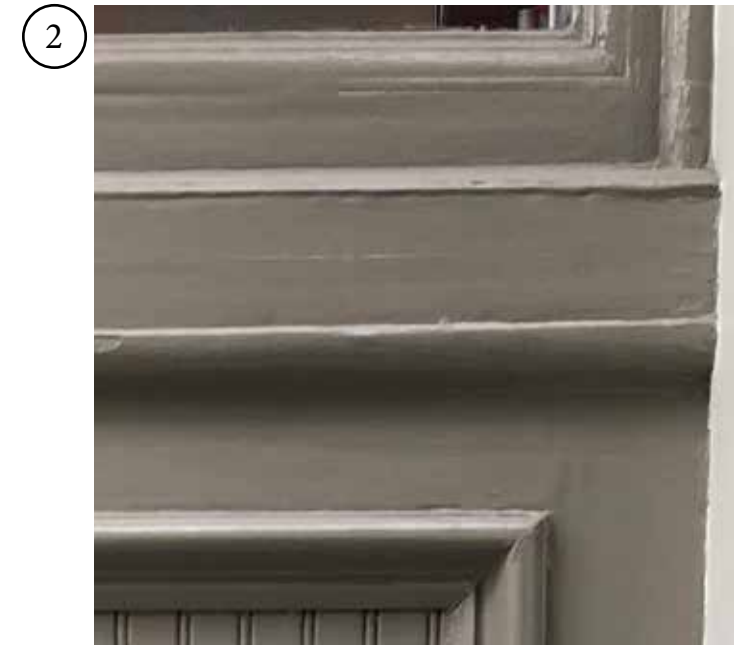
EXISTING HORIZONTAL PAINTED TRIM DOES
NOT MATCH OTHER STOREFRONT WINDOW
BAYS WITH CAST IRON TRIM

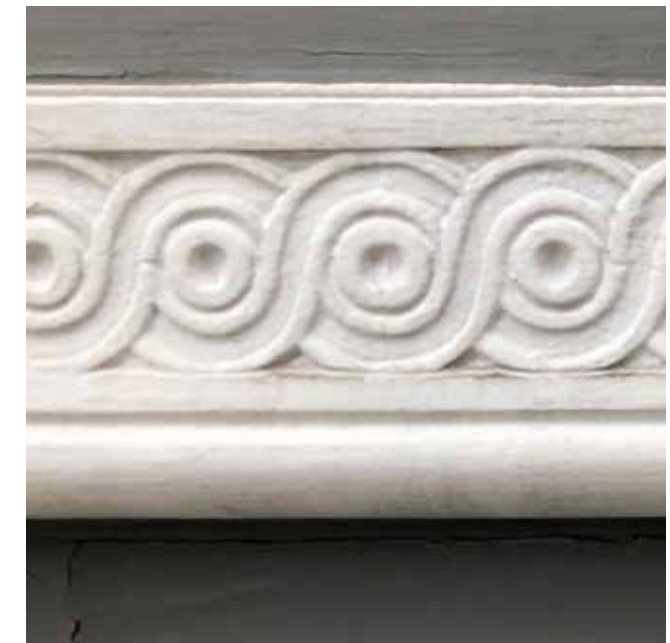
TYPICAL EXISTING HORIZONTAL CAST IRON
DETAIL

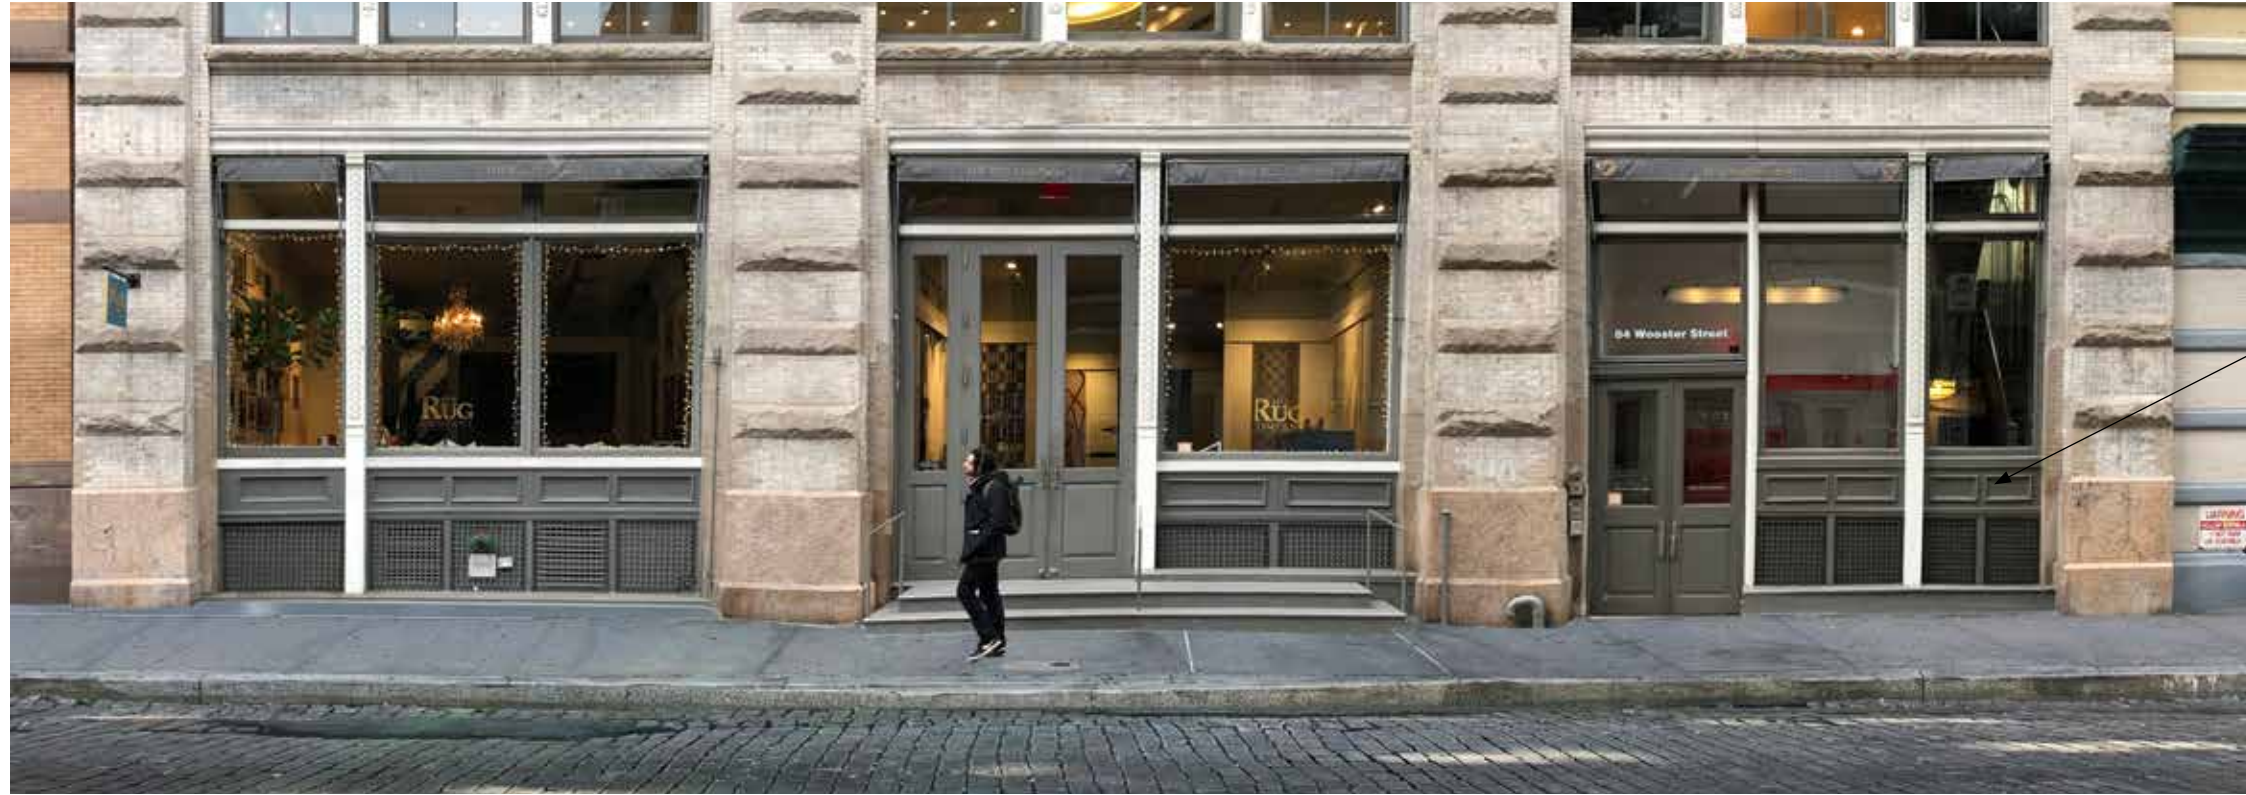
EXISTING STOREFRONT

REMOVE BULKHEAD INFILL PANEL

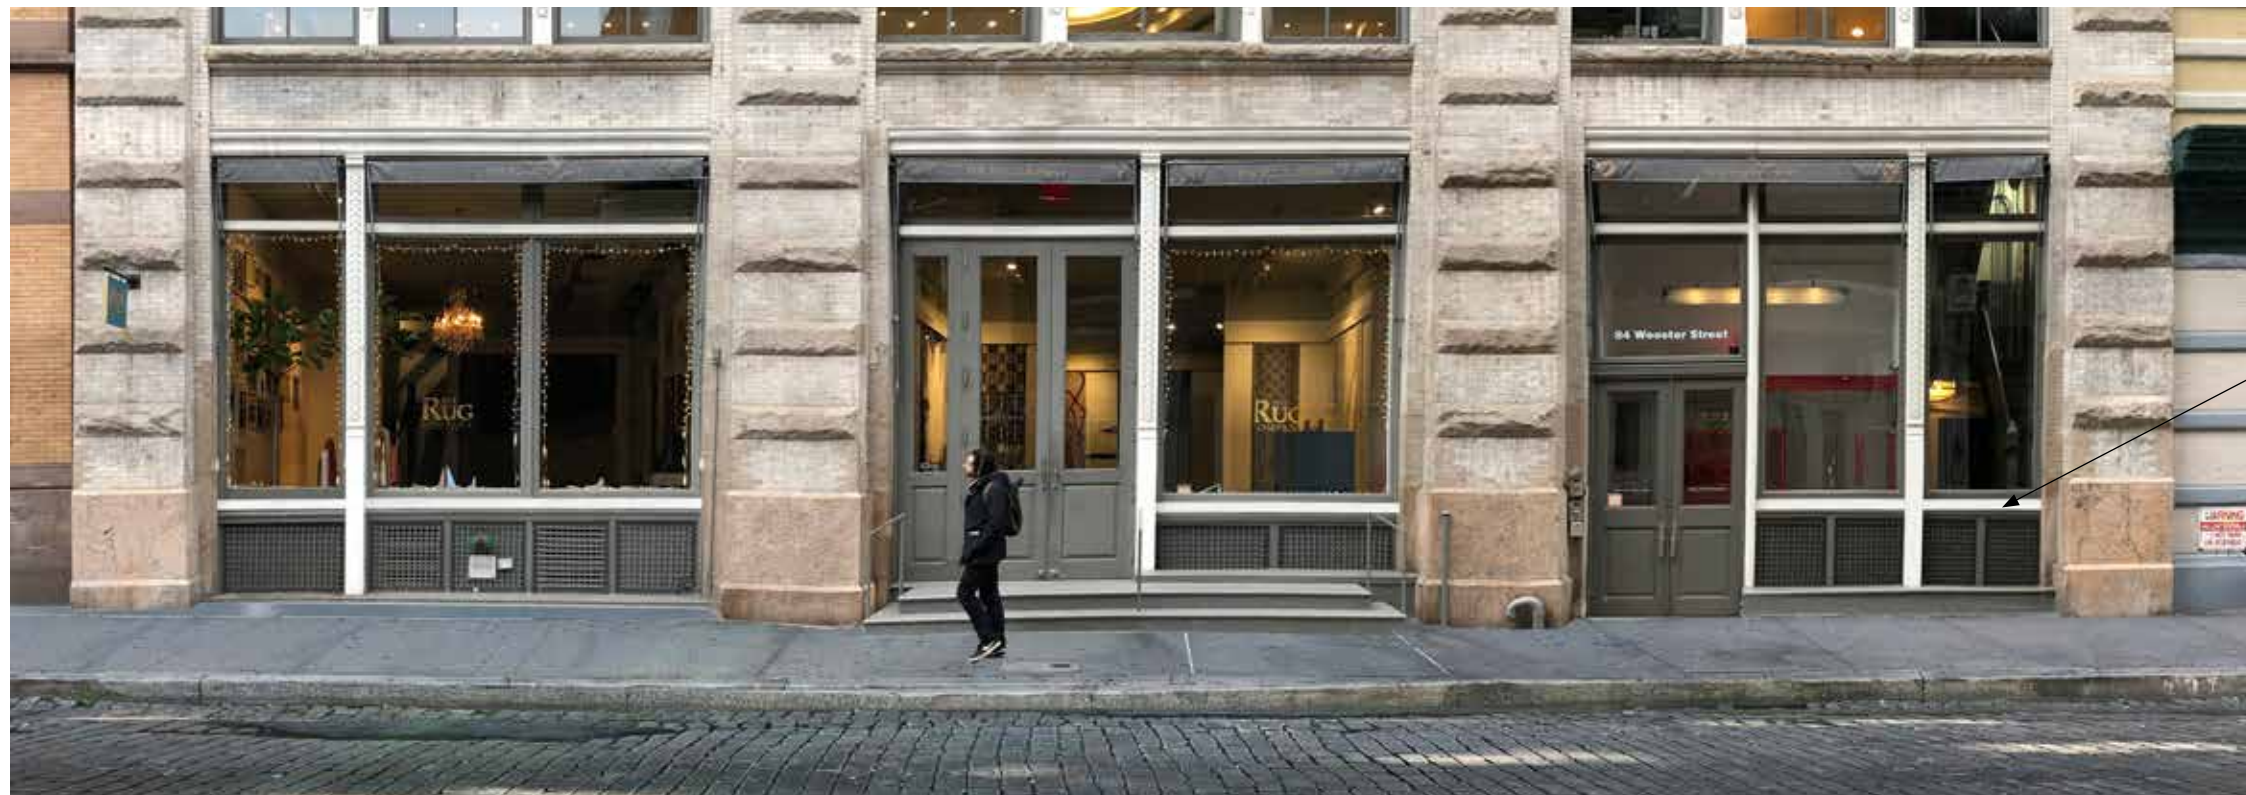
PROPOSED STOREFRONT

VERTICALLY ENLARGE SINGLE PANE WINDOW & FABRICATE NEW TRIM PIECE.

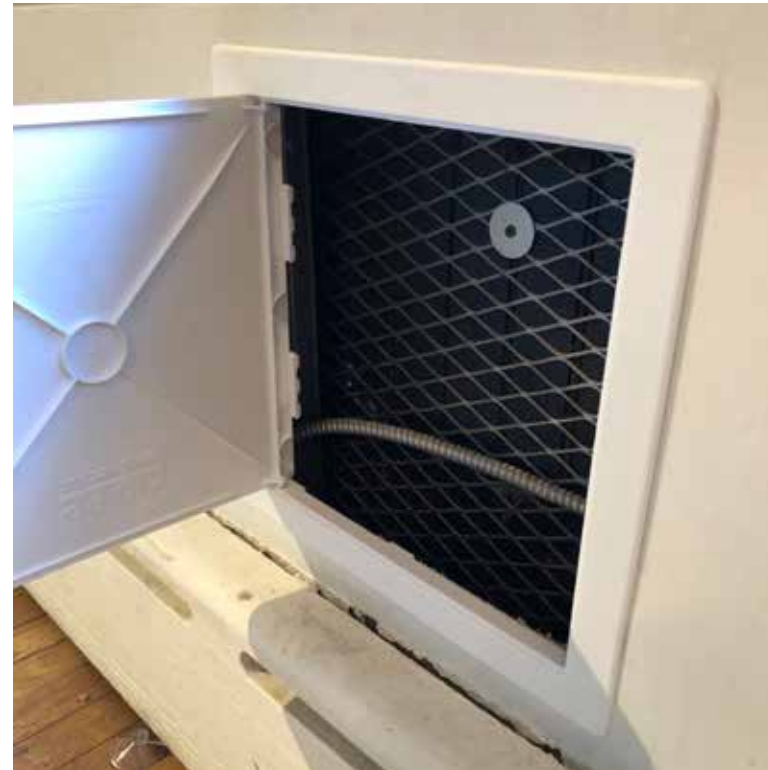
WALL ASSEMBLY DETAIL PHOTO

- ① NEW STEEL STUD CONSTRUCTION (NOT ORIGINAL)
- ② MODERN PLYWOOD BEADBOARD AND STEEL LATH.

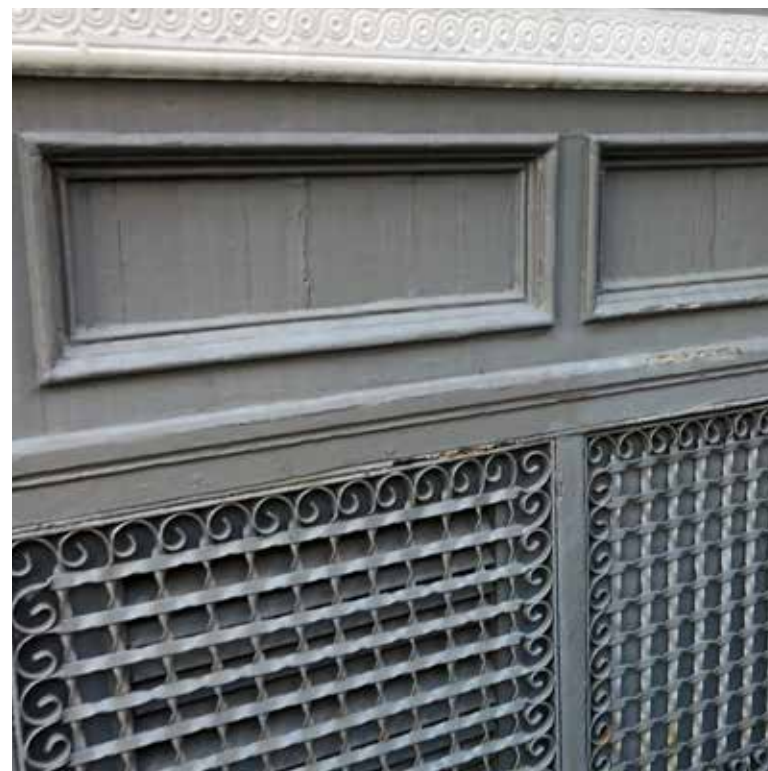
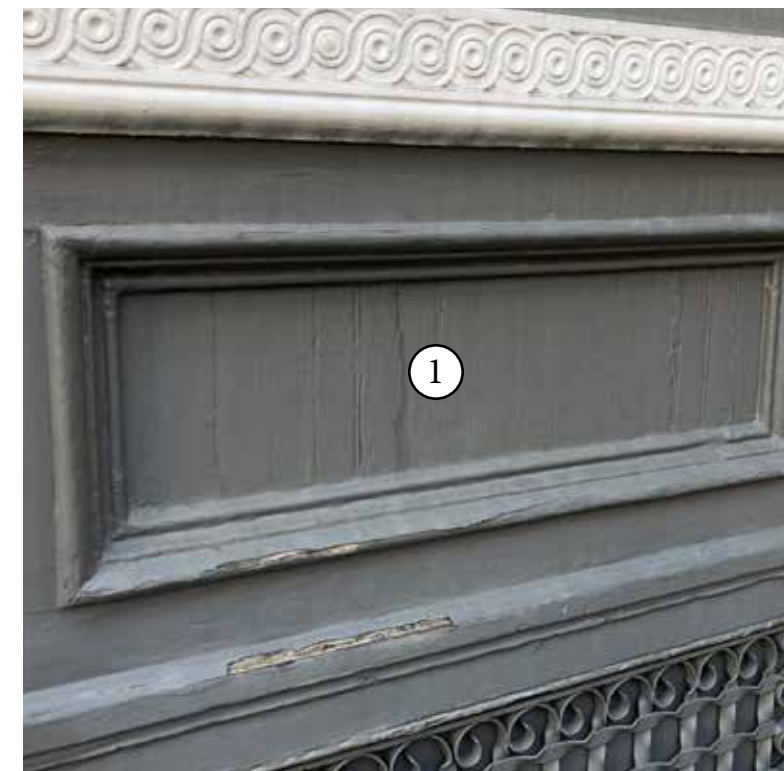
WALL MATERIAL DETAIL PHOTO

- ① PLYWOOD BEADBOARD AND TRIM ATTACHED TO NEW STEEL STUD. (NOT ORIGINAL)

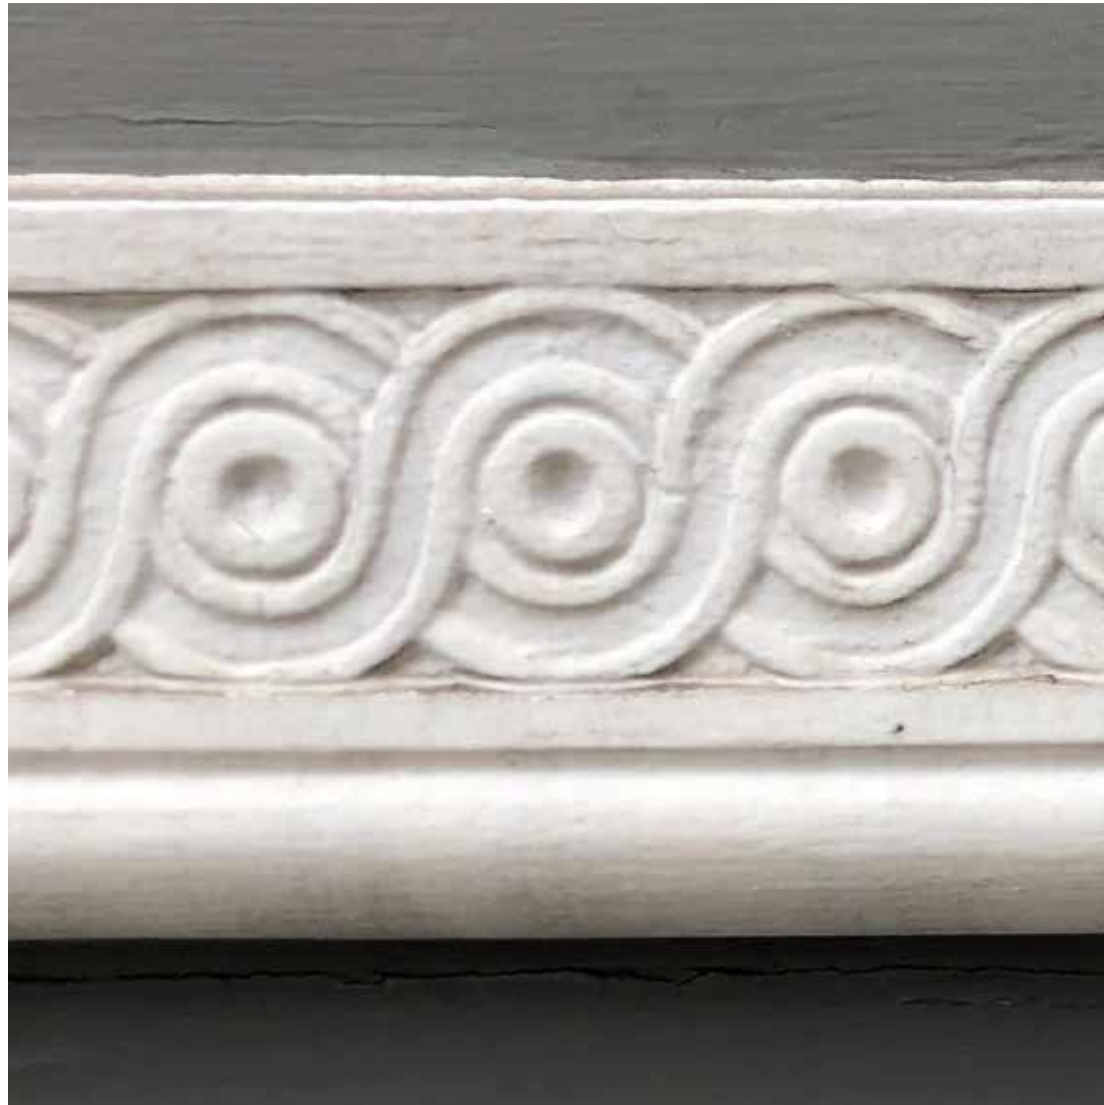
PHOTO OF EXISITING HORIZONTAL CAST IRON TRIM
