## 2 Feature of the Fha Lai Thermal Power Joint-stock Company

## 2.1 Corporate development

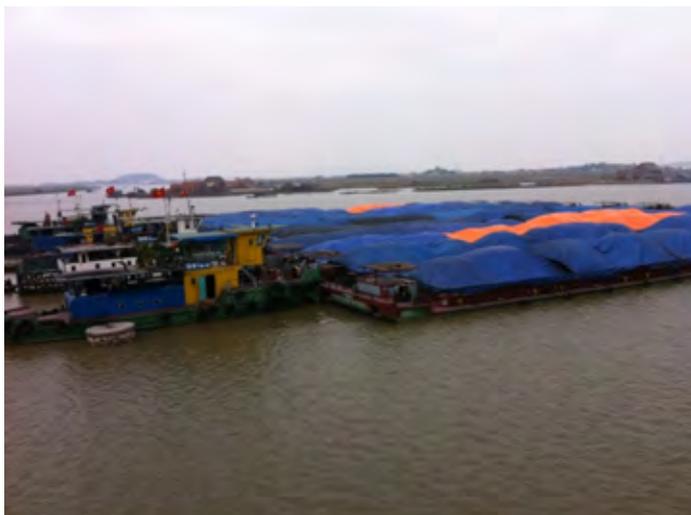
Figure 2.3-1 Coal transfer by coal carriers

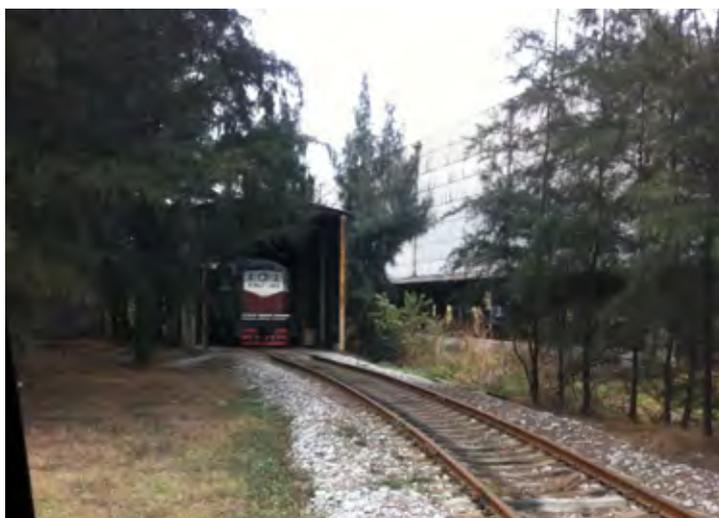
Figure 2.3-2 Coal cars

Coals transferred by coal cars are directly thrown onto conveyor by tilting wagon in both case of Pha Lai I and Pha Lai II

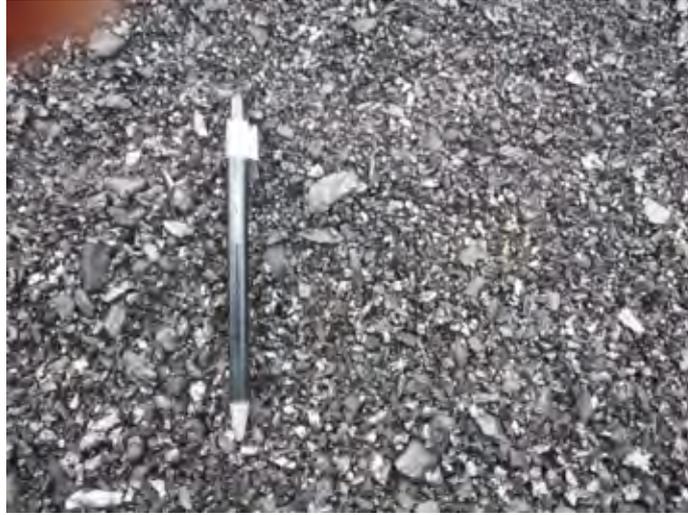
Figure 2.3-3 Anthracite coal used in PLPC

Type:	Anthracite coal
Calorific value:	5035 kcal/kg
Ash contents:	28.3%
Moisture:	9.65%
Oxygen contents:	2.22%
Hydrogen contents:	2.32%
Sulfur contents:	0.73%
Nitrogen contents:	0.4%
Fixed carbon:	56.38%

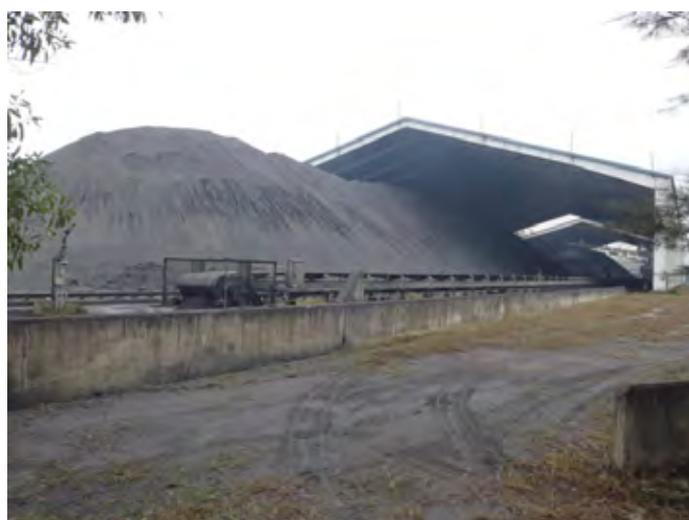
Because of low contents of volatile matter in stored coal, there is no risk for loss of calories. Coals in roofed yards and hypethral yard have been used without distinguishing between rainy season and dry season.

Figure 2.3-7 Roofed coal storage yard

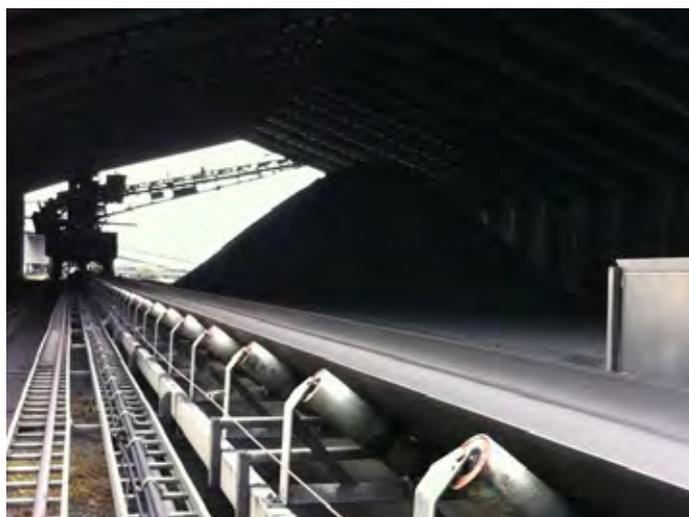
Coal is thrown into a bunker by downing a scraper which has been attached above each conveyor.

Figure 2.3-9 Belt conveyor in a roofed coal yard

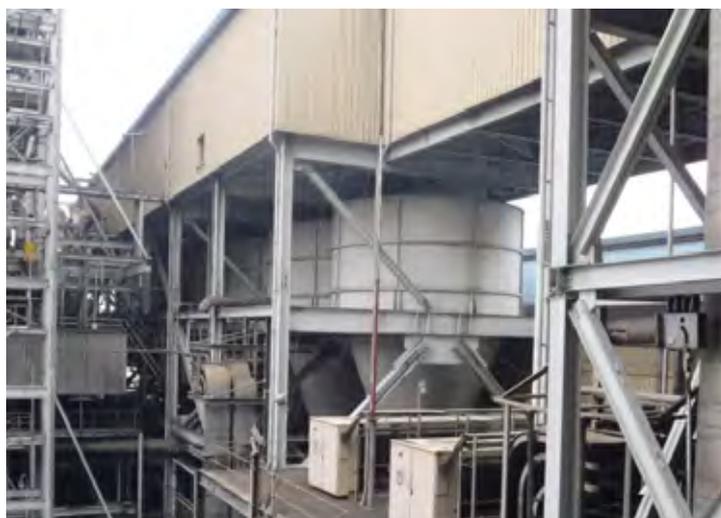
Pha Lai II has 8 bunkers (Figure 2.3-12). The capacity is 250 m<sup>3</sup> per a bunker. Additionally, there is a sub-bunker at the downstream of coal particle separators.

Figure 2.3-12 Coal bunker in Pha Lai II

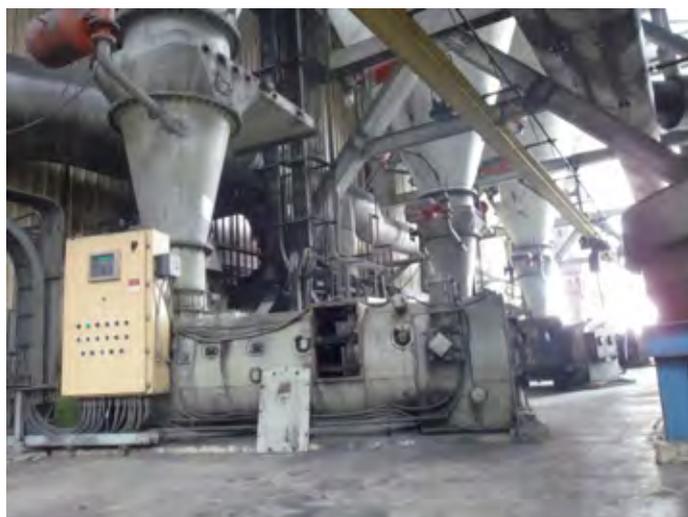
Figure 2.3-13 Coal feeder in Pha Lai I

Belt feeder-type coal feeder is equipped at the outlet of each coal bunker in both Pha Lai I and Pha Lai II (Figure 2.3-13 and Figure 2.3-14). Rotational speed of the belt feeder is possible to control.

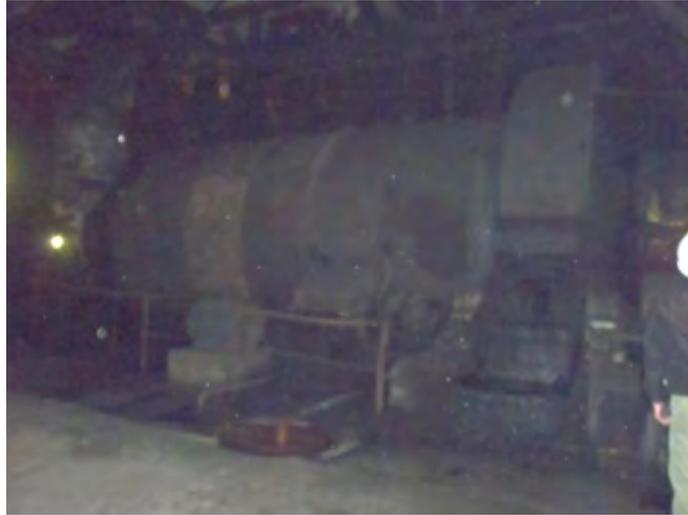
Figure 2.3-15 Tube type mill in Pha Lai I

Mills in Pha Lai I has 1600 kW of motor output and 33.1 ton/h of mill capacity, and includes totally 65.5 ton of steel ball indenters that are 40 mm in diameter. Pulverized coals are ca. 90  $\mu\text{m}$  in diameter. Mill temperature is 110 to 120 deg. C.

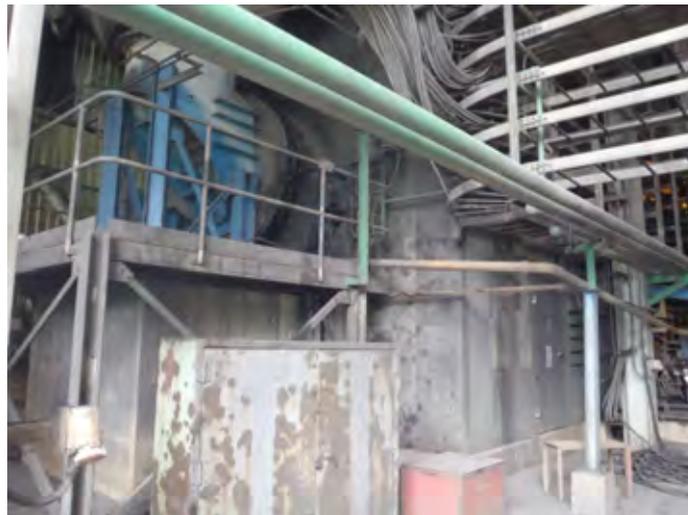
Figure 2.3-16 Tube type mill in Pha Lai II

Mills in Pha Lai II has 1400 kW of motor output and 48.8 ton/h of mill capacity, and includes totally 95 ton of steel ball indenters that are 40mm in diameter. Pulverized coals are ca. 90  $\mu\text{m}$  in diameter. Actual mill temperature is 110 to 120 deg. C but it is ca 30 deg C. lower than its designed value.

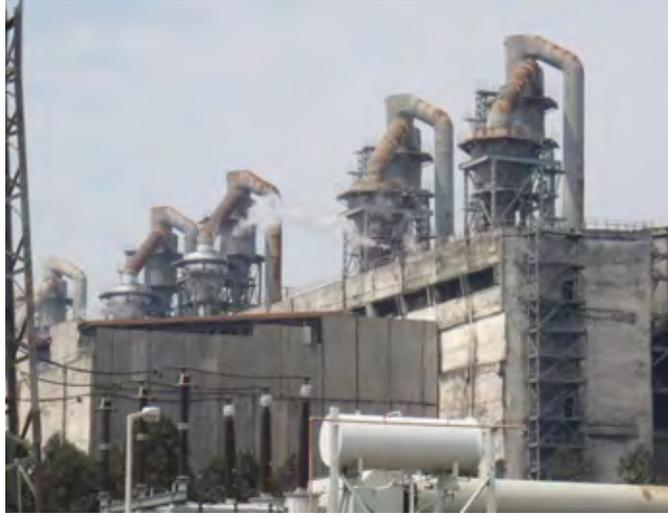
These separators classify the pulverized coals according to the sizes, and have been placed at downstream of fuel pipes in both Pha Lai I and Pha Lai II (Figure 2.3-17). Coarse coal dissociated by the coarse powder separator is back to mill again. Coarse coal dissociated by cyclone separator is transferred to facing burners and the fine coal is transferred to diagonal burners. Every two hour, coal samples are taken at sub-bunker locating the downstream of cyclone, to analyze the physical character.

Figure 2.3-17 Cyclone separator in Pha Lai I

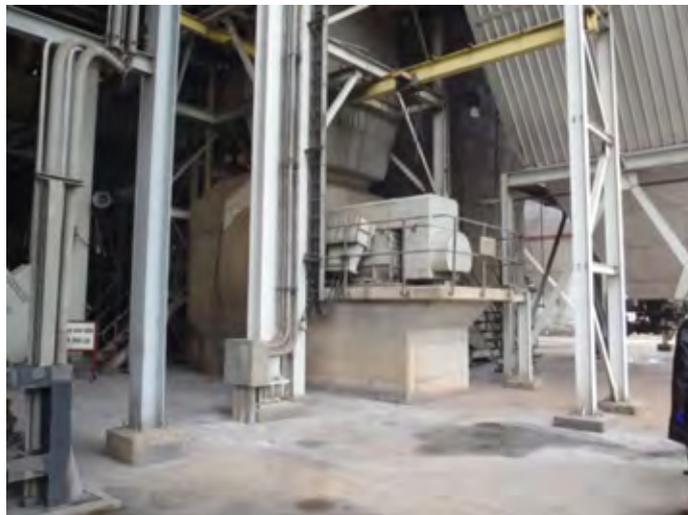
Powdered coal distributed by cyclone separator is transferred to a sub-bunker, a mill or a boiler by this equipment. The coal destination is selected by the condition of boiler operation on various cases. Two powdered coal air blower has been equipped by each boiler (Figure 2.3-18).

Figure 2.3-18 Powdered coal air blower in Pha Lai II

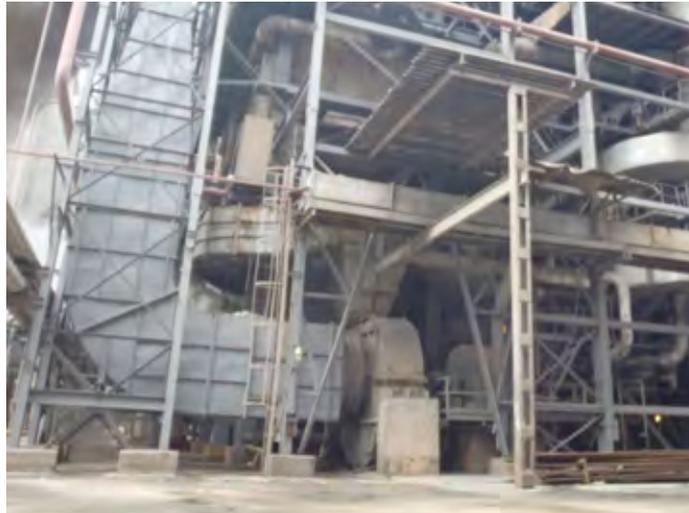
Each unit has two FDFs in Pha Lai I (Figure 2.3-19). A centrifugal type fan is equipped and the efficiency is 93%.

Figure 2.3-19 Forced draft fan in Pha Lai I

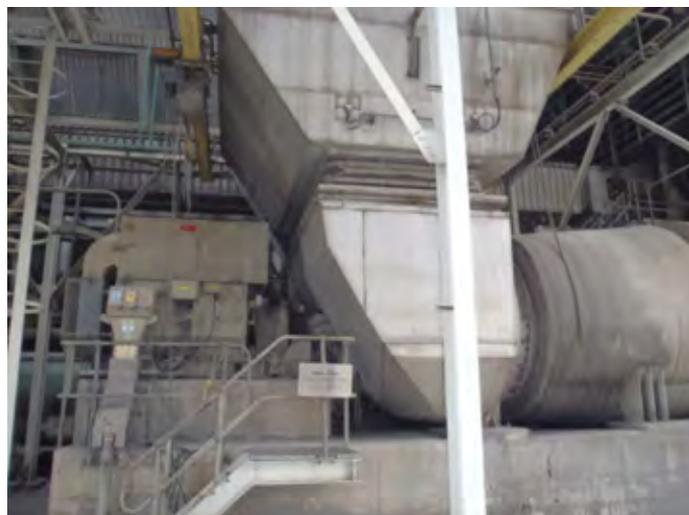
Figure 2.3-20 Forced draft fan in Pha Lai II

FDF supplies air to boilers for fuel burning.

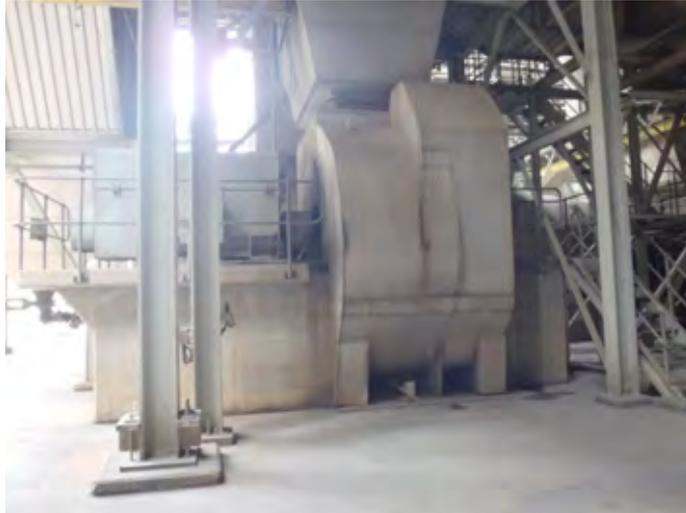
Figure 2.3-21 Primary air fan in Fha Lai II

PAF provides fuel to burners by giving an air pressure to coal powder.

Pha Lai II has 2 PAFs per a boiler (Figure 2.3-21). The revolution is 1490 rpm. The air flow rate is adjusted by a flow control fin locating a suction head of PAF.

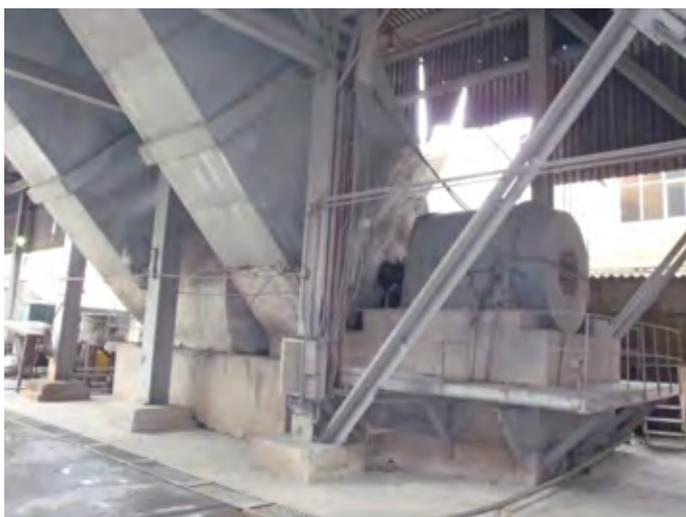
A unit of Pha Lai I has two IDFs (Figure 2.3-22). The revolution is 750 rpm. The fan efficiency is 80%. It has been under overloaded operation because there has been an air leakage at some parts of flue.

Figure 2.3-22 Induced draft fan in Pha Lai I

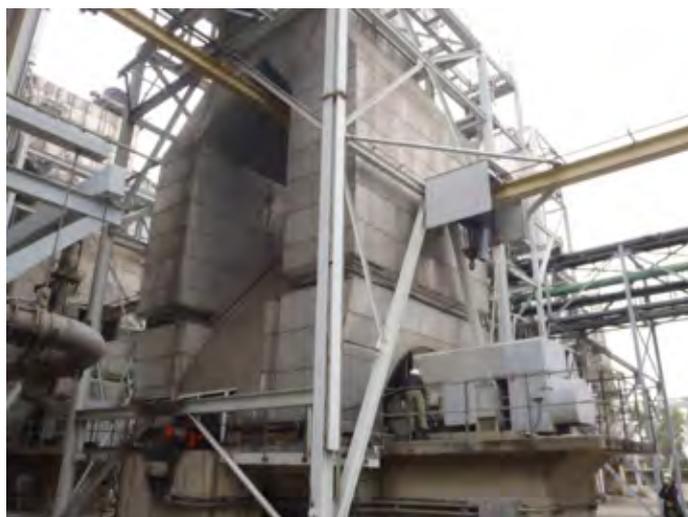
Figure 2.3-23 Induced draft fan in Pha Lai II

Each boiler has two IDFs in Pha Lai II, which are centrifugal type fan (Figure 2.3-23). The efficiency is 82.2%. The revolution is adjustable between 450 rpm and 750 rpm. Additionally, the air flow rate is also adjusted by a control fin locating a suction head.

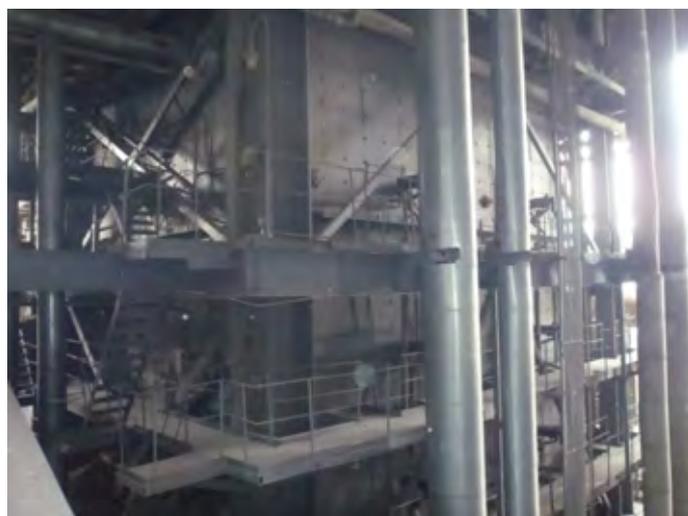
Figure 2.3-24 Air heater in Pha Lai I

Pha Lai I has adopted a tube type structure (Figure 2.3-24).

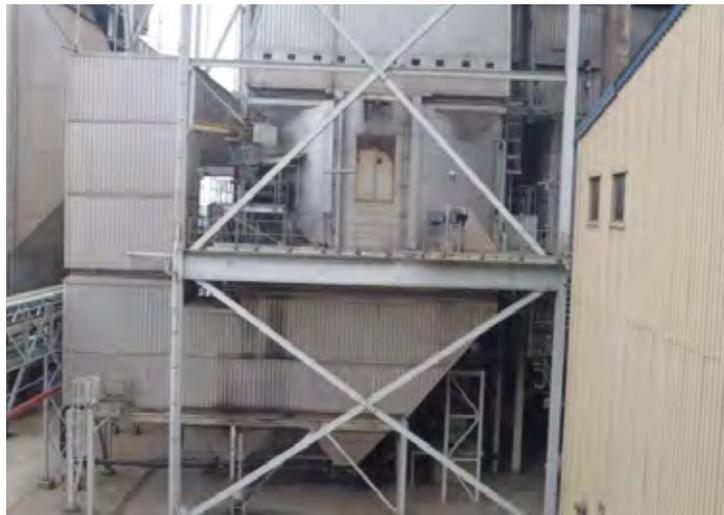
Pha Lai II has adopted a Ljungstrom-type air-preheater (Figure 2.3-25). It has equipped SDS sensor drive system which can automatically fill interspaces of sealed portion. However, the element part of the AH have been damaged and air leakage have occurred.

Figure 2.3-25 Air heater in Pha Lai II

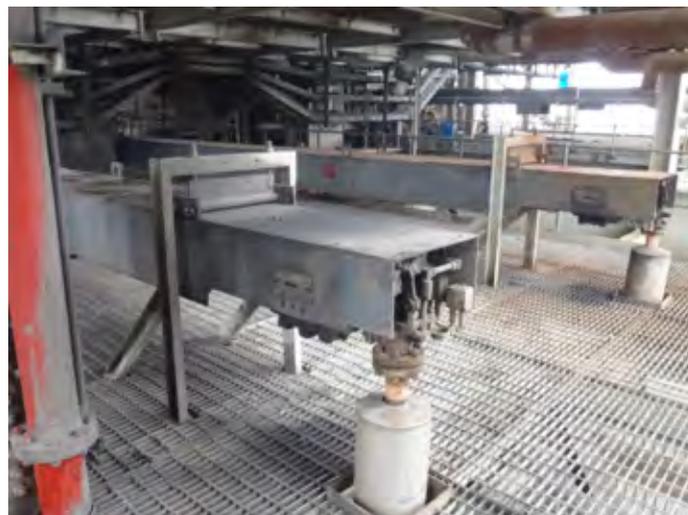
Figure 2.3-26 Sootblower for boilers.

Pha Lai I has rotary sootblowers which are operated once a day (Figure 2.3-26).

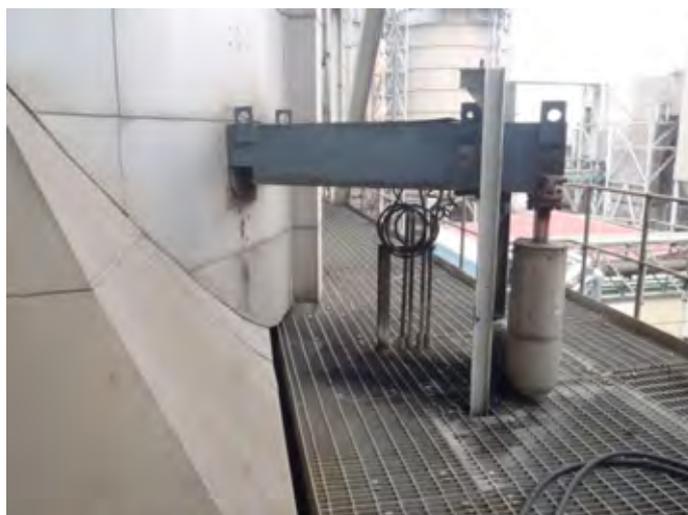
Figure 2.3-27 Sootblower for AH in Pha Lai II

Pha Lai II has equipped sootblowers for boiler and AH (Figure 2.3-27). The boiler sootblower and AH sootblowers have been operated twice a week and at a proper timing, respectively. However, the elements of AH has ash erosion.

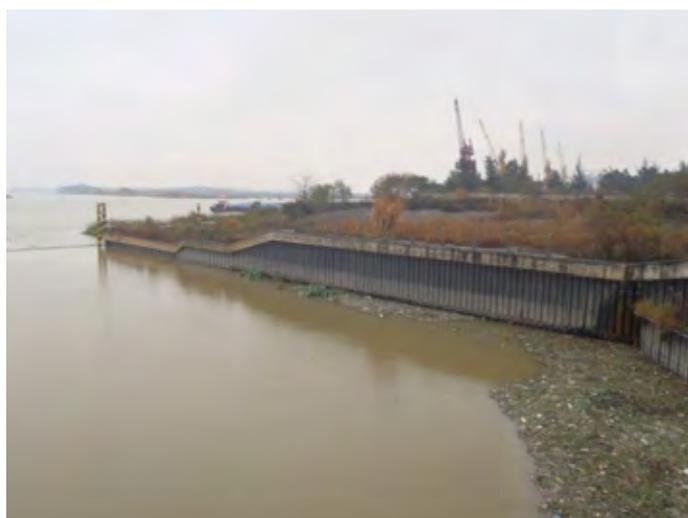
Figure 2.3-28 Feature of water intake

River water has been used for circulating water. Temperature of the river water is 32 deg C in summer and 19 deg C in winter. The average is ca. 23 dig. C. Raw water contains a lot of pet bottle, vinyl product, can and wood chip (Figure 2.3-28). To remove these, Pha Lai I has 8 bar screens and 4 rotary screens and Pha Lai II has 10 bar screens and 5 rotary screens (Figure 2.3-29, Figure 2.3-30, Figure 2.3-31 and Figure 2.3-32).

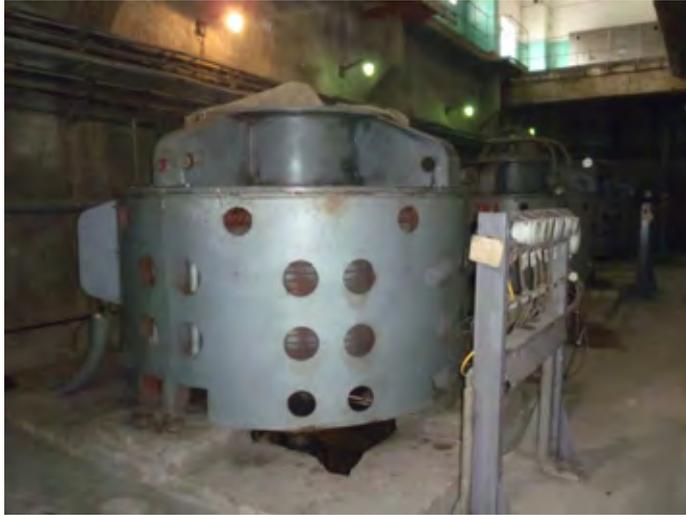
Pha Lai I has 4 CWPs including a backup pump and a pump under repairing (Figure 2.3-33). These are available over 0.5 m in water level. The river water temperature in summer increase to 32 deg C. but only two pumps are operated. Also in case that steam condensers cannot get enough vacuum level, additional pumps are not operated. Current recognition in PLPC is that the operation of third pump is insignificant to increase vacuum level of steam condensers.

Figure 2.3-33 Circulating water pump in Pha Lai I

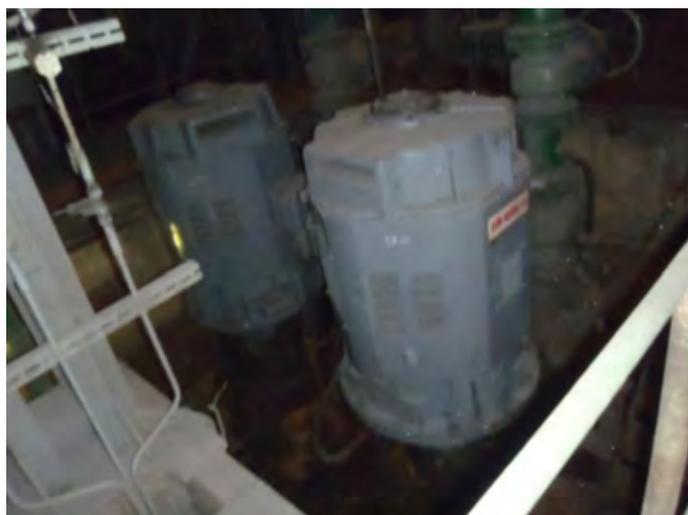
Figure 2.3-35 Condensate pump in Pha Lai I

Pha Lai I has three CP per a unit (one for backup. Figure 2.3-35). The revolution is 1480 rpm. The fan efficiency is 76%.

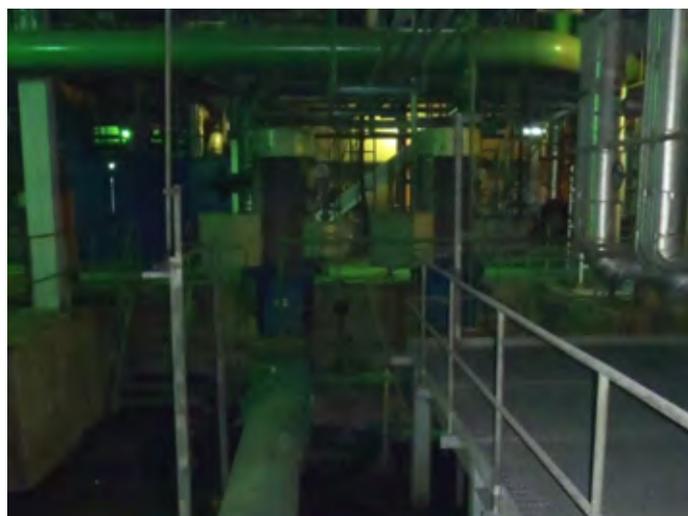
Figure 2.3-36 Condensate pump in Pha Lai II

Pha Lai II has two CP per a unit (Figure 2.3-36). The revolution is 1486 rpm. The fan efficiency is 80%. Additionally, Pha Lai II has 2 CBP per a unit (Figure 2.3-37).

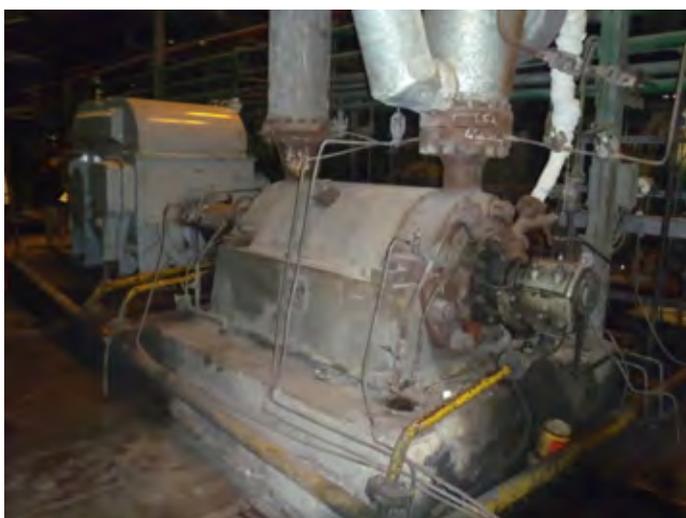
Figure 2.3-38 Boiler feed pump in Pha Lai I

Pha Lai I has one BFP per a unit (Figure 2.3-38). The revolution is 2970 rpm. The efficiency is 76%.

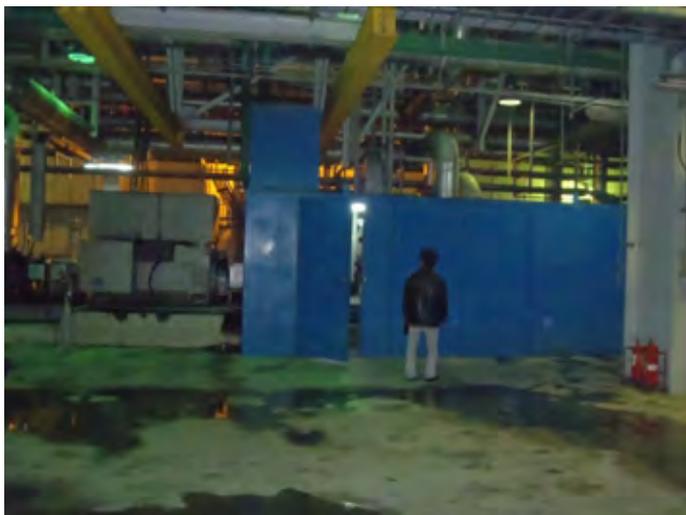
Figure 2.3-39 Boiler feed pump in Pha Lai II

Pha Lai II has two BFPs per a unit (Figure 2.3-39). The revolution is 1491 rpm. The efficiency is 82%.

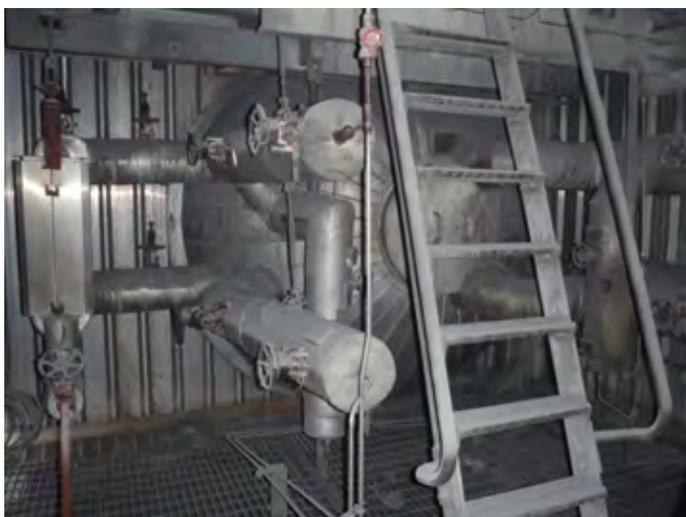
Figure 2.3-40 Steam drum of Pha Lai II

Both Pha Lai I and Pha Lai II have a drum on the top of each boiler, which separates water and steam to take out the steam (Figure 2.3-40).

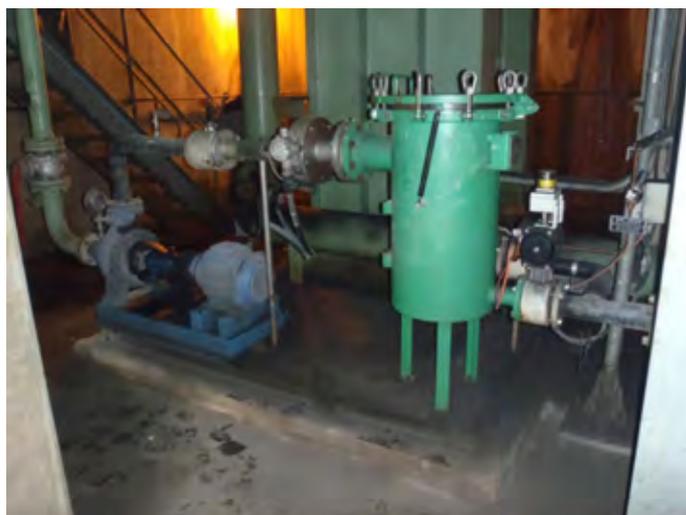
Pha Lai I does not have the system. Pha Lai II has it which is sponge ball-type cleaner (Figure 2.3-41). The condensate pipe of Pha Lai II is made of SS304 stainless.

Figure 2.3-41 Condenser cleaning equipment of Pha Lai II

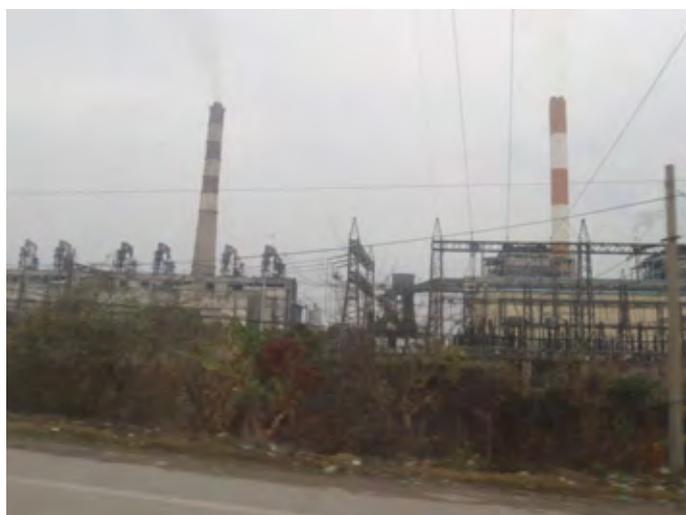
Chimneys of both Pha Lai I and Pha Lai II have 200 m in height (Figure 2.4-1).

Figure 2.4-1 Chimneys of Pha Lai I (left) and Pha Lai II (right)

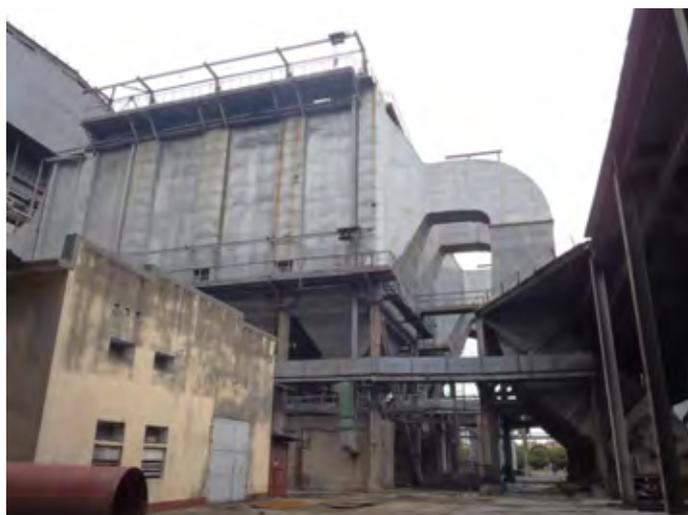
Both Pha Lai I and Pha Lai II have a dry electrostatic precipitator (Figure 2.4-2 and Figure 2.4-3).

Figure 2.4-2 Electrostatic precipitator in Pha Lai I

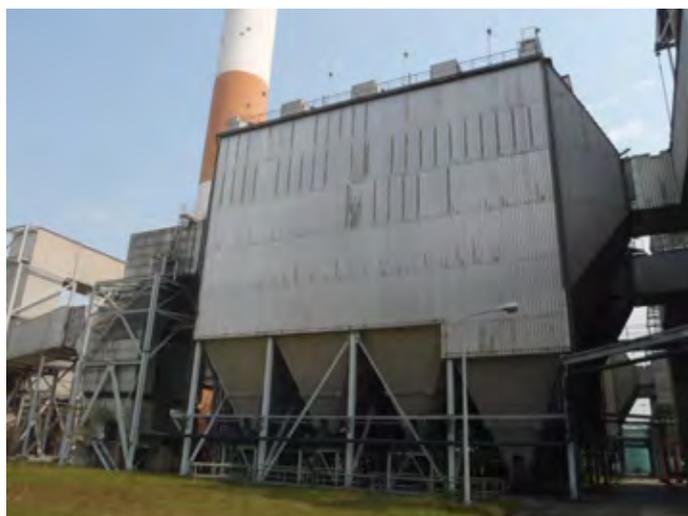
Figure 2.4-3 Electrostatic precipitator in Pha Lai II

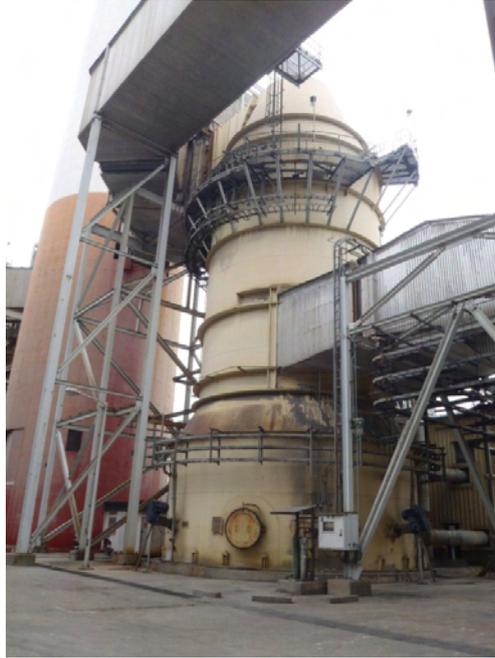
Figure 2.4-4 Wet flue-gas desulfurization equipment in Pha Lai II

To remove sulfur oxides from exhaust gas, Pha Lai II has wet flue-gas desulfurization equipment (Figure 2.4-4).

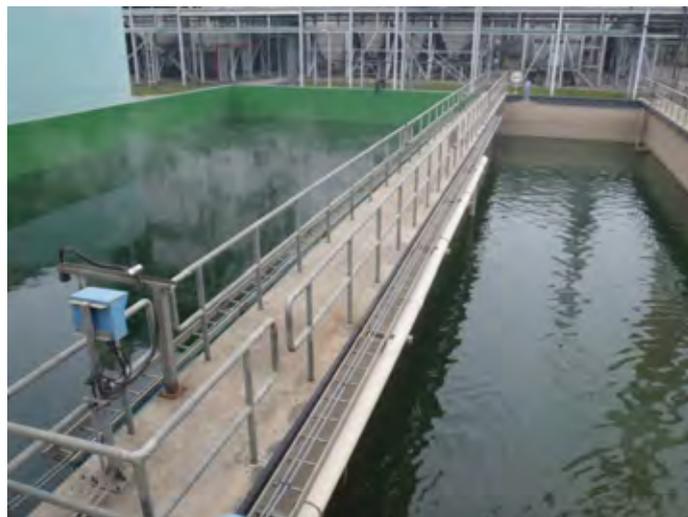
Figure 2.4-5 Drainage tank

For both plants, starting drainage, desulfurization drainage, oil-containing wastewater and domestic wastewater has been treated by a facility for wastewater treatments (Figure 2.4-5). Chemical oxygen demand, hydrogen-ion concentration and suspended solids of treated water have been ministered on a steady basis, and have met environmental criteria in Viet Nam. Additionally an external organization checks the wastewater quality once in every three month.

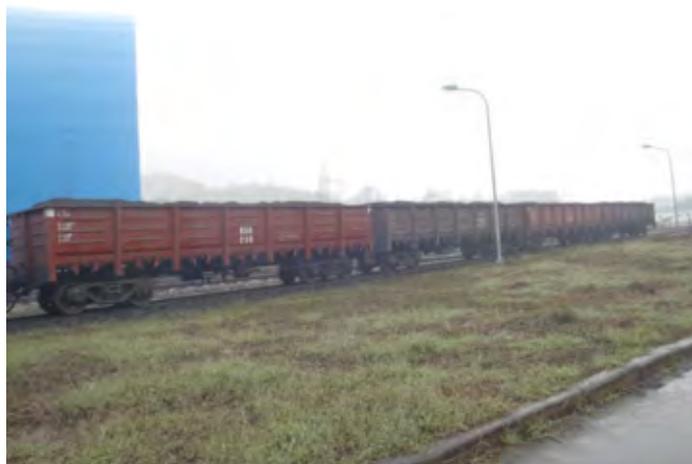
Figure 3.3-1 Coal cars

In this plant, all used coal has been transferred by coal cars. Coal cars open side hatch after stopping in an acceptance yard (Figure 3.3-2 and Figure 3.3-3). Then,

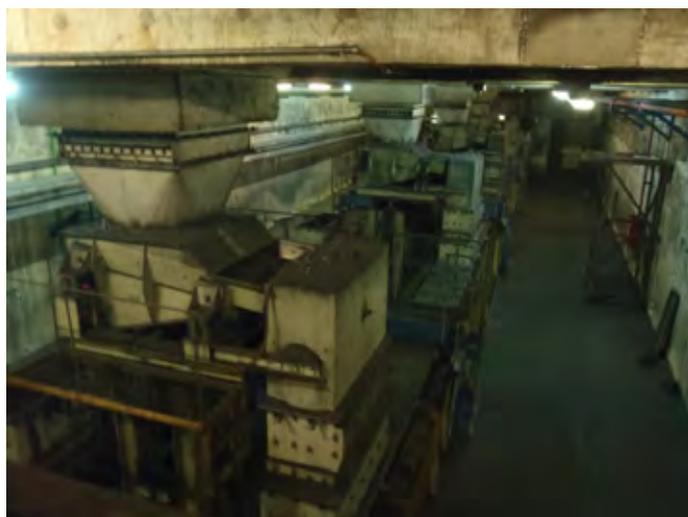
Figure 3.3-4 Overview of underground hopper

flushed out coal has been entered into an underground hopper and has been transferred by belt conveyor to bunkers or coal yards (Figure 3.3-4 and Figure 3.3-5).

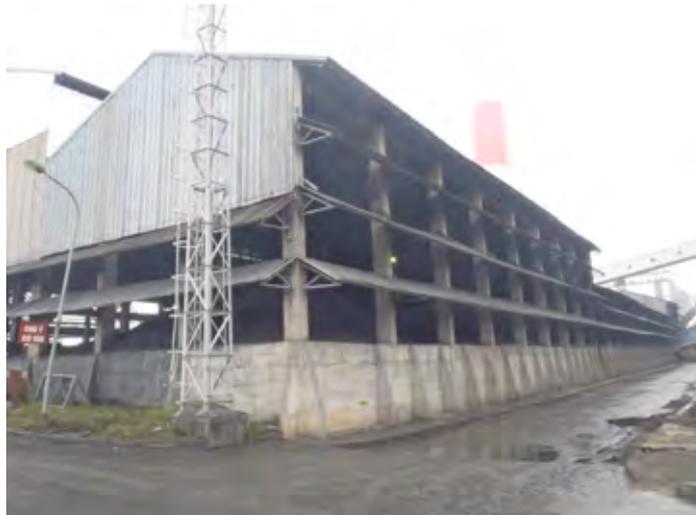
Figure 3.3-6 Roofed coal storage yard in Uong Bi 5/6

Because of low contents of volatile matter in stored coal, there is no risk for loss of calories. The roofed yards have sidewall. Therefore, it can prevent rain water from the sides.

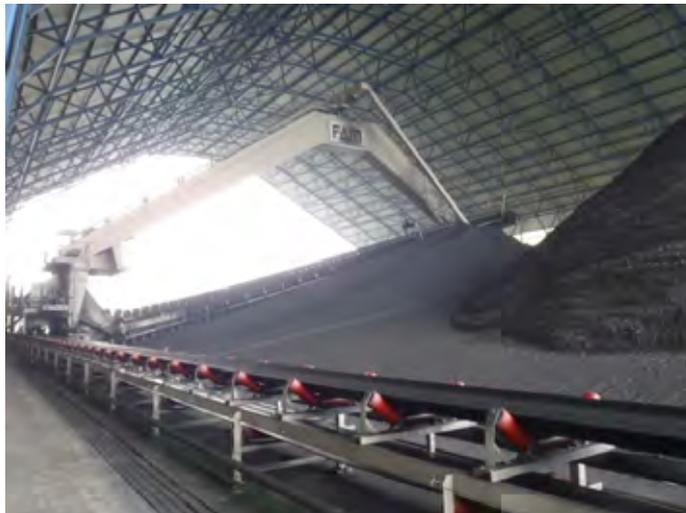
Figure 3.3-9 Belt conveyor in a roofed coal yard

Uong Bi 5/6 and Uong Bi 7 have independent conveyor system (Figure 3.3-9 and Figure 3.3-10). Both conveyors are composed of three types of lines which connect between the coal-hoisting place and the coal bunker, between coal-hoisting place and the stock yard, and between the stock yard and the coal bunker. Conveyor-belts in Uong Bi 7 are new and have no erosions. They placed indoor for water resources.

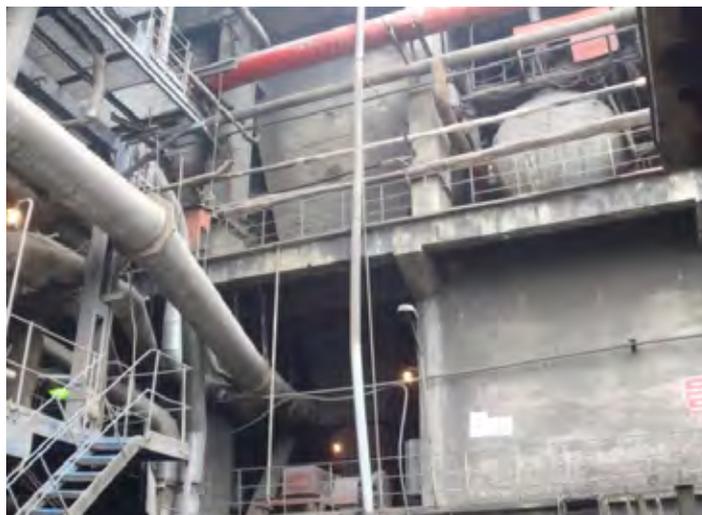
Figure 3.3-11 Coal bunker in Uong Bi 5/6

Uong Bi 5/6 has 2 bunkers per a boiler (Figure 3.3-11). The capacity is 200 m<sup>3</sup> per a bunker. Additionally, there is a sub-bunker at the downstream of coal particle separators and the capacity is 140 m<sup>3</sup>.

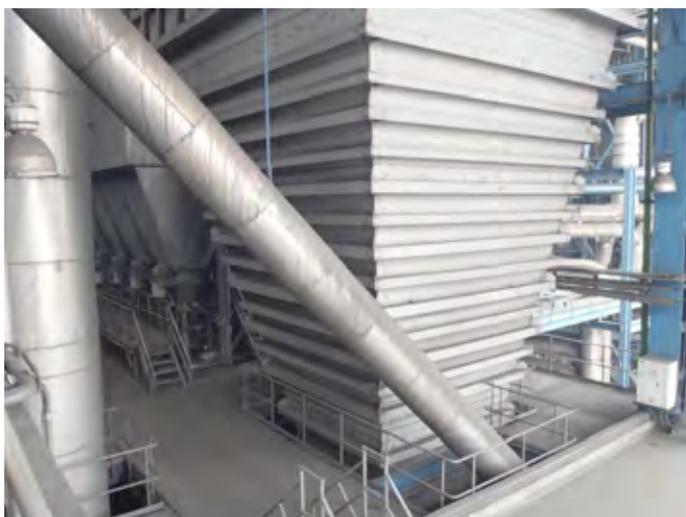
Figure 3.3-12 Coal bunker in Uong Bi 7

Uong Bi 7 has 2 bunkers (Figure 3.3-12). The capacity is 400 m<sup>3</sup> per a bunker. Additionally, there is a sub-bunker at the downstream of coal particle separators and the capacity is 300 m<sup>3</sup> (Figure 3.3-13).

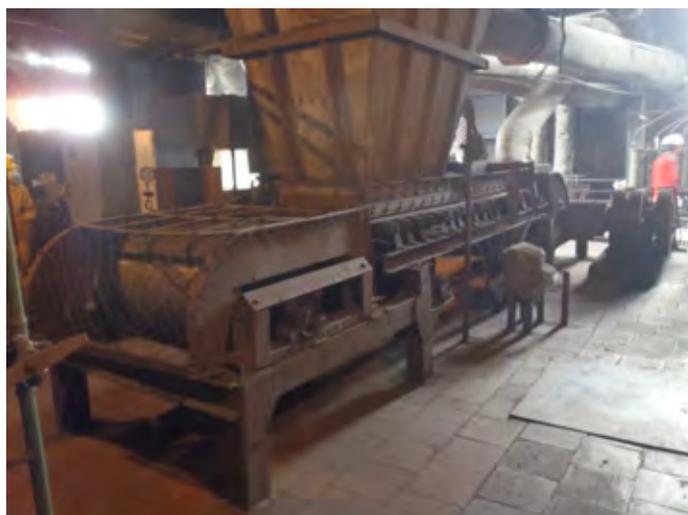
Figure 3.3-14 Coal feeder in Uong Bi 5/6

Belt feeder-type coal feeder is equipped at the outlet of each coal bunker in both Uong Bi 5/6 and Uong Bi 7 (Figure 3.3-14 and Figure 3.3-15). Rotational speed of the belt feeder is possible to control for adjusting coal supply.

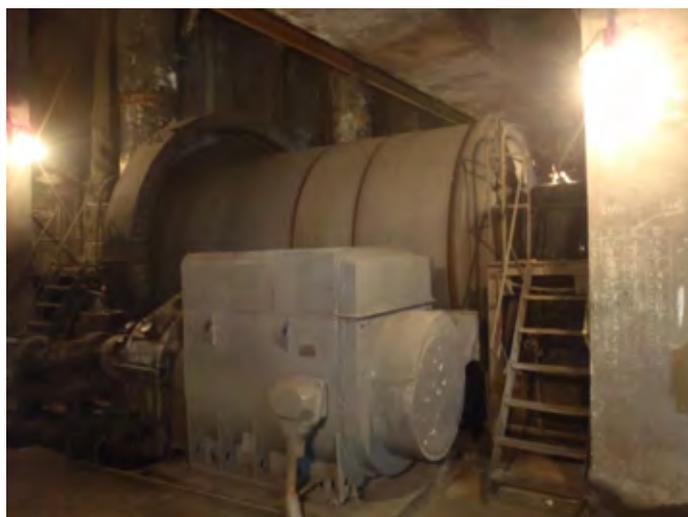
Figure 3.3-16 Tube type mill in Uong Bi 5/6

Pulverized coals are ca. 90  $\mu\text{m}$  in diameter in both. Abrasions are significant at the tubes passing pulverized coals. They are arbitrarily fixed by partial exchange or welding.

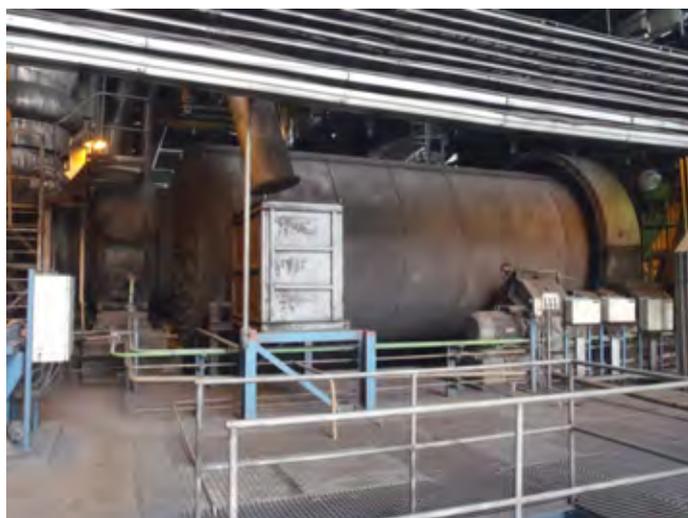
Figure 3.3-17 Tube type mill in Uong Bi 7

Mills in Uong Bi 7 has 1600 kW of motor output and includes totally 93 ton of steel ball indenters.

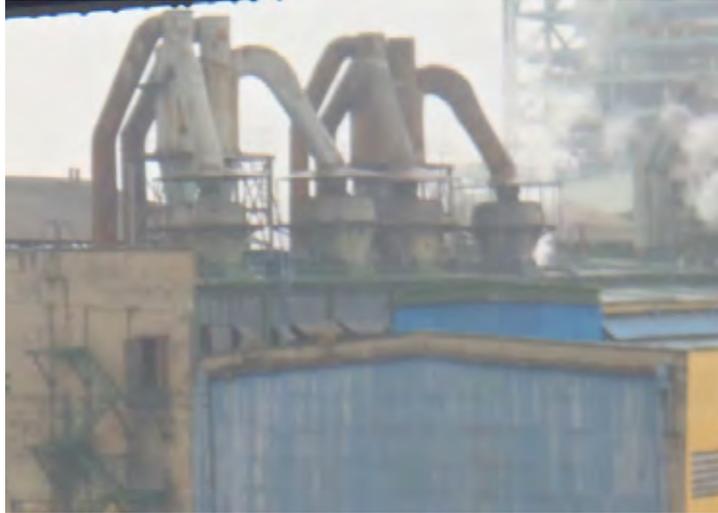
Figure 3.3-18 Cyclone separator in Uong Bi 5/6

These separators classify the pulverized coals according to the sizes, and have been placed at downstream of fuel pipes in both Uong Bi 5/6 and Uong Bi 7 (Figure 3.3-18, Figure 3.3-19 and Figure 3.3-20). Coarse coal dissociated by the coarse powder separator is back to mill again. Coarse coal dissociated by cyclone separator is transferred to facing burners and the fine coal is transferred to diagonal burners. Every two hour, coal samples are taken at sub-bunker locating the downstream of cyclone, to analyze the physical character.

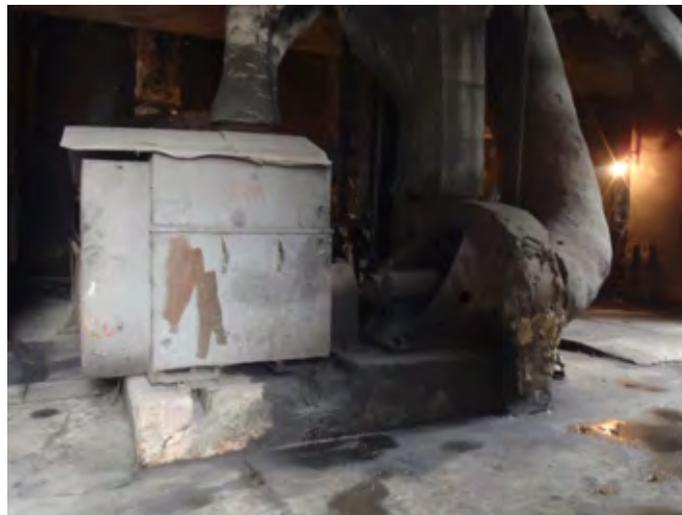
Figure 3.3-21 Powdered coal air blower

Powdered coal distributed by cyclone separator is transferred to a sub-bunker, a mill or a boiler by this equipment. The coal destination is selected by the condition of boiler operation on various cases. Two powdered coal air blower has been equipped by each boiler in Uong Bi 5/6 and Uong Bi 7 (Figure 3.3-21 and Figure 3.3-22).

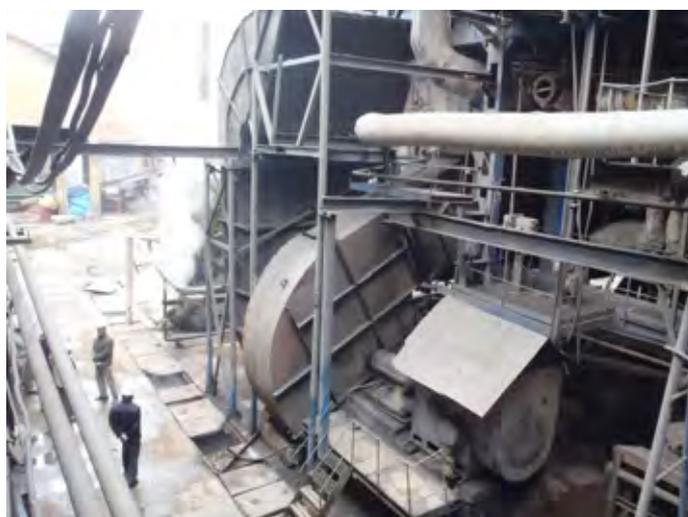
Figure 3.3-23 Forced draft fan in Uong Bi 5/6

Each unit has two FDFs in Uong Bi 5/6 (Figure 3.3-23). Centrifugal type fans are equipped.

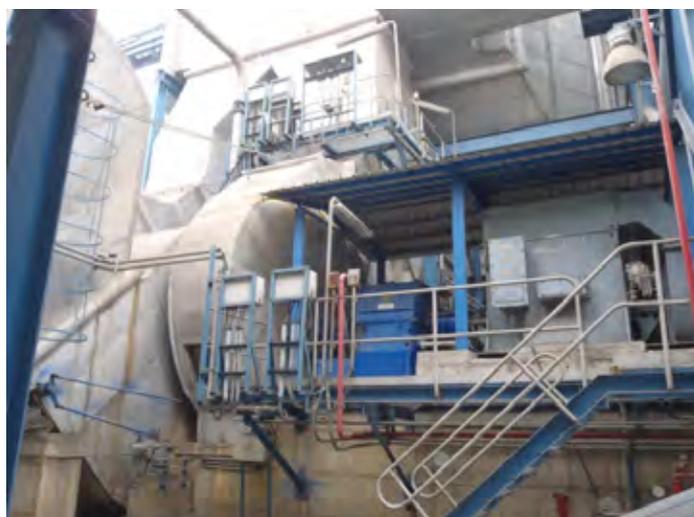
Uong Bi 7 has 4 PAFs (Figure 3.3-25).

Figure 3.3-25 Primary air fan in Uong Bi 7

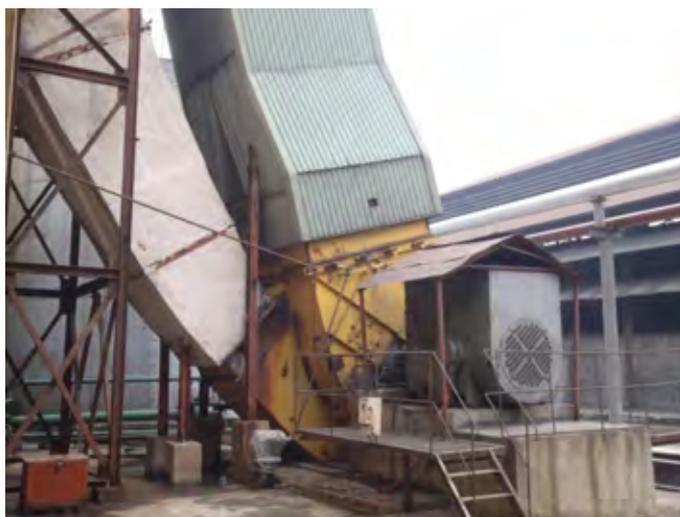
Figure 3.3-26 Induced draft fan in Uong Bi 5/6

A unit of Pha Lai I has one IDF which is a centrifugal type fan (Figure 3.3-26).

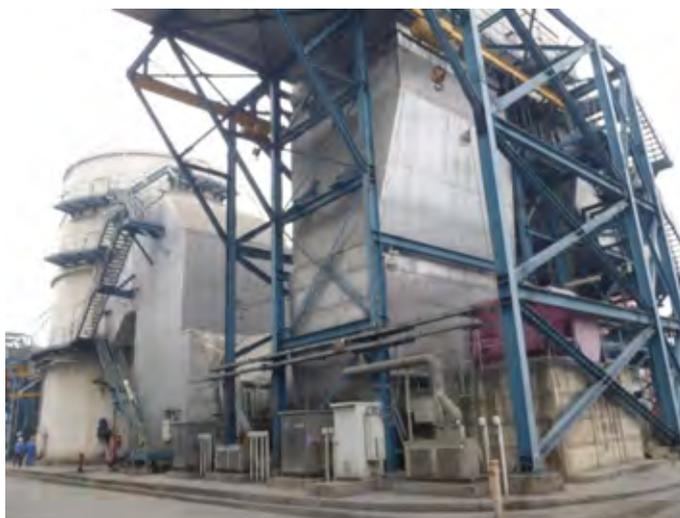
Figure 3.3-27 Induced draft fan in Uong Bi 7

Uong Bi 7 has two IDFs which are centrifugal type (Figure 3.3-27).

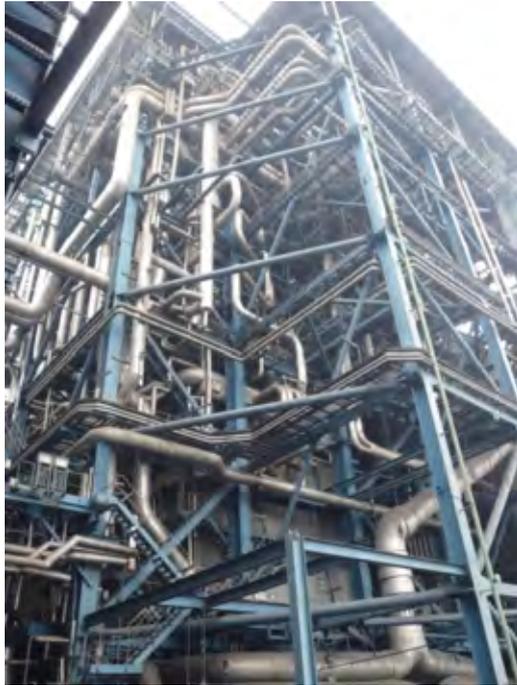
Figure 3.3-28 Air heater in Uong Bi 7

AH pre-heats air for boiler combustion, utilizing heat of combustion gas. All units have adopted a tube type structure (Figure 3.3-28).

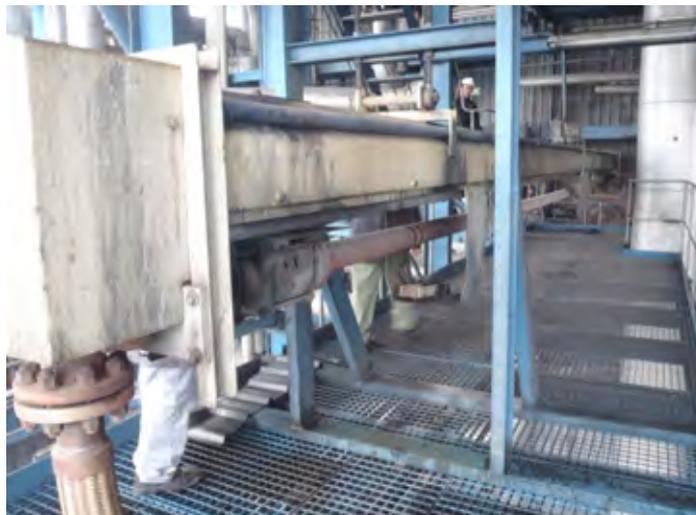
Uong Bi 7 has rotary sootblowers and deslaggers (Figure 3.3-29 and Figure 3.3-30). Inside wall of boiler has been eroded by the injected steam.

Figure 3.3-29 Rotary sootblower in Uong Bi 7

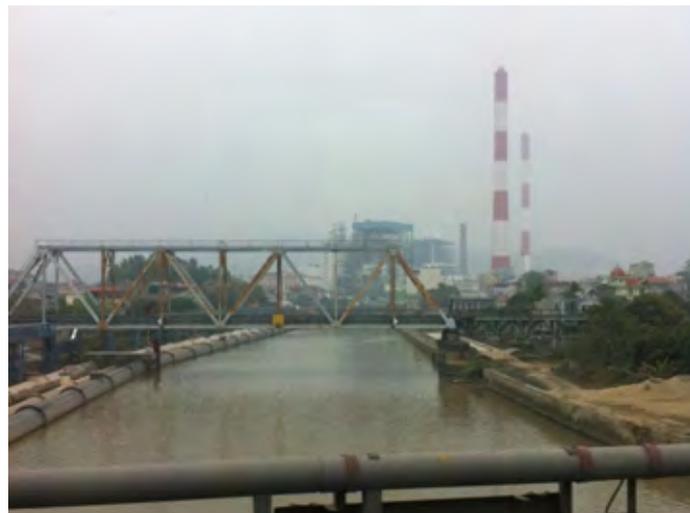
Figure 3.3-31 Water line to the plant

River water has been used for circulating water. Water intake is located at 1.7 km point from the plant. The water conveyance is done by dedicated water lines along the river (Figure 3.3-31). Raw water contains a lot of pet bottle, vinyl product, can and wood chip. To remove these, Uong Bi 5/6 has 2 rotary screens and Uong Bi 7 has 2 rotary screens, without a bar screens (Figure 3.3-32).

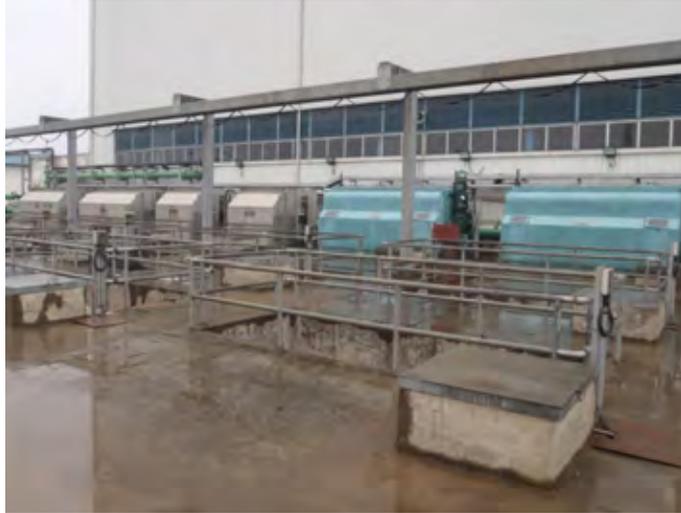
Figure 3.3-32 Rotary screens

(Left two ones are for Uong Bi 7, following two ones are Uong Bi 5/6 and right two ones are for new Uong Bi 8.)

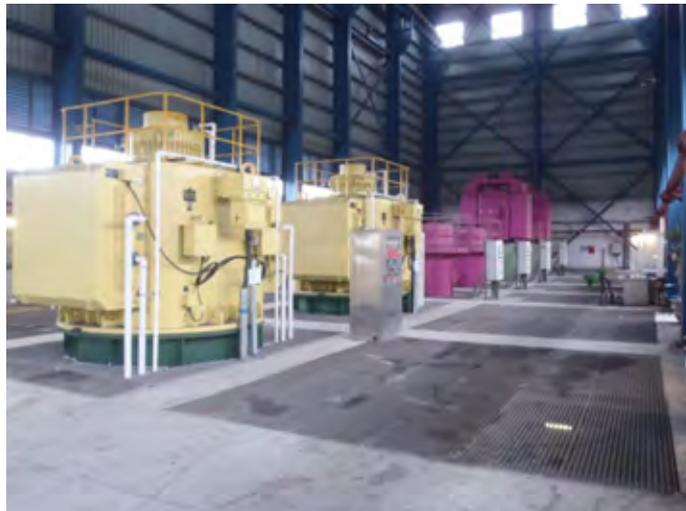
Figure 3.3-33 Feature of the establishment for circulating water pump  
(Yellow ones are for new Uong Bi 8.)

CWP pumps river water up form intake to supply chilling water to steam condensers.

Uong Bi 5/6 and Uong Bi 7 have 2 CWP's each (Figure 3.3-33, Figure 3.3-34 and Figure 3.3-35).

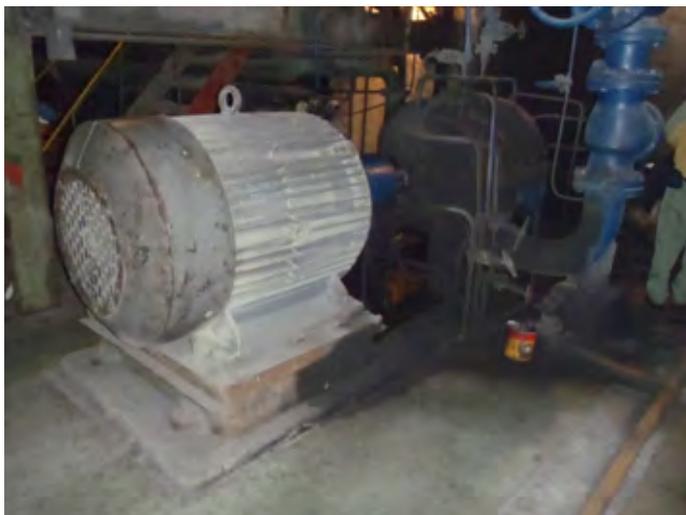
Figure 3.3-36 Condensate pump in Uong Bi 5/6

Uong Bi 5/6 has two CP per a unit (Figure 3.3-36). Uong Bi 7 has three CPs which include a backup (Figure 3.3-37).
