## 2 Feature of the Fha Lai Thermal Power Joint-stock Company

## 2.1 Corporate development

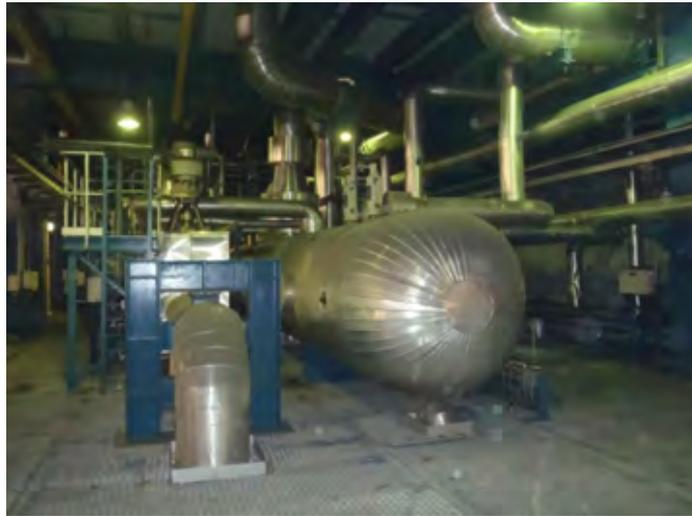
Figure 3.3-38 Low pressure feed water heater in Uong Bi 7

CP distills steam condensate from hot wells and pump to a low pressure feed water heater (Figure 3.3-38) and a deaerator (Figure 3.3-39).

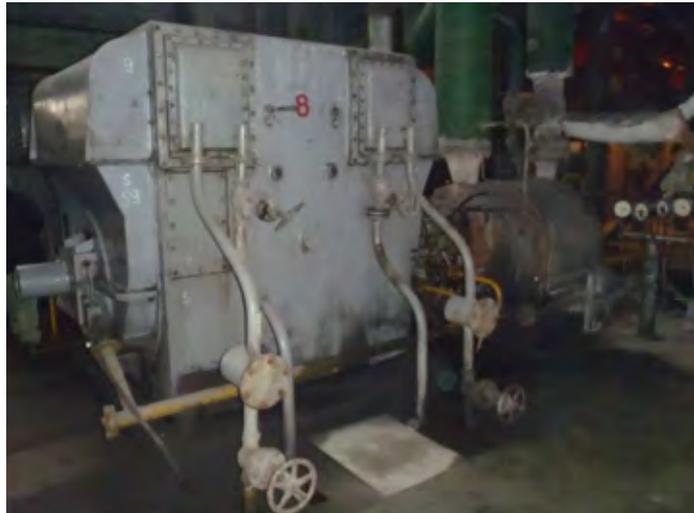
Figure 3.3-40 Boiler feed pump in Uong Bi 5/6

Uong Bi 5/6 has two BFP per a unit (Figure 3.3-40).

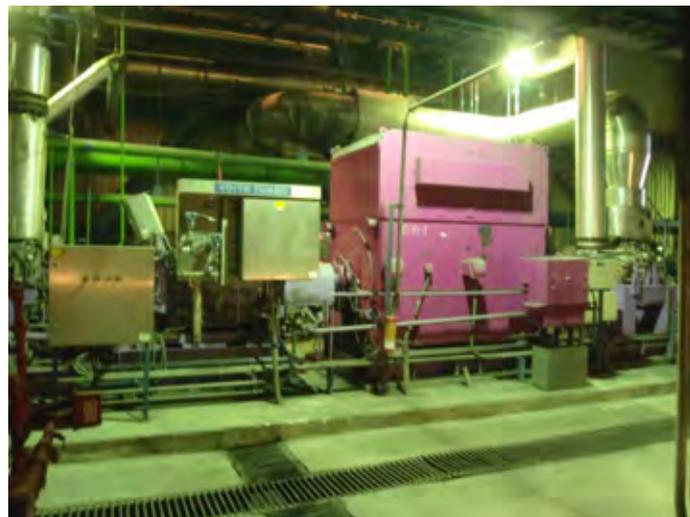
Figure 3.3-41 Boiler feed pump in Uong Bi 7

Uong Bi 7 has three BFPs including a backup pump (Figure 3.3-41).

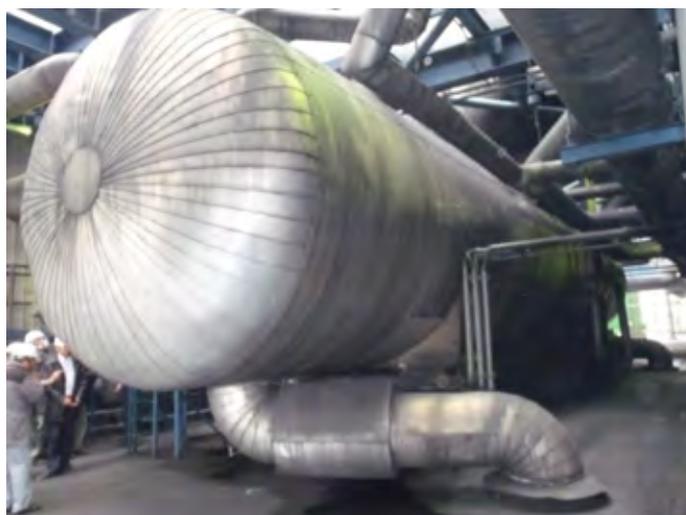
Figure 3.3-42 Steam drum of Uong Bi 7

Both Uong Bi 5/6 and Uong Bi 7 have a drum on the top of each boiler, which separates water and steam to take out the steam (Figure 3.3-42).

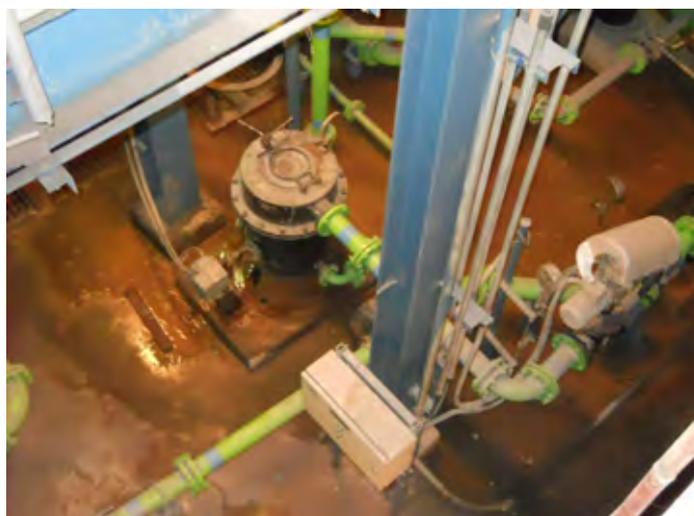
Uong Bi 5/6 does not have the system. Uong Bi 7 has it which is sponge ball-type cleaner (Figure 3.3-43). The condensate pipe of Uong Bi 7 is made of titanium and is cleaned up every day.

Figure 3.3-43 Condenser cleaning equipment of Uong Bi 7

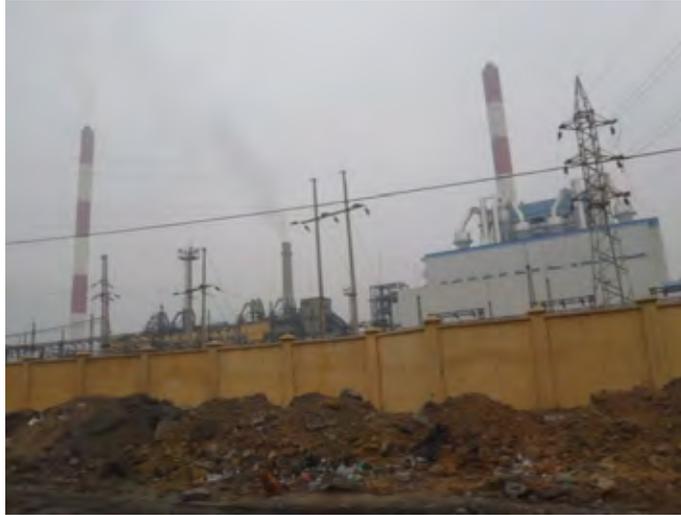
A chimney of Uong Bi 5/6 is low (70 m). Uong Bi 7 has a 200 m chimney (Figure 3.4-1).

Figure 3.4-1 Chimneys in Uong Bi power plant  
(Left; for Uong Bi 7, Center; for Uong Bi 5/6, Right ; for Uong Bi 8)

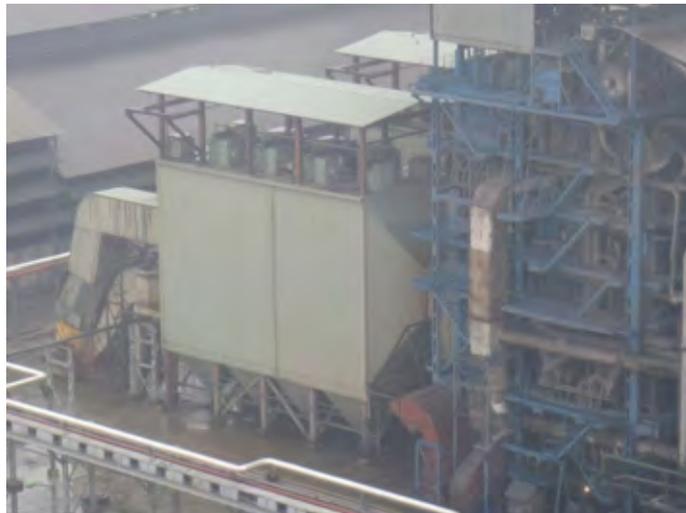
Figure 3.4-2 Electrostatic precipitator in Uong Bi 5/6

Both Uong Bi 5/6 and Uong Bi 7 have a dry electrostatic precipitator, respectively. (Figure 3.4-2 and Figure 3.4-3). Uong Bi 5/6 extended it in 2005.

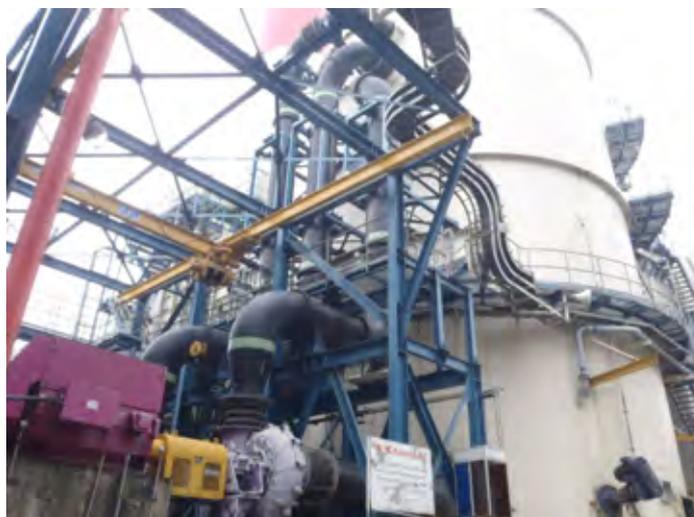
To remove sulfur oxides from exhaust gas, Uong Bi 7 has flue-gas desulfurization equipment (Figure 3.4-4).

Figure 3.4-4 Flue-gas desulfurization equipment in Uong Bi 7

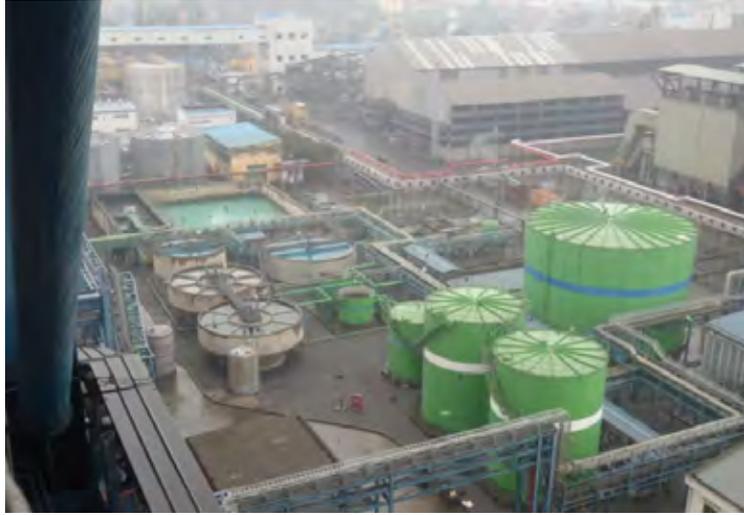
Starting drainage, desulfurization drainage, oil-containing wastewater and domestic wastewater has been treated by a facility for wastewater treatments (Figure 3.4-5). Chemical oxygen demand, hydrogen-ion concentration and suspended solids of treated water have been ministered on a steady basis, and have met environmental criteria in Viet Nam.

Figure 3.4-5 Wastewater treatment facility

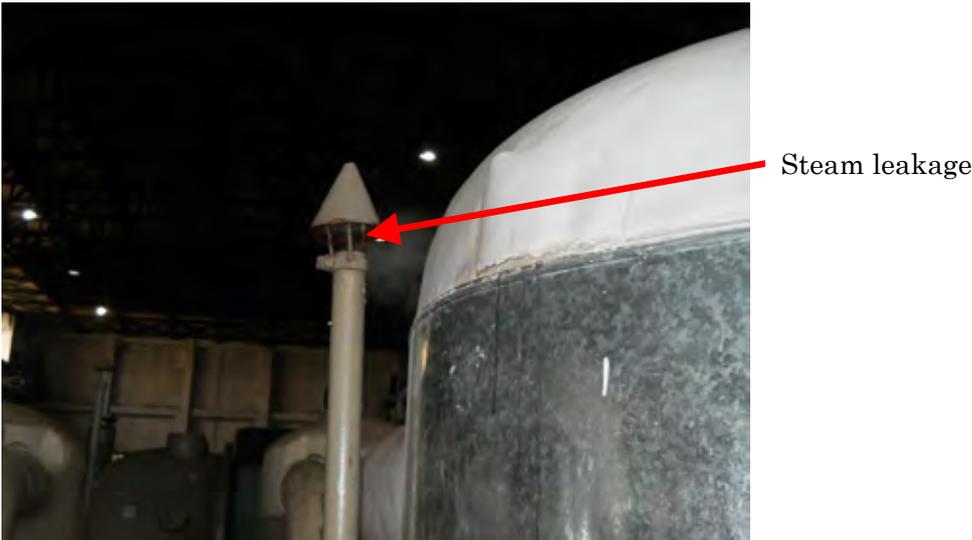
Figure 1.5-1 High-pressure 2HTR

The plant has been operating for more than 35 years and shows some deterioration, but the site is in good order. None of the turbine facilities showed signs of abnormality as viewed from the outside. There was leakage at the shell-side safety valve of the high-pressure 2HTR on Turbine 4, but it was minor and could be handled on the occasion of shutdown for repair of other equipment.

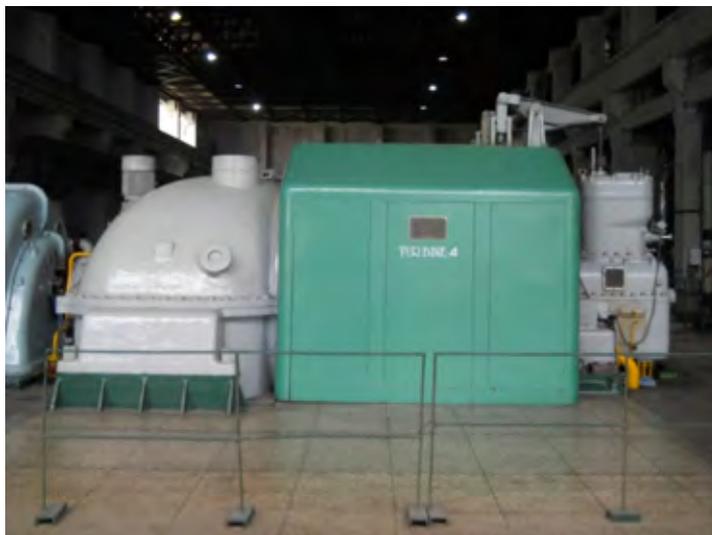
The main turbine underwent work for replacement and repair of the final 12-stage rotor blades from 2000 to 2002. The reason for the work was blade corrosion. Purchases have already been made for replacement of the 11th and 10th stages. For other blades, the plant has not made replacements or performed welding or other repairs since the start of operation. The amount of scale adhering to the turbine blades is reportedly not very significant. Detailed records have not been kept on the situation as regards corrosion. Data have been recorded for the gap between the outer shroud perimeter and the radial

fan of the outer wall, and the gap between the shaft and labyrinth packing. These items are being managed within the permissible limits.

Figure 1.5-2 Main turbine

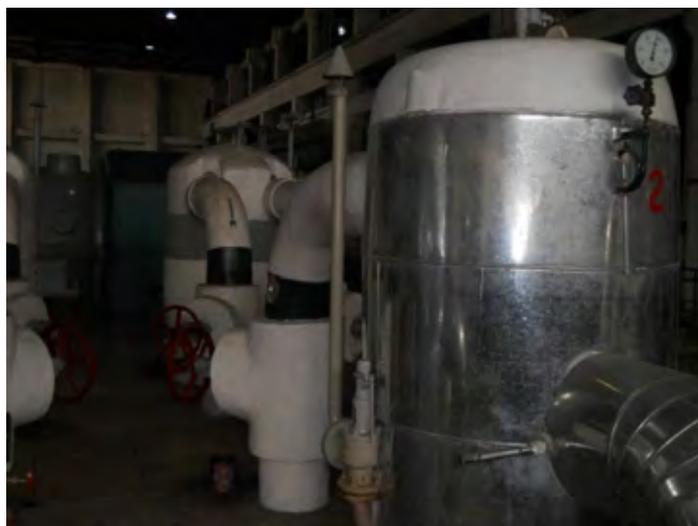
The tubes on the high-pressure feed water heaters (1 and 2) were replaced over the years 2001 - 2005. Before this replacement, there was leakage at the welds on the pipe plates and tubes. At present, none are plugged. The plant does not perform preventive maintenance for leaks from tubes, which are maintained only after occurrence. It has no experience in washing the tubes.

Figure 1.5-3 Feed water heaters

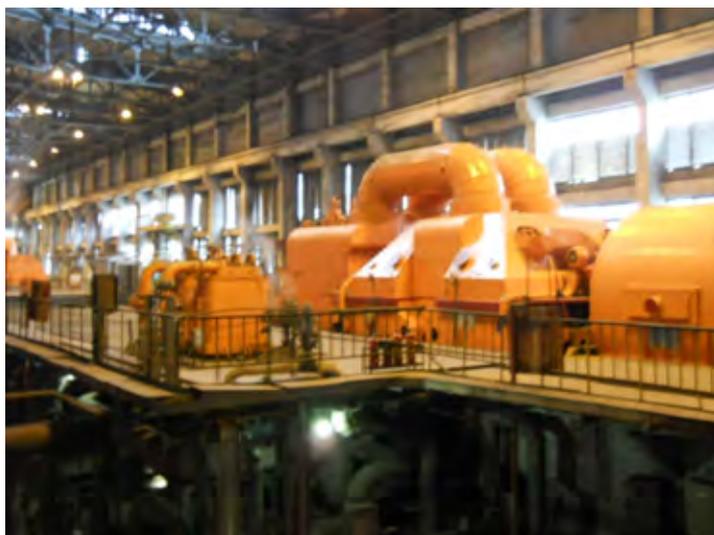
The turbine facilities have been operating for nearly 30 years and have shown some deterioration. Deterioration was seen in valves and there was occasional leak of steam from gland parts and bonnet flanges.

Figure 2.5-1 Pha Lai I turbine building

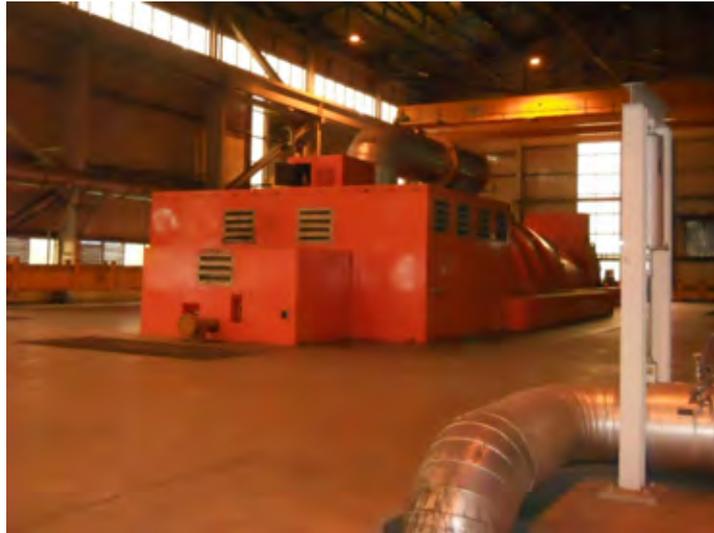
Figure 2.5-2 Pha Lai II turbine building

Since the turbine facilities are relatively new with the operation continuing for 10 years, the on-site conditions are favorable. No abnormalities were detected as far as the appearance of turbine facilities is concerned. Built under the ODA program of Japan, the turbine equipment has orderly arrangement similar to one in Japan.

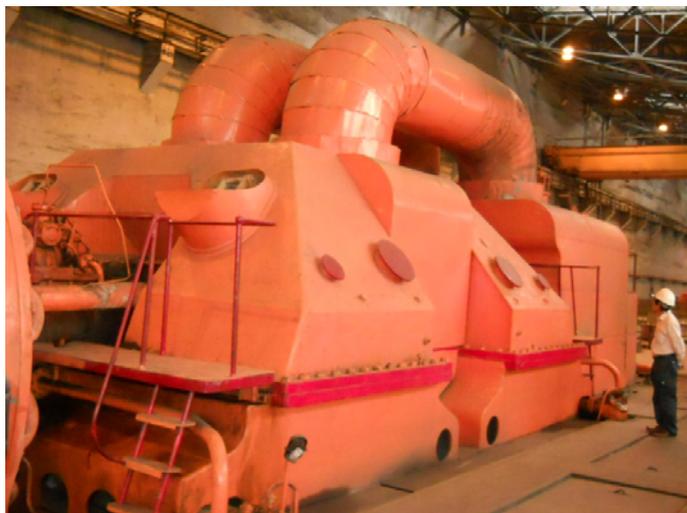
According to the plant personnel, as to the main turbine, blade tips and sealing fins of gland are regularly replaced, but no repairs were made to the rotor blades and stator vanes. Detailed checks are commissioned to an external company and there were no records of checks available at the plant. Only visual checks on the gaps in blade tips and sealing fins of gland are performed at the plant. The low-pressure final stage of rotor blades at the unit 2 was damaged and its replacement has been planned. Despite the damaged rotor blades, the turbine is continuing its operation. Rotor blades of other units have been also corroded, and their sequential replacement has been planned. Scale has also adhered to the turbine blades.

Figure 2.5-3 Main turbine

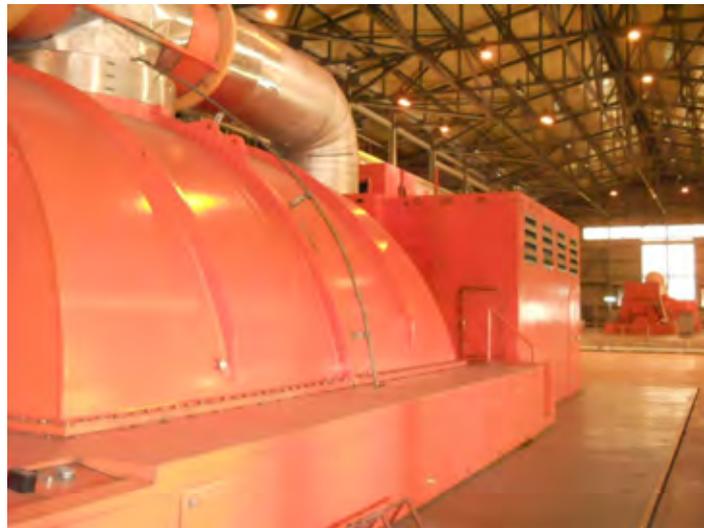
The turbine facilities have been operating for 10 years, but no overhaul inspections have been performed on the main turbine due to tight supply of electric power. Although full checks were planned in 2009, they have not yet been performed up till now. According to the plant personnel, the suction of substantial amount of air from the low-pressure gland part was detected during the checks performed by the plant, and the seals of gland part will be replaced when the plant stops operation next time. The plant personnel were aware that there might have been substantial leak of steam from blade tips and the seals of rotors inside the turbine. The adhesion of scale was detected from the low-pressure manhole when the low-pressure blades were checked. It is possible that there are corrosion of rotor blades and adhesion of scale to the stator vanes.

Figure 2.5-4 Main turbine

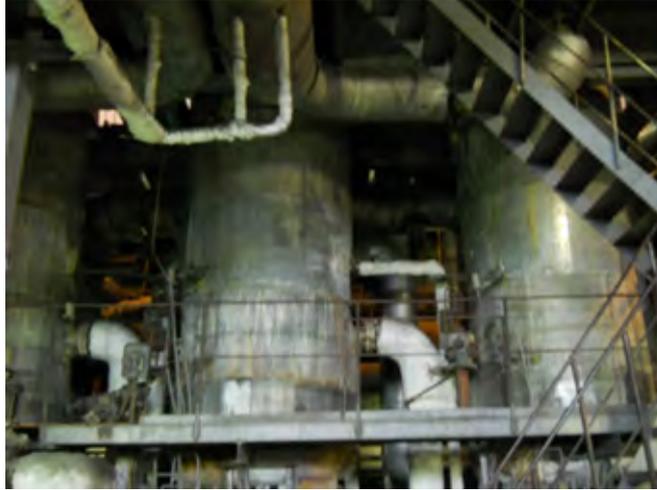
According to the plant personnel, checks and repairs have been commissioned to an external company and the power plant does not manage the records of plugging. Although the conditions of wall thickness of capillaries have been managed for the Pha Lai I Thermal Power Plant, no details were confirmed because the management has been commissioned to an external company. All tubes for low-pressure heaters and part of the tubes of high-pressure heaters were replaced 10 years ago. During the simple checks conducted once in two years, the inside of capillaries is washed with water (10kg/cm<sup>2</sup>). (No checks have been performed on the heaters at the Pha Lai II Thermal Power Plant.) The plant does not perform preventive maintenance of the feed water heaters, which are repaired only after occurrence of troubles.

Figure 2.5-5 Pha Lai I feed water heaters

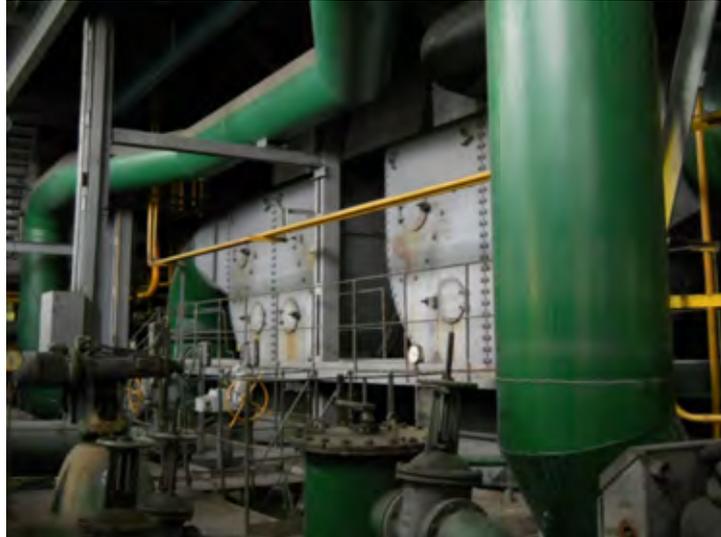
According to the plant personnel, all condenser capillaries were replaced 10 years ago without changing their material (aluminum brass tube). Current plugging conditions could not be confirmed at the plant. The ball cleaning system is not installed, while the cleaning of capillaries is performed with brush cleaning once in two years. It can be inferred that the thermal power plant has been forced to operate in a state where the condenser vacuum has fairly deteriorated. The plant does not perform preventive maintenance against possible leaks from condenser capillaries, which are repaired only after occurrence of troubles (breakdown maintenance).

Figure 2.5-6 Condensers

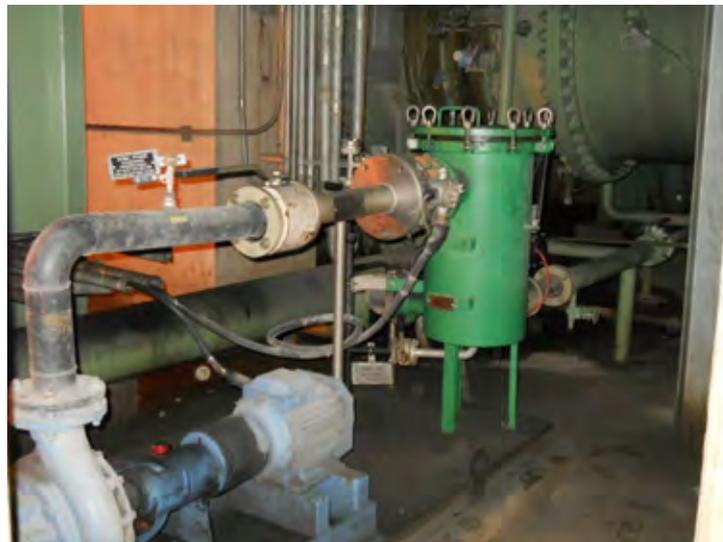
SUS304 is used as the material of condenser capillaries while the ball cleaning system is installed to clean the balls every day. However, the management of ball size has not been carried out, and with the continuation of use of balls, the size has become smaller and balls are discharged from the screen. The plant does not perform preventive maintenance of the condenser, which will be repaired only after occurrence of troubles (breakdown maintenance).

Figure 2.5-7 Ball cleaning system

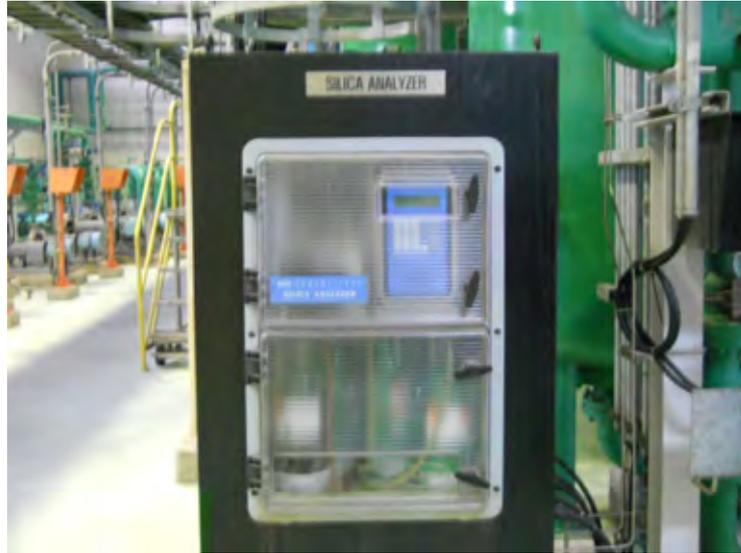
Figure 2.5-8 Silica meter that is broken

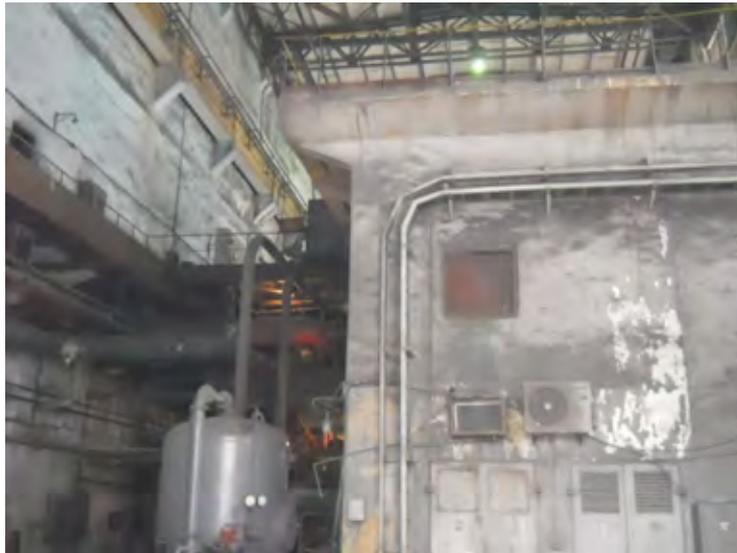
Figure 3.5-1 Uong Bi unit 5 and 6 main building (Turbine foundation and its surroundings)

The turbine facilities have been operating for more than 30 years and have considerably deteriorated. With the leak of steam seen from valves and feed water heaters, the facilities are in considerably difficult conditions.

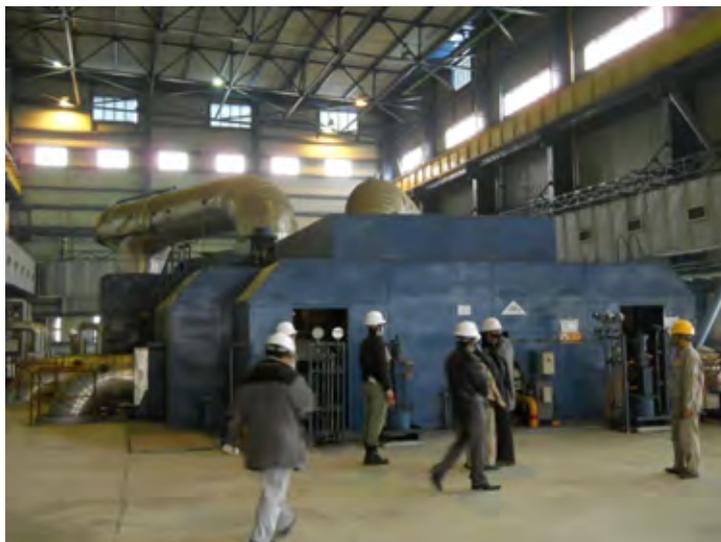
Figure 3.5-2 Uong Bi unit 7 main building

The turbine facilities have been operating for less than two years and no overall problems were detected as far as the appearance is concerned.

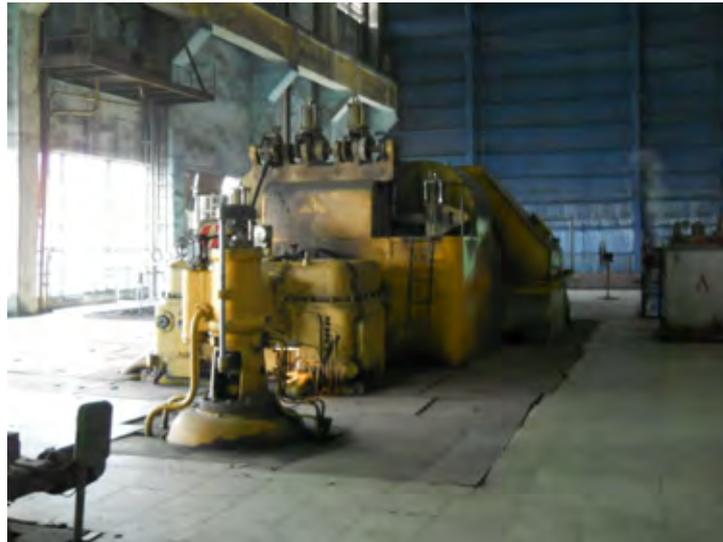
Figure 3.5-3 Uong Bi unit 5 and 6 main turbine

The main turbine of the unit 5 was under regular checks. The replacement of part of stator vanes was planned but it would take some time until vanes will be delivered, according to the plant personnel. The 18-stage rotor blade of the unit 5 was replaced in 2008, while the 22-stage rotor blade of the unit 6 was replaced in 2000.

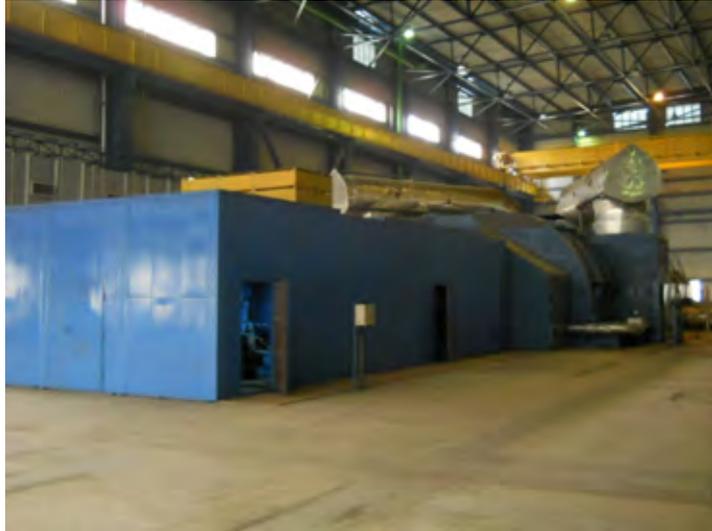
Figure 3.5-4 Uong Bi unit 7 main turbine

There were problems of vibration when the main turbine in operation as well as differential expansion in the turbine. The problems of vibration were solved by adjusting the opening and closing timing of the steam governing valve and balance shot, while the problems of differential expansion were solved by making assure that the designed casing warming and starting schedule are observed, according to the plant personnel. High-pressure 17 stages, intermediate pressure 15 stages and low-pressure four stages (double flow).

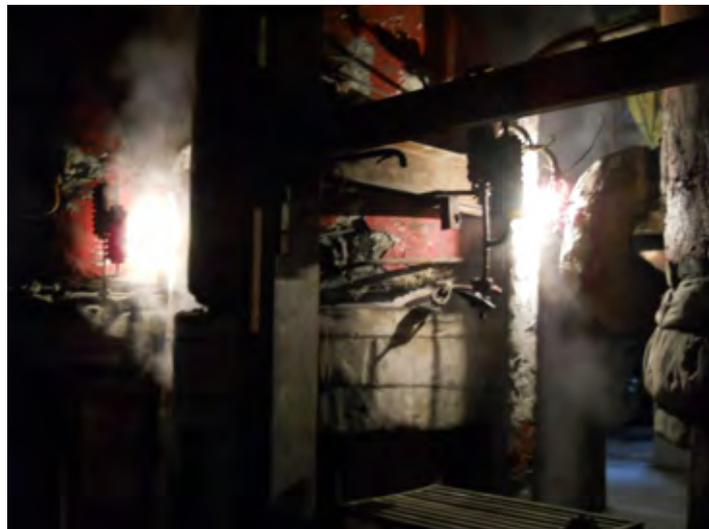
Figure 3.5-5 Uong Bi unit 5 and 6 feed water heaters and its surroundings

The entire high-pressure (HP) No. 6, 7 and 8 heaters of the unit 5 were replaced. And the tubes of high-pressure (HP) No. 6, 7 and 8 heaters of the unit 6 were replaced in 2003. The power plant manages the records of plugging. There was the leak of steam from the feed water heater of the unit 6, and it can be inferred that the heater has considerably deteriorated. The plant does not perform preventive maintenance of feed water heaters, which are repaired only after occurrence of troubles.

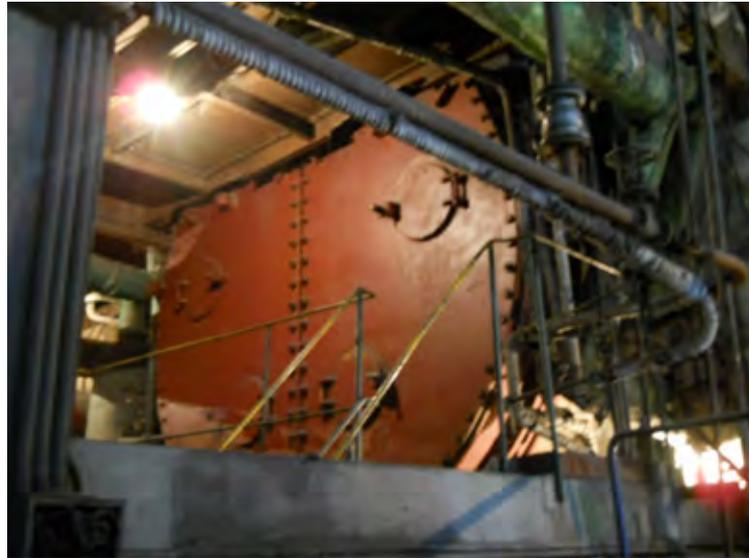
Figure 3.5-6 Uong Bi unit 5 and 6 condensers

All the capillaries of the unit 5 were replaced with new ones made from brass tube in 2000. The capillaries of the unit 6 were also replaced in the past. The power plant manages the records of

plugging, and when the allowed value (12 %) is exceeded, capillaries are replaced. When the conditions of condenser vacuum have deteriorated, the condenser is cleaned by back washing. Moreover, the condensers are cleaned during regular checks that are performed every two and four years. The plant does not perform preventive maintenance of condensers, which are repaired only after occurrence of troubles.

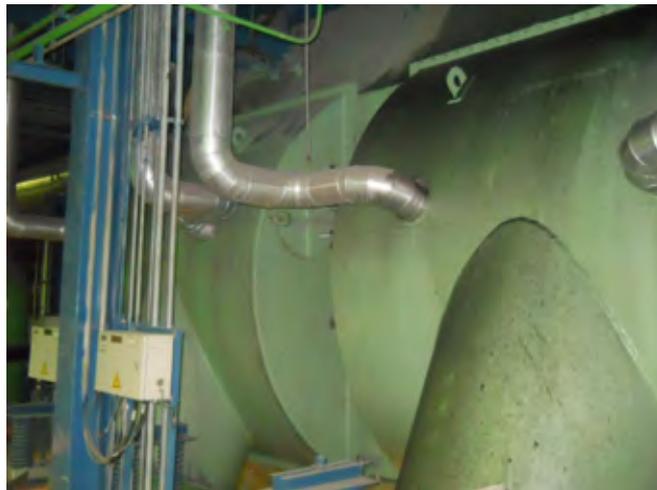
Figure 3.5-7 Uong Bi unit 7 condensers

Titanium tubes are used for condenser capillaries, while the ball cleaning system is installed to clean the balls every day. However, the management of ball size has not been carried out, and with the continuation of use of balls, the size has become smaller and balls are discharged from the screen.
