TECHNICAL SEMINAR

Automatic Transmission Rebuilders Association

FORD Contents

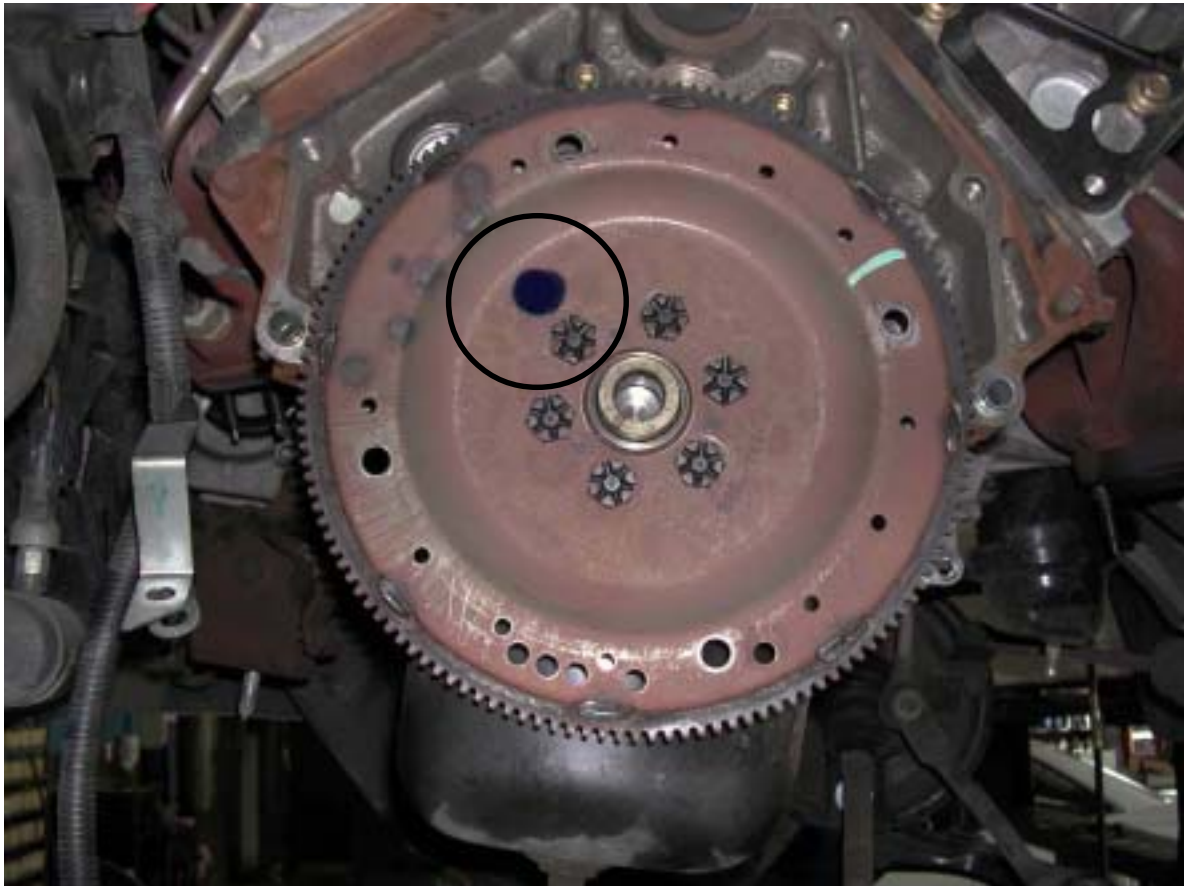
A Vibration or broken Flexplate on models between 1995-2001 that are equipped with 3.8L engines may be caused by the misalignment of the converter to flexplate. The Flexplate has an alignment paint dot on the flexplate and torque converter from the factory. This dot is there to ensure proper alignment.

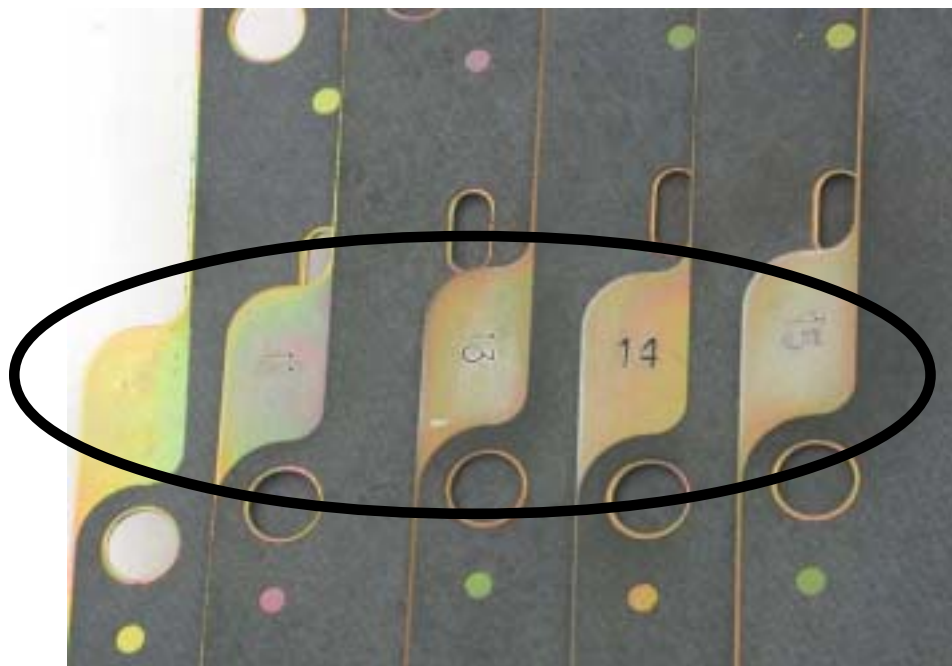
Seperator Plate and Gasket

Lincoln 1995-97	(stamped 11)	part #F50Z-7Z490-A
Lincoln 1998.....	(stamped 84)	part #F80Z-7Z490-AA
Lincoln 1999-00.....	(stamped 90)	part #FX3Z-7Z490-AA
Taurus/Sable 1994-95 w/3.0L	(no stamp)	part #F5DZ-7Z490-A
Taurus/Sable 1996-97 w/3.0L 2V	(stamped 13)	part #F6DZ-7Z490-B
Taurus/Sable 1998-99 w/3.0L 2V	(stamped 87)	part #F8DZ-7Z490-BA
Taurus/Sable 1996-97 w/3.0L 2V	(stamped 14)	part #F6DZ-7Z490-A
Taurus/Sable 1998-99 w/3.0L 4V	(stamped 86)	part #F8DZ-7Z490-AA
Taurus SHO 1996-97 w/3.4L.....	(stamped 15)	part #F6DZ-7Z490-D
Taurus SHO 1998-99 w/3.4L.....	(stamped 85)	part #F8DZ-7Z490-CA
Taurus/Sable 2000	(stamped 03)	part #YF1Z-7Z490-CA
Taurus/Sable 2001-03	(stamped 05)	part #1F1Z-7Z490-AA

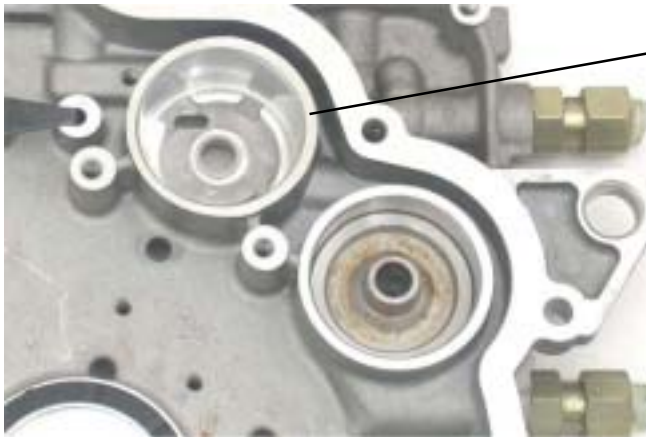
A Damaged Accumulator Piston assembly can cause a number of shifting problems from late, early, harsh, soft and more. When reassembling this unit pay close attention to the housing and piston areas. If the piston is worn or the housing scored the chances of the piston cocking in the bore are increased.

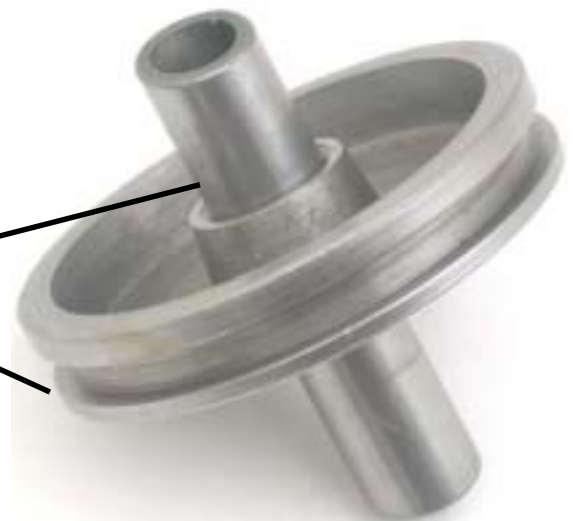
Check the Piston housing for wear, grooves, or scoring

Check the Piston and Rod assembly for wear

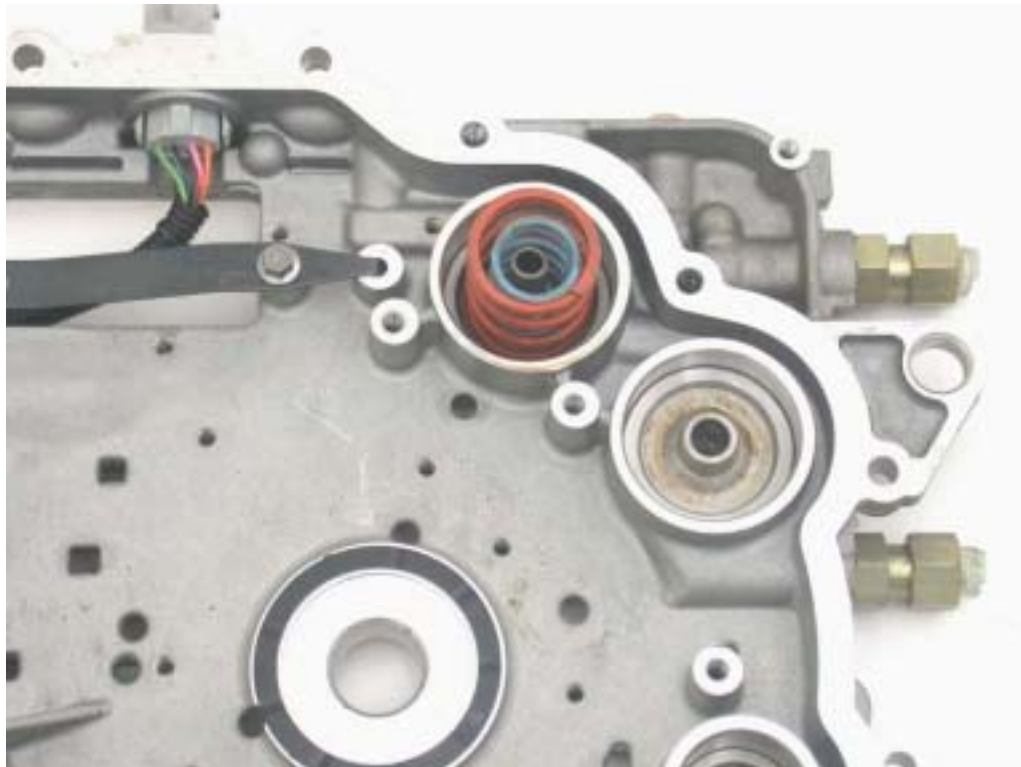
Wrong Accumulator Spring

VEHICLE	1-2 ACCUMULATOR	COLOR
95-02	F5DZ-7G267-A	ORANGE
95-96 SHO ONLY	F6DZ-7G267-A	PURPLE
97-01 SHO ONLY	F7DZ-7D397-AA	PLAIN

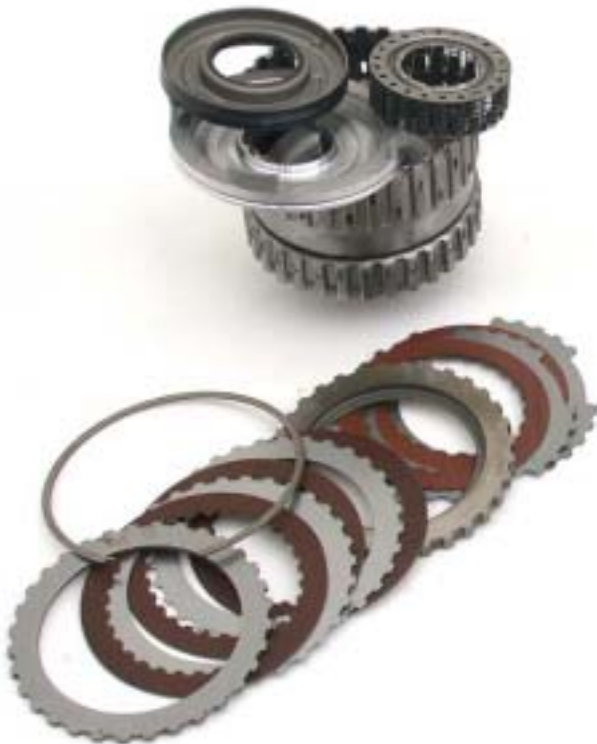
EARLY 94-97

Forward clutch assemblies with a wave plate are intended for use on later style valve bodies with the larger Forward feed orifice. Forward clutch assemblies without the wave plate are intended for use on earlier style valve bodies with the small forward feed orifice. If the Earlier style Drum assembly is installed to a Late model vehicle a harsh Forward engagement may be felt. This is due to the large feed hole in the Separator plate assembly.

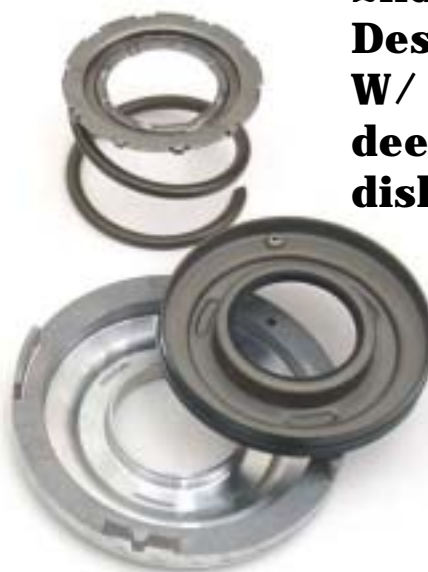
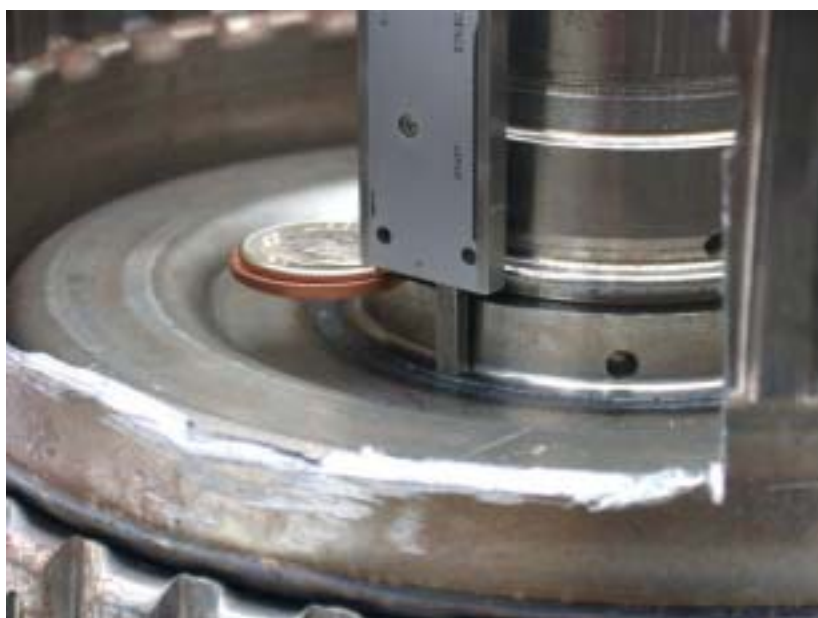
**2nd
Design
W/
deep
dish**

**1st
Design
0.315"**

**2nd
Design
0.400"**

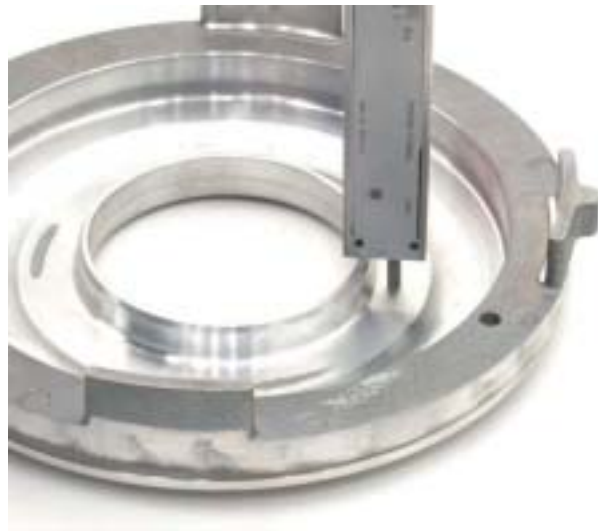
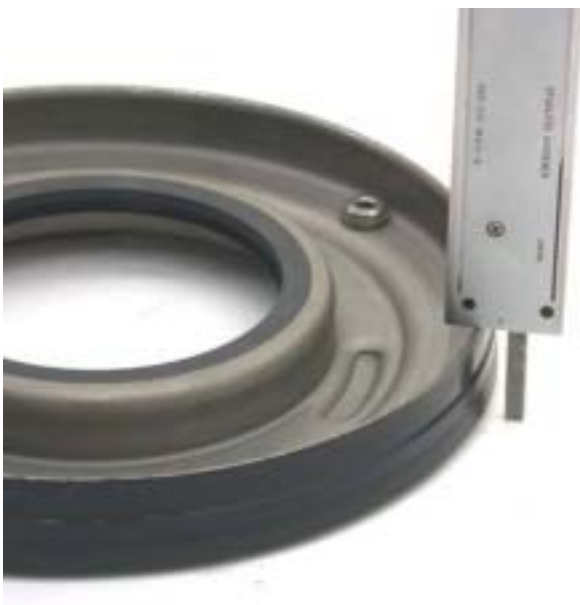
**1st Design 0.595"
Shallow Dish**

**2nd Design 0.680"
Deep Dish**

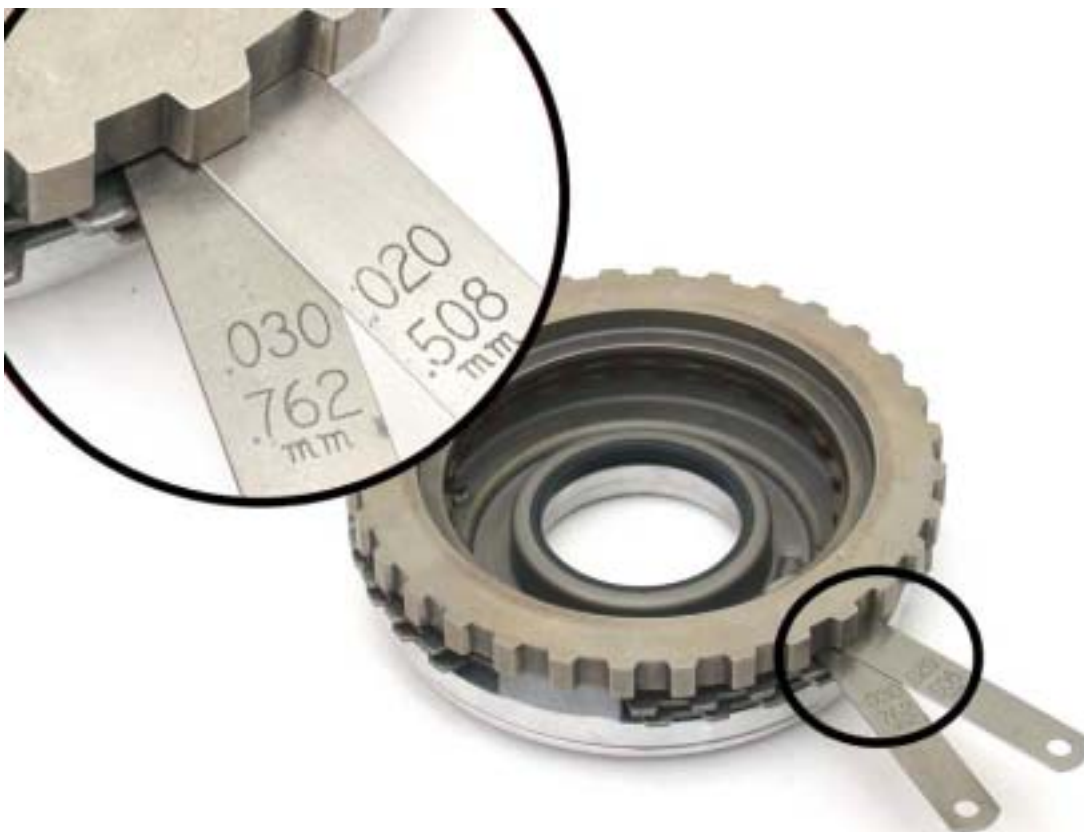
A 3-4 Bind may be caused the Clearance of the Coast Clutch being incorrect. Install the coast clutch piston into the forward piston, then stack 2 coast clutch steels, 2 frictions and the forward apply plate on top. Clearance should be around 0.050" in.

Other causes of this may be:

- › Forward Sprag (seized or wrong rotaion)
- › Cracked Forward piston
- › Crossleaks into the Coast Clutch

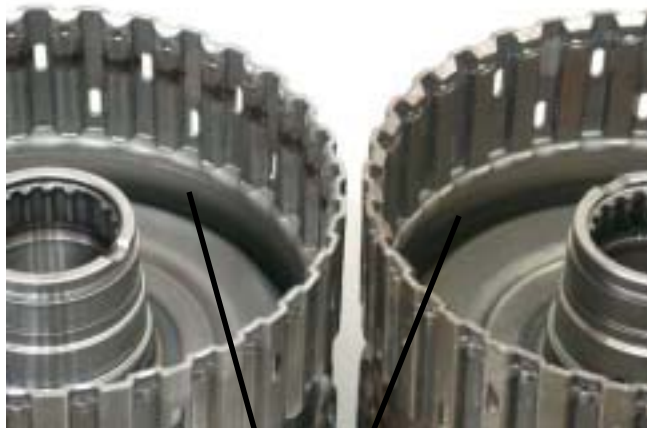
After rebuild, when hot car drives forward in Neutral and binds in Reverse. This problem occurs after a Forward/Direct drum has been replaced. Care needs to be taken when replacing the forward/direct clutch drum. Make sure that the piston slides into the drum bore with a top clearance (top of drum bore for outer seal) of at least .010 or more. Always feel outer seal riding surface for being smooth. If it appears that the top area of the drum where the seal rides is ballooned inward and not a true straight flat surface, do not use this drum as it will swell when hot locking the forward piston from returning to its relaxed position. This creates a mechanical bind on the piston not releasing the forward clutches

Look at the Ridges in the Drum and Piston surface area

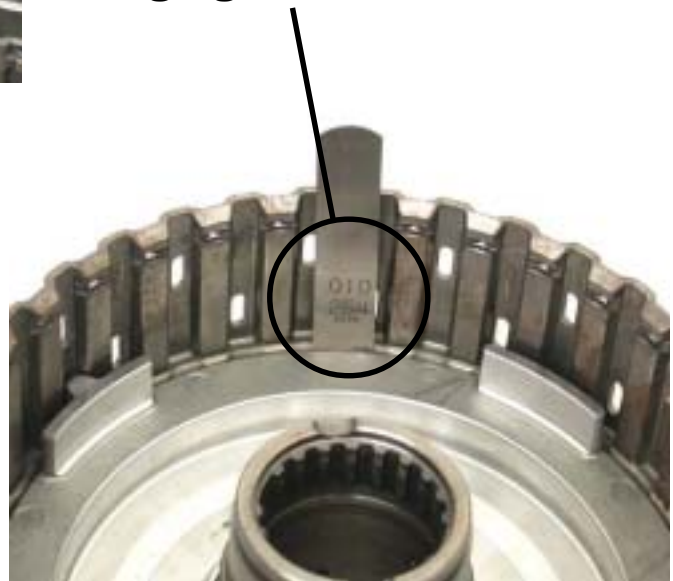
Make sure the Piston can sit in the Drum with a .010" feeler gauge

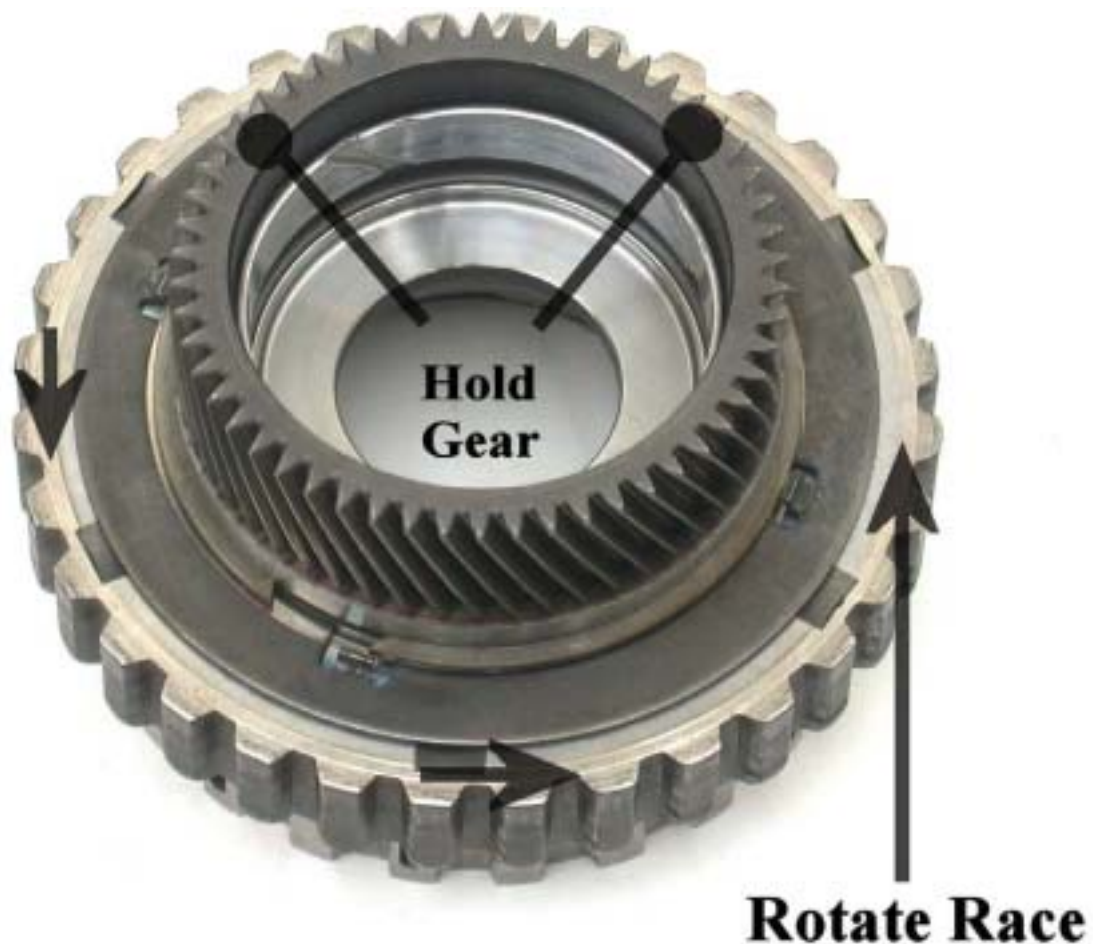
No Forward movement or Binds in fourth can be caused by the Forward sprag damaged or incorrectly installed

Race freewheels counter-clockwise while holding the sun gear stationary

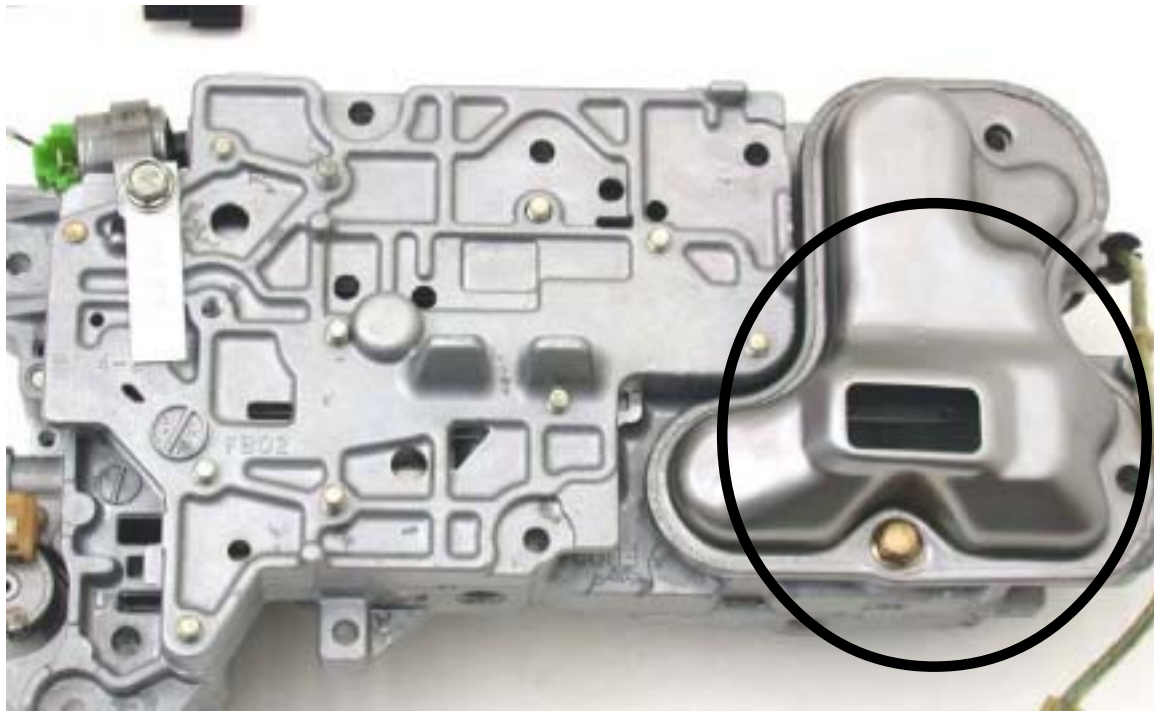
If a transmission repair is being performed for a contamination-related failure, always use a new filter and grommet. Many people think that simply cleaning a screen filter will work, but this is not always the case. Small particles can become lodged in the screen and restrict flow, causing slips, and ratio errors.

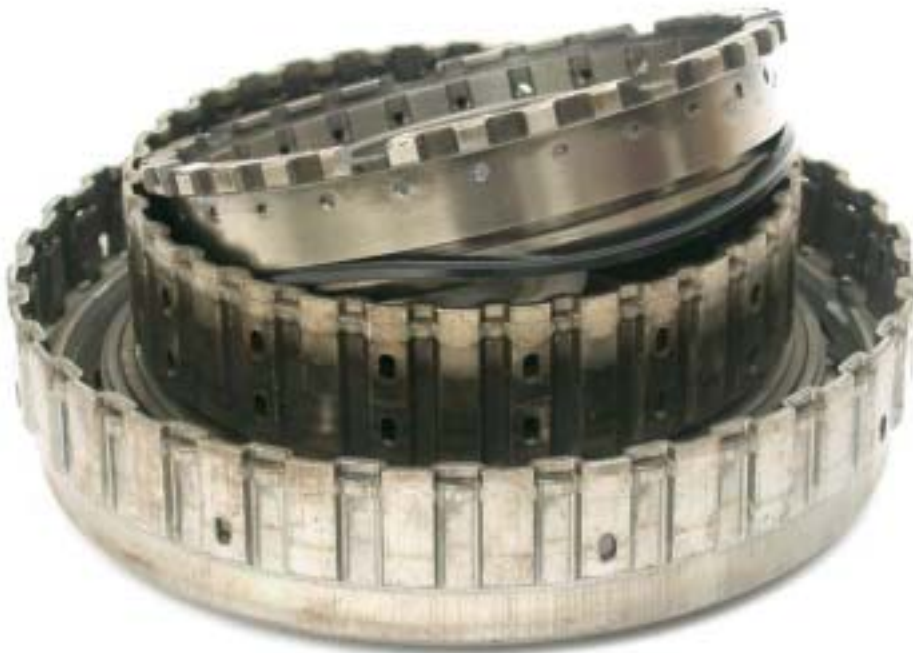
A bad seal or drum can be a difficult problem to diagnose. Some areas to look at are the sealing surfaces of the piston and drum assembly. A slipping Forward clutch can cause sluggish engagements into Drive. Here again knowing what's applied will help you diagnosis this unit quickly.

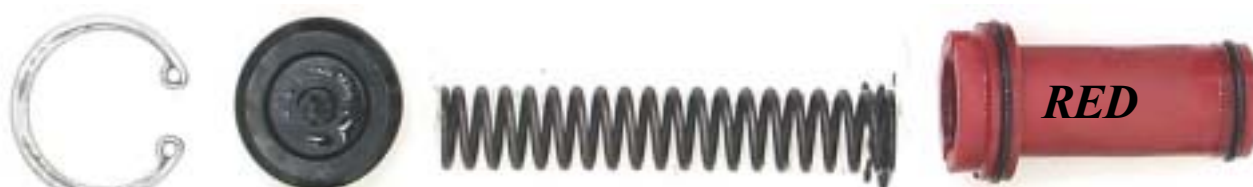
F4E-III***Ratio Codes (Continued)******Accumulators*****Accumulators — 1-2**

Spring
Length 3.425
Diameter 0.630
Coil 0.080

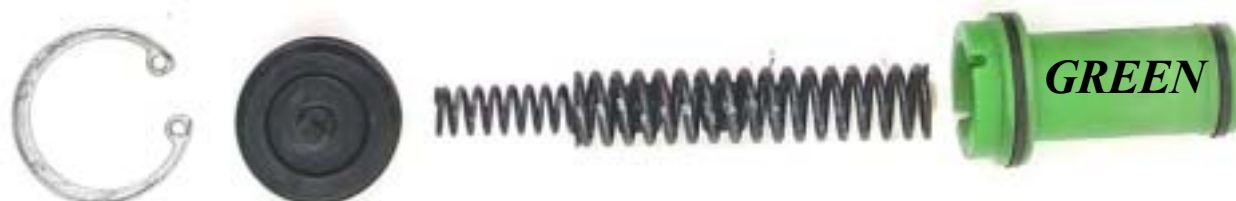
Accumulators — 2-3

Outer Length **2.729**
Outer Diameter **0.580**
Outer Coil **0.078**

Inner Length **2.665**
Inner Diameter **0.396**
Inner Coil **0.052**

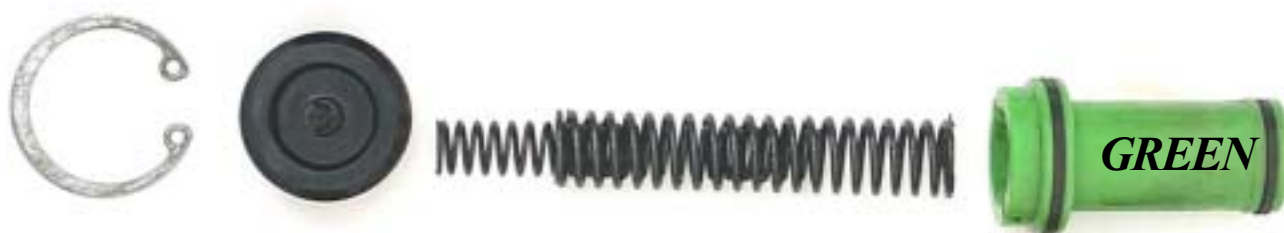
Accumulators — N-D

Outer Length	2.954
Outer Diameter	0.580
Outer Coil	0.062

Inner Length	2.802
Inner Diameter	0.420
Inner Coil	0.047

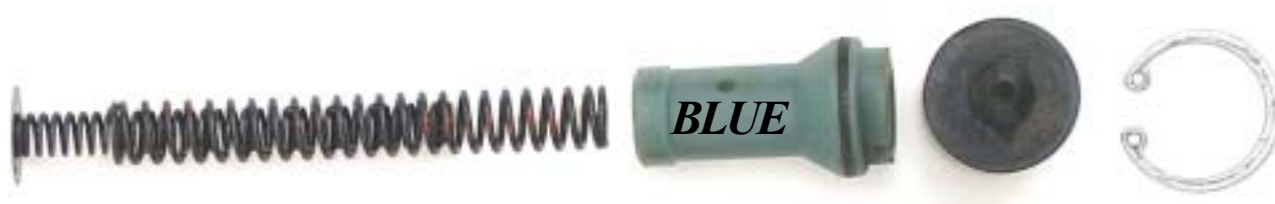
Accumulators — N-R

Outer Length	4.134
Outer Diameter	0.553
Outer Coil	0.066

Inner Length	3.657
Inner Diameter	0.384
Inner Coil	0.050

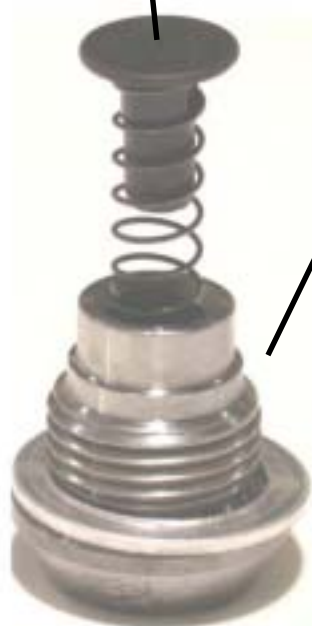
**The Orifice size
is .020" in**

**Always take the time
to remove the servo
apply orifice.**

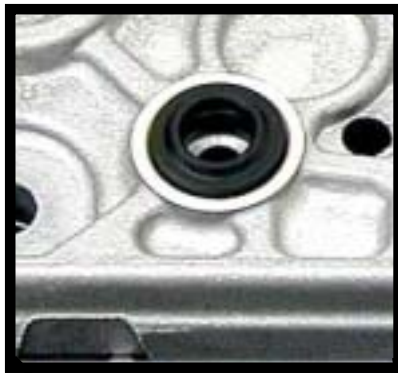
It is important to install the Servo seal to the Valvebody correctly make sure there are no tears in the lip of the seal and that there is no knicks on the Valvebody seal surface. Make sure you torque the Valvebody to specifications and air check the unit after. A loose valve body can cause the seals to tear from the oil pressure passing the feed.

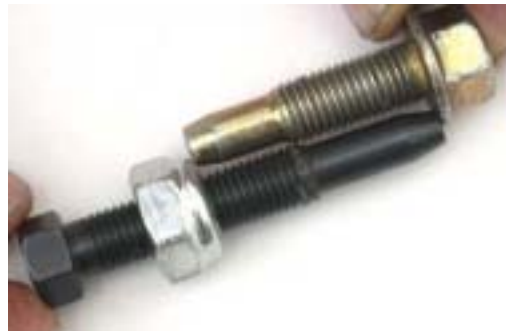
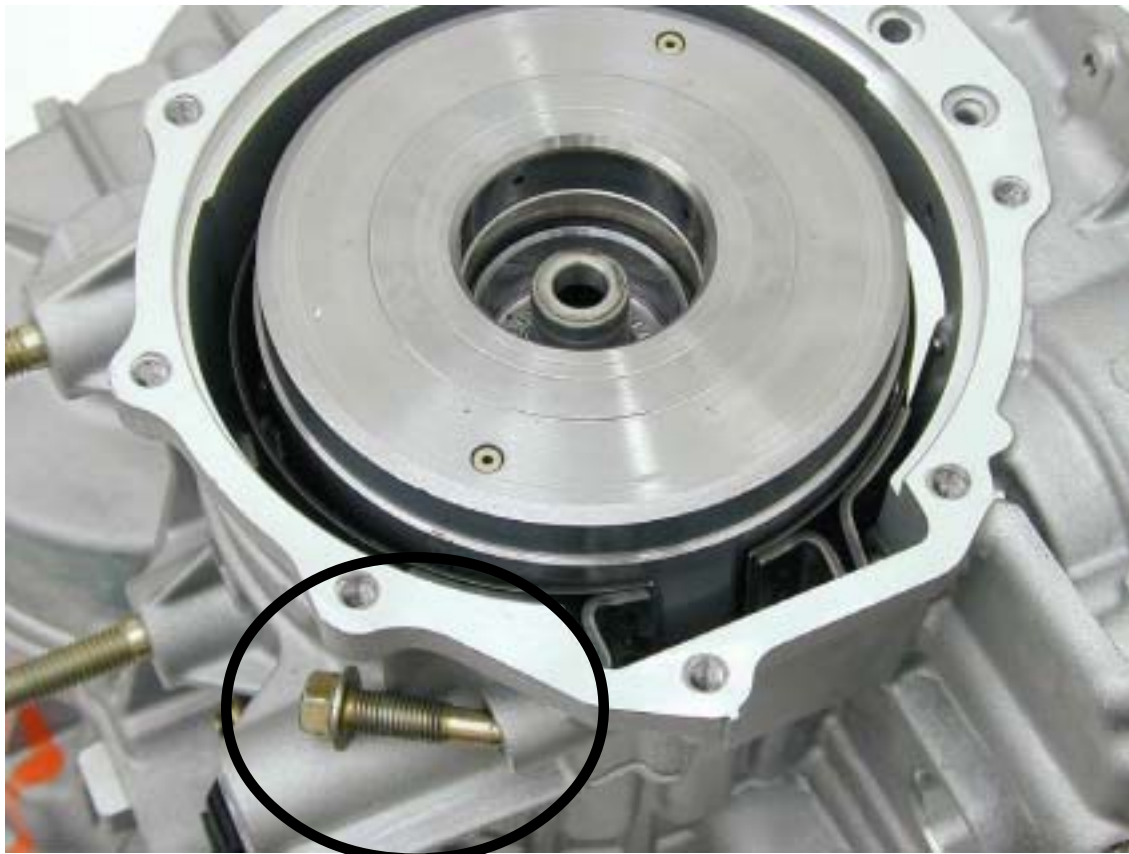
OTC# 307-416

Band adjustment is crucial during a rebuild. Many times a repeat failure of the band will occur because the specified bolt was not installed. This tool can be purchased from the after market.

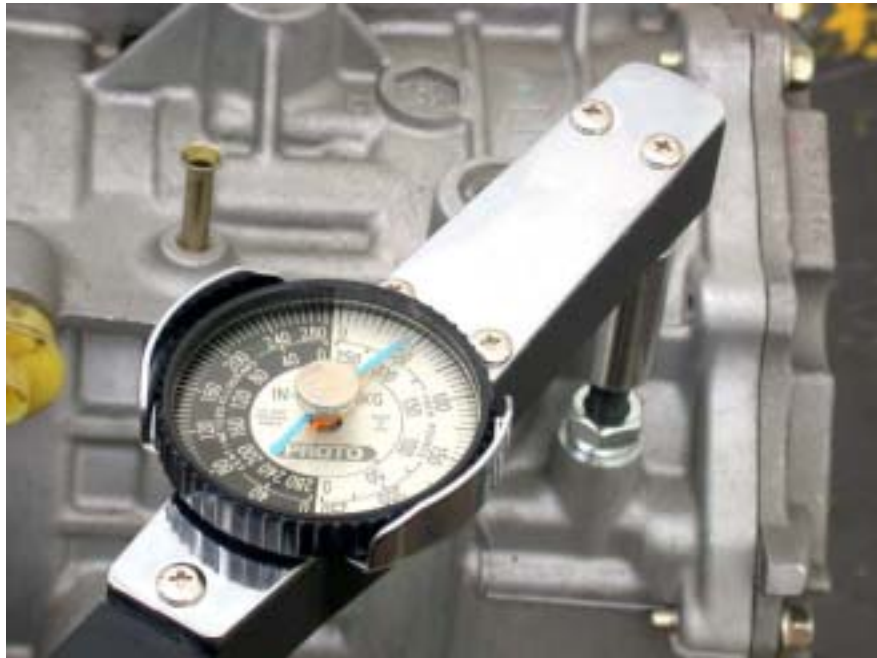
- › Tighten the band select gauge tool to 45 lb-in
- › Back out the gauge 3 ½ turns
- › Holding the tool bolt in position, lightly seat the nut and washer against the transaxle case
- › Remove the tool without changing the position of the nut on the bolt

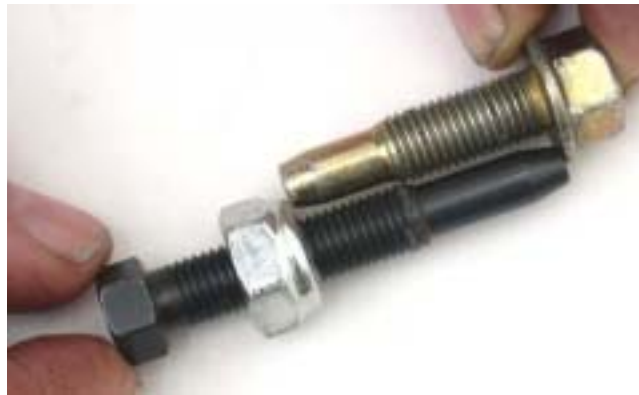
2 / 4 Band Adjustment

- › Compare the 2/4 band anchor bolt with the measurement tool
- › If the adjustment is off use the chart to verify the correct pin

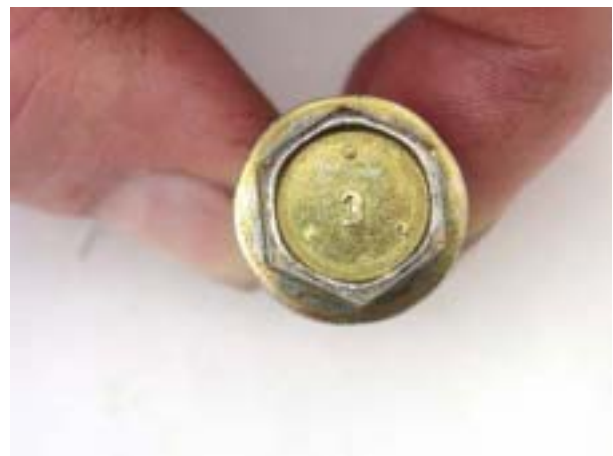
Anchor Bolt Selection Chart		
Part Number	Bolt Head Number	Bolt Length
XS4Z9F206GB	7	39.0 mm
XS4Z9F206FB	6	38.5 mm
XS4Z9F206EB	5	38.0 mm
XS4Z9F206DB	4	37.5 mm
XS4Z9F206CB	3	37.0 mm
XS4Z9F206BB	2	36.5 mm
XS4Z9F206AB	1	36.0 mm

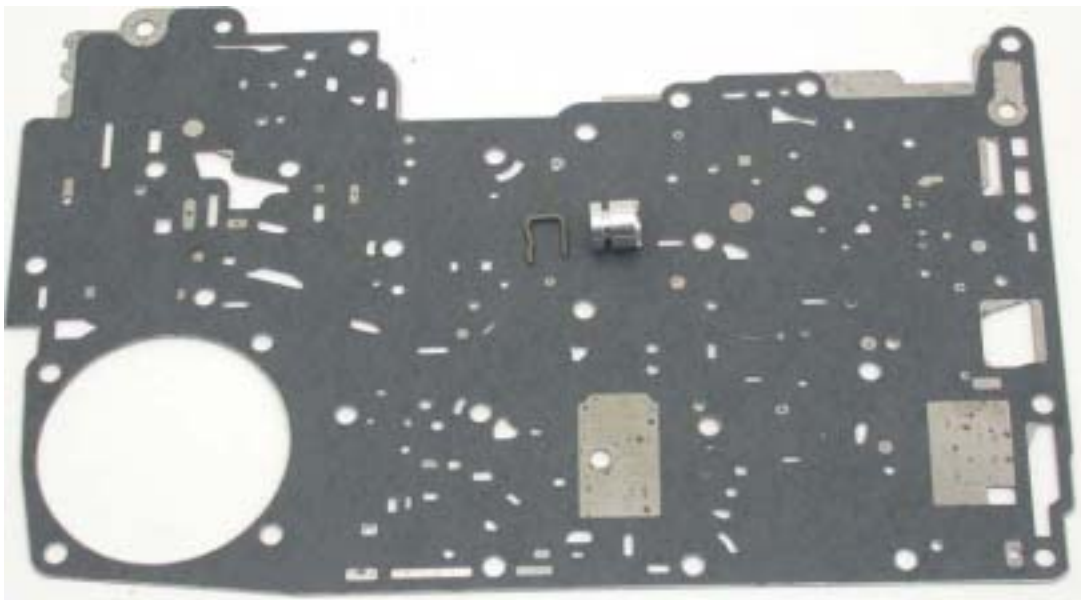
The separator plate orifice sizing has been changed to repair this problem, a new Separator plate is now available from Ford. In some cases due to heavy contamination the Valve Body will need to be replaced if there isn't a heavy amount debris in the pan refer to chart for specific separator part number. If it is determined the valve body needs replacing refer to chart on the opposite page.

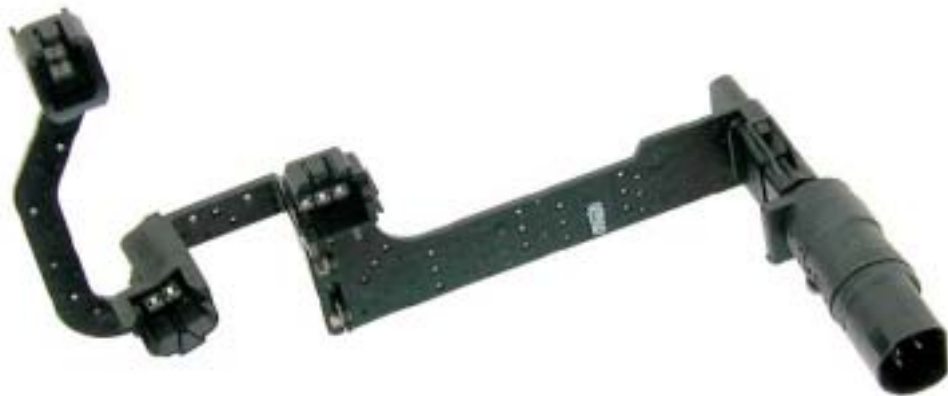
Intermittent TCIL flashing may be caused by the internal solenoid hard shell harness being distorted or not being fully seated between the solenoid and the harness.

Check the Mating Surfaces

**This Pin is
damaged**

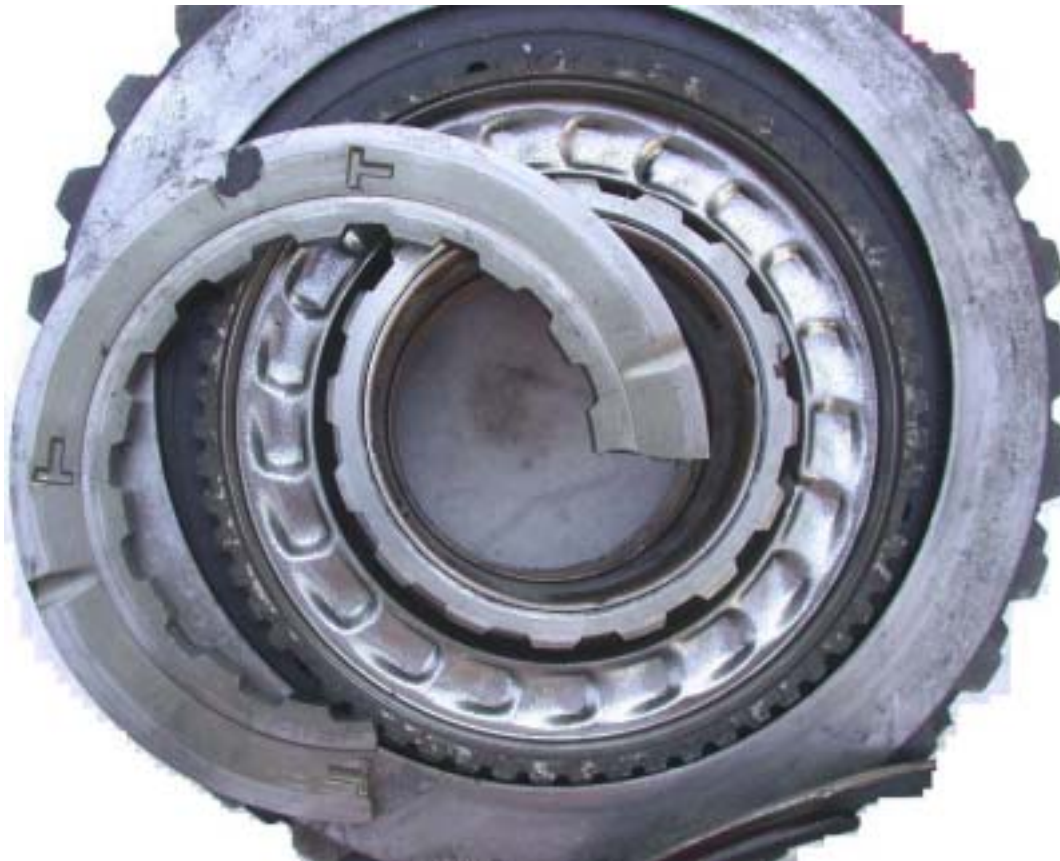
The common cause for this problem is duability of the Intermediate Diode sprag. A new drum and sprag assembly was introduced last year in ATRA Bulletin #642. When a replacemnet is necessary you may need to replace the piston and return spring also. The new Drum deletes the thrust washer assembly and has a smaller piston travel area.

E9TZ-7A089-B	Intermaediate sprag
1C3Z-7B164-BA	Clutch Plates
YC3Z-7D044-AA	4 Plate Drum 5.4L and 6.8L
YC3Z-7D044-BA	5 Plate Drum 7.3L only
F3TZ-7G401-AA	Thrust Washer#7

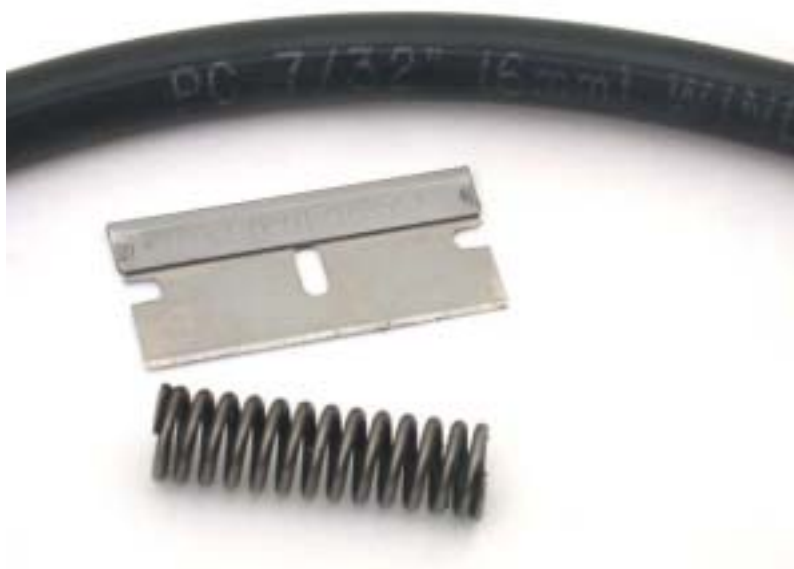
A common failure of the Intermediate clutch is almost always caused by lack of feed oil to the piston, typically due to case damage, one modification you can do is install a rubber gasket/seal around the feed hole of the Intermediate clutch drum. There are a few things your going to need to do before this repair.

1 = C6 Direct Clutch Return Spring

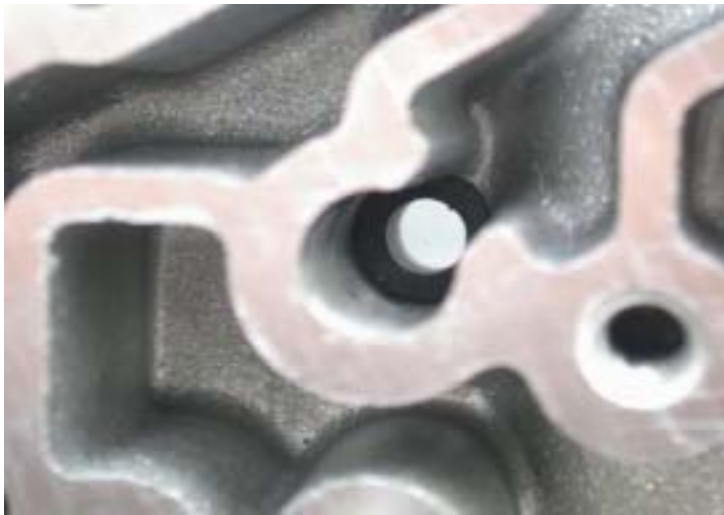
Seat hose at the bottom of the channel case

With hose extended through case, trim it with the razor blade.

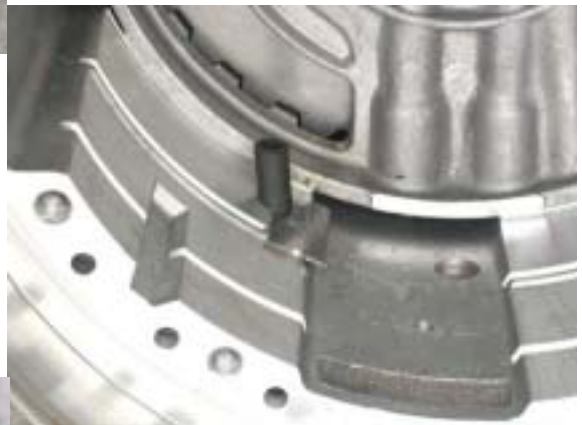
Make sure it is flush against the case.

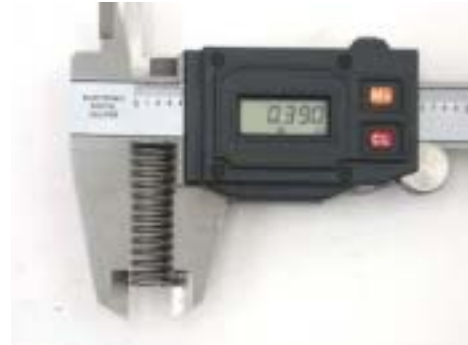
Spring specification

Should be less then a 1/8 of an inch above the seperator plate

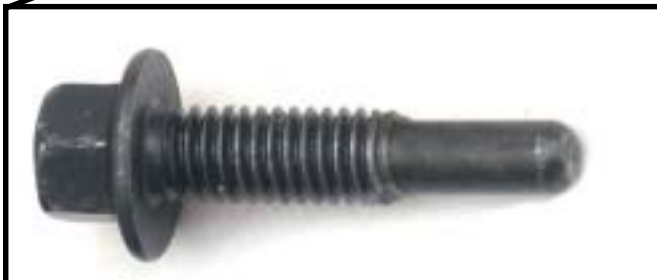
A No Reverse or Manual low condition can be caused by the Low/Reverse plate bolts being too long and bottoming out in the case. Signs of this are evident when initial inspection shows the tip of the bolt and the bottom of the case having signs of damage

Discard these types of bolts. Install thread-only bolts.

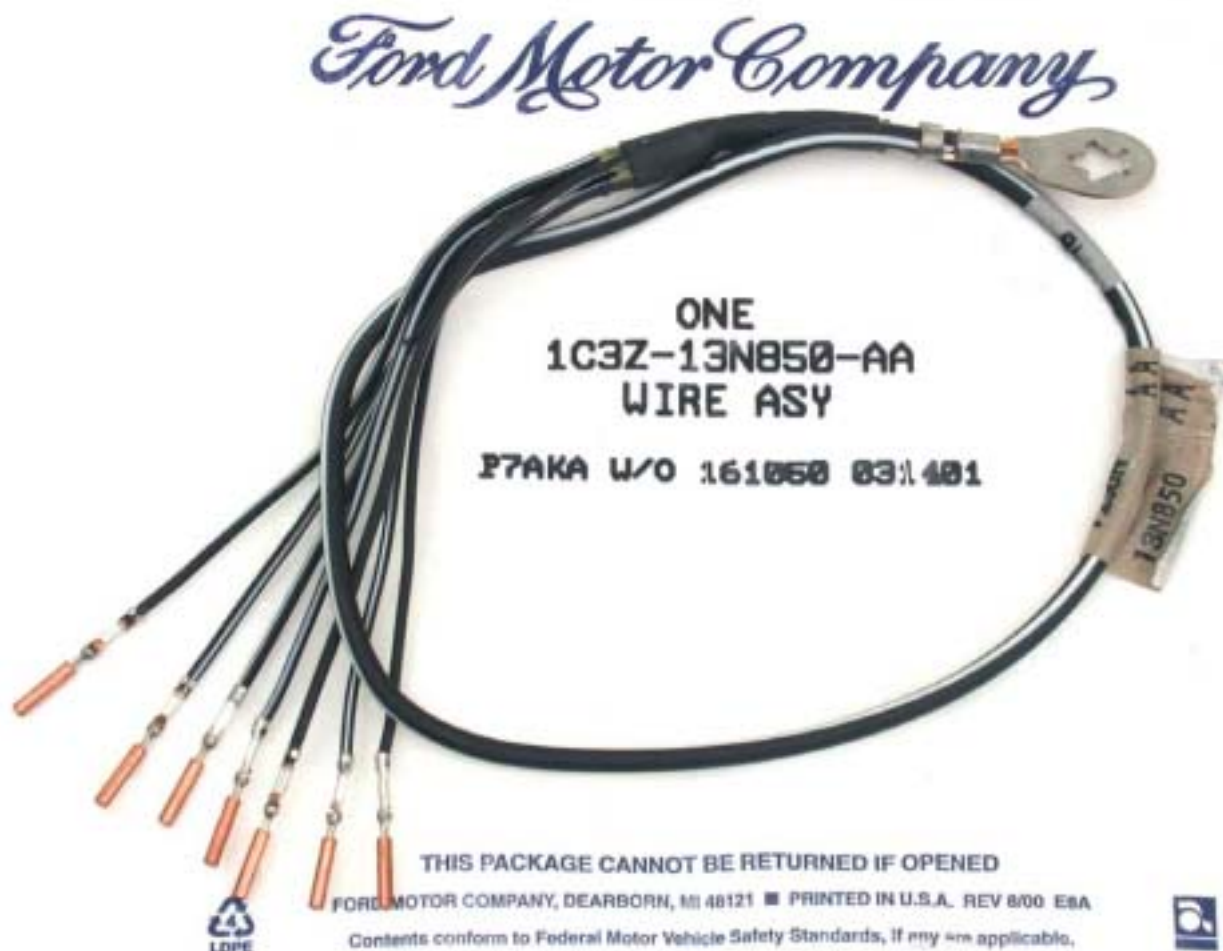
Part # 1C3Z-13N850-AA

An erratic 1-2 upshift or 2-1 downshift may be caused by a VSS input while the vehicle is stationary. Monitor the VSS on you scanner, if the scanner shows a VSS signal with the KEY ON and the ENGINE OFF. It may be necessary to install a jumper kit from FORD. This kit replaces the computer's current ground wires with a single body ground cable.

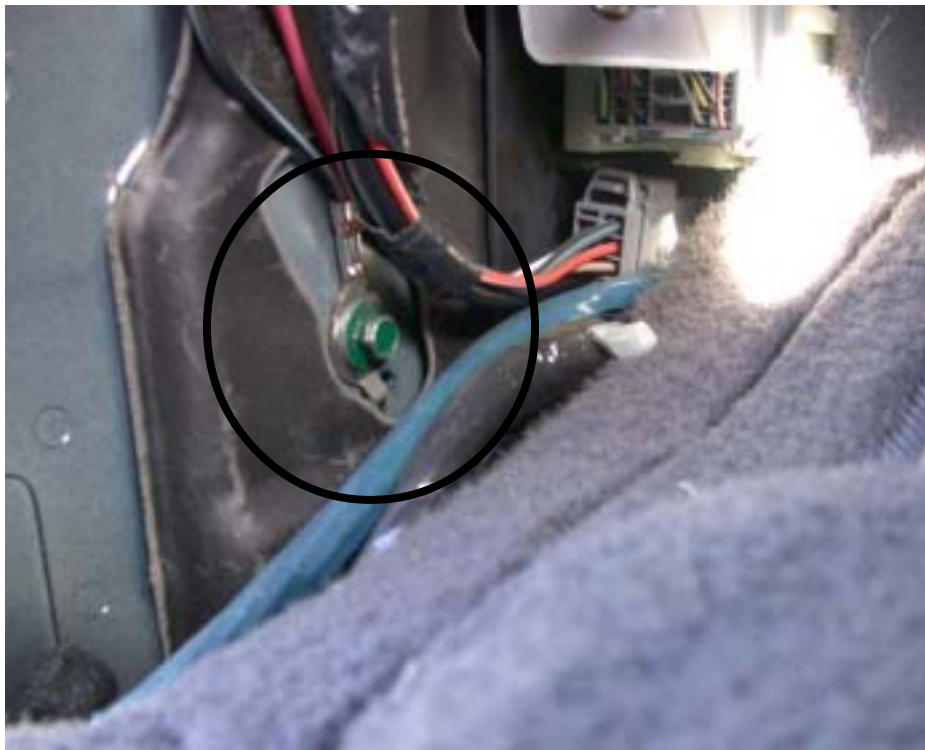
1. Disconnect the battery negative cable.
2. Remove the ground screw from under the dash.
(Left side of the brake pedal)
3. Drill a 6mm (1/4) hole near the original ground screw location and clean to bare metal. **(make sure you can attach a nut behind the bolt)**
4. Using a new bolt and nut attach the original ground eyelets to the sheet metal.

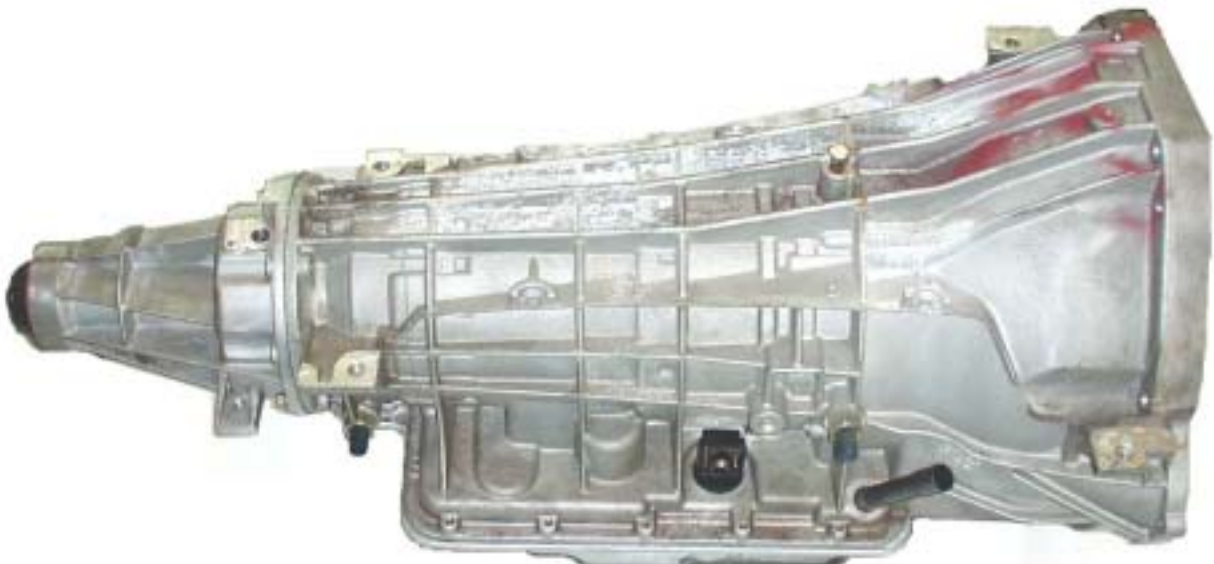
- › a torque converter clutch.
- › six multiple-disc friction clutches.
- › two mechanical diode one-way clutches (OWC).
- › three planetary gear sets.
