# SERVICE BULLETIN

Classification: AT15-014b	Reference: NTB15-085b	Date: April 1, 2016
------------------------------	--------------------------	------------------------

## 2013-2015 ALTIMA; CVT DELAYED ENGAGEMENT WHEN SHIFTING INTO DRIVE OR REVERSE

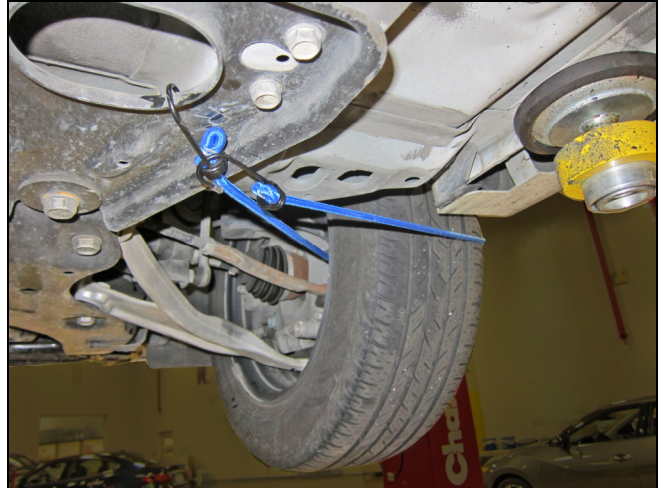
Figure 9

2. Secure the front right tire with a suitable strap.
  - This will assist in making the belt turn.
3. Mark the front left tire with a suitable marking.
  - This will assure all 360° of the belt is inspected.

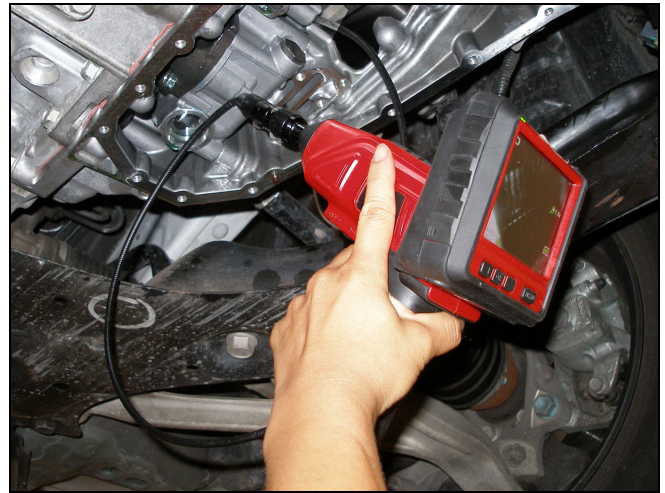
Figure 12

- Holding the borescope with one hand allows for turning the tire with the other hand (see Figure 12).

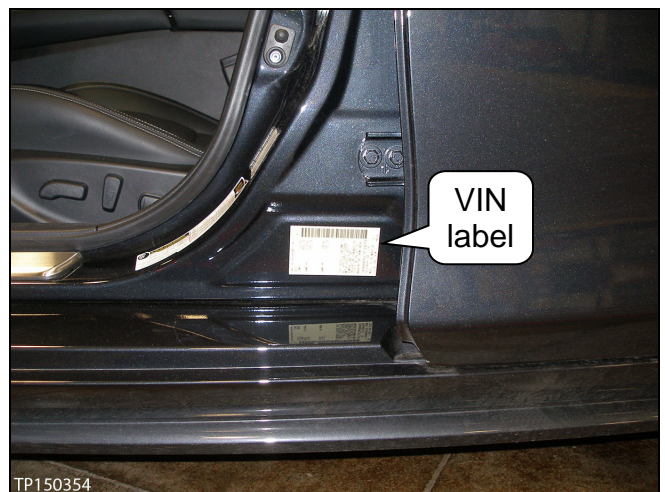
Figure 14

- e. Once CVT replacement is determined as required, use borescope J-51951 to record a 15 second or less continuous video of the most severe evidence of belt slip and the VIN on the F.M.V.S.S. certification label (VIN label). See Figure 14.

**NOTE:** This required video must be attached to the Powertrain Call Center CVT Preauthorization Form (in ASIST) prior to calling for authorization. Failure to submit a continuous video will cause immediate denial of request for replacement.

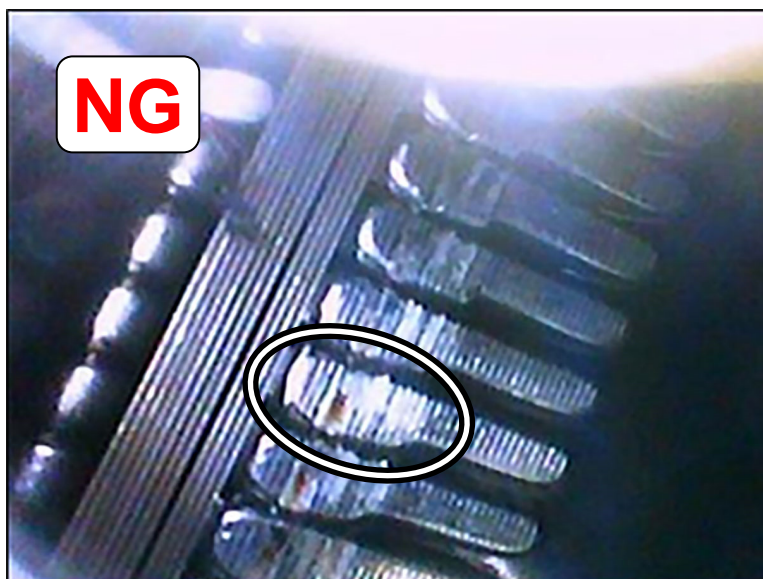
Pictures in Figures 22-24 were taken with borescope J-51951.

Figure 24: Example of NG belt

6. If the belt inspection result is NG, replace the CVT assembly.
- Get authorization to replace the CVT assembly (see page 26).
  - Make sure to perform step 4e on page 13.
