# Austin/San Antonio Weather Forecast Office WEATHER EVENT SUMMARY

# 2015 Memorial Day Weekend Flooding

23 – 24 May 2015

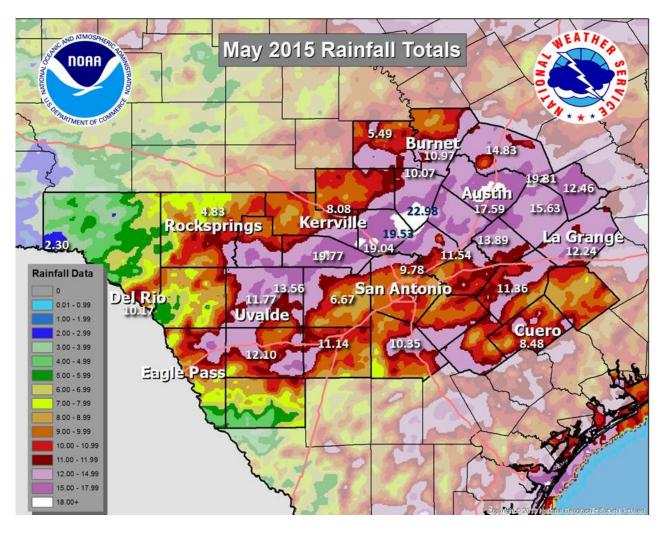
Figure 1: May 2015 rainfall totals.

A persistent weather pattern from the beginning of May began to set the stage for a more concentrated and more impactful flash and river flooding event. May 2015 will go down in history as one of the wettest months across the state of Texas (Figure 1). For the first two to three weeks of the month, most locations across south-central received well-above normal rainfall that saturated the soils. By the time Memorial weekend arrived, much of the region was at least 2-4 inches (100-300%) above normal. These wet antecedent conditions meant that any new rain and especially heavy rain would become run-off directly into rivers, streams, and flash flood prone areas. Ingredients came together during the memorial weekend for several rounds of very heavy rain and severe thunderstorms to develop. Widespread 6-8 inches fell across Bandera, Kerr, Kendall, Blanco and far west portions of Comal and Hays counties with a max of 10 to 13 inches of rain across southern Blanco and extreme NE Kendall counties. Most of this rain fell from Saturday afternoon into the overnight hours of early Sunday morning, leading to a rapid rise in the Blanco and San Marcos Rivers (Figure 2). The Blanco River at Wimberley rose from near 5 feet at 9pm to near 41 feet by 1am. One staggering statistic is that the river rose 5 ft every 15 minutes from 10:45pm to 11:45pm. This equates to a 20ft rise along the river within a one hour time frame. The river gauge hydrograph for Wimberley can be seen in Figure 3 below depicting this rapid rise. Numerous high water rescues occurred throughout the late evening and morning hours along the banks of the Blanco and eventually the San Marcos Rivers.

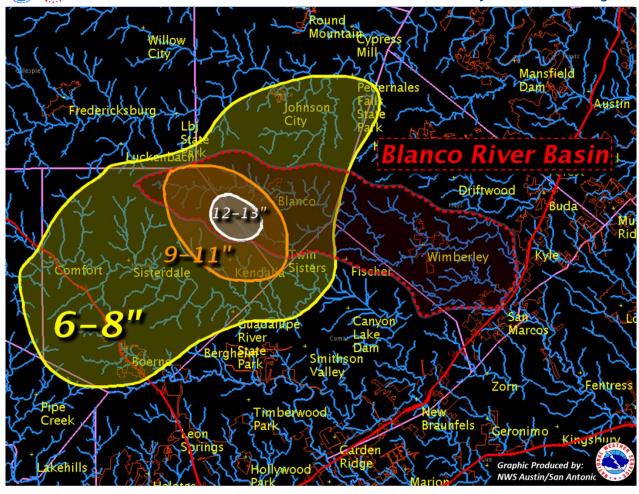
**Figure 2:** Widepsread 6-8 inches of rainfall with local 9 to 11 inches and a maximum of 12-13 inches fell in the head waters of the Blanco River Basin over 4-6 hours.

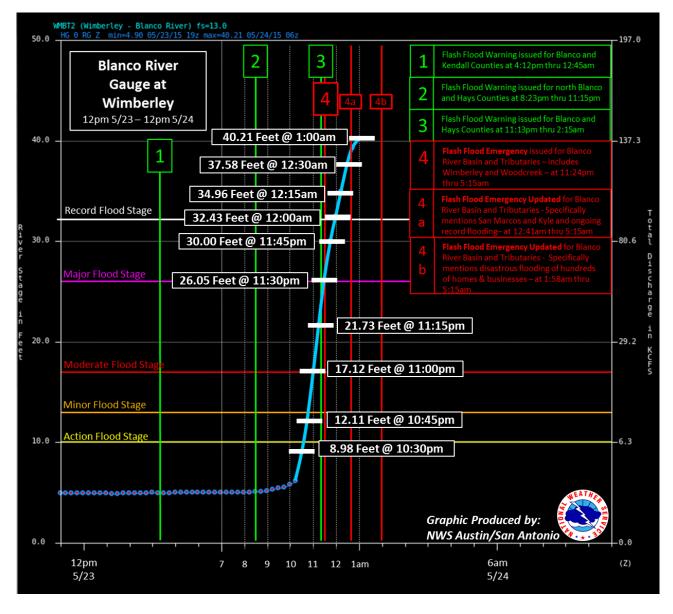
Figure 3a: Hydrograph for Blanco River at Wimberley, TX. Note the extreme rapid rise of river levels given the high rainfall amounts and rates in the Blanco River Basin headwaters from Figure 2. The river went from below flood stage to major flood stage in 45 minutes. A Flash Flood Emergency Warning was issued for Wimberley at 11:24pm with several flash flood warnings issued at 4:13pm, 8:23pm and again at 11:13pm.

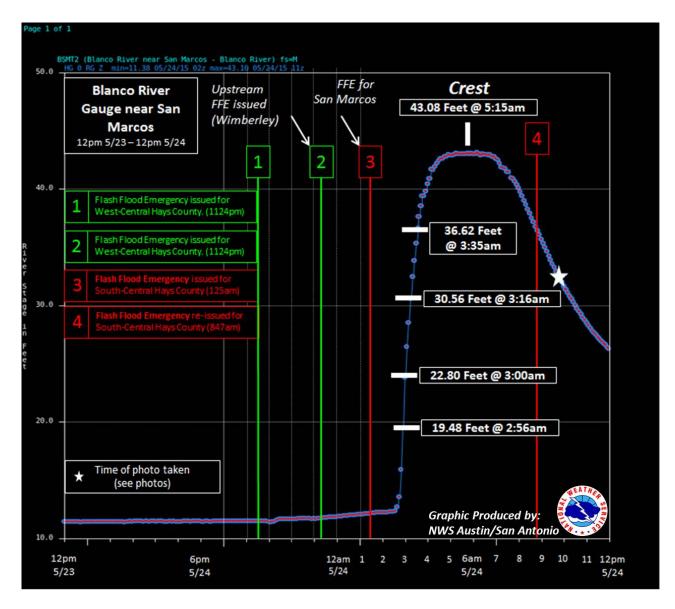
Figure 3b: Hydrograph for San Marcos River near San Marcos, TX. Note the similar rapid rise of river levels compared to the Wimberley gauge (Figure 3a). The heavy rains falling upstream created a river surge downstream into the city of San Marcos. The initial flash flood warning for this area was issued at 11:24PM and an upgrade to a Flash Flood Emergency was issued for San Marcos at 1:25am. The river surge arrived in San Marcos just before 3:00am. Several upstream warnings were issued prior this time. The river crested at 43.08 feet at 5:15am on the 24th. The significant impacts due to this river warranted a re-issuance of the Flash Flood Emergency at 8:47am when the river had already receded to 36.78 feet. An NWS employee that lives nearby this gauge took a picture of the river from the viewpoint of the gauge at 9:45am (see below).

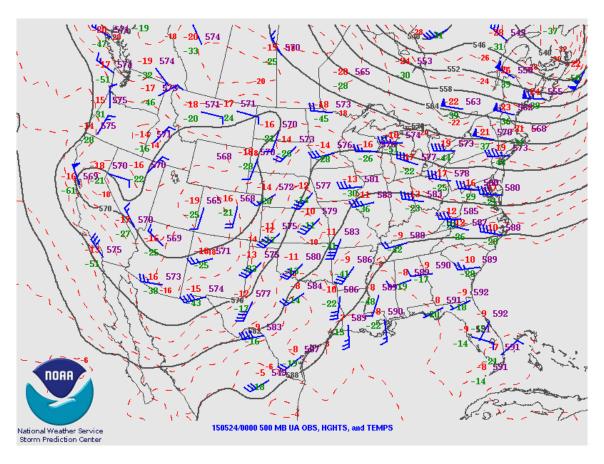
**Figure 4:** 500 mb chart for 5/24 at 00z (May 23 7pm). Mid-level Atmospheric pattern on May 23rd at 7pm. Note the little ripples in the lines over Texas. These ripples can indicated enhanced areas of lift and when combined with cyclonically-curved winds, can result in supportive environment for longer lived storms.

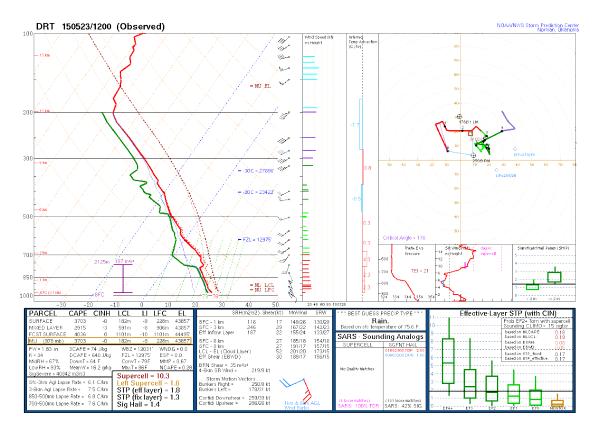
Figure 5: SPC Sounding chart from KDRT 05/23 12Z. Note the PW value of 1.83" taken from the weather balloon sampling in Del Rio, Texas from Saturday morning. CAPE values were already high that morning ahead of developing storms and indicated more storms would be likely that afternoon. This instability in combination with modest shear values allowed for organized storms to develop.

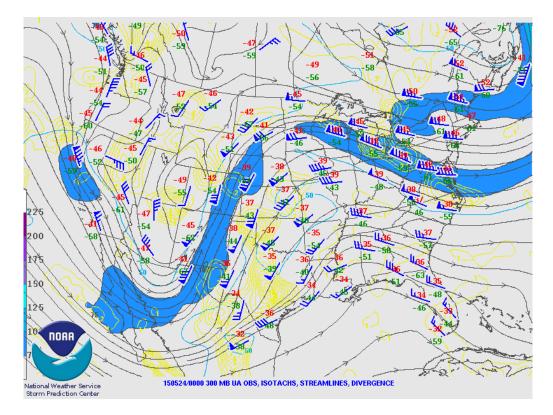
Figure 6: 300mb winds and divergence outlined in yellow. Note the sharp air flow direction change across northern Mexico with a potent long wave trough. This strong diffluence allowed for strong horizontal divergence that supported stronger and long-lived updrafts that tapped into the ample moisture in place over Texas. Note the high contouring of yellow outlines across south central Texas.

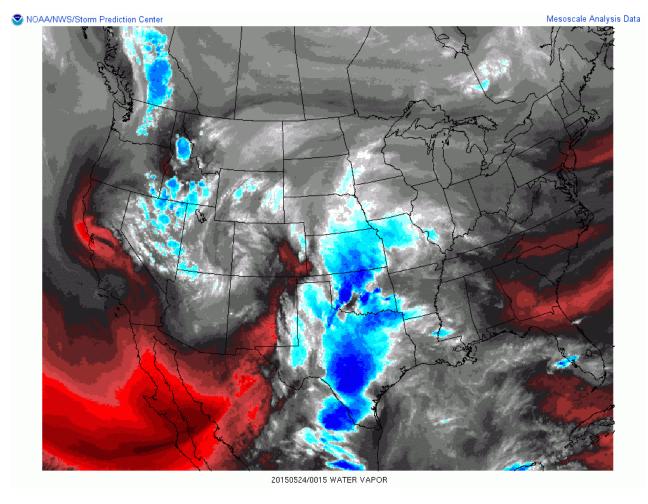
Figure 7: Water Vapor Image for 7:15pm on Saturday, May 23rd. Note the significant thunderstorm activity over southcentral Texas that is producing heavy rainfall.

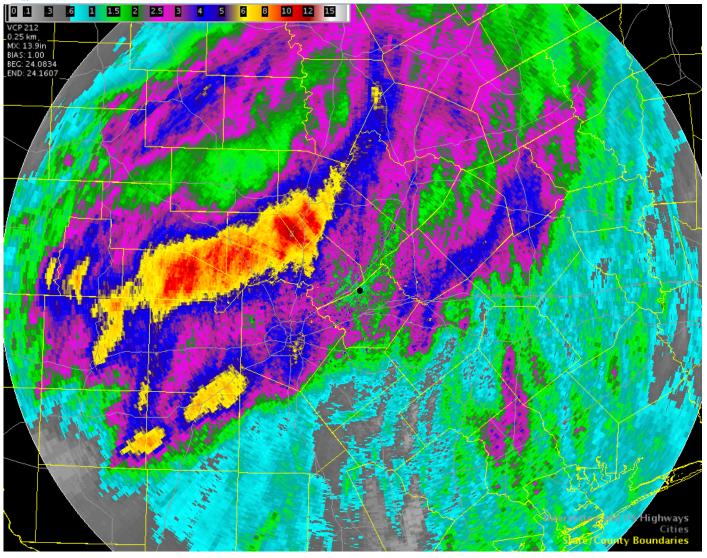
**Figure 13:** Dual-Polarization Radar Storm total Rainfall Estimates. Note the 9-11 inches with Max nearing 13" in the dark red to White area along the Blanco/Kendall County Line

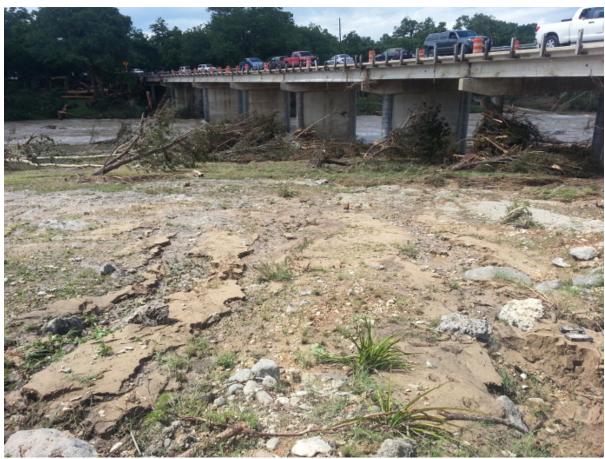
Ranch Road 12 at Blanco River Crossing in Wimberley, TX on May 24, 2015.

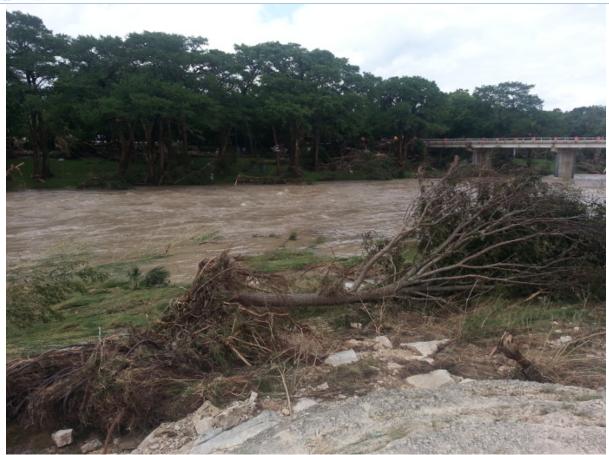
Near Ranch Road 12 at Blanco River Crossing in Wimberley, TX on May 24, 2015.

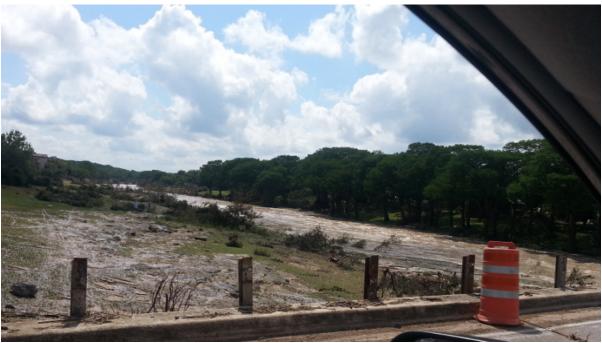
Upstream of Ranch Road 12 at Blanco River Crossing in Wimberley on May 24, 2015.

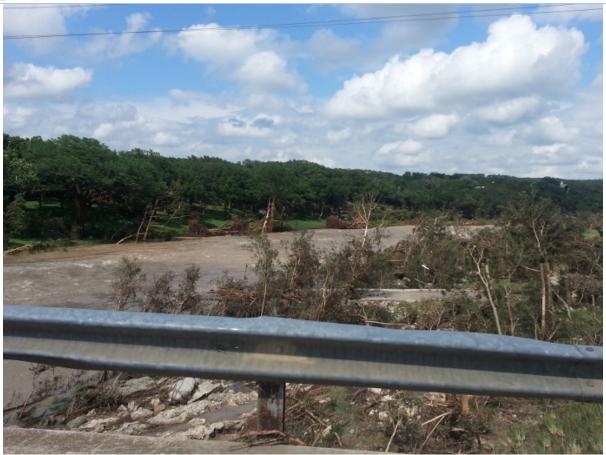
Downstream of Ranch Road 12 at Blanco River Crossing in Wimberley on May 24, 2015.

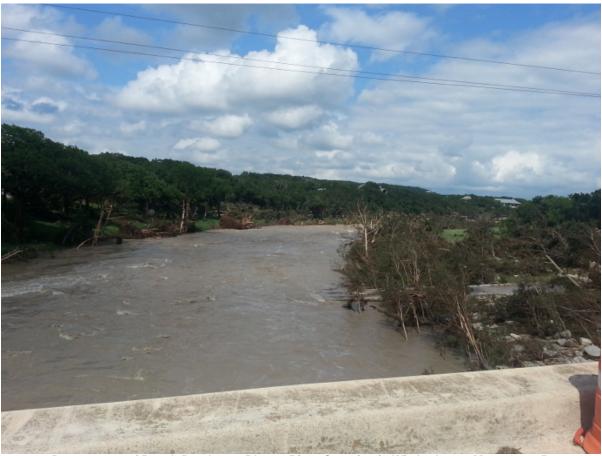
Downstream of Ranch Road 12 at Blanco River Crossing in Wimberley on May 24, 2015.

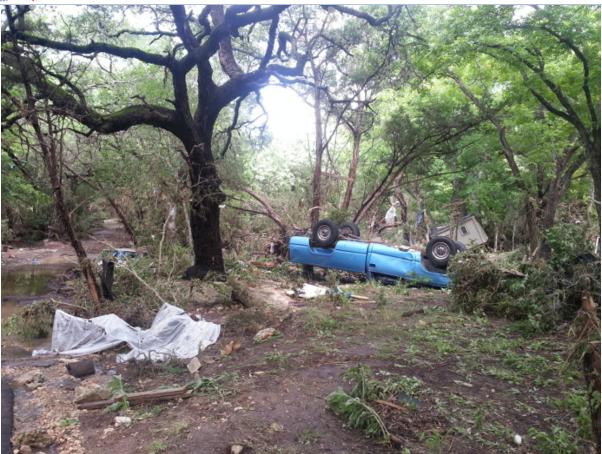
Malone Drive in Wimberley, TX on May 24, 2015.

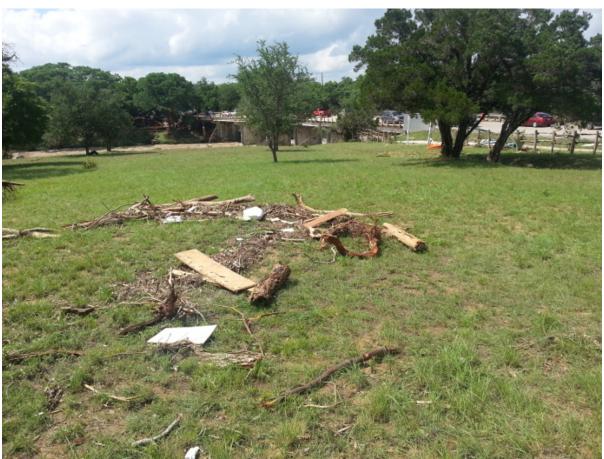
View from near water line at Ranch Road 12 Blanco River Crossing in Wimberley on May 24, 2015.

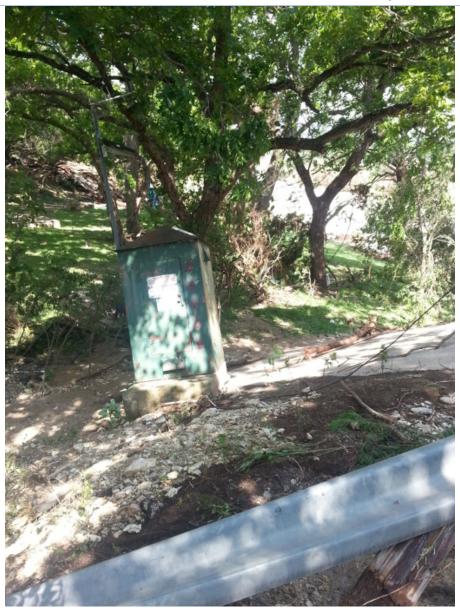
USGS Gage Housing at Ranch Road 12 Bridge (Blanco River at Wimberley, TX) on May 24, 2015.

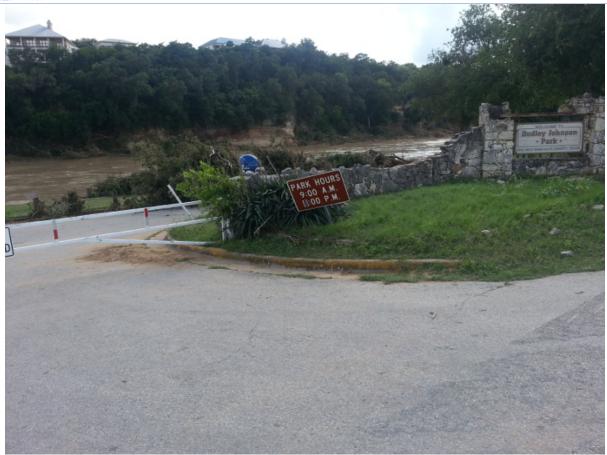
Dudley Johnson Park - Five Mile Dam Parks Complex in San Marcos, TX on May 24, 2015.

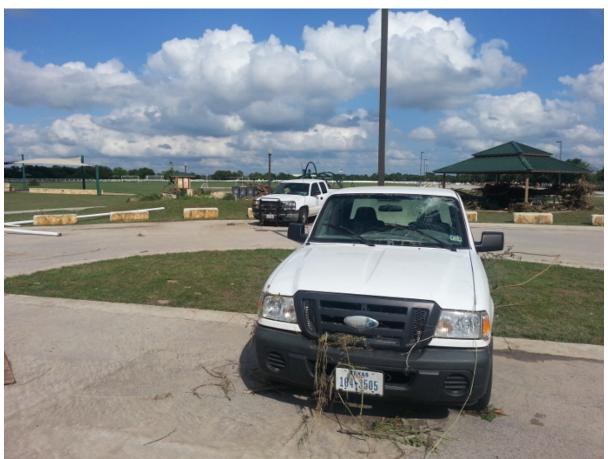
Parking lot, county vehicles, pavilion at Five Mile Dam Parks Complex in San Marcos, TX on May 24, 2015.

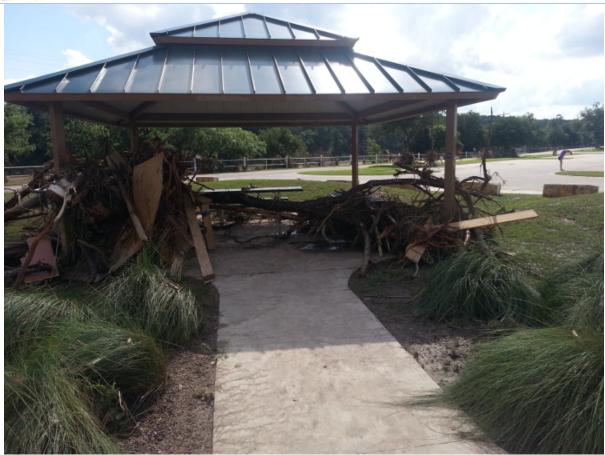
Large pavilion at Five Mile Dam Parks Complex in San Marcos, TX on May 24, 2015.

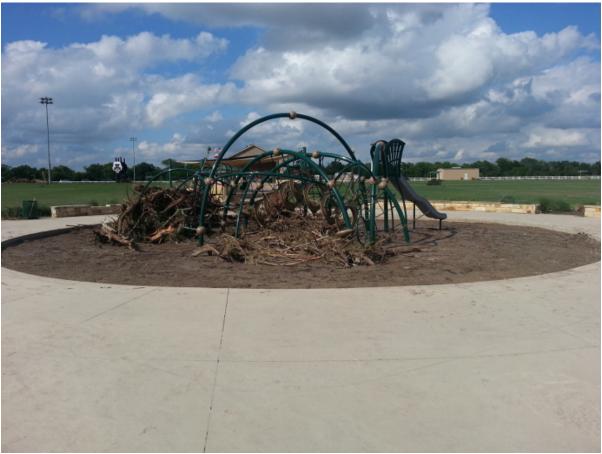
Playground at Five Mile Dam Parks Complex in San Marcos, TX on May 24, 2015.

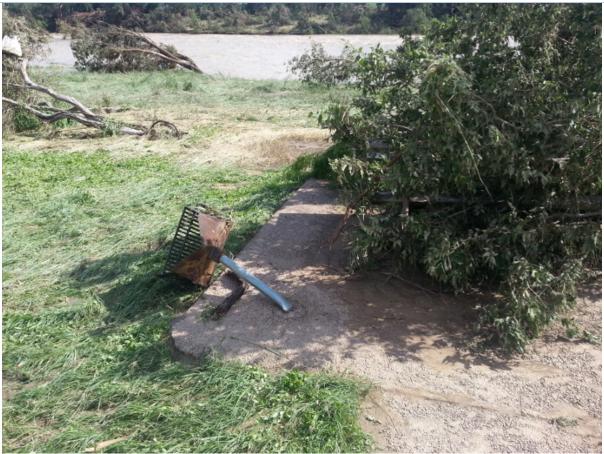
Grill at Five Mile Dam Parks Complex in San Marcos, TX on May 24, 2015.

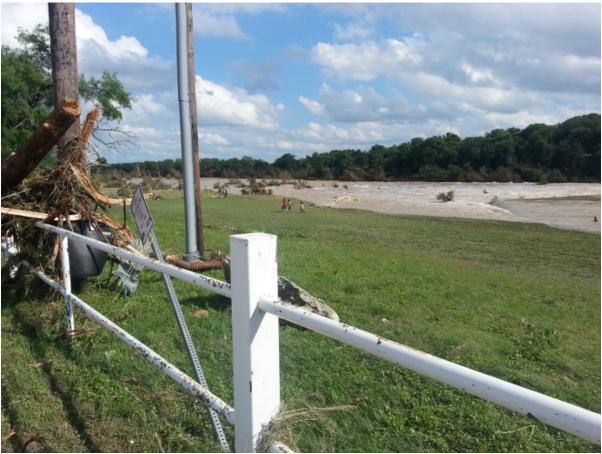
Blanco River Dam at Five Mile Dam Parks Complex in San Marcos, TX on May 24, 2015.

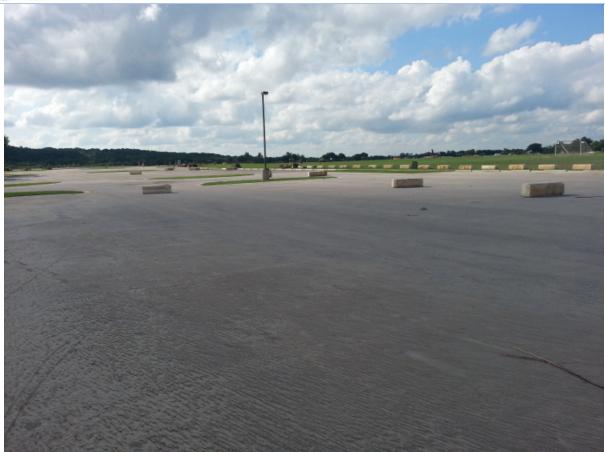
Stone boulders pushed across a parking lot at Five Mile Dam Parks Complex in San Marcos, TX on May 24, 2015.

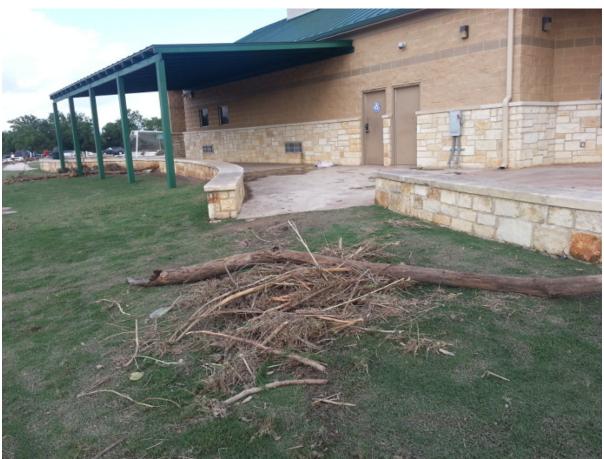
Main park building in soccer complex at Five Mile Dam Parks Complex in San Marcos, TX on May 24, 2015.

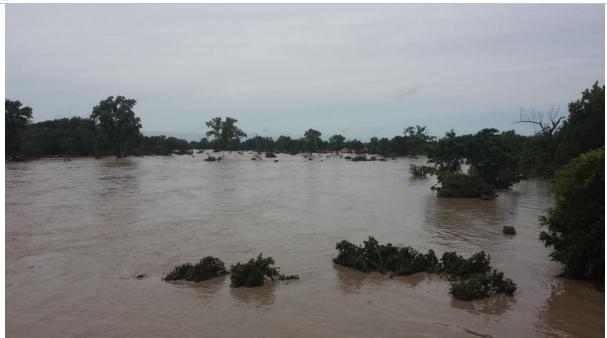
(From Figure 3b) The Blanco River near San Marcos at 9:45am 5/24/2015. Photo taken from HWY 80 Bridge. The BSMT2 gauge is located 30 feet to the left of this photo. The river reported a level of 32.59 feet at this time, over 10 feet below its crest height of 43.08 feet 4.5 hours earlier.

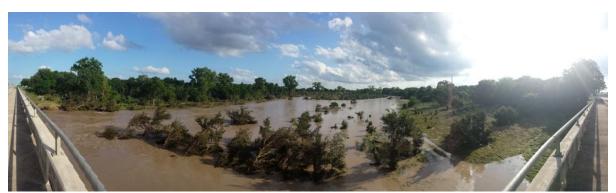
The Blanco River near San Marcos at 6:29am 5/24/2015, almost 7 hours after the image above. River level was 21.88 feet at this time, almost 11 feet lower than above. The gauge is located on the left side of the photo where the tree line meets the bridge. You can see the trees are less submerged compared to the above photo.
