**5-alt REPORT FOR GAP CREEK  
IN THE WATAUGA RIVER WATERSHED (06010103)**

**AN ALTERNATIVE RESTORATION APPROACH UNDER THE LONG-TERM VISION FOR TMDLs**

Tennessee Department of Environment and Conservation  
Division of Water Resources

September 16, 2019

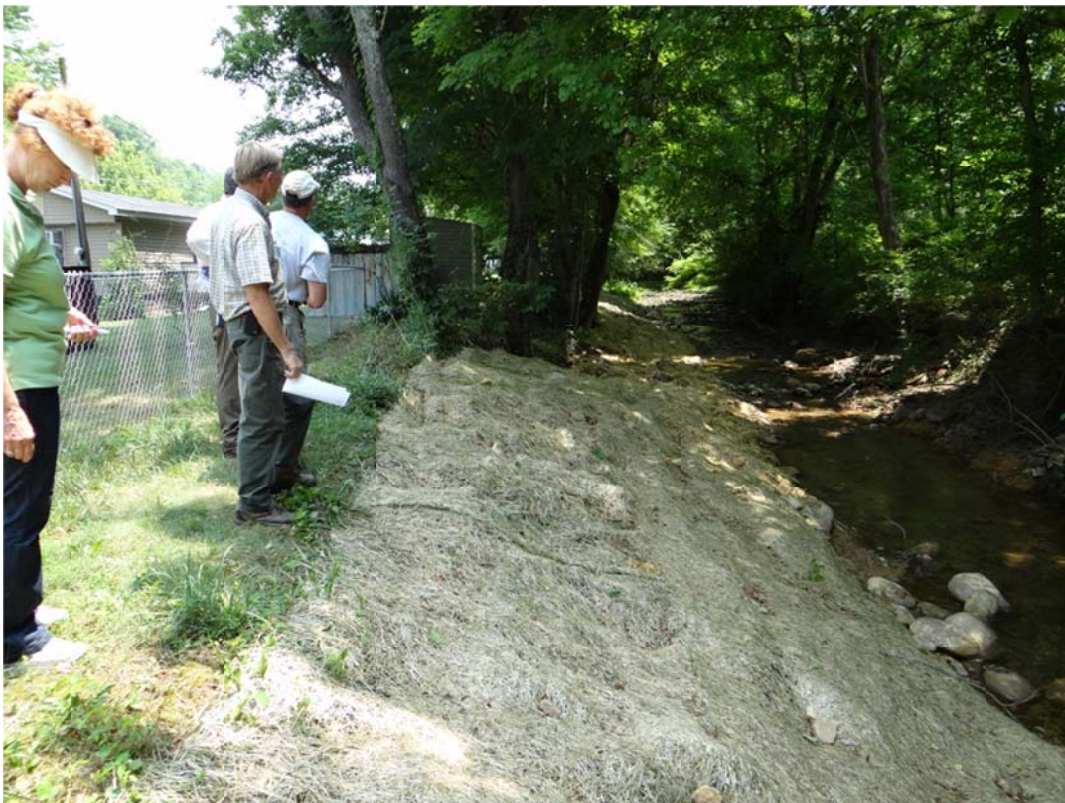
This site of 140' in length was originally a 6' high, eroded, undercut bank. It required sloping and rock in the toe. Matting was secured along with grass and tree plantings. (Photo taken shortly after construction work was completed in 2012.)

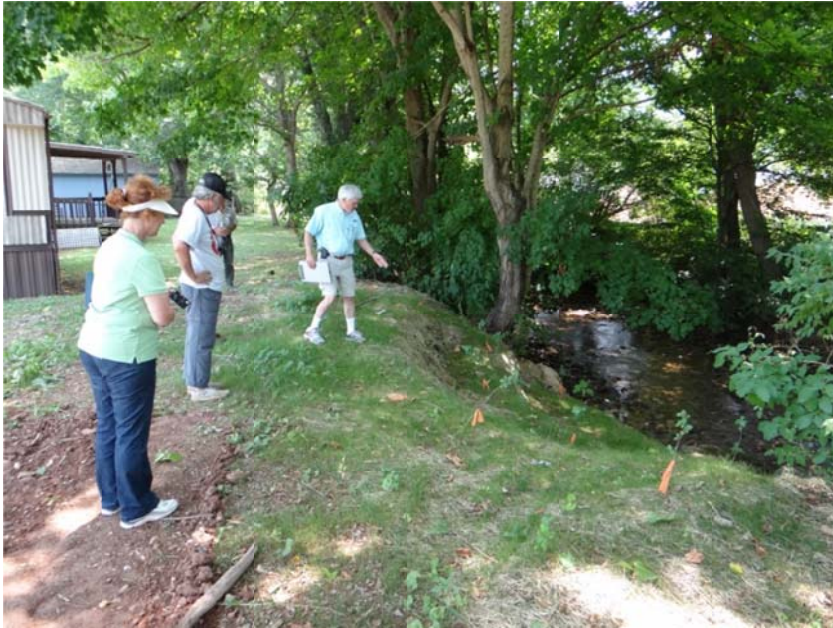
This site of 25' in length was a 3' high, eroded, bank. It required sloping along with matting, grass and tree plantings.

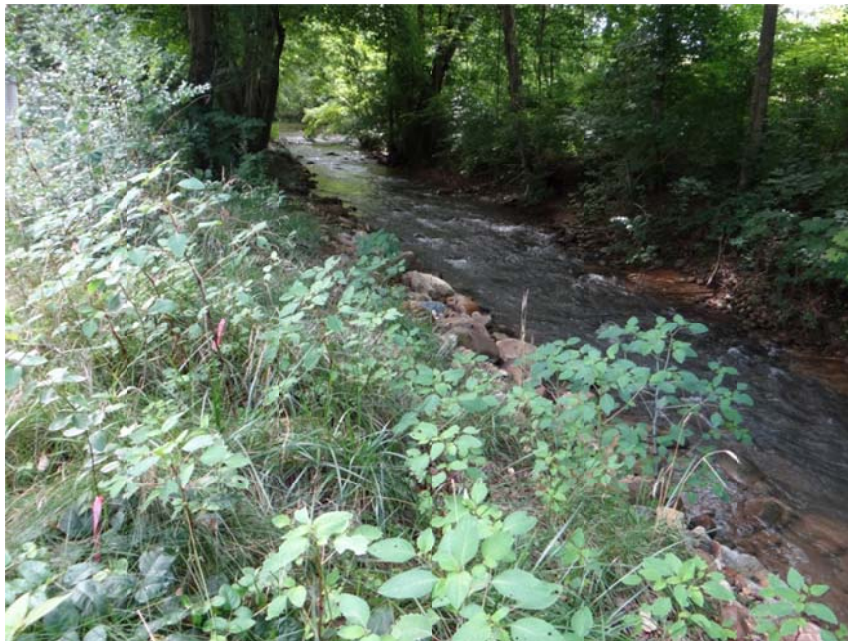
Section of the restored streambank showing tree and other vegetation growth

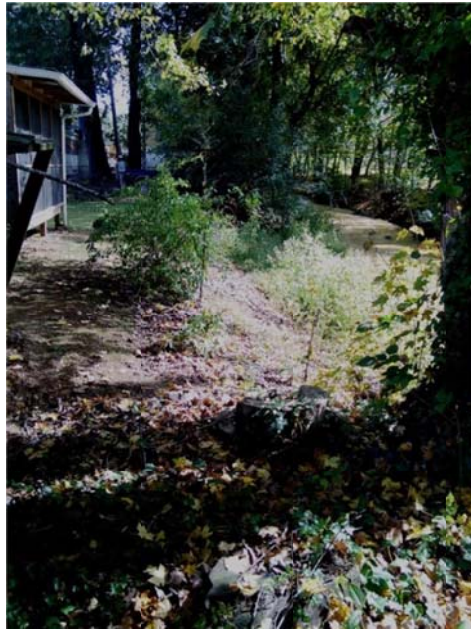
Mobile home next to Gap Branch (After stream stabilization in previous project and before current project of septic system removal & sewer connections).

Septic system replacement in the trailer park was delayed for technical engineering reasons (the trailer park was not easily connected to the existing sewerage system). The solution was for the stakeholders to contract for a new main line on the opposite side of the trailer park and tie it into the city sewer system. Septic replacement was completed in April 2017 (note: this is after the most recent stream monitoring data were collected).

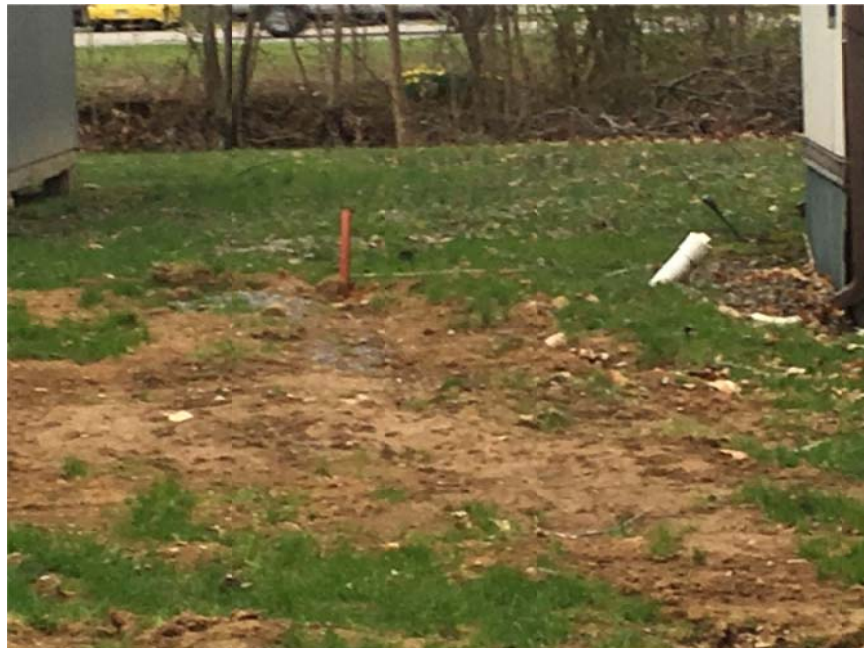
Sewer line installed, not yet connected to mobile home.

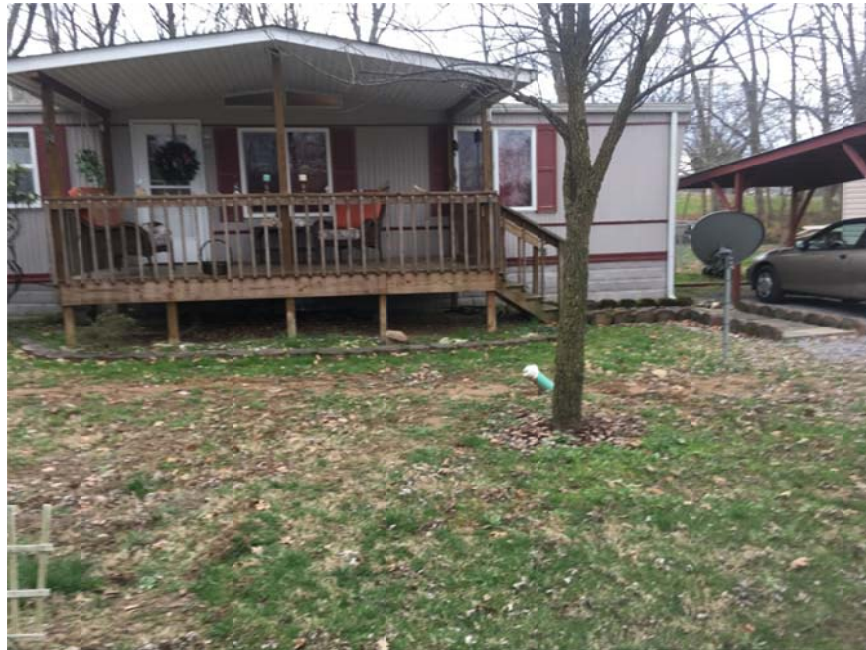
Sewer line installed, not yet connected to mobile home.

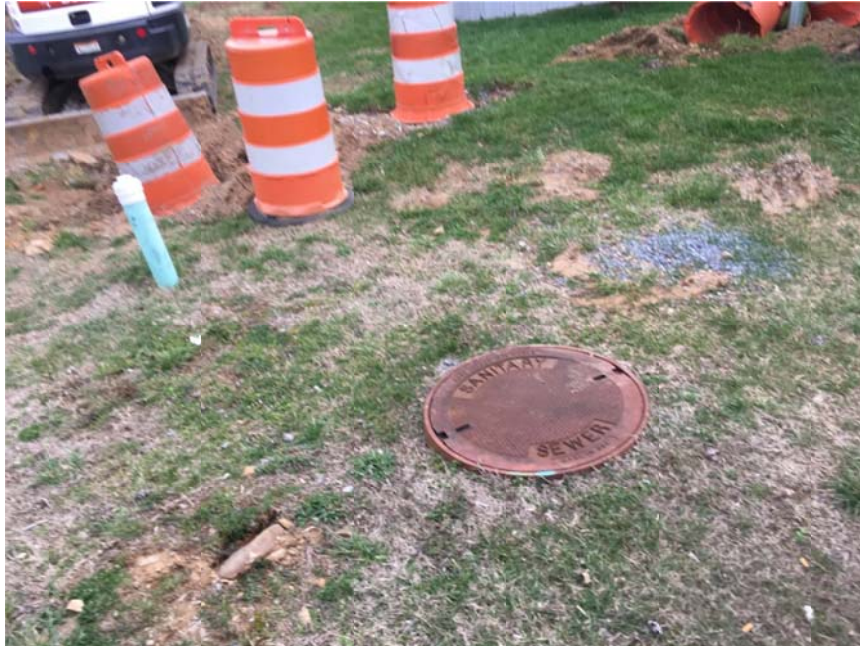
Sewer lines connected to city sewer system.

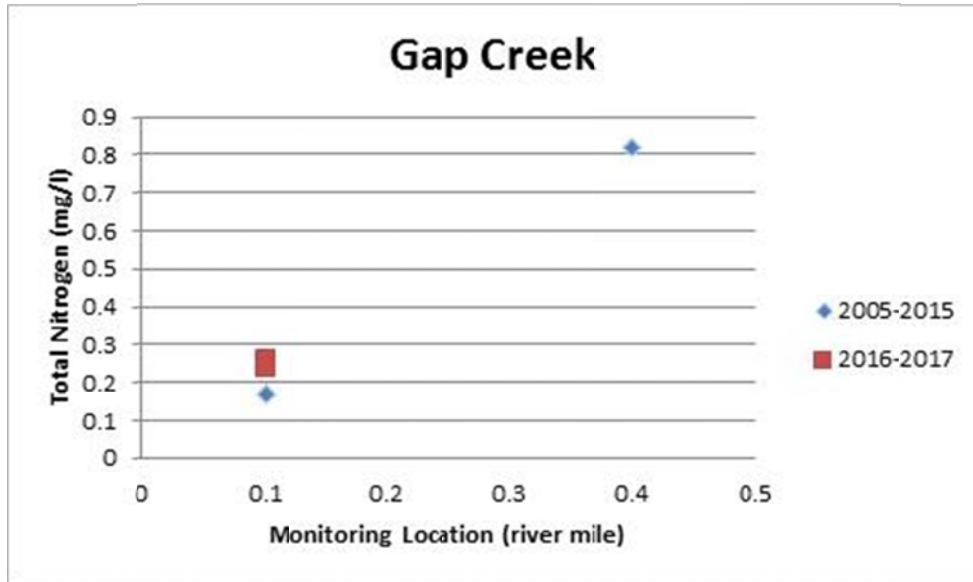
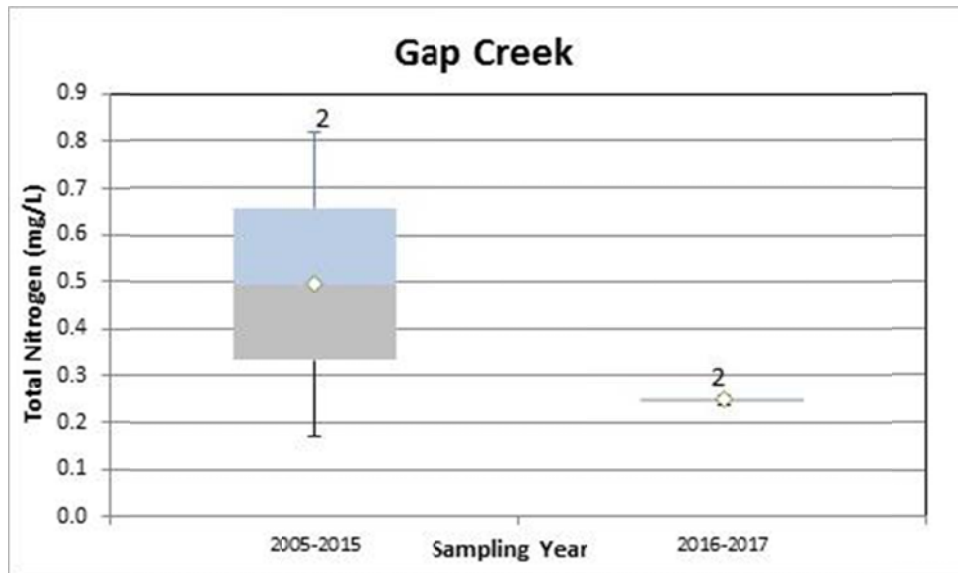
Figure 10. Comparison of Total Nitrogen at Gap Creek Monitoring Sites Between 2005-2015 and 2016-2017 Monitoring Seasons.

Figure 11. Comparison of Total Nitrogen at Gap Creek Monitoring Sites Between 2005-2015 and 2016-2017 Monitoring Seasons. Numbers indicate number of samples in the analysis (n).

Figures 10 and 11 illustrate that there were reductions in instream nitrogen concentrations at Gap Creek monitoring stations from 2005-2015 and 2016-2017 sampling seasons. More data are needed to confirm this observation.

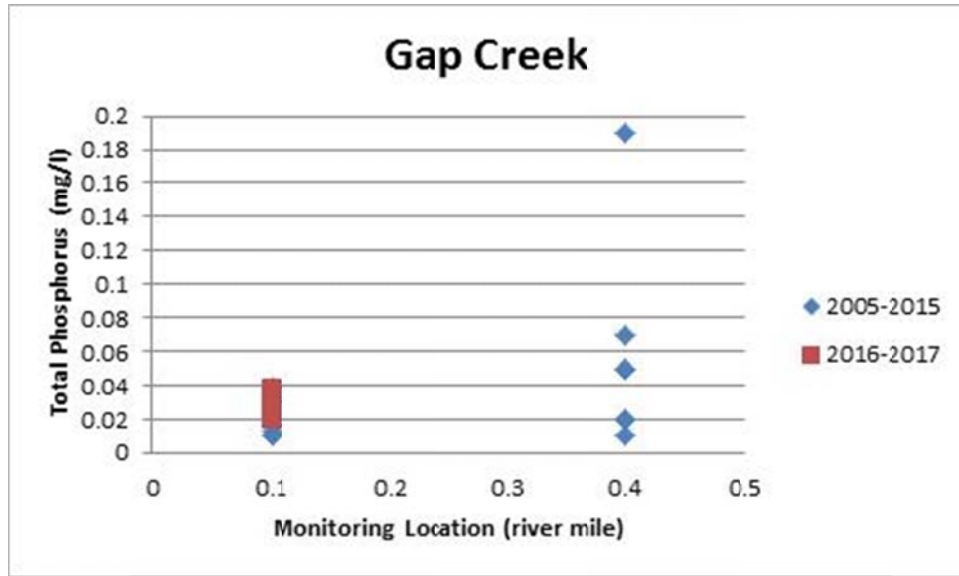
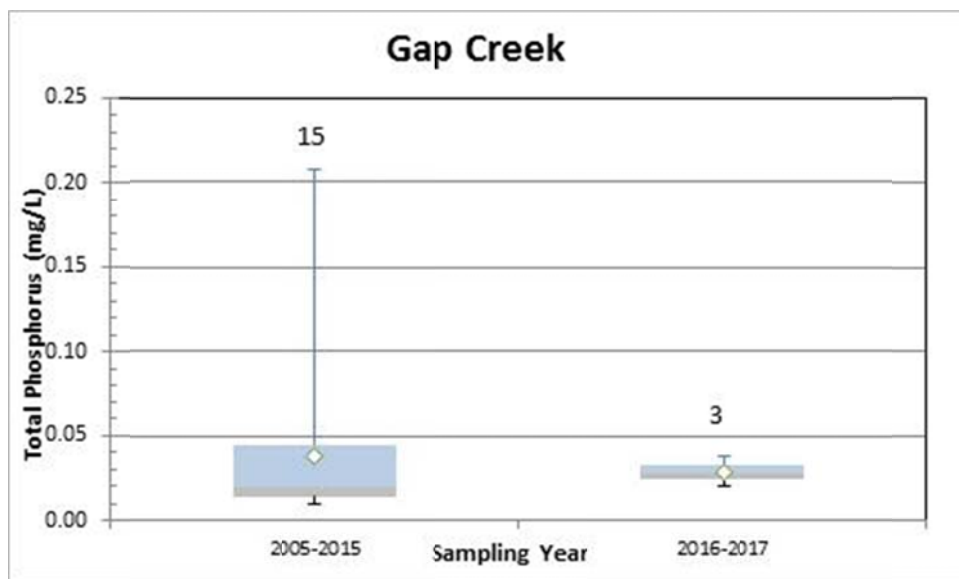
Figure 12. Comparison of Total Phosphorus at Gap Creek Monitoring Sites Between 2005-2015 and 2016-2017 Monitoring Seasons.

Figure 13. Comparison of Total Phosphorus at Gap Creek Monitoring Sites Between 2005-2015 and 2016-2017 Monitoring Seasons. Numbers indicate number of samples in the analysis (n).

Figures 14 and 15 illustrate that there were reductions in instream phosphorus concentrations at Gap Creek monitoring stations from 2005-2015 and 2016-2017 sampling seasons. More data are needed to confirm this observation.
