#### Kubota D 722 injector pump repair: ruiskutuspumpun korjaus

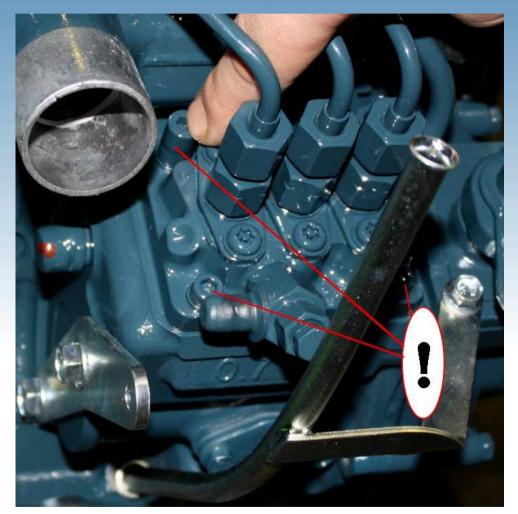
The Injector pump Avant p/n 65136, Kubota p/n 16006-51010 is bolted to the engine with 4 pcs 5 mm allen screws.

When opening the srews the injector pump will pop upwards a little.

There is a shim plate between the engine body and the pump body. This must be placed back in its position when mounting. If the shim is forgotten the engine will not run properly.

Cover the opening in the engine body during injector pump repair so that nothing falls into the engine.

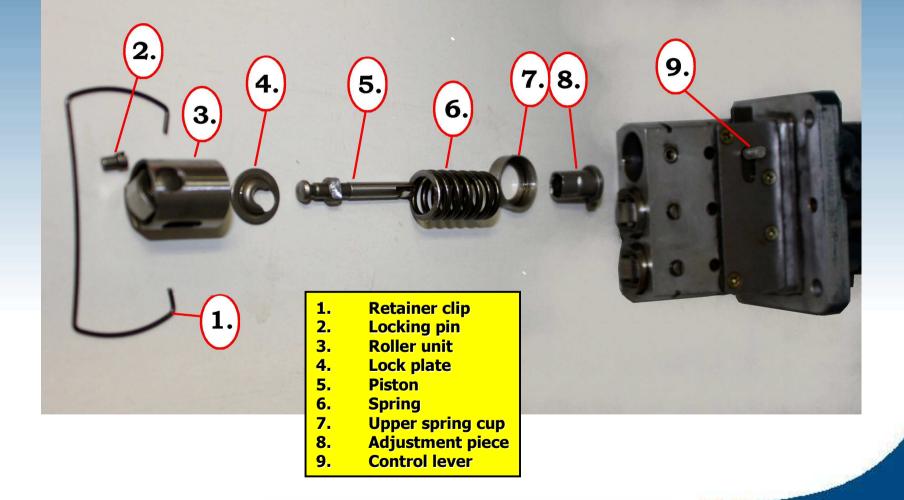
These parts are often corroded by the cold slime: Both parts must be cleaned from rust with fine sandpaper or steel wool.

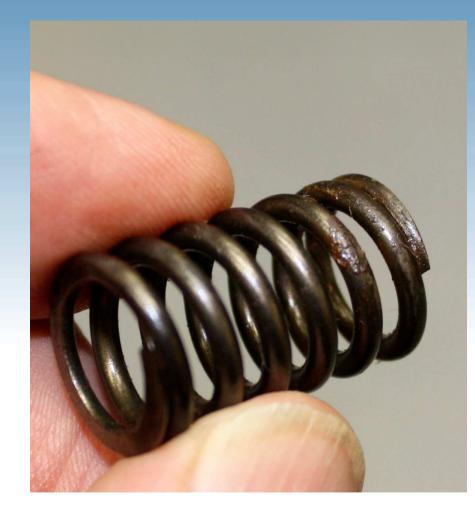
Spring : Kubota p/n 15841-51280 In this picture there is rust that will cause the spring to break soon.

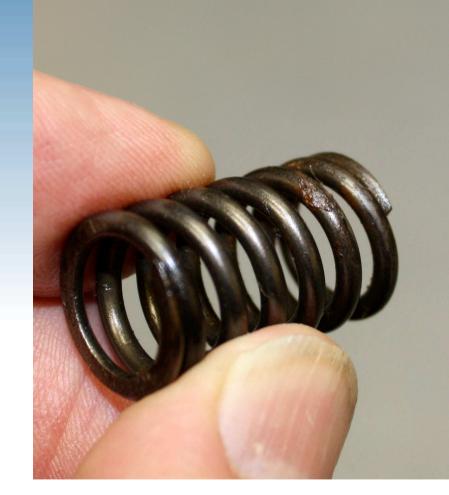
Spring : Kubota p/n 15841-51280 If there is rust the springs need to be changed. It is a good idea to change all 3 springs when doing this repair.

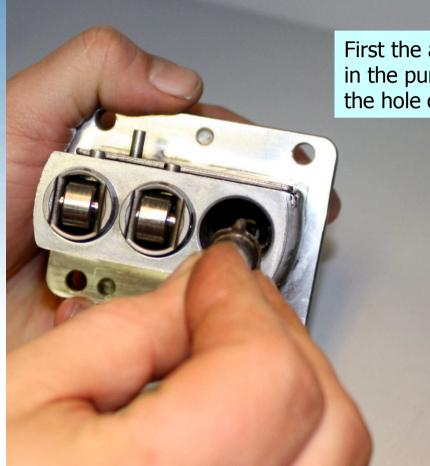
First the adjustment piece is placed in the pump body so that the ball is in the hole of the control lever.

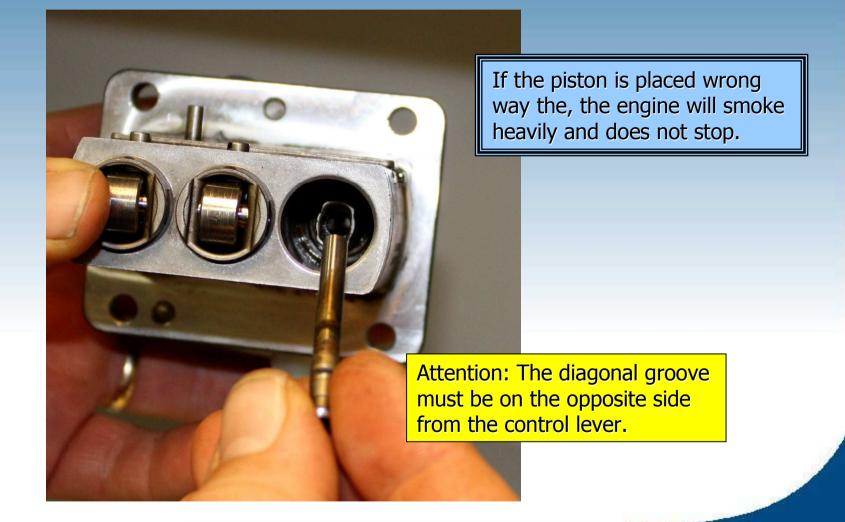
Attention: The diagonal groove must be on the opposite side from the control lever.

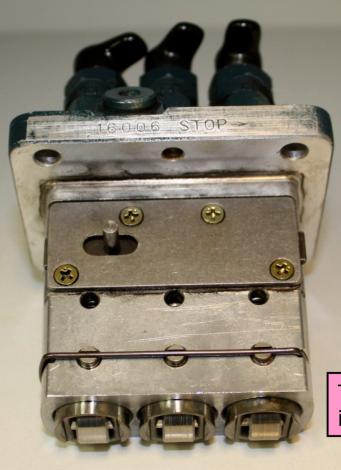
When the repair is complete the control lever should move form side to side when tilting the pump.

The pump should be lubricated with weapon oil or engine oil before being mounted back to the engine

The retainer clip is placed back to its position.
