68RFE Thermostat Bypass

Transmission Cooler Line Thermostatic Valve Bypass Kit

1061528	2013-2018 RAM Truck with 68RFE
1061527	2019+ RAM Truck with 68RFE

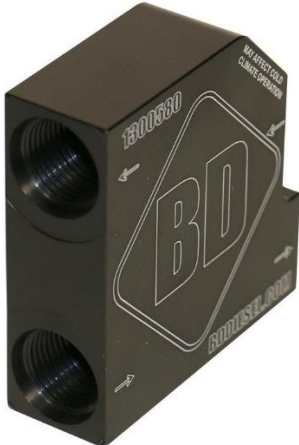
1061528 kit content		
1300580	1300579	1453153

Bypass Block Qty: 1	Quick Connect Fitting Qty: 2	O-ring Qty: 2

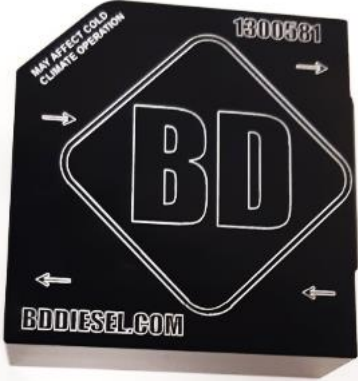
1061527 kit content		
1300581	1500402-SS	1453153

Bypass Block Qty: 1	Qty: 2	O-ring Qty: 2

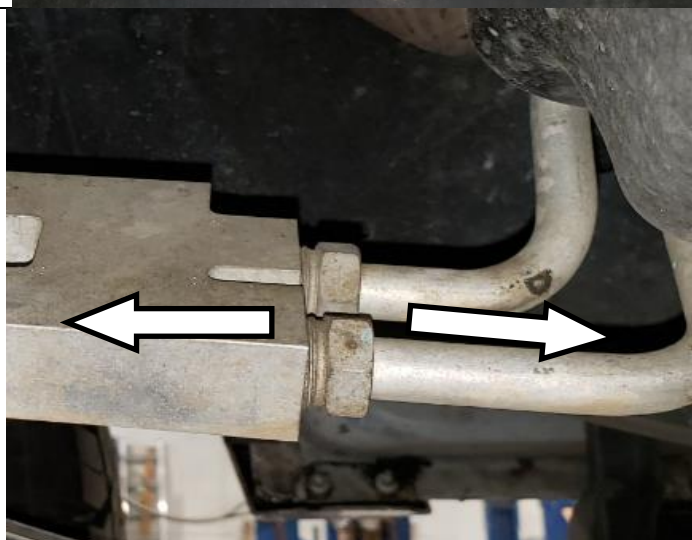
Pull out the cooler lines from cooler bypass block and collect drain trans oil

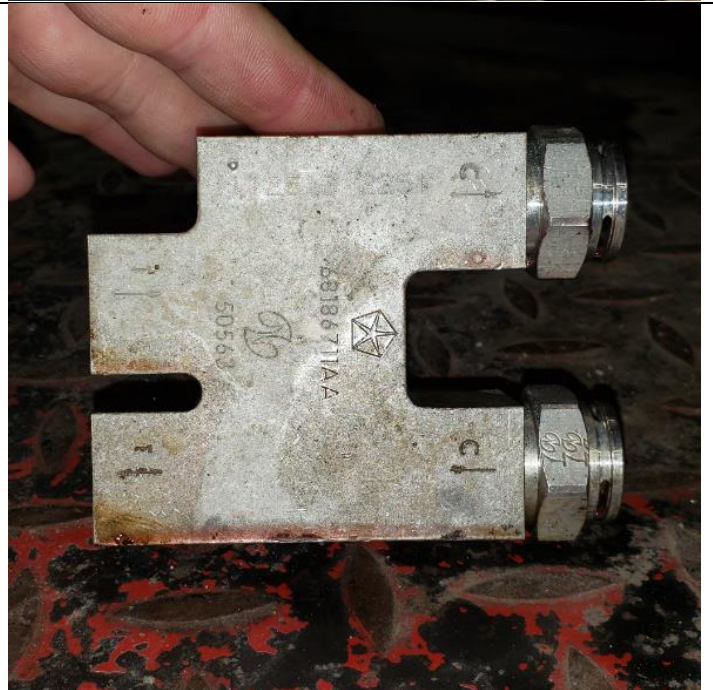
The original thermostat housing should now be removed. Clean the ends of the lines if needed to prevent debris contamination upon reassembly.

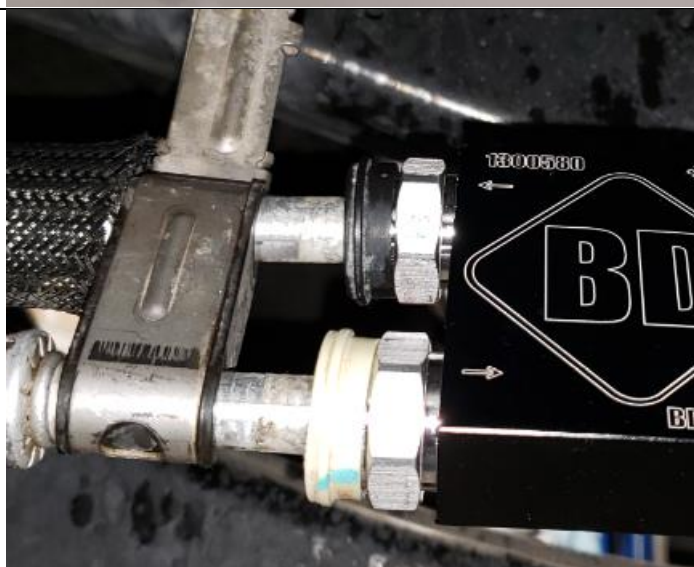
Align both quick connect ports with the transmission lines and push until the clip clicks in behind the flange on the quick connect fittings

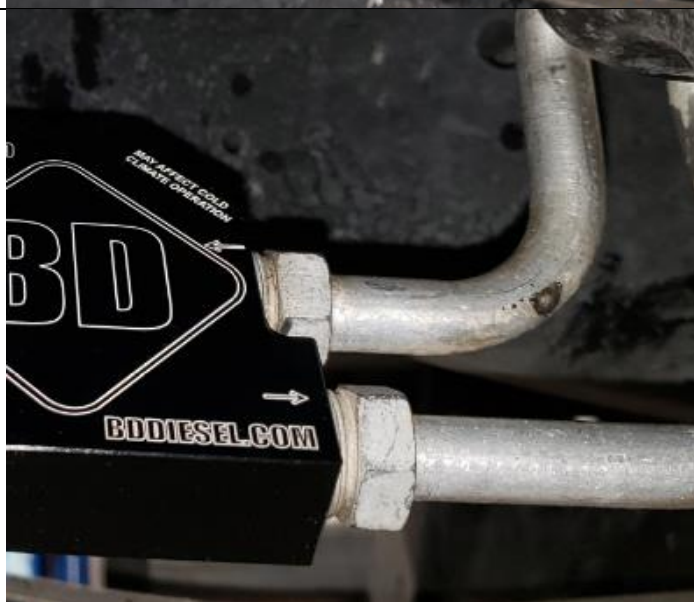
Inspect original O-ring on the tube, replace with supplied viton O-ring (1453153) if it is damaged.

Reinstall both transmission cooler lines in to threaded end of the block, wiggle the lines and nut to start the threads. Tighten nuts 24 lb-ft.

Correct transmission fluid level and check for possible leakage.

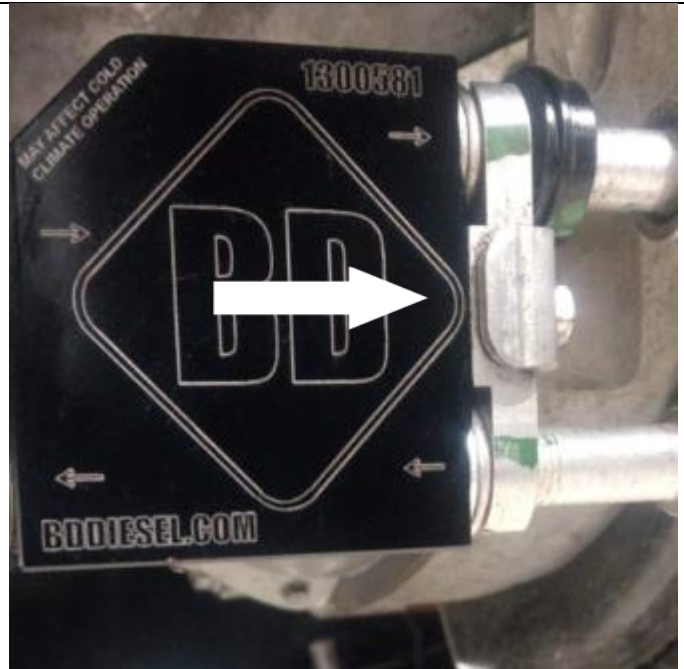
Align both tubes with bracket and the holes on the block and hand tight the M8 bolt.
And tighten the M8 bolt using 10mm wrench torque 13 lb-ft

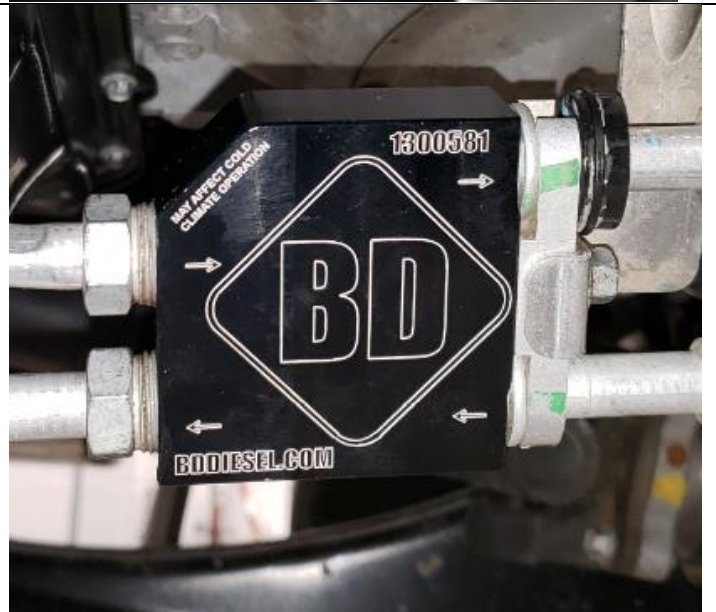
Reinstall both transmission cooler lines in to threaded end of the block, wiggle the lines and nut to start the threads.
Tighten nuts 24 lb-ft.

Correct transmission fluid level and check for possible leakage.
