Upper Maple River Watershed

Hardy Jennings Drain; Bennington Township sections 11, 13, and 14.

The Lake Manitou Association (LMA) has been investing in water quality testing and monitoring in and around Lake Manitou since 2016 and have confirmed that the Hardy Jennings Drain (HJD) is carrying into the lake, hazardous levels of human and bovine E. coli bacteria, excessive phosphorus, and high levels of ammonium in the form of nitrogen, potassium and large amounts of soil sediment.

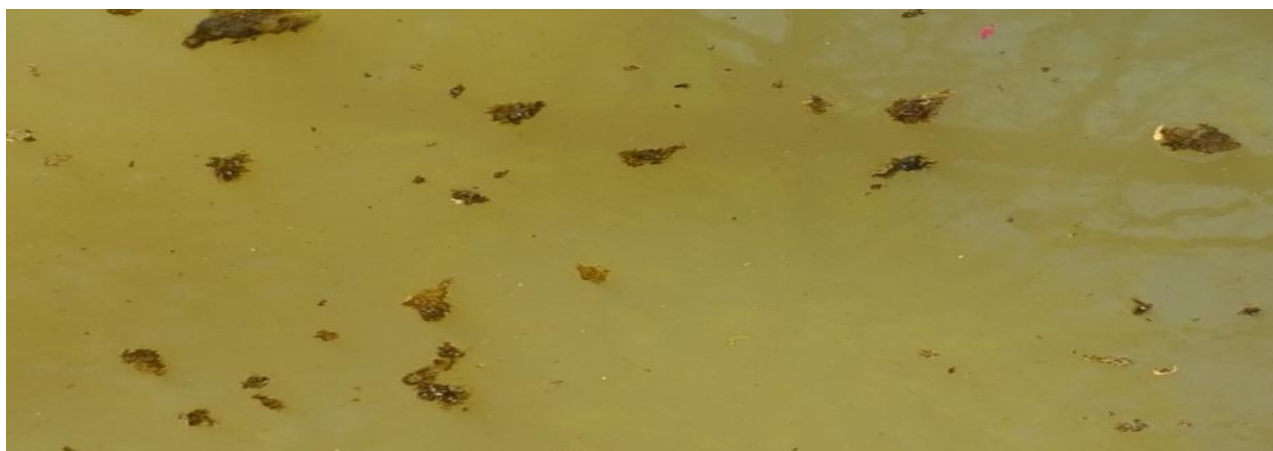
The photo below is of the Hardy Jennings Drain water on May 15, 2018^{vi} between the farm and Lake Manitou. The water was a distinct yellowish color, nontransparent and cloudy with floating and suspended semisolid matter. The day before and the day after, the drain water did not have this appearance. A water sample was collected by LMA and forwarded to Michigan State University Plant and Soil laboratory for analysis.^{vii} The results measured 62.2 ppm ammonium nitrogen, (High) and 364ppm potassium, (High). Nitrate and phosphorus were low. This type of visual observation is not uncommon. A previous water quality study (1993-2002) by Limnologist W. Fusilier, PhD^{viii} concluded that the Hardy Jennings drain carries 85 times more nitrogen than the other two inlets to Lake Manitou.^{ix}

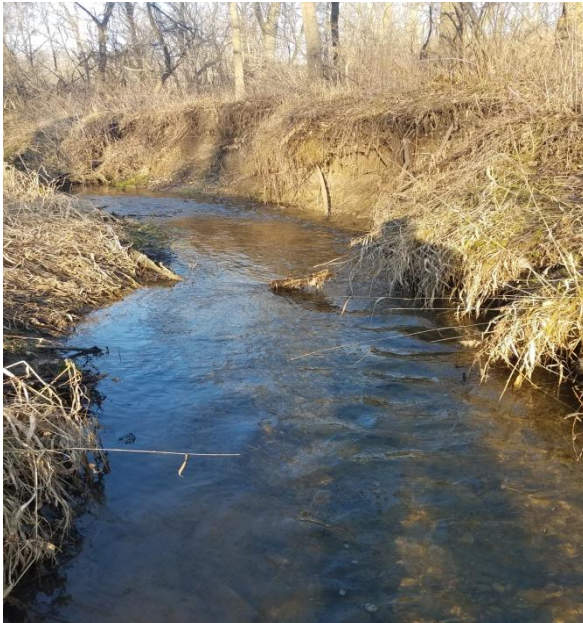
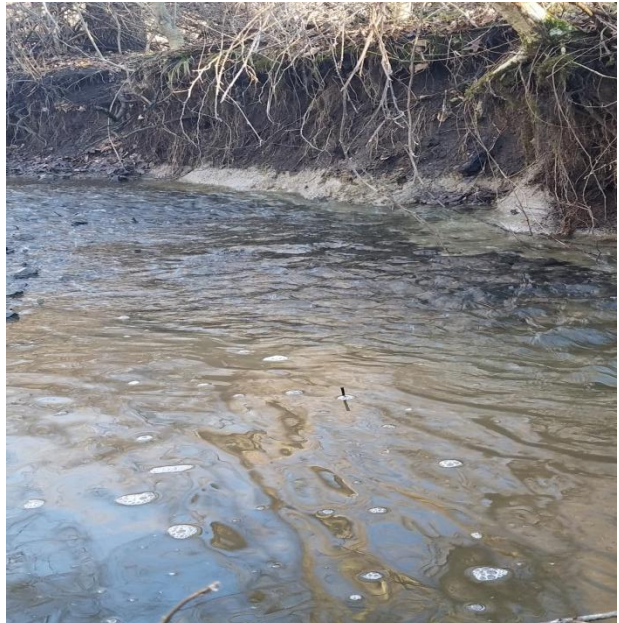
From the entrance to Lake Manitou at Waugh road, the HJD extends east southeast approximately 3 miles in length. Upstream from Lake Manitou it first meanders through a wood lot about ½ miles, in which the first 1,900 feet is not under county drain authority. The next 740 feet is within the woodlot. There are several bends and banks in the woodlot that are from 3 to 7 feet in height. The soil is primarily Gilford Sandy Loam and the relic stream bed is approximately 35 feet. The average width of flowing water ranges from 5 feet to 10 feet wide and is just inches to 24 inches in depth. The drain floor is primarily packed small stone. The remainder of the drain cuts through agricultural land and branches into an east arm and a southerly arm west of Garrison road.

HJD meandering through the woodlot

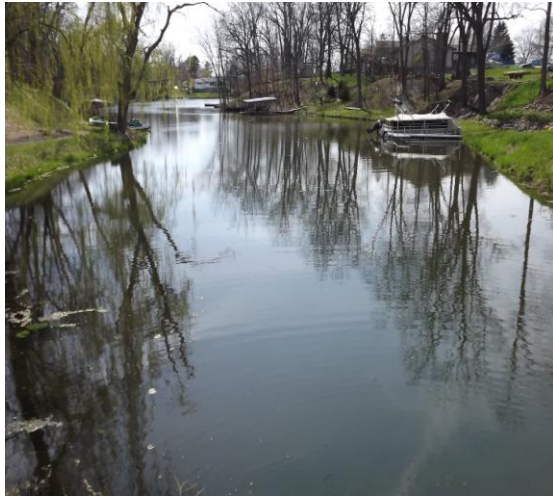
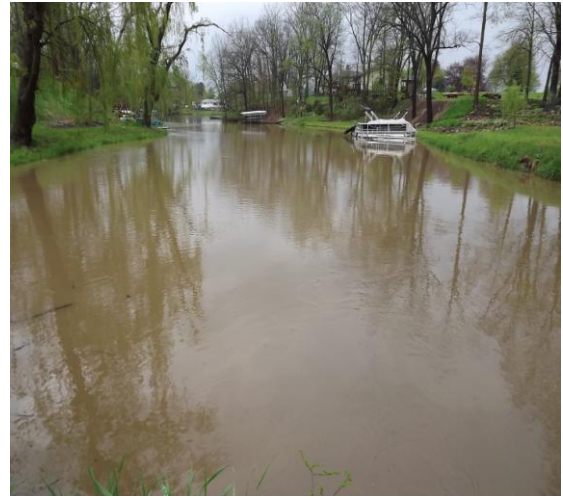
The photos below are of an arm of Lake Manitou that first receives water from the HJD. The photo on the left was taken May 9, 2014. The photo on the right was taken May 14, 2014 after a significant rain. Some HJD stream banks and bends up stream of Lake Manitou are seven feet in height and there is a significant amount of cropland upstream and adjacent to the HJD.

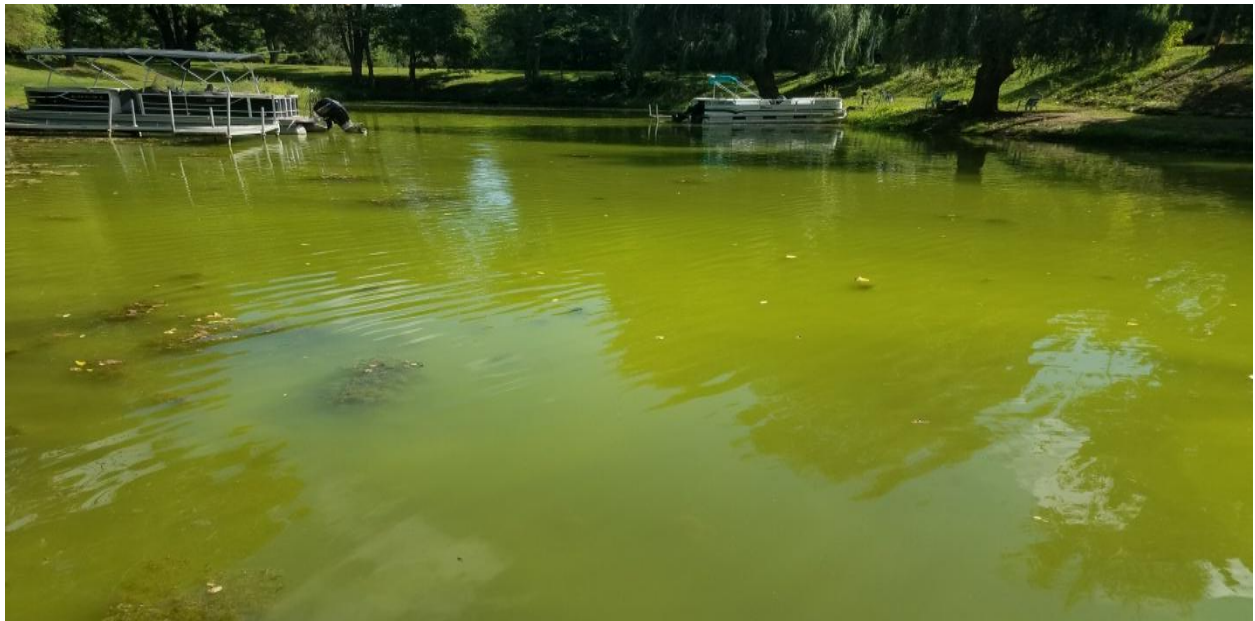
Historically, the lake experiences severe seasonal algal blooms, (especially predominant at the inlet from the Hardy Jennings Drain). This is a direct result of excessive nutrient loading from the drain

The photo below is the arm of Lake Manitou that first receives water from the HJD. Photo taken August 31, 2018.

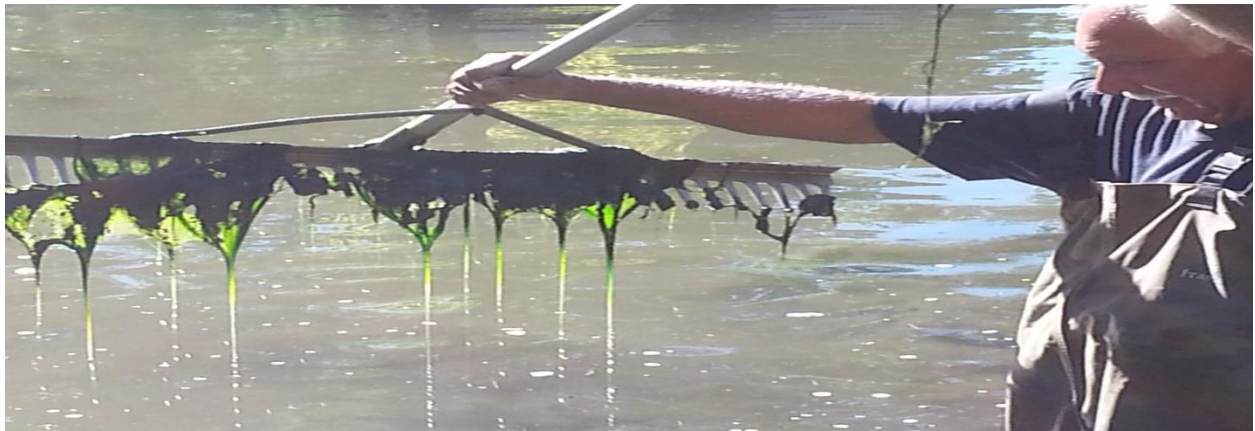
June 12, 2017. Filamentous algae from the lake floor of the arm of Lake Manitou that first receives water from the HJD.

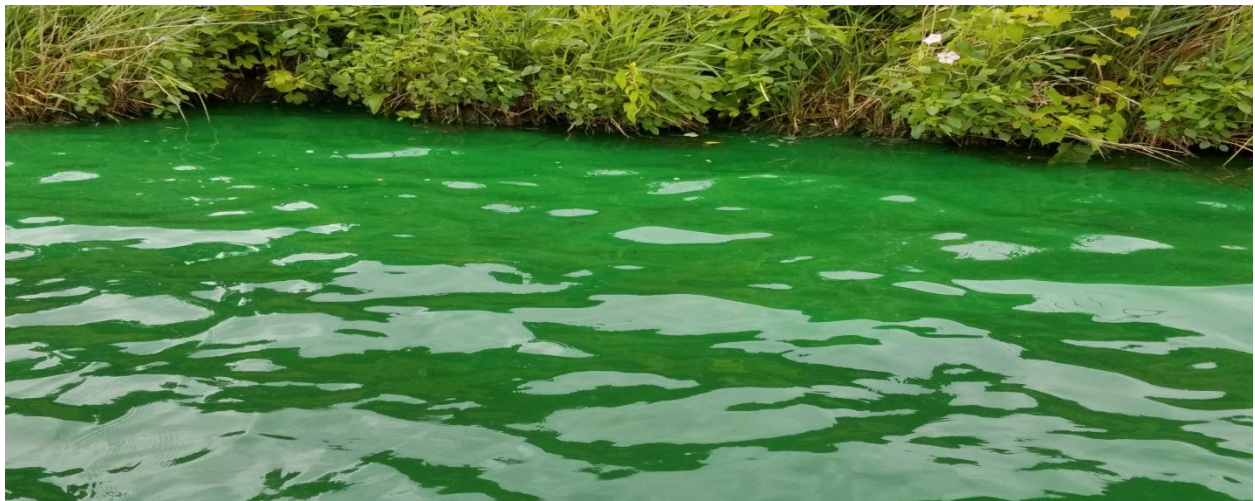
July 12, 2017. The Main body of Lake Manitou showing an algae bloom.

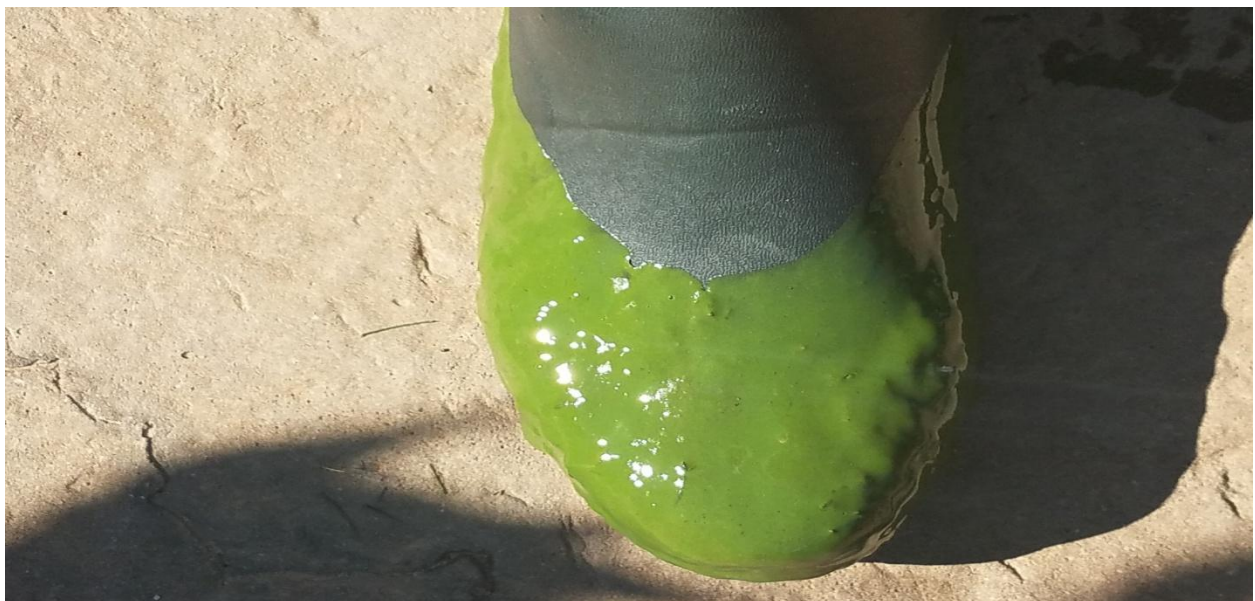
October 5, 2017. Boot covered in paint like algae from the surface of Lake Manitou water.

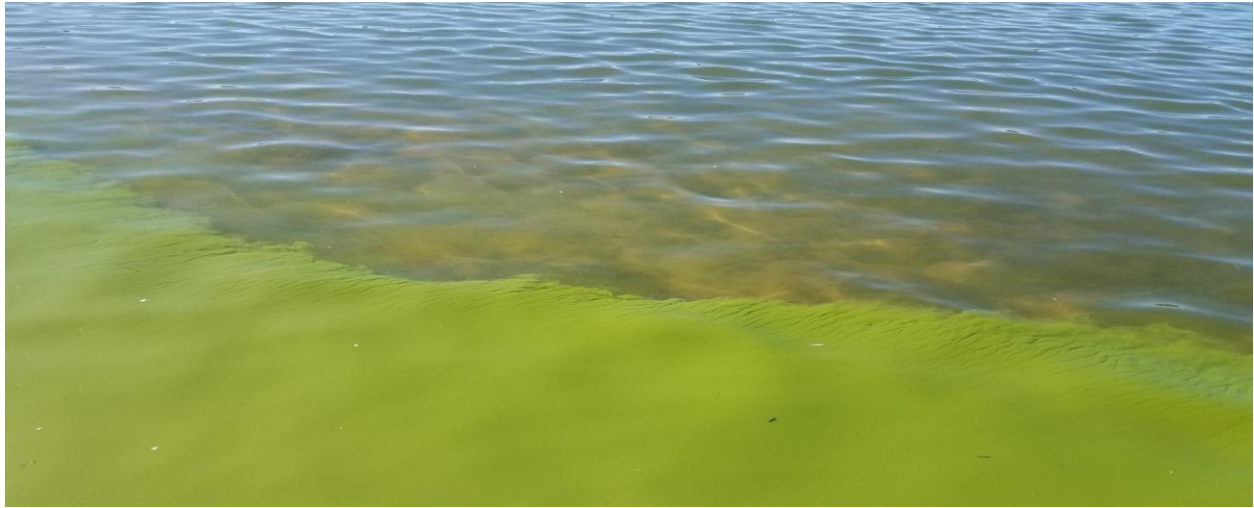
October 5, 2017. Algae concentrated in Lake Manitou near shore due to wind and water currents.
