A Technical Note on
Monitoring of Jhakri Landslide in Bari Village
Area of Himachal Pradesh

S.K. Mittal^{1,*}
Manjeet Singh¹
Bhoop Singh²

¹*CSIR-Central Scientific Instruments Organisation*
Chandigarh, India

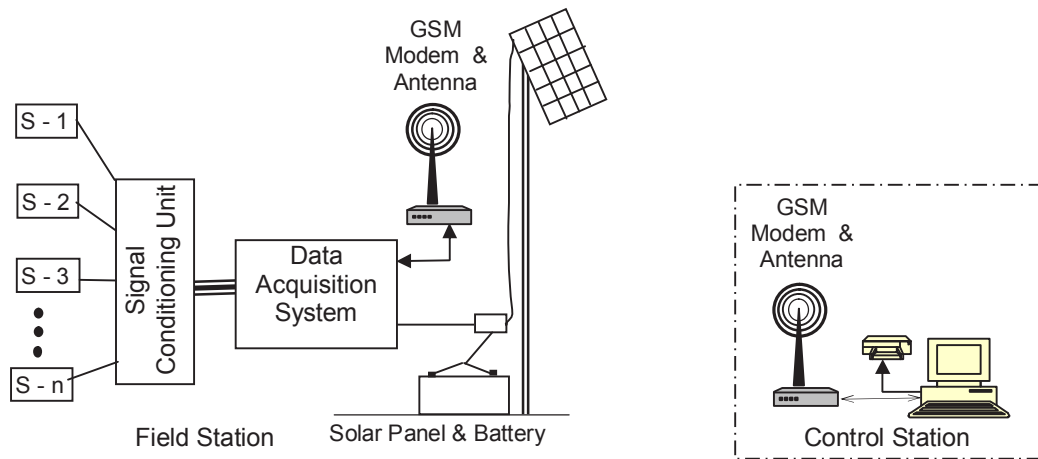
Installed landslide monitoring instrumentation system is designed as two-tier structured modular system and its block diagram is given in Fig. 2 (Mittal et al. 2008, 2009a, 2009b).

Fig. 2 - Block diagram of landslide monitoring instrumentation network

It consists of a series of geotechnical sensors: piezometer, rain gauge, total earth pressure cell, crackmeter, tiltmeter and inclinometer; located within the landslide zone. Data acquisition unit and solar power station are kept in nearby stable area. This cluster of instrumentation is named as field station (FS). Piezometer is installed at 50m depth. Inclinometer casing is 50m deep which crosses the NH-22 elevation level. FS is also

equipped with GSM/GPRS modem to communicate with Control Station (CS) situated at CSIR-CSIO, Chandigarh. Complete instrumentation was made operational in May 2012. CS allows the remote, automated management of FS over GSM/GPRS interface and retrieves recorded data and analyses it. To monitor the whole landslide area; more numbers of sensors can be interfaced to existing FS and also more FS can be configured and linked with CS.

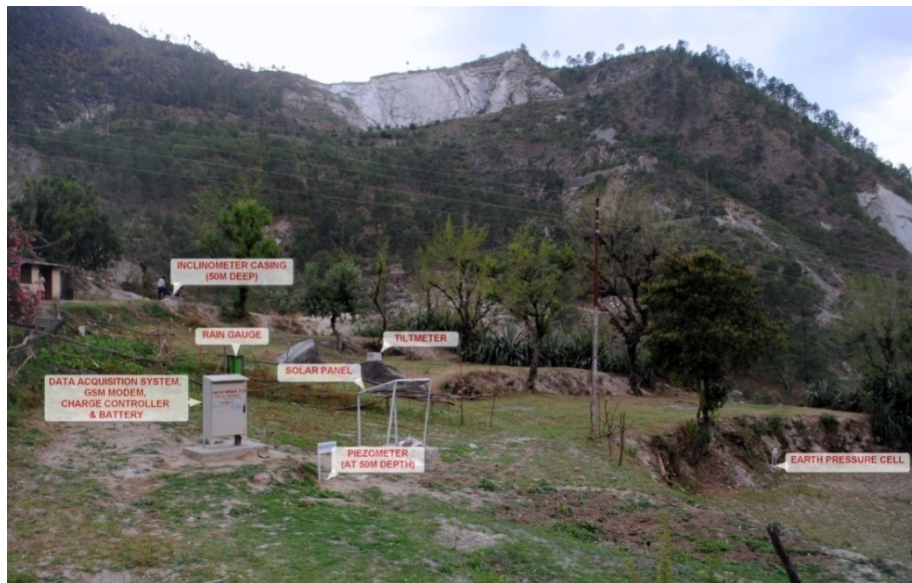
Fig. 3 - A view of instrumented landslide site from SJVNL guest house side

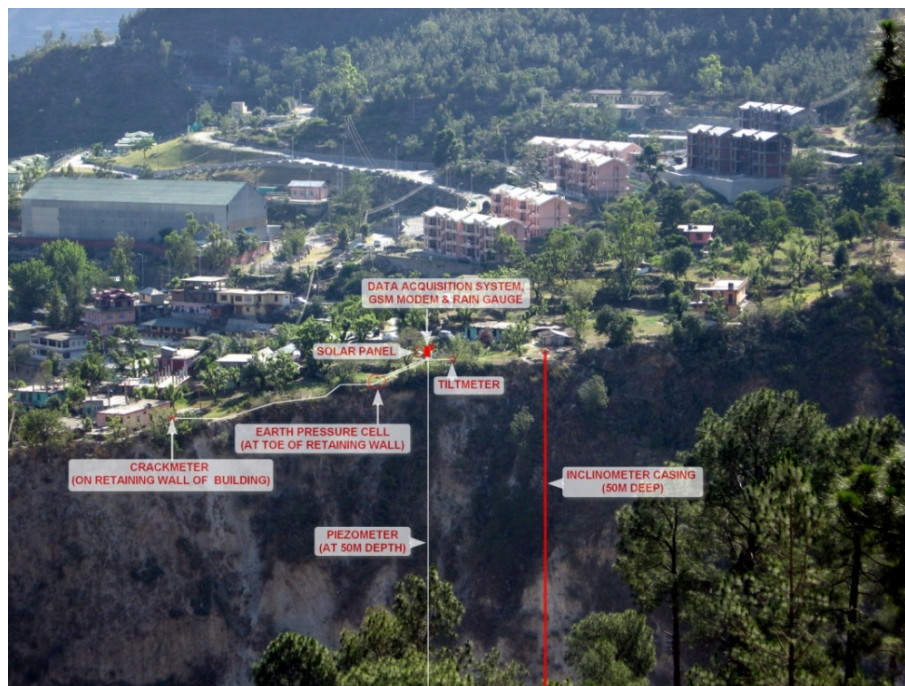
Fig. 4 - A view of instrumented landslide site from Rampur side hill

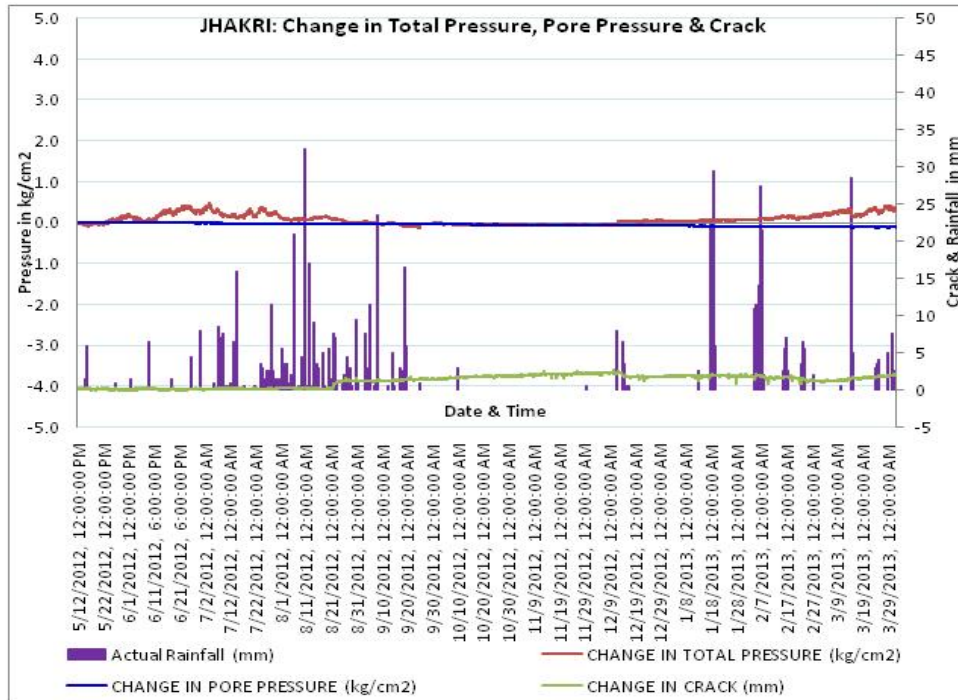
Data of rain gauge, piezometer, total earth pressure cell and crackmeter is recorded at six hour interval in real-time mode from May 2012 to March 2013. Graphs showing the change in recorded parameter is shown in Fig. 5. It is evident from Fig. 5 that in the middle of monsoon season crack was widened by one millimetre but no change occurred in pore pressure.

Fig. 5 - Graph showing change in recorded pore pressure, total earth pressure, rainfall and crack
