Abandonment Issues: An Assessment of Military Vessel Discard Trends Derived from Australasia's Torpedo Boat Defences, 1884-1924

James W. Hunter, III

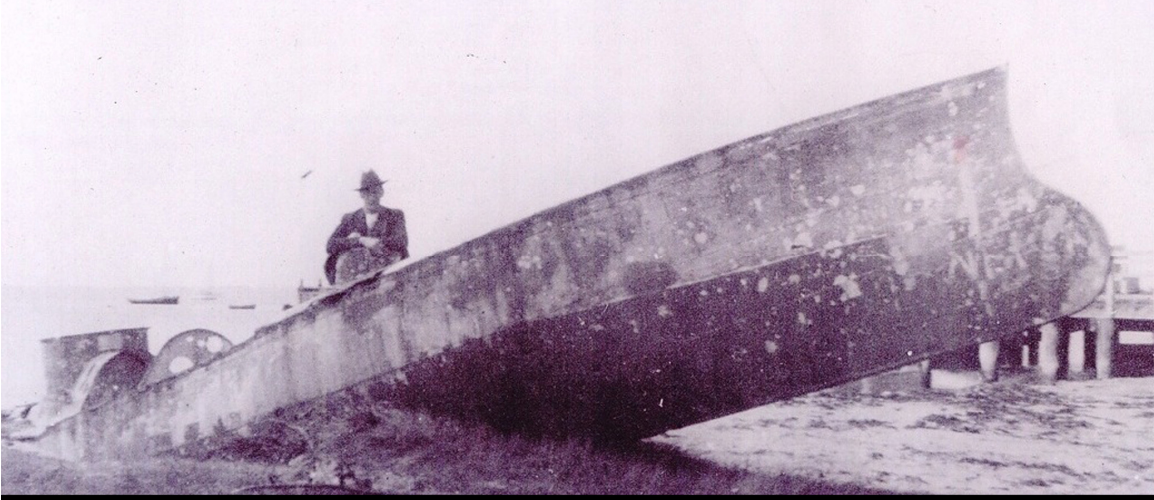
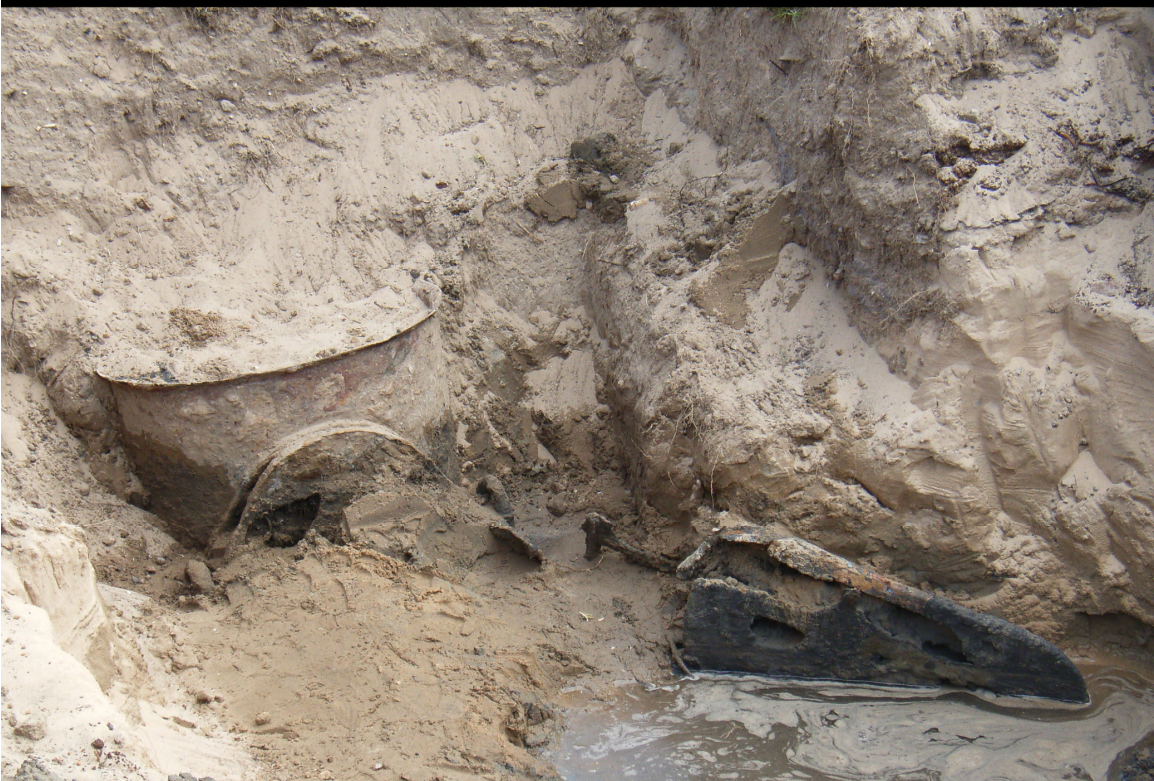
Figure 1. *Top*, HMVS *Lonsdale*'s hulked remnants at Queenscliff, Victoria ca. 1915; *bottom*, *Lonsdale*'s conning tower (centre) and disarticulated bow section (bottom right) as they appeared during the 2005-2006 investigation. Top photograph reproduced with kind permission of the Queenscliffe Maritime Museum. Bottom photograph by Geoffrey Hewitt, courtesy Terra Culture Heritage Consultants.

Data recovered during archaeological investigations of *Lonsdale's* abandonment site has proven useful in the development of general hypotheses regarding its discard (see Hewitt and Tucker 2009). When exposed and documented, the torpedo boat's conning tower and the hull beneath it were still largely intact and appeared much as they did when photographed during the early twentieth century (see Figure 1). The same can be said of the hull aft of the

conning tower, which appears to have retained its overall structural integrity (D. Cahill, as cited in Hewitt and Tucker 2009:32). By contrast, the foreship and bow are no longer articulated with the remainder of the vessel (Figure 1). Indeed, the vast majority of *Lonsdale*'s forward section disintegrated into largely incoherent structure as a consequence of "gross corrosion" and collapse of the hull subsequent to its complete burial (Hewitt and Tucker 2009: 30-32).

Discovery of *Lonsdale's* disarticulated prow constitutes the only archaeological evidence of culturally manifested alteration of its discarded hull. However, as the prow was ultimately re-deposited on site, its removal almost certainly did not constitute salvage activity. To the contrary, its presence lends credence to local lore that states it was intentionally cut away and moved aside during boundary fence construction at Queenscliff's former Buoy Depot (Ferrier 1989).

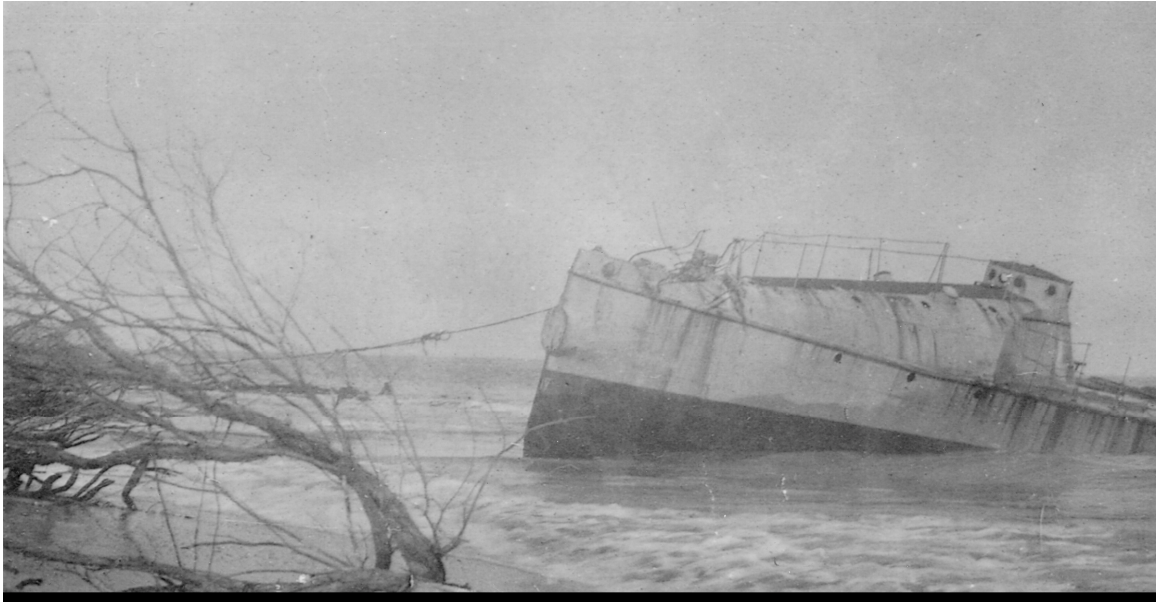
Figure 2. *Top*, HMVS *Countess of Hopetoun* hulked at Swan Island, Victoria ca. 1930; *bottom*, archaeological plan of the *Countess of Hopetoun* site as it appeared during the 1980s and 1990s. Photograph reproduced with kind permission of the Queenscliffe Historical Museum, Inc. Site plan produced by the author.

The photograph depicts a form of placement assurance in direct association with *Countess of Hopetoun*. A crude mooring line comprising a length of cable is shown extending shoreward from the torpedo boat's bow. A number of trees are present in the image along the shoreline and it is possible the mooring line was attached to one or more of these in an attempt to prevent *Countess of*

Hopetoun's movement after it was abandoned. Orientation does not appear to have played a role in the discard process, as the discarded hull was partially awash and oriented perpendicular to the shoreline when captured on film.

A length of steel cable was also observed in association with *Countess of Hopetoun's* stern structure (Williams 1992). Although tentatively identified as the remnants of a towline, its diameter appears to approximate that of the mooring cable visible in the archival photograph. The presence of the cable could account for the absence of other methods of anchoring the discarded hull in place. Alternate forms of placement assurance were not observed archaeologically and do not appear to have been utilised, even though their absence runs counter to Richards' (2008:172-177) discussion of what constitutes a logical vessel abandonment scenario in a beach environment.

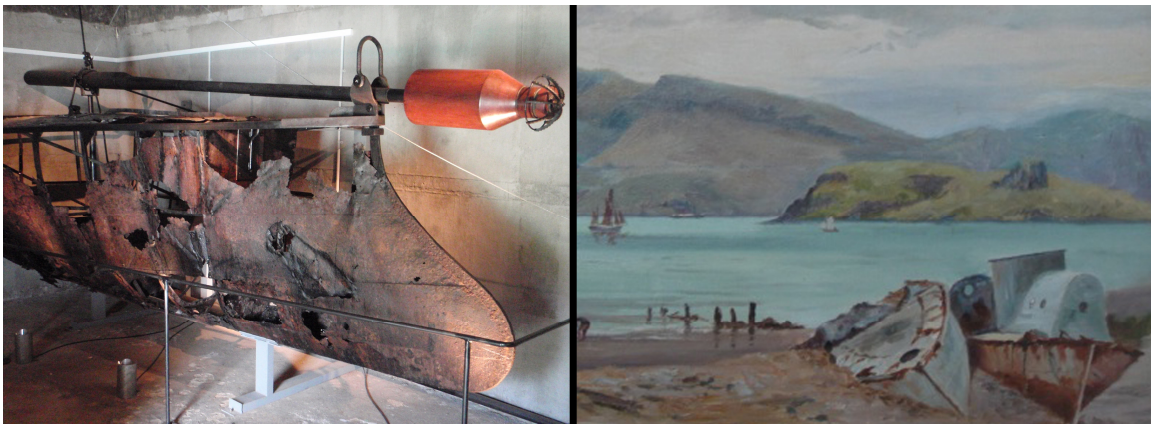
Figure 3. *Left*, reconstructed bow section of New Zealand torpedo boat *Defender*, as exhibited today at the Thornycroft Torpedo Boat Museum, Lyttelton; *right*, ca. 1930 painting *Purau Beach*, showing *Defender's* broken and disarticulated hull. Photographs by the author.

A circa-1930 painting entitled *Purau Beach* depicts *Defender* in a secondary discard context, after its broken hull was removed from Purau Bay's foreshore (Figure 3). One particularly noteworthy aspect of the torpedo boat's remnants is that they were still largely intact approximately 30 years after being abandoned. Aside from obvious hull separation and isolated flash rusting, both the bow and stern sections are largely complete. The same can be said for the vessel's conning tower and adjacent casemate. Elements missing from *Defender* include the conning tower hatch cover and various deck fittings. By the 1940s and 1950s when the surviving hull was documented photographically some hull plating and casemate structure visible in the painting was noticeably absent, likely as a consequence of both natural and cultural processes.

Examination of the torpedo boat's existing architectural elements has confirmed a significant portion of the discarded hull survived up to its burial in 1959. This is particularly true of the bow and stern sections, which in their reconstructed form are approximately 65 to 75 percent intact (Figure 3). Most hull elements visible in historic renderings of *Defender's* remnants have survived to the present day, as have internal components such as framing and bulkheads (Hunter 2009: 6-9; Hunter 2010:152; Thornycroft Torpedo Boat Museum 2003). *Defender's* conning tower was not discovered among the site's buried components and its current whereabouts remain an open question, although at least one source claims it was acquired by the Lyttelton Museum and later accidentally sold to a scrap merchant (Cooke 2000: 132).

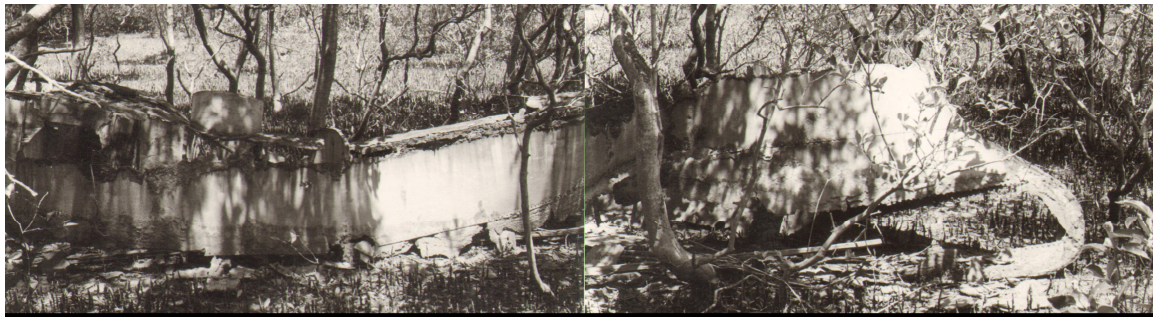
Figure 4. *Top*, starboard bow section of HMQS *Mosquito*'s discarded hull, as photographed in 1966; *bottom*, archaeological plan of the *Mosquito* site as it appeared during the 2009 survey. Photograph by S. Prior, courtesy Queensland Maritime Museum collection. Site plan produced by the author.

By contrast, the sides of the hull, all but one bulkhead, and the remaining upperworks had collapsed either within or outside the hull and become partially or completely buried in mud by 1966. A single articulated bulkhead visible in the photographs seems to have played a significant role in holding the torpedo boat's surviving stern structure together. The vessel's conning tower, which by the 1960s was disarticulated from the rest of the hull and lying on its side, was still almost completely intact as an architectural element. Attached to the conning tower was a surviving—but heavily corroded—section of its hatch cover (Hunter 2011: 379-382).

Archaeological investigation of *Mosquito's* discard site has confirmed most of the exposed hull collapsed and subsequently settled into the mud and silt of the swamp floor (Hunter 2011:381-384). By contrast, *Mosquito's* stern, already largely buried at the time of the 1966 photographs, appears to have retained its structural integrity. This is best evidenced by results of a probe survey, which detected contiguous metal contacts along the hull's projected stern centreline. A

Based on available evidence, human alteration of *Mosquito*'s hull prior to 1966 seems to have been restricted to the conning tower, which was removed and re-deposited at some point between the boat's disposal at Boggy Creek and when it was captured on film (Hunter 2011:381). Individual artefacts, including the complete stern section of its casemate, were removed between 1966 and 1972. All were eventually donated to the Queensland Museum and later accessed and analysed by the author (Hunter 2011: 382). A notable feature of these objects is their relatively good state of preservation. For example, the casemate section is intact, ductile, largely free of corrosion and still retains paint over much of its exterior surface. If these attributes are indicative of the overall condition of *Mosquito*'s hull at the time it was discarded, it is surprising the majority of its metal constituents weren't targeted for salvage.

With the possible exception of the mud and silt substrate in which the hull was embedded, placement assurance strategies do not appear to have played a role in *Mosquito*'s abandonment. Inspection of the site's visible components neither reveal evidence of treatments such as filling or induced perforation of the hull nor are indicators of these techniques apparent in the 1966 photographs. As
