# Long-Term Durability of GFRP Internal Reinforcement in Concrete Structures

**Synopsis:** Glass fiber reinforced polymer (GFRP) bars are emerging as a feasible economical solution to eliminate the corrosion problem of steel reinforcements in concrete structures. Confirmation of GFRP long-term durability is crucial to extend its application especially in structures exposed to aggressive environments. The objective of this study is to investigate the performance of GFRP bars exposed to the concrete alkalinity and ambient condition in two bridges with more than a decade old located in the City of Rolla, Missouri: i) Walker Bridge (built in 1999), which consists of GFRP-reinforced concrete box culverts; and; ii) Southview Bridge (built in 2004), which incorporates GFRP bars in the post-tensioned concrete deck. In order to monitor the possible changes in GFRP and concrete after years of service, samples were extracted from both bridges for various analyses. Carbonation depth, chloride diffusion, and pH of the concrete surrounding the GFRP bars were measured. Scanning electron microscopy (SEM) imaging and energy dispersive X-ray spectroscopy (EDS) were performed to monitor any microstr

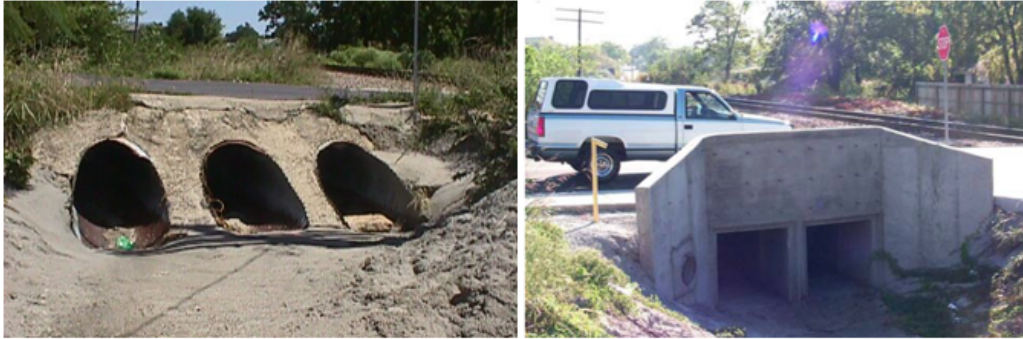
Fig. 1—Old (left) and new (right) Walker Bridge

The Walker box-culvert bridge was constructed in 1999 on Walker Avenue in the City of Rolla, Missouri to replace the original bridge which was made of three concrete-encased corrugated steel pipes and became unsafe to operate due to excessive corrosion of the steel pipes. GFRP bars were implemented in the new bridge as an alternative for steel rebar in order to extend the service life beyond that of conventional steel-RC construction. The new bridge is 10.97 m (36 ft.) wide, consisting of eighteen 1.5 by 1.5 m (4.92 by 4.92 ft.) box culverts with a

thickness of 150 mm (5.9 in.). The old and new bridges are shown in Fig. 1. The RC boxes were entirely reinforced with No.2 GFRP bars (nominal diameter of 6.3 mm) pre-bent and cut to size by the manufacturer. The 25.4 mm (1 in.) concrete cover was maintained using plastic wheel spacers. Fig. 2 shows a completed GFRP cage before concrete casting. Conventional concrete made of Portland cement, fly ash, tap water, and Missouri river aggregate with a maximum aggregate size of 9.5 mm (3/8 in.) were used to produce the units. The measured concrete compressive strength was 42.7 MPa (6.2 ksi) [4].

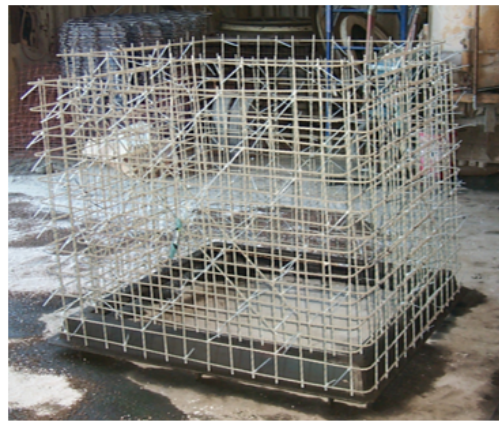
Fig. 2—A complete GFRP cage before concrete casting

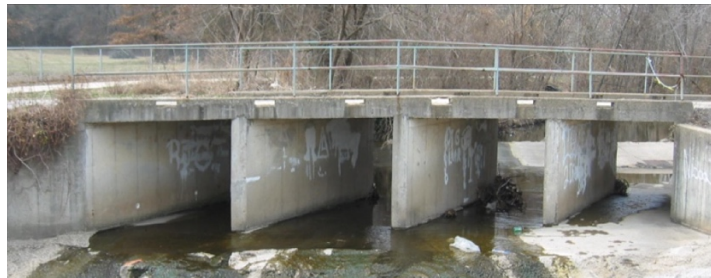
Fig. 3—A view of the former Southview Bridge

Southview Bridge initially included four-cell steel reinforced concrete (RC) box-culverts (Fig. 3). The 250 mm (10 in.) thick RC bridge slab went through an expansion in 2004 which included the construction of an additional lane and a sidewalk [5]. The new deck was built on three conventional RC walls as for the existing structure. The concrete deck of the complementary part implemented Nos. 3, 4 and 6 GFRP bars (Fig 4) and No. 3 prestressed CFRP tendons [6]. The construction of the FRP reinforced slab, plus a 2 m (6.6 ft.) wide conventional RC sidewalk on the opposite side, allowed extending the overall width of the bridge from 3.9 m (12.8 ft.) to 11.9 m (39.0 ft.). The measured concrete compressive strength was 41.4 MPa (6 ksi). The guaranteed properties of the GFRP bars used in Southview Bridge is shown in Table 1.

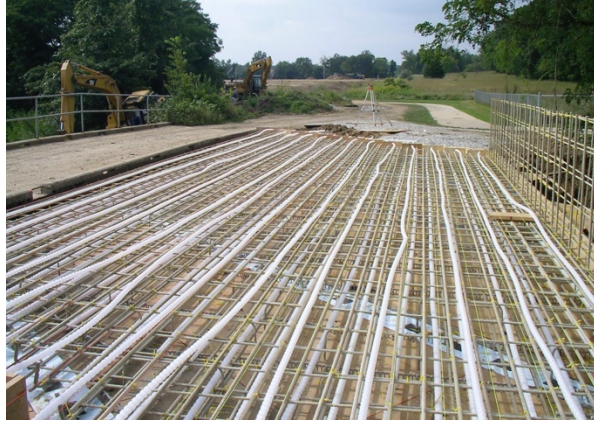
Fig. 4—Southview Bridge deck top-GFRP layer and CFRP tendons

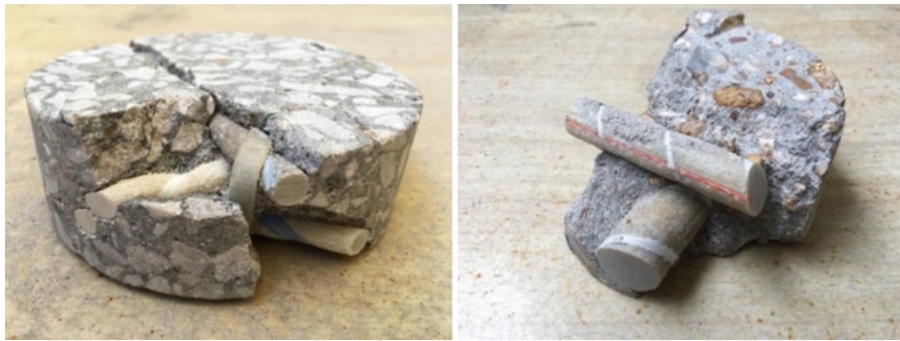
Fig. 5—GFRP coupons extracted from the concrete cores of Walker (left) and Southview (left) Bridge

Technically-competent personnel performed the extraction of concrete cores from both bridges in 2016. Four 102 mm (4 in.) diameter concrete cores were extracted from the bottom of two culverts of Walker Bridge and two cores with similar size were extracted from the deck of the Southview Bridge. GFRP coupons were extracted from the cores (Fig. 5) and were sliced to an approximate width of 10 mm (0.4 in.) using a diamond saw for microscopic examination. The surface of the GFRP samples was prepared by sanding using different levels of sandpaper and employing polishing equipment. Fine polishing completed the specimen preparation using a wet-polishing agent and polycrystalline diamond paste. The specimens used in SEM imaging were also employed in EDS analysis. Additionally, the coupons were cut in appropriate sizes for horizontal shear strength,  $T_g$  and fiber content measurements.

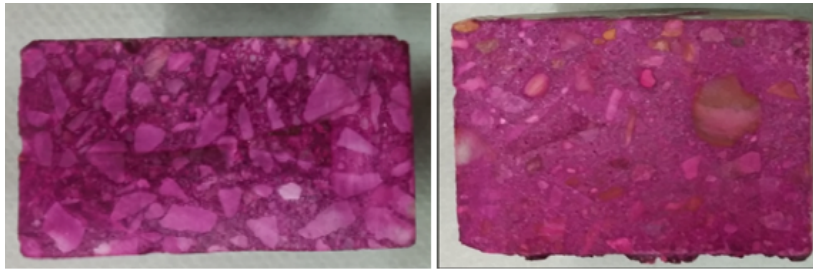
A carbonation depth equal to the concrete cover may be responsible for steel corrosion initiation. The carbonation depth was measured by spraying the 1% solution of phenolphthalein in 70% ethyl alcohol on freshly fractured concrete surfaces [8]. The colorless solution turned to pink/purple when the pH was higher than 9 and stayed colorless otherwise. No indication of concrete carbonation was observed using this method in samples from both bridges (Fig 6). While no carbonation of concrete can be considered beneficial to steel rebars because the pH remains at high values, the opposite is true for GFRP reinforcement that is more sensitive to high alkalinity. Thus, the GFRP bars extracted from these cores were subject to an aggressive alkaline environment over the 17 and 11 years of service for Walker and Southview bridge respectively.

Fig. 6—Carbonation depth measurement of concrete samples extracted from Walker (left) and Southview (right) Bridge

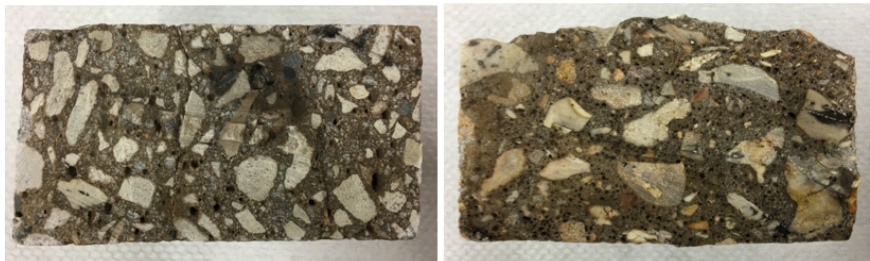
An adaptation of the rapid migration test (RMT) using silver nitrate solution was employed to determine the chloride diffusion in the concrete samples. Two concrete samples were cut in order to provide fresh split surfaces. A 0.1 mol/L silver nitrate solution was poured on the entire cut surface [9]. In presence of chloride, a clearly visible white/silver precipitation takes place on the surface while in the absence of chlorides, the solution reacts with the hydroxides present in the concrete, changing the surface color to brown. No clear evidence of chloride diffusion was observed in all the tested specimens of both bridges using this method. It was noticed that the surface became darker, to a color similar to brown, while there was no visible gray area (Fig 7).

Fig. 7—Chloride diffusion measurement of concrete samples extracted from Walker (left) and Southview (right) Bridge

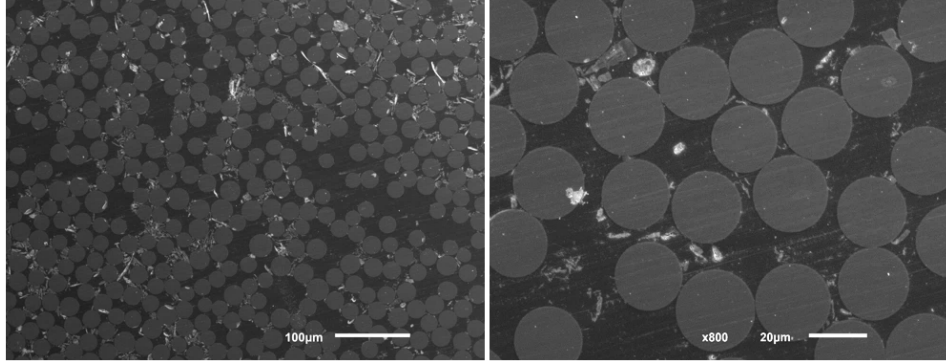
The GFRP microstructure was investigated since it is a critical parameter in performance and durability of GFRP bars [10]. The full cross-section of prepared GFRP coupons were scanned using SEM at different levels of magnification and images were taken at random locations. Attention was paid to the areas in the vicinity of the bar edges since possible degradation due to chemical attack starts at GFRP-concrete interface. Representative images are shown in Fig 8 and Fig 9. SEM analysis suggests that there was no apparent sign of deterioration in the GFRP coupons. No damage was observed in the matrix and at the matrix-fiber interface. Glass fibers appeared to be intact without no loss of cross-sectional area.

Fig. 8—SEM images of GFRP bar after 16 years of service in Walker Bridge in magnification levels of 200x (left) and 800x (right)

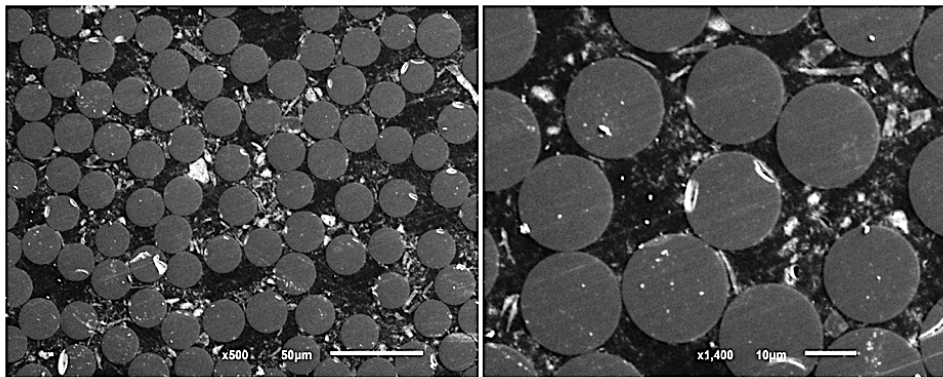
Fig. 9—SEM images of GFRP bar after 11 years of service in Southview Bridge in magnification levels of 500x (left) and 1400x (right)

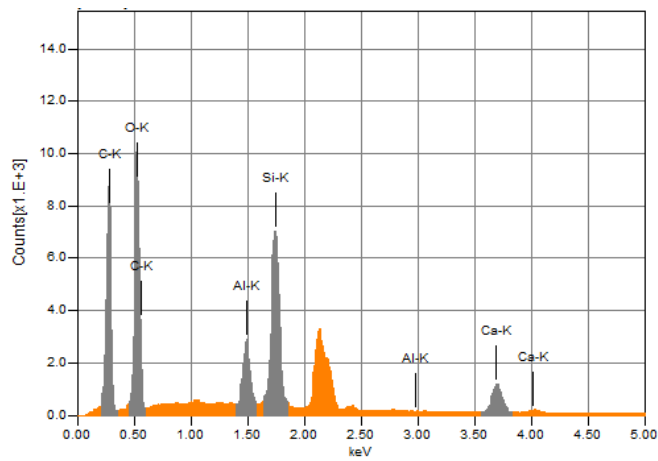
EDS was performed at several locations of each GFRP slices with a focus on the edge of the bar to identify existing chemical elements. Results are shown in Fig 10 and Fig 11 where the vertical axis corresponds to the counts (number of X-rays received and processed by the detector) and the horizontal axis presents the energy level of those counts. Si, Al, Ca (from glass fibers) and C (from the matrix) were the predominant chemical elements in the extracted samples. No apparent sign of any chemical attack was observed in the bars.

Fig. 10—Result of the EDS analysis performed on GFRP samples extracted from Walker Bridge

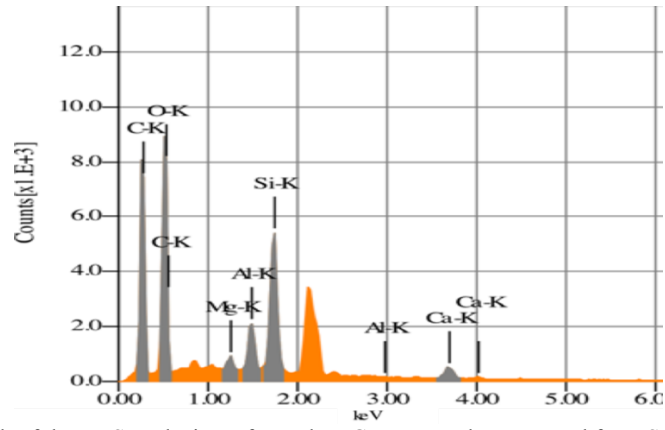
Fig. 11—Result of the EDS analysis performed on GFRP samples extracted from Southview Bridge

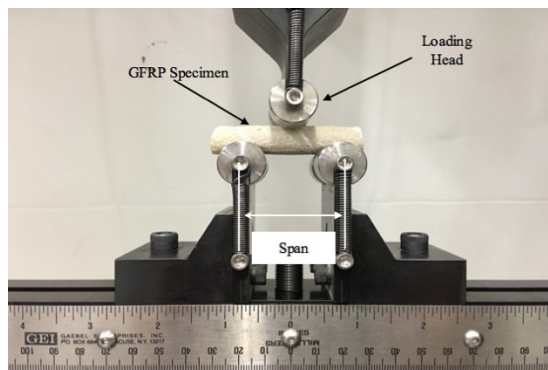
The horizontal shear strength of the extracted GFRP coupons was determined following ASTM D4475 [11] as a useful parameter for durability evaluation. The test was performed on three GFRP coupons extracted from Southview Bridge: i) one No. 4 GFRP bar with the total length of (58 mm) 2.3 in, and ii) two No. 6 GFRP bars with the total length of 76 mm (3 in.) and (74 mm) 2.9 in. No horizontal shear test was performed on samples extracted from Walker Bridge due to their small diameter. Since no historic data was available at the time of construction, the results were compared to the test performed on pristine bars produced by the same manufacturer in 2015 as a benchmark. Specimens were tested with the span-to-diameter ratio equal to three, according to standard and compared with pristine samples. The test was performed in displacement control with the rate of 1.27 mm/min (0.05 in/min) of the cross head (Fig 12).

Fig. 12—Horizontal shear test performed on GFRP bars extracted from Southview Bridge
