Defence Aviation Safety Authority

# ADF Aircraft Propulsion Systems - Challenges & Lessons Learnt

Flight Lieutenant Rashmin (Rash) Gunaratne

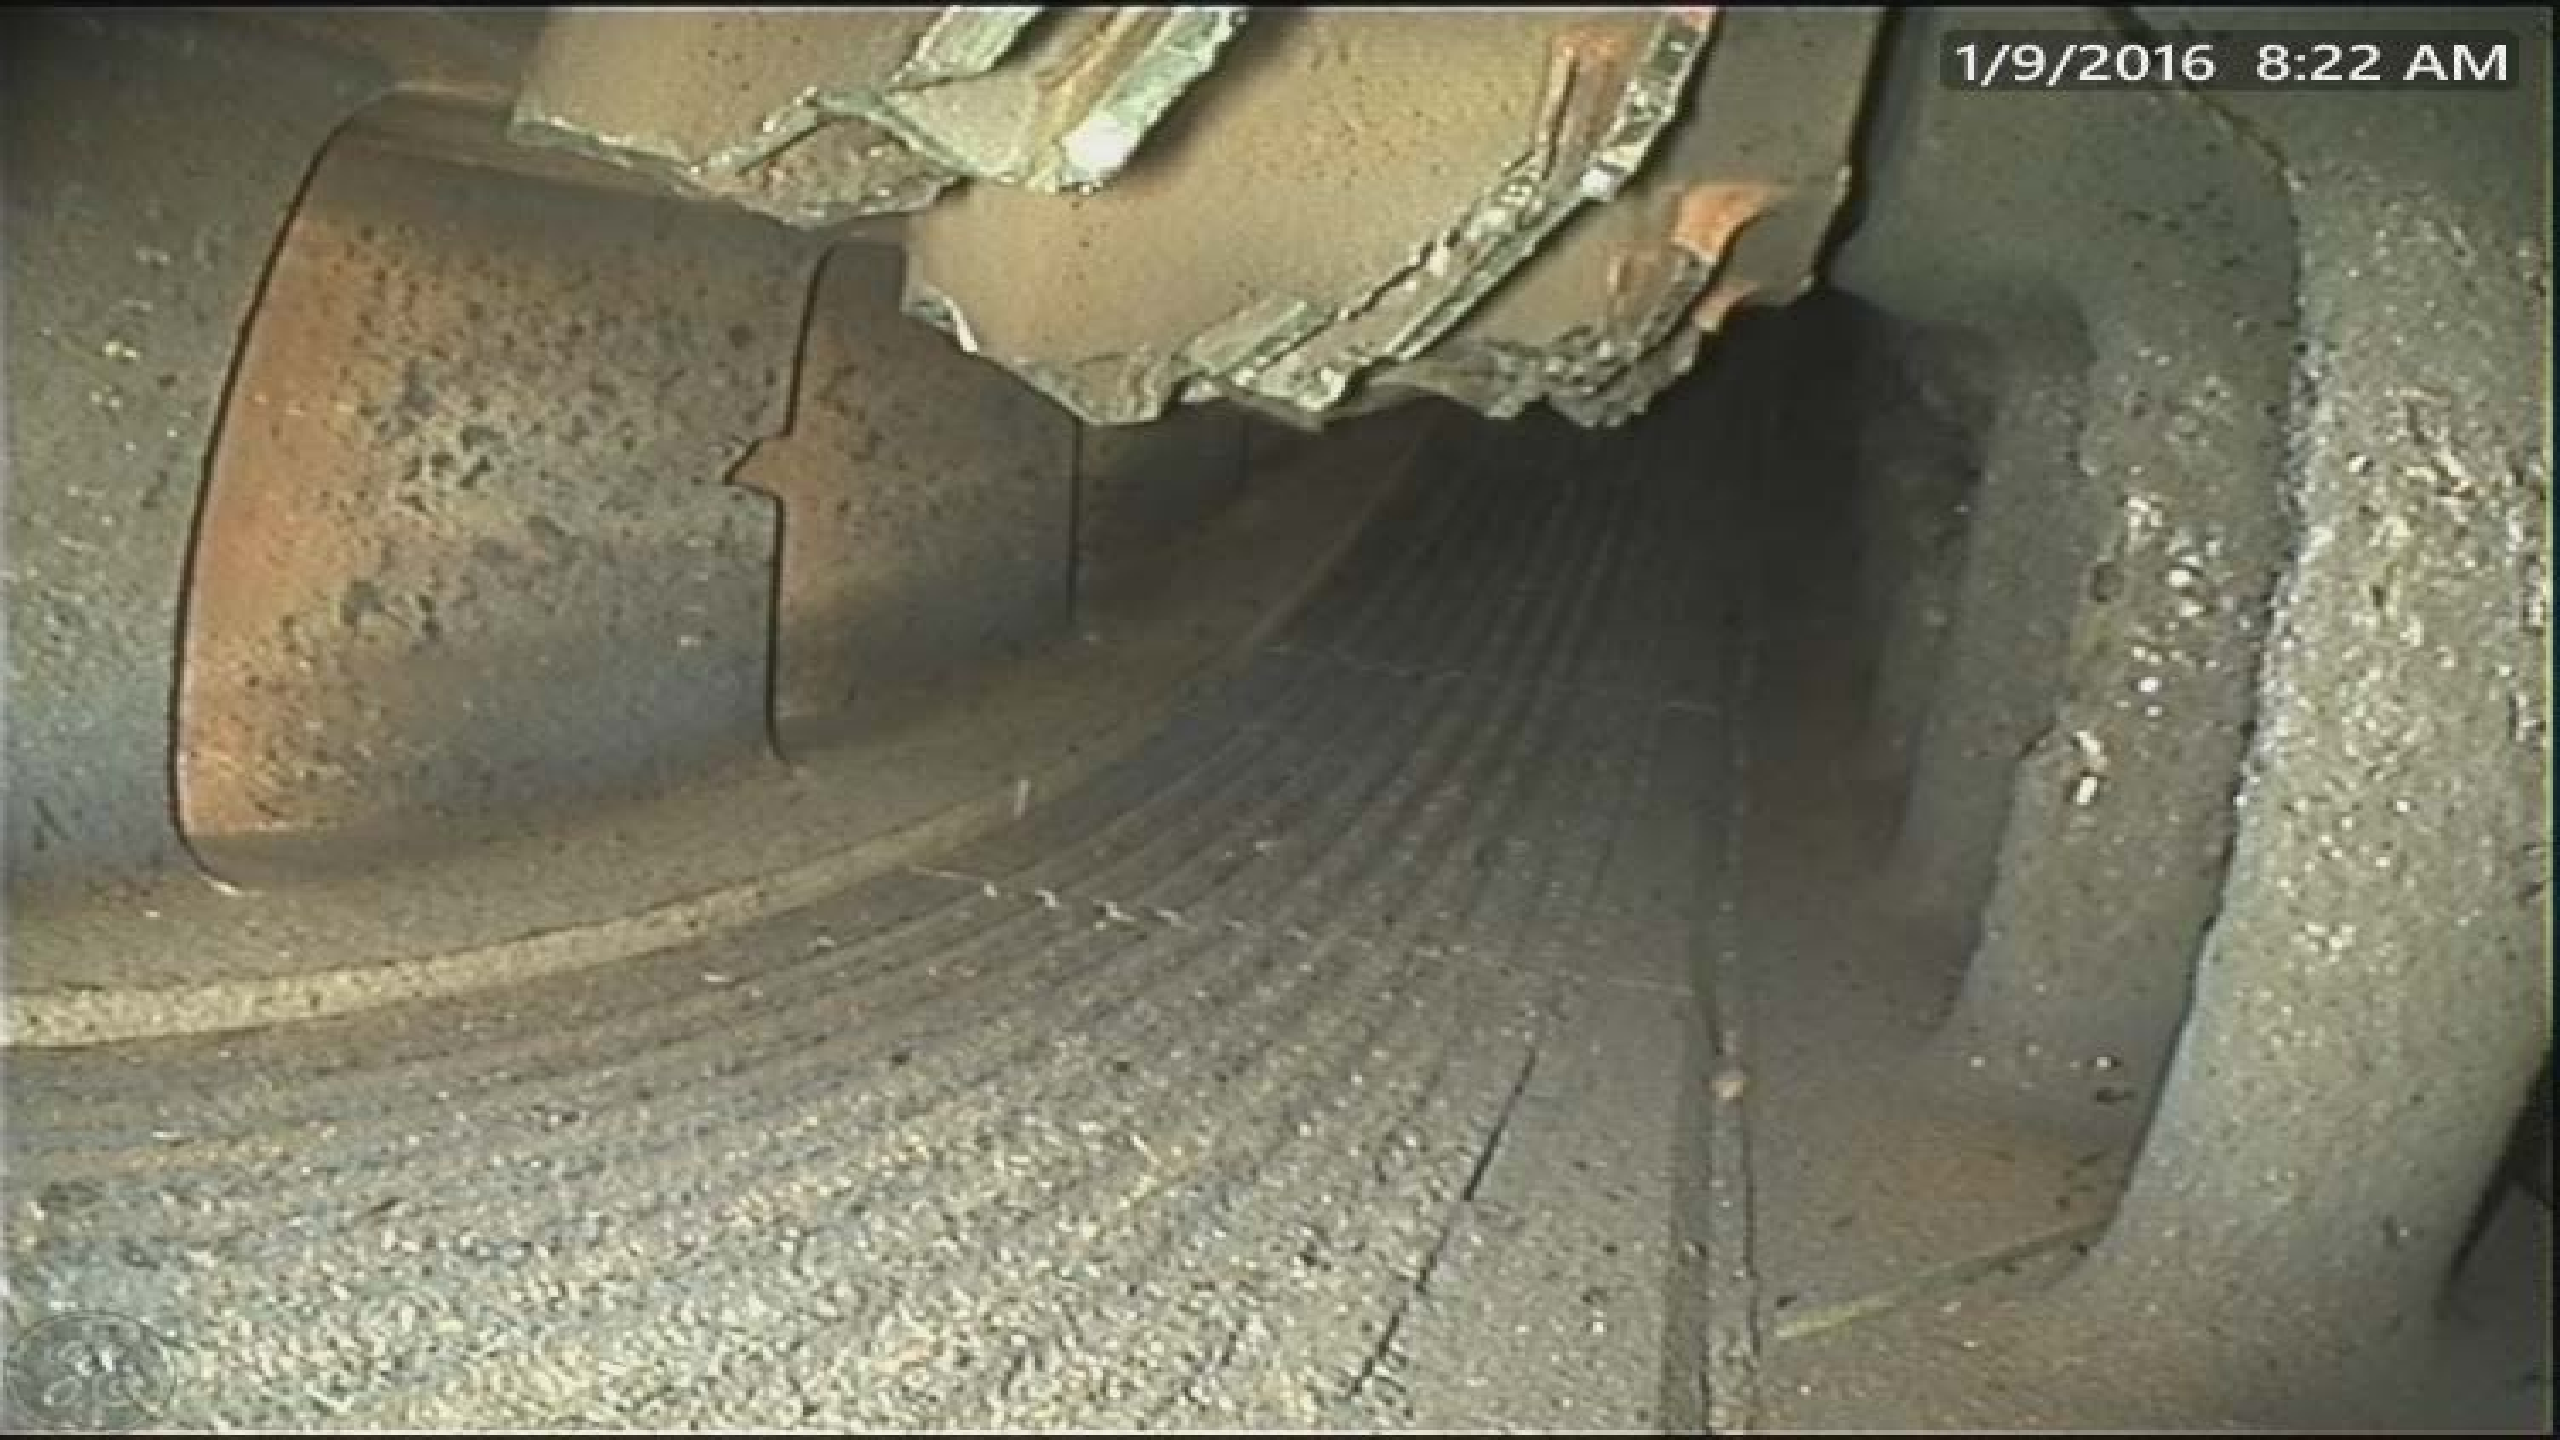
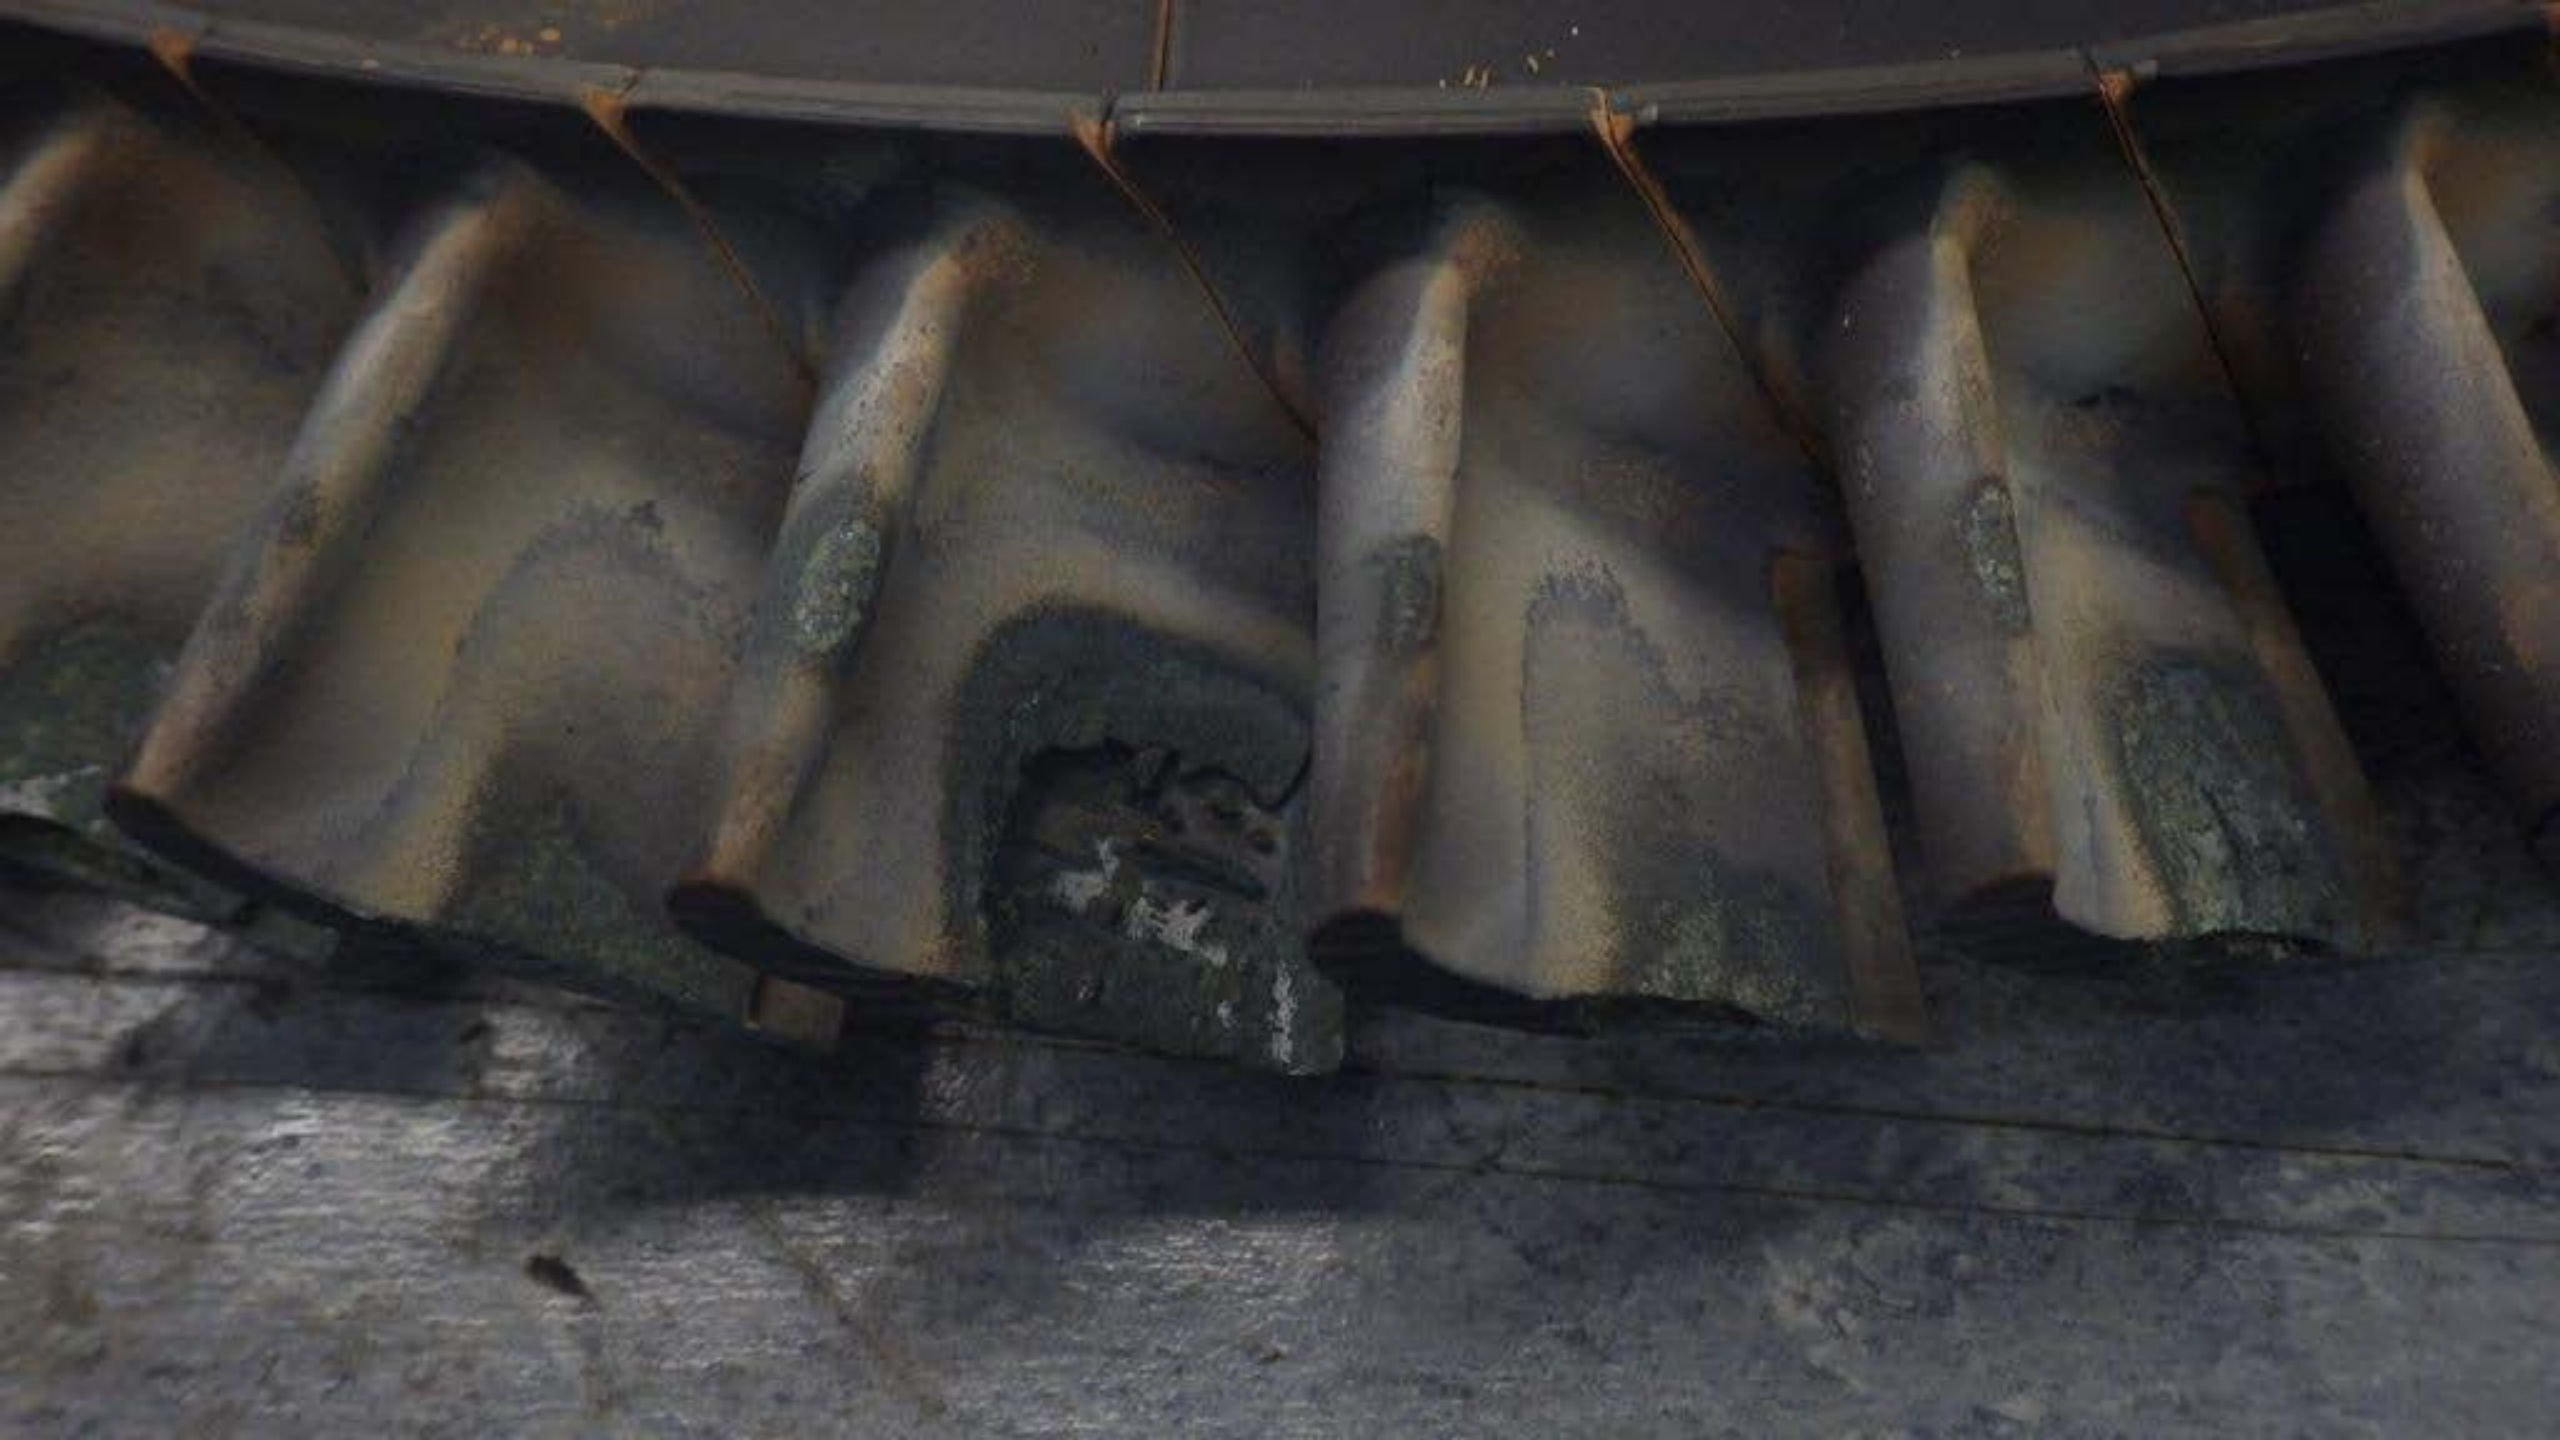
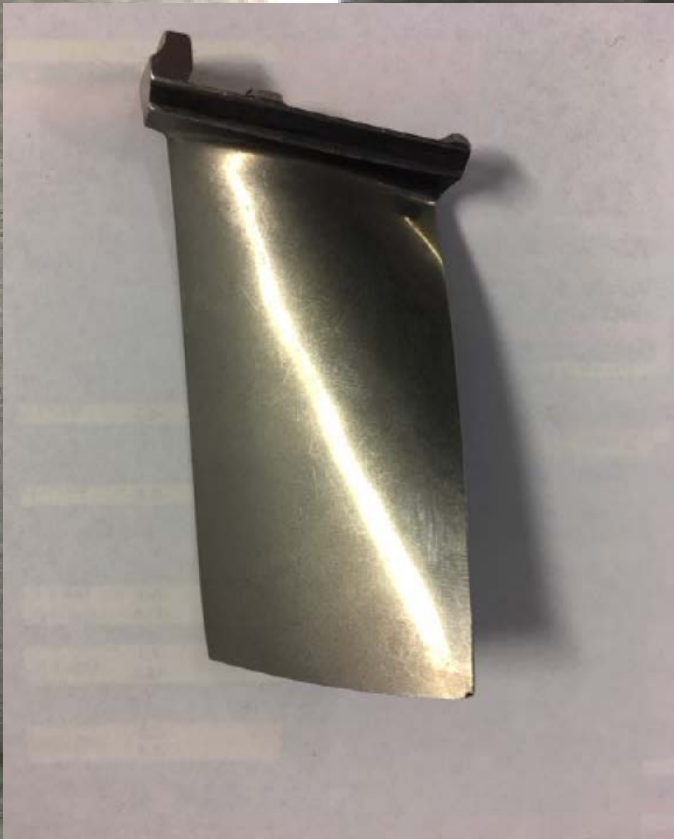
- Presented at the 2018 AA&S conference by StandardAero
- Multiple engine IFSDs in a short period of time
- Cause:
  - Worn compressors
  - Lack of MGT margin
  - Engine attempts to increase fuel flow – attempts to run hot section hotter
  - Significant degradation of hot section – Requires replacement

- Impact of engine degradation
  - Lack of engine availability – impact on missions
  - Increased engine induction to DM venue
  - Increased cost of engine repair & OH
    - Significant damage on downstream components
  - Increased maintenance burden
    - Engine removal & installation
    - Increased effort to make other aircraft serviceable

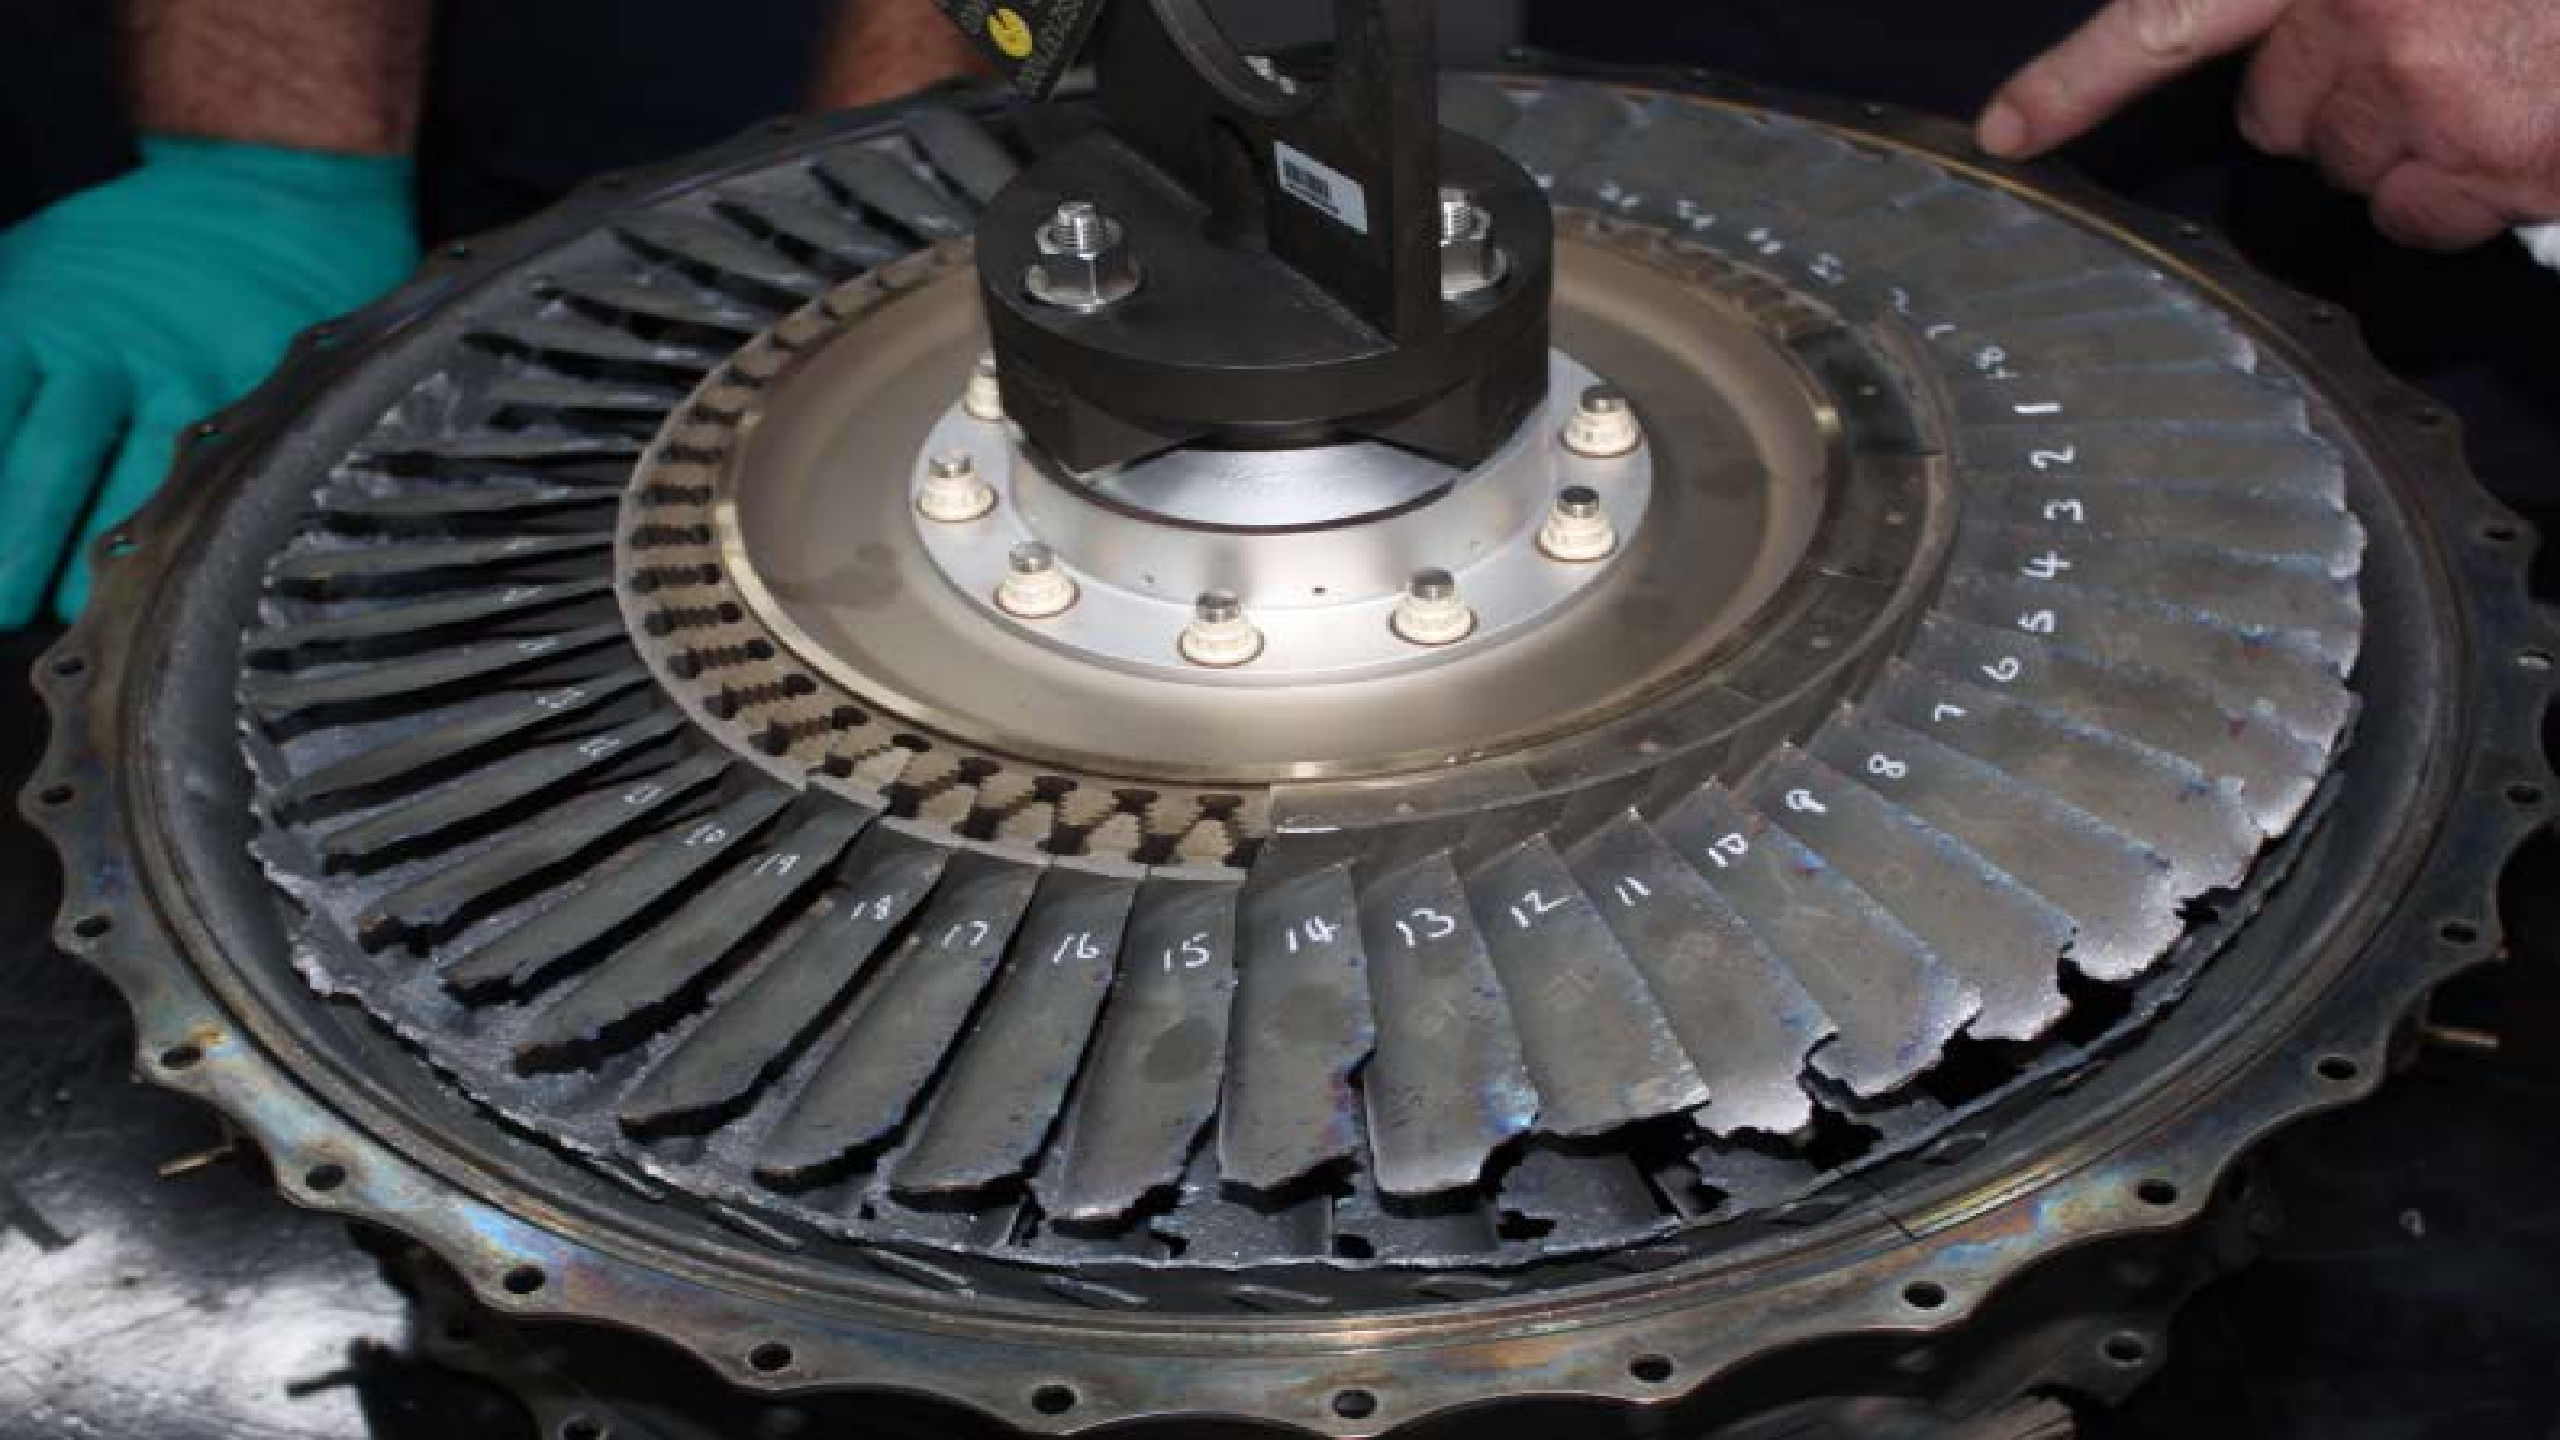
2 mm

- Recently an ADF helicopter suffered an engine component failure
- Investigation revealed:
  - A PT blade migrated forward within its PT1 disc slot
  - Blade liberation caused secondary damage to PT1 and PT2 blades, cascading with further liberation of debris
  - First of type in global fleet

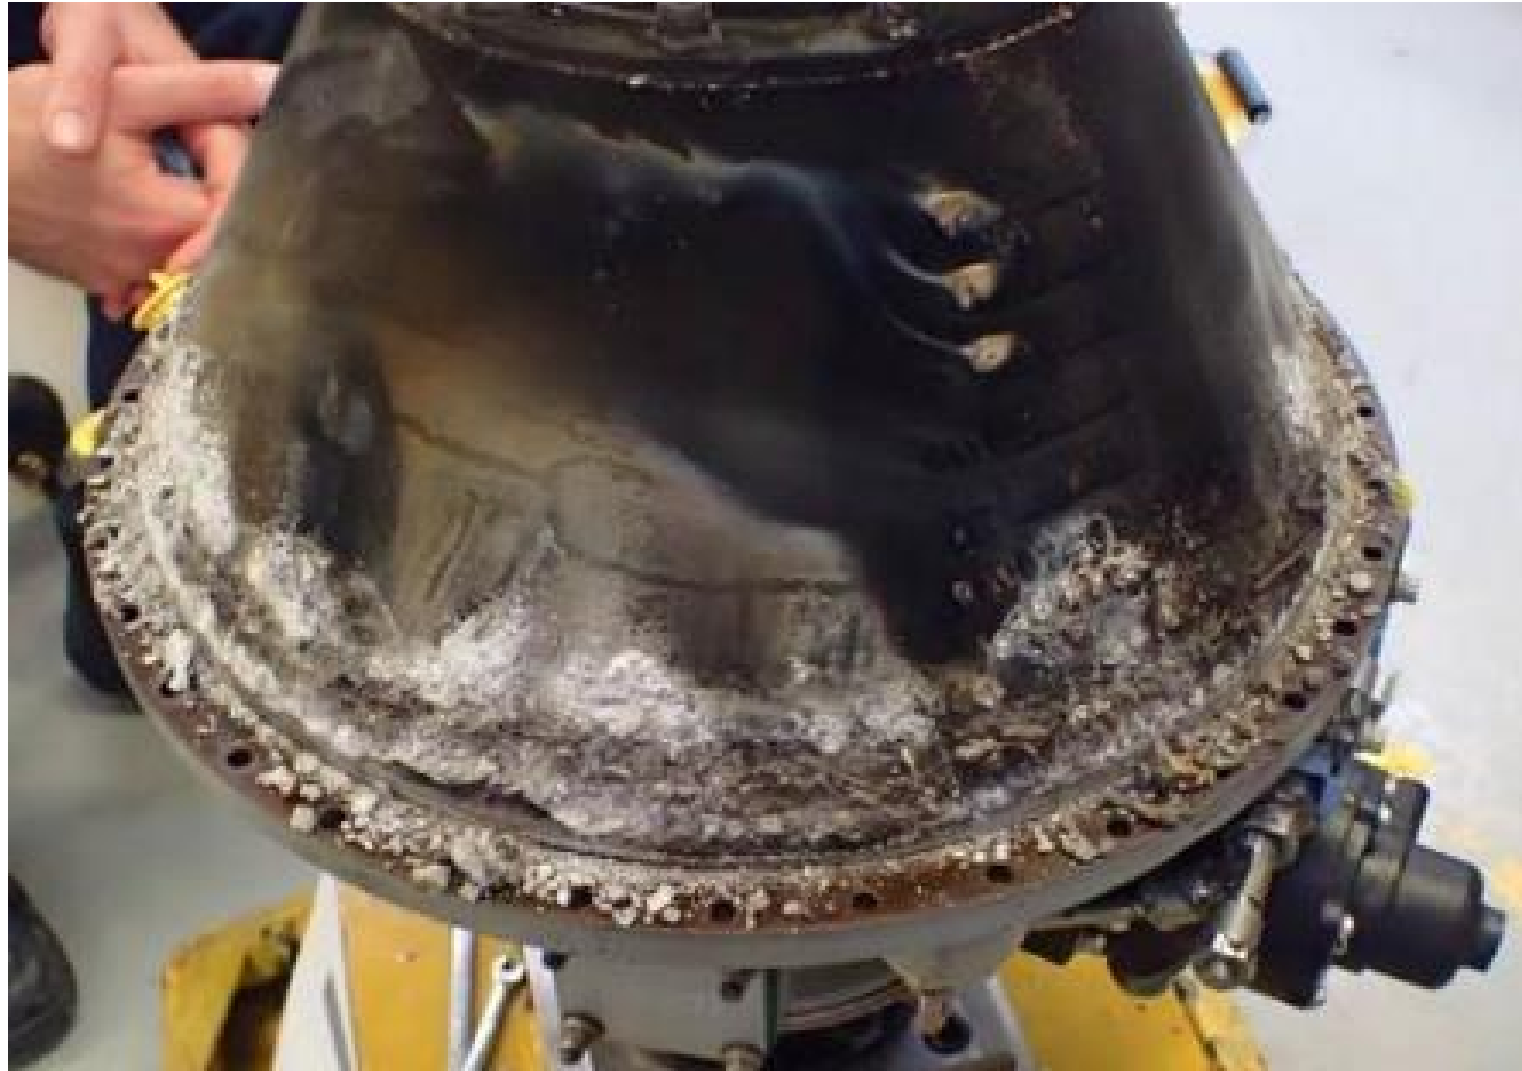
- **Situation:** During a compressor wash, gravel/ceramic substance was discovered in the turbine case drain hole
  - Substance was identified as Magnesium Oxide
  - Further investigation revealed **significant** corrosion of the reduction gearbox
  - Corrosion penetrated the case
- Engine in question: 16 months inactive in the previous 3 years of service
- **Cause:**
  - Age
  - **Lack of preservation during inactive time**
  - Multiple maintenance venues & organisations

- **Effect:**
  - Fleet inspection of RGB for corrosion
  - Permanent change to publications to conduct boroscope inspections to identify corrosion
  - Conduct further analysis of water captured from compressor washes to detect MgO
  - Another costly fleet recovery activity

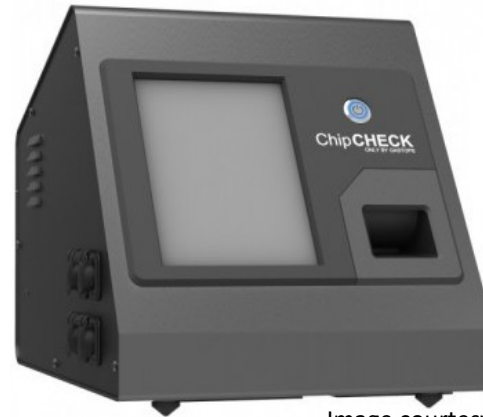
Image courtesy of GasTOPs

- The ChipCHECK instrument is specifically designed for in-field composition analysis of aviation propulsion machinery wear debris

- Manufactured by GasTOPs Ltd and is commercial off-the-shelf
- Uses Laser Induced Breakdown Spectroscopy (LIBS) to determine elemental composition of wear debris

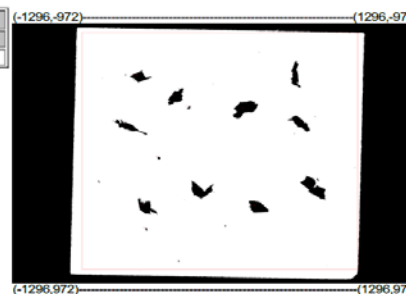
#### Patch Image (2592 x 1944)

Alloy	No. Particles	Particle Area (um <sup>2</sup> )		
		Mn	Mxc	Total
Brass	13	9,010	713,684	4,538,620

Particle ID	Area Size (um <sup>2</sup> )	Centroid XY	Alloy Match
1	713,684	(X=586,Y=260)	Brass
2	672,995	(X=175,Y=-323)	Brass
3	502,741	(X=-99,Y=275)	Brass
4	445,137	(X=251,Y=403)	Brass
5	404,971	(X=-461,Y=402)	Brass
6	402,414	(X=-263,Y=-419)	Brass
7	374,222	(X=531,Y=-219)	Brass
8	347,484	(X=491,Y=-585)	Brass
9	340,857	(X=-575,Y=-196)	Brass
10	295,053	(X=-507,Y=-572)	Brass
11	16,915	(X=-183,Y=-338)	Brass
12	13,137	(X=-374,Y=39)	Brass

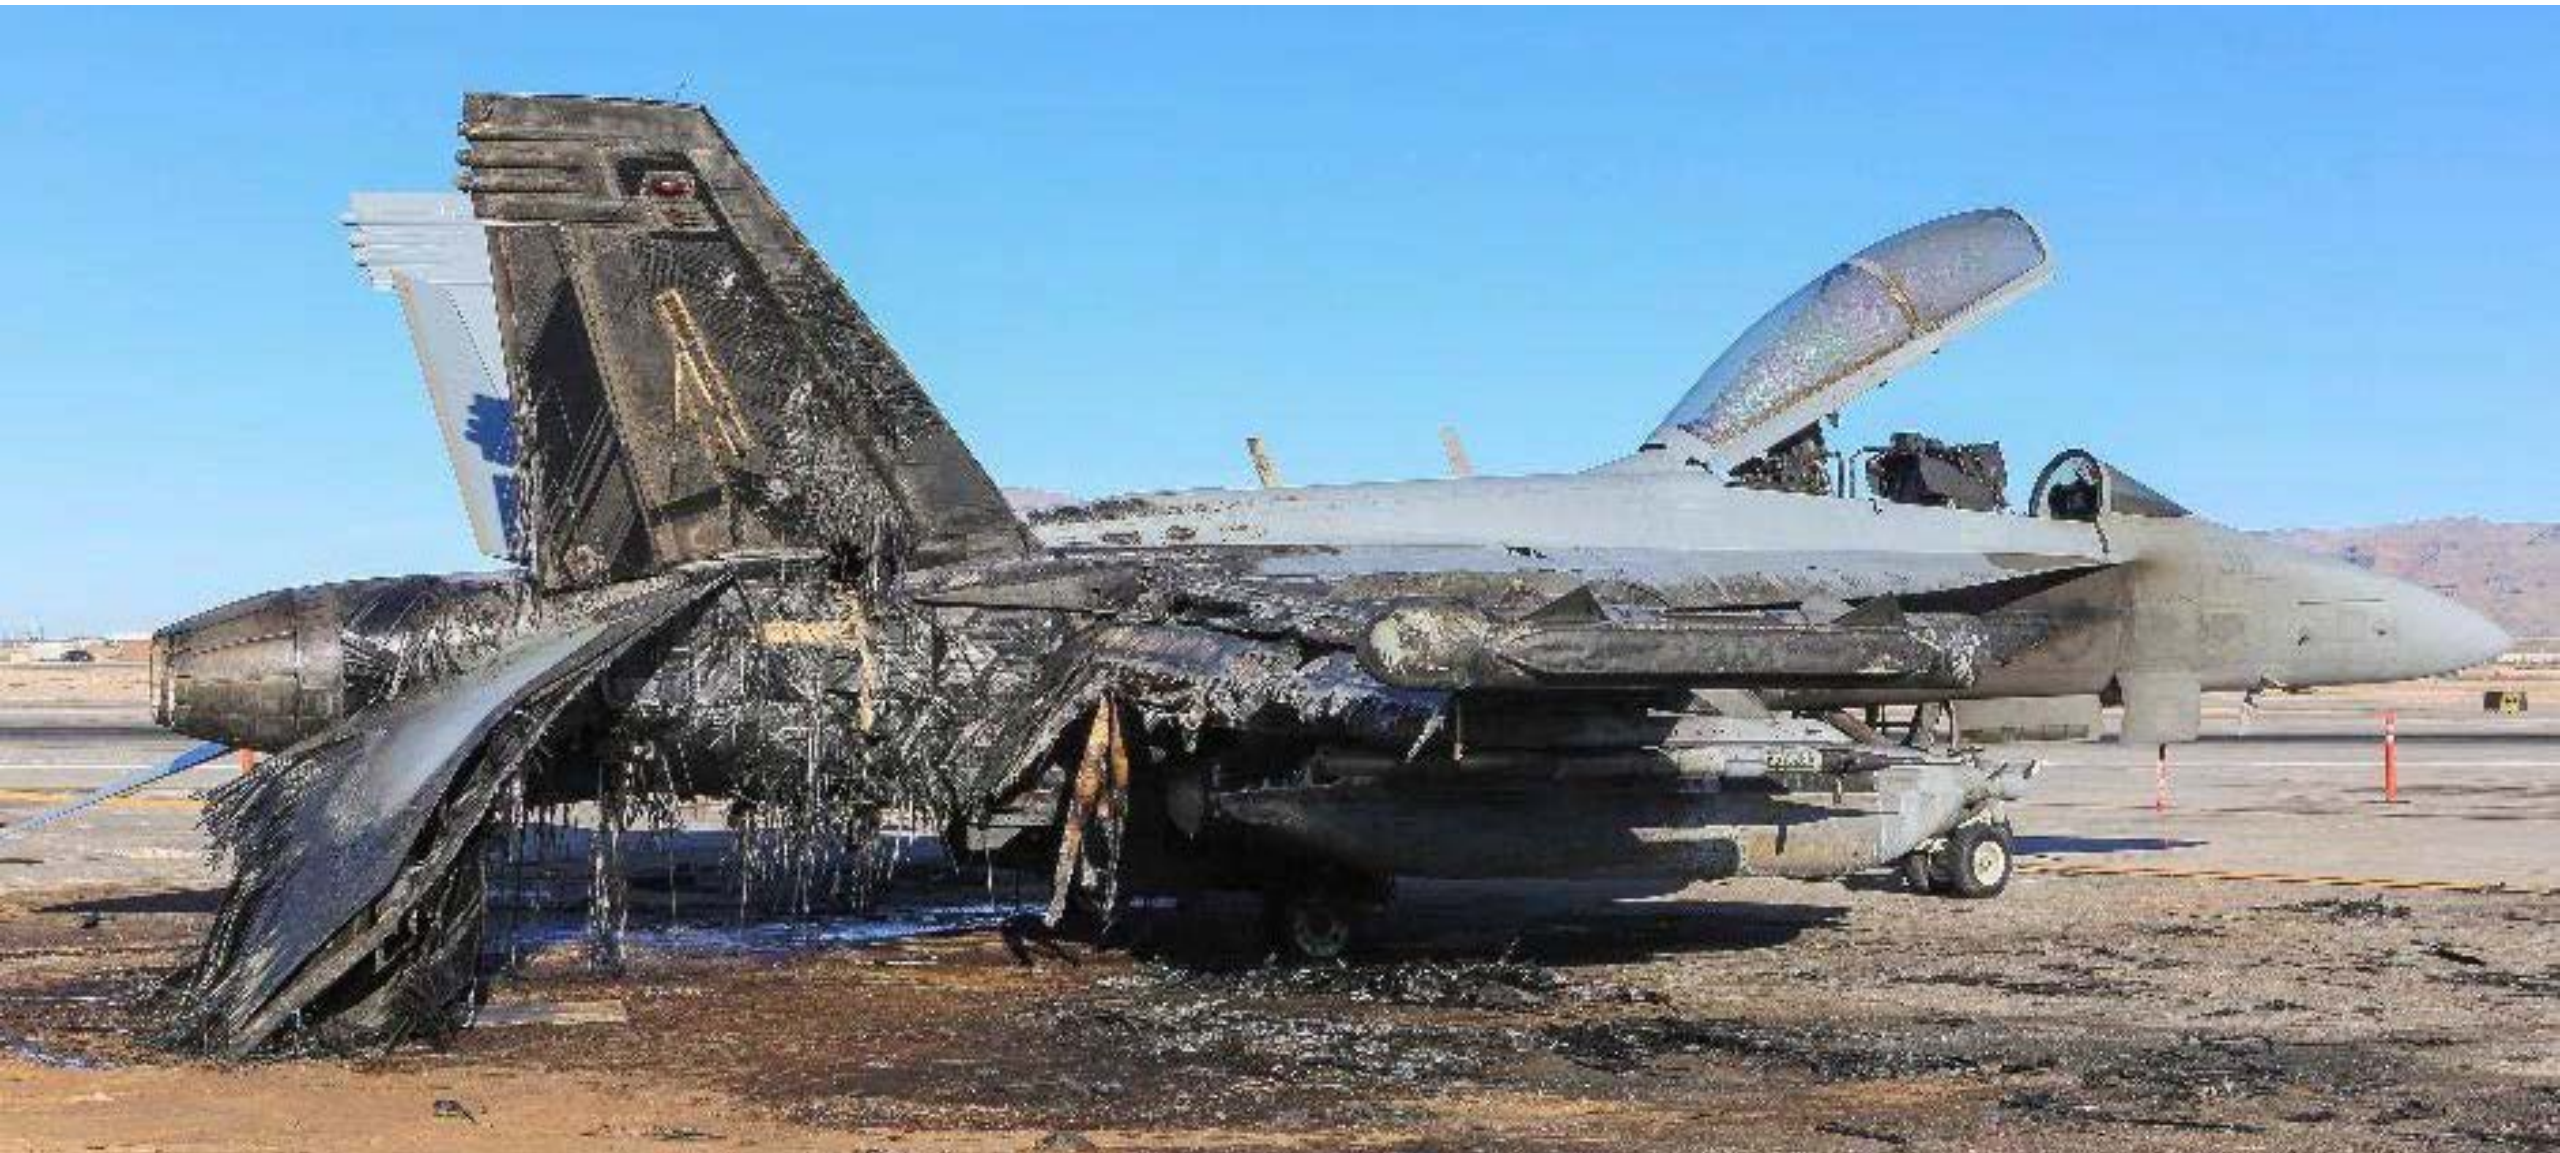
What can happen if a critical component fails
