Advanced Manufacturing Development of a Composite Empennage Component for L-1011 Aircraft

QUARTERLY TECHNICAL REPORT - NO. 12

This report is for the period 1 October 1978 through 31 December 1978

Lockheed Corporation
Lockheed-California Company
Post Office Box 551
Burbank, California 91520

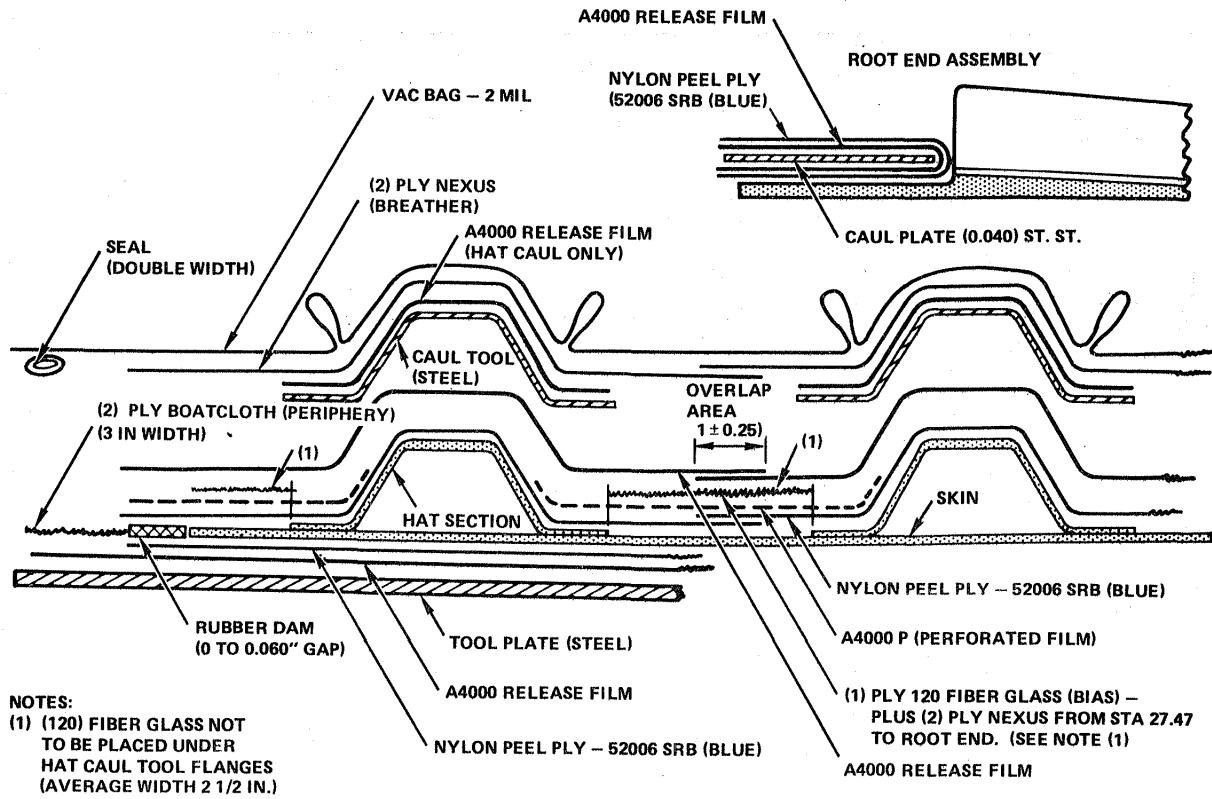
Figure 2-4. Bleeding System Assembly - Low Resin Content Prepreg

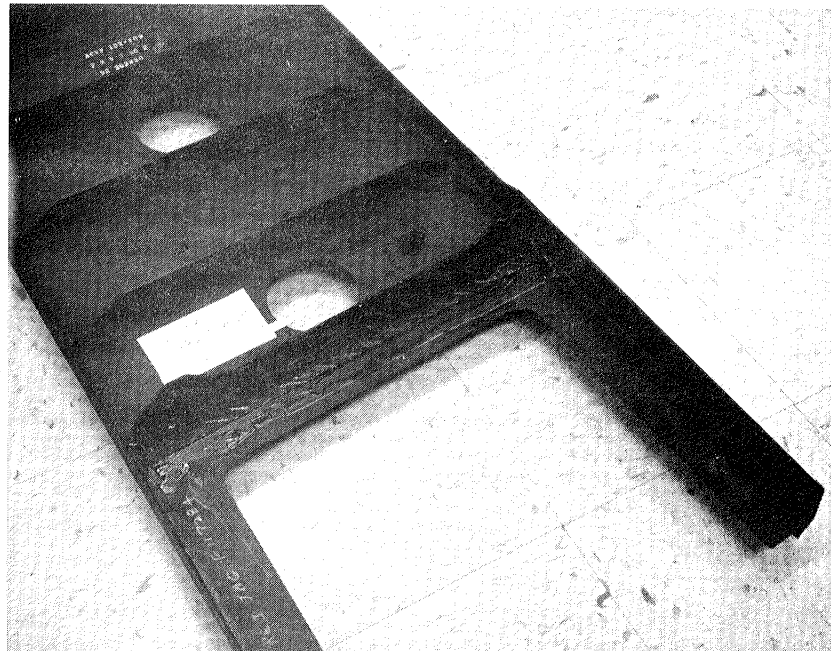
Figure 3-16. PRVT Spar Specimen No. 2, Ultrasonic Inspection Results - Crosshatched Areas Indicate Delamination

During shipment of the first lot of PRVT spar specimens, two were damaged. A contact pulse-echo technique was used to determine the extent of damage to the spars. This technique was used to simulate field conditions. Spar specimen number 2 (durability test specimen), Figure 3-16, showed evidence of delaminations on two stiffeners. The delaminations were between the stiffener and web. Spar specimen No. 3 (static test specimen), Figure 3-17, showed evidence of delaminations on one stiffener. This delamination was nearly continuous across the length of the stiffener-to-web interface. Additionally, the vertical leg showed evidence of extensive delamination.

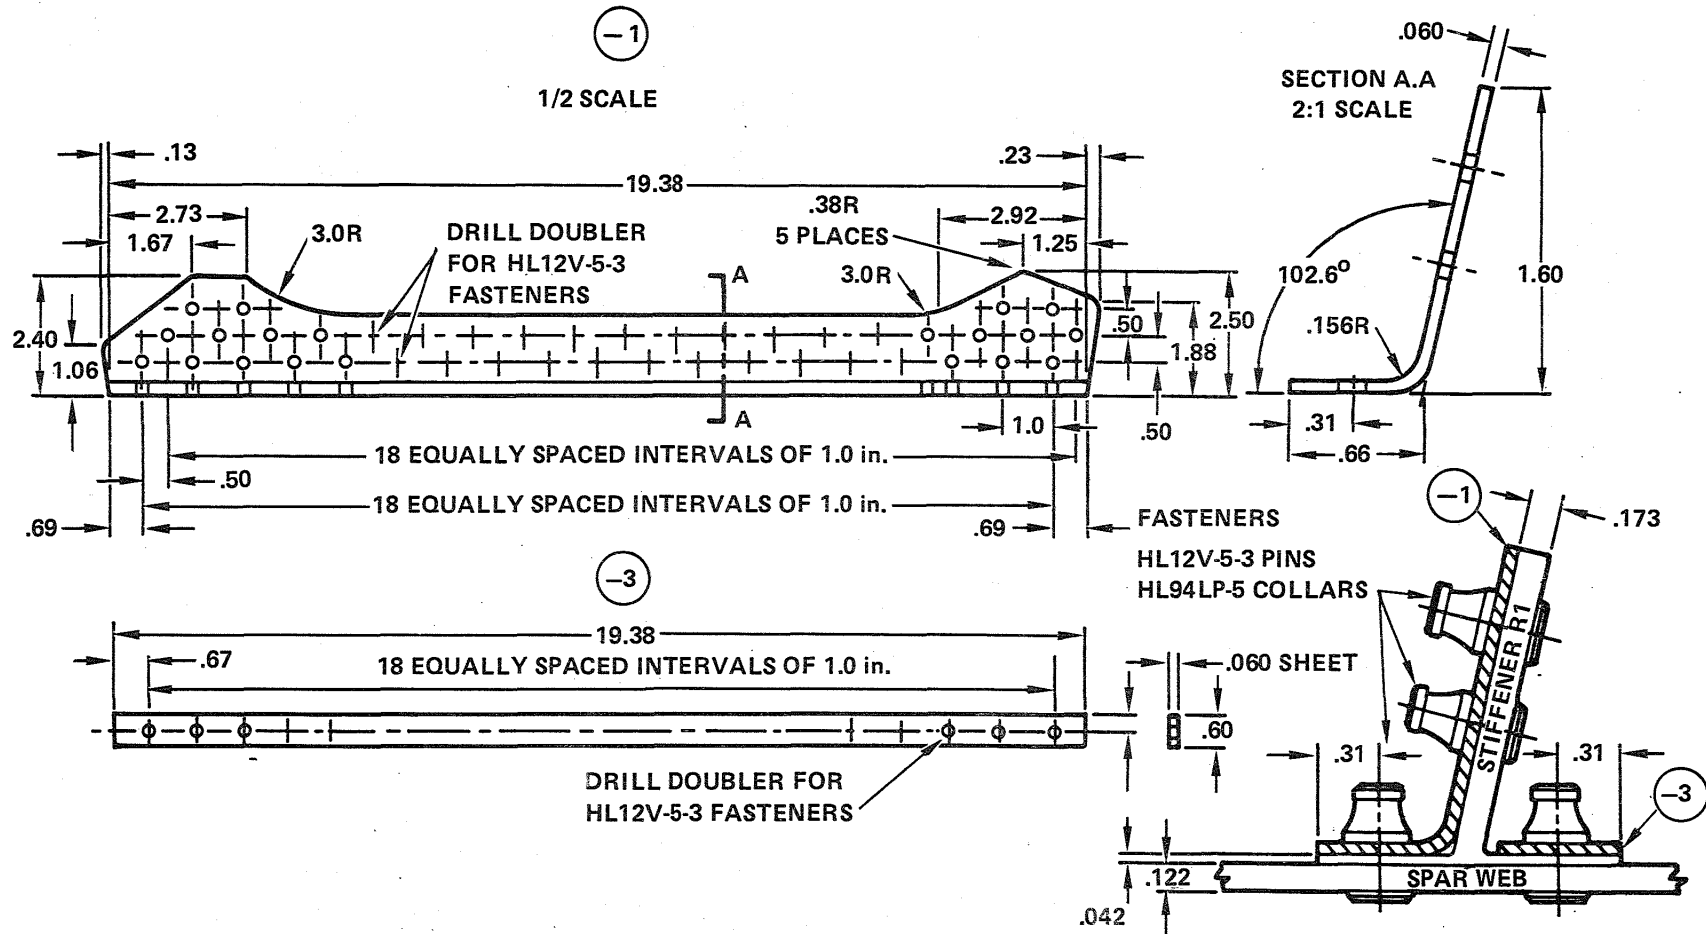
1. **MATERIAL** -3 2024-T3, -1 2024-T4 (H.T. AFTER FORMING BOND RADIUS)
2. **FINISH CODE** AA-83
3. **ALL FASTENERS TO BE INSTALLED WET**

Figure 3-18. Detail of Aluminum Doublers and Installation on PRVT Spar No. 2

1. The surface to be bonded must be free of any debris, grease, oil or other foreign material.
2. Smooth all rough exterior surfaces which will be in contact with aluminum repair doublers.
3. Fabricate aluminum doublers to the configuration and quantity shown in Figures 3-18 and 3-19.

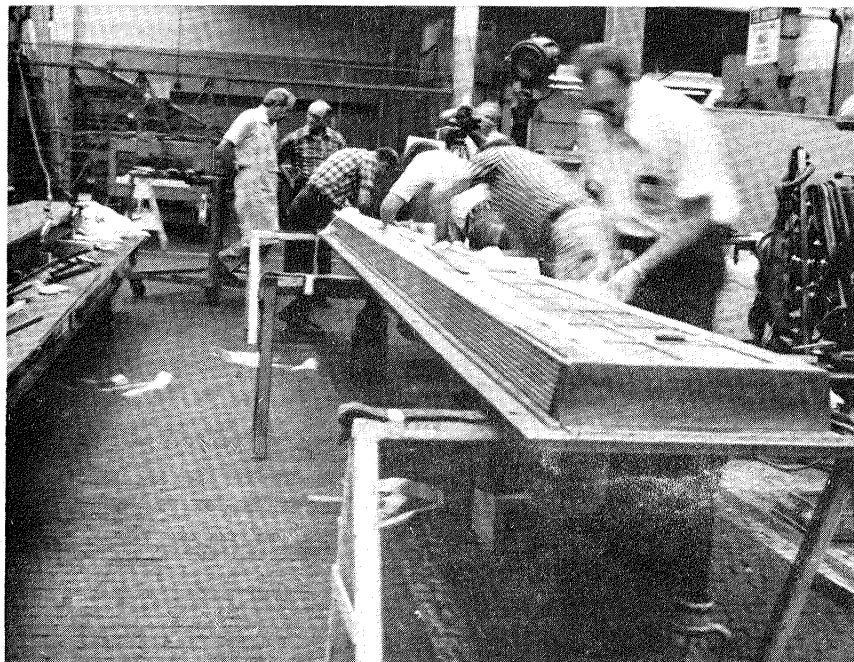
RL 3917-12

Figure 4-6. Spar Cap Rails Shown in Place

The sequence of fabrication of the first graphite spar is shown in Figures 4-4 through 4-17. Figure 4-4 shows the preplied stiffeners being loaded into the tool. Figure 4-5 shows the spar web laid on the stiffeners. The armalon breather is then laid on top of the web and the island blocks and rubber placed on top of the web. After web and stiffeners are secured the spar caps which had been preplied in the cap rails are attached to the web as shown in Figure 4-6. Final hard compaction of all the internal parts is shown in Figure 4-7. Figure 4-8 shows the cover placed on the tool and Figure 4-9 shows the tool being prepared for bagging.

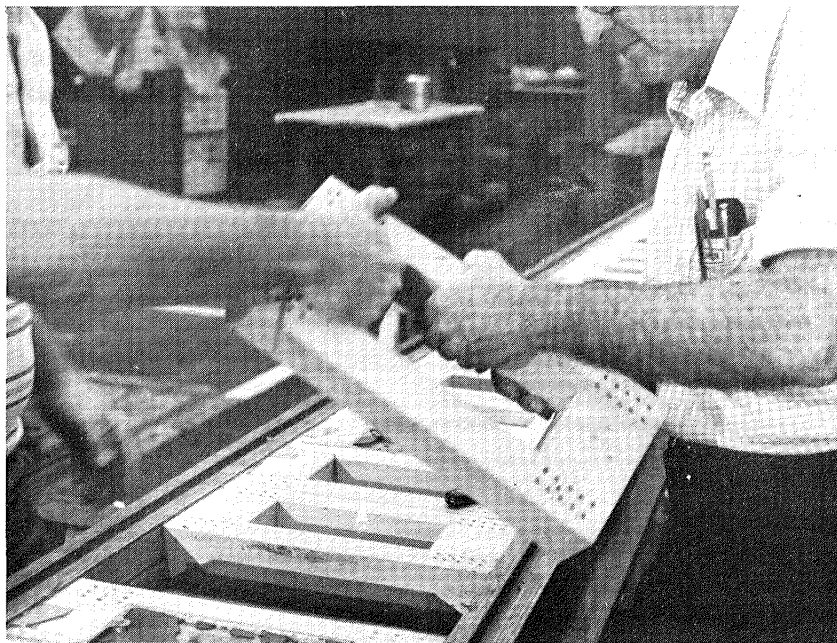
RL 3938- 3

Figure 4-11. Spar Upper End Exposed Inside Tool

After curing, the tool is disassembled. Figures 4-10 and 4-11 show the lower and upper ends of the spar inside the tool cover. The removal of the rubber blocks is shown in Figure 4-12 and removal of the lower steel island blocks is shown in Figure 4-13. Once all the internal tool parts have been removed from the stiffener side of the spar, the baseplate is put back and the tool is turned over. The cover is then lifted off and the spar is removed as shown in Figure 4-14.
